# REPLACEMENT FOR A FLEX HOSE COATING AT THE SPACE SHUTTLE LAUNCH PAD

Keywords: flex hose coatings

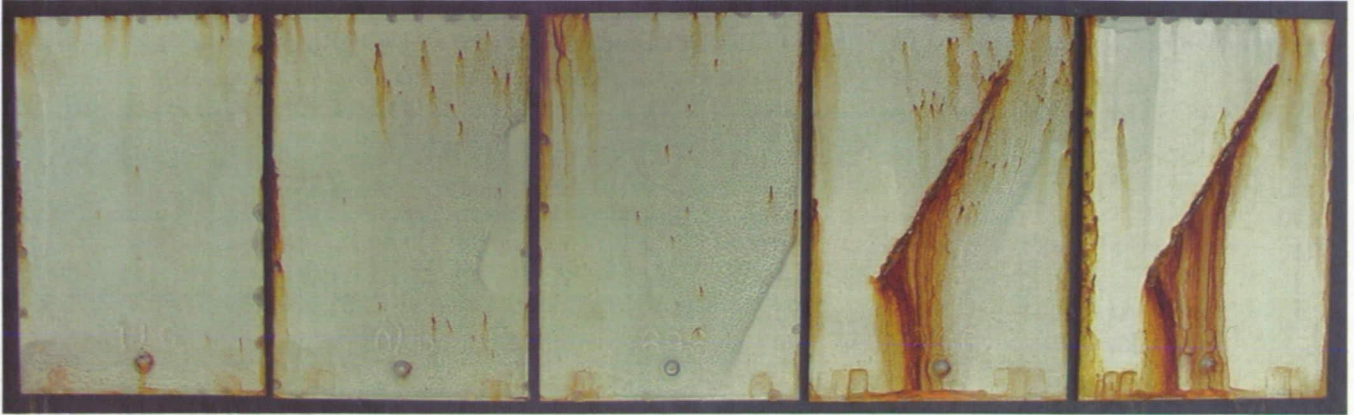
After 2000 hours in the salt fog chamber per ASTM B117, AR-7 and the candidate coatings were evaluated. Three different ASTM methods were used to evaluate the panels. The first was ASTM D 1654-05 *Standard Test Method for Evaluation of Painted or Coated Specimens Subjected to Corrosive Environments*.<sup>5</sup> This method is used as a basis to evaluate corrosion, blistering and adhesion in the area of a scribe on a panel. A rating number of 10 is the best evaluation a panel can receive, with zero being the worst. AR-7 received a rating of 7 after 2000 hours in the salt fog. The second method used was ASTM D 610 -01 *Standard Test Method for Evaluating Degree of Rusting on Painted Steel Surfaces*.<sup>6</sup> A panel with no rusting would receive the highest rating of 10. The percent of rusting of a panel increased with a decreasing rating number. The letter after the number for this method designated the type of corrosion present, spot (S), general (G), or pinpoint (P). After 2000 hours in the salt fog, AR-7 had a rating of 8G. The third ASTM method used for the evaluation of the coatings was ASTM D 714-02, *Standard Test Method for Evaluating Degree of Blistering of Paints*.<sup>7</sup> AR-7 received a rating of Size 6 Medium. Figure 3 shows carbon steel panels coated with AR-7 after 2000 hours in the salt fog chamber. Three panels were not scribed, and two panels were.

**FIGURE 3 – AR-7 after 2000 hours in the salt fog chamber.**
