# Design, Analysis and Testing of a PRSEUS Pressure Cube to Investigate Assembly Joints

Nicolette Yovanof<sup>\*</sup>, Andrew E. Lovejoy<sup>†</sup>, Jaime Baraja<sup>‡</sup>, and Kevin Gould<sup>§</sup>

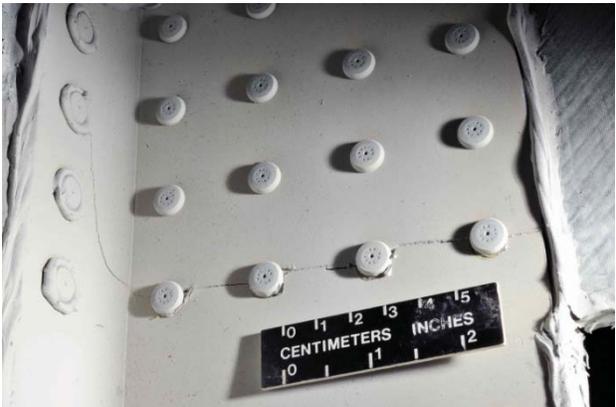
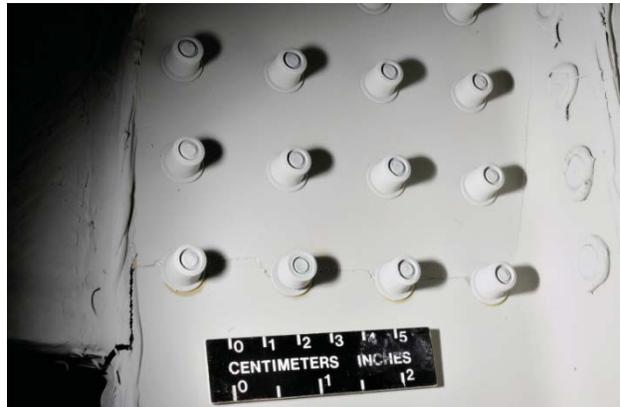
a) Location of failed fitting in cube, crown frame to VIC rib frame

b) Outside fitting

c) Inside fitting

Figure 40. Failed frame attachment fitting between crown and VIC rib in pressure cube.

Lastly, the pressure cube was loaded to catastrophic failure after BVID was introduced. Throughout the loading, many indications of local damage were observed by the DCDTs and strain gages, but no visible damage was observed, and catastrophic failure did not occur until 48 psi. Displacement plots for selected DCDTs are shown in Figures 29-32, and the VIC-measured displacements just prior to catastrophic failure are shown in Figures 33 and 34 for the rib and bulkhead, respectively. The maximum strains observed were on the bulkhead frame in the vicinity of a keyhole and on the cap, as shown in Figures 35-36. In the vicinity of the keyhole, the strain instantaneously increased from  $-4,000 \mu\epsilon$  to  $-12,000 \mu\epsilon$  at 45.7 psi for SG83BW, and from  $-5,000 \mu\epsilon$  to  $-12,000 \mu\epsilon$  from 47 to 48 psi for SG75BW. However, at the keyhole, local failures would be expected due to the stress concentration, but may not necessarily lead to catastrophic failure. The maximum strains in the frame caps were approximately  $-10,000 \mu\epsilon$ , as seen in Figures 37 and 38. The pressure cube after failure is shown in Figure 39. In addition to the composite failure, failure in the aluminum connection between the crown panel and VIC rib frames was found, as shown in Figure 40.

The most likely final failure sequence as indicated by the test results and analysis begins with failure of the metallic splice plates connecting the crown and rib frame. Once the splice plates failed, the detached rib frame would be subjected to increased in-plane bending due to the reduced moment carrying capability, which can result in frame buckling. Frame buckling is supported by the observed damage as shown in Figure 41. After the frame buckles, the load has to redistribute to the adjacent integral cap attaching the rib to the bulkhead, which is incapable of handling the loads, leading to failure of the integral cap. Failure of the integral cap adjacent to the failed frame splice is supported by the fact that when the bulkhead panel blew out, it flew up and away from the VIC rib that had the frame splice failure. The failures in the bulkhead frames that remained in the box can be due to local failures at the keyholes through which the top and bottom stringers pass. Local keyhole failures, such as indicated by the strains shown in Figures 35 and 36, can result in the failure across the frames once the load is redistributed to them after the frame fitting failure and rib frame buckling. The proposed likely final failure sequence is speculative due to the fact that the failure occurred instantaneously and there were no indications by the instrumentation from which to draw clear conclusions, but catastrophic first failure of the frame fitting is supported by the analysis and test data.
