Stennis Space Center (SSC) B-1 Test Facility Liquid Hydrogen Run Tank Vacuum Anomaly & Repair

Nicholas J. Nugent
April 10, 2012

Engineering & Test Directorate
NASA, Stennis Space Center

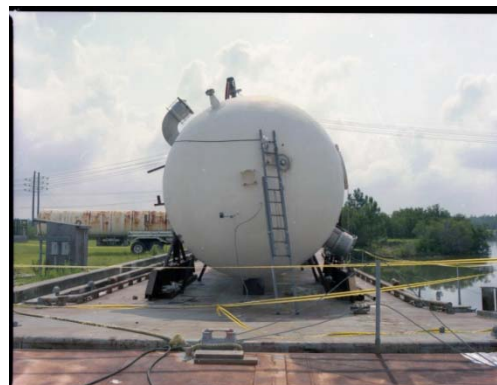
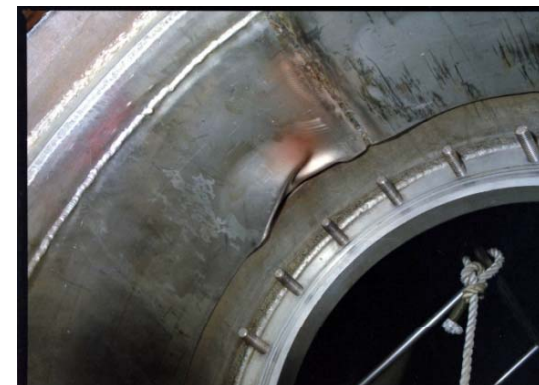
1985 Damage to Manway Liner

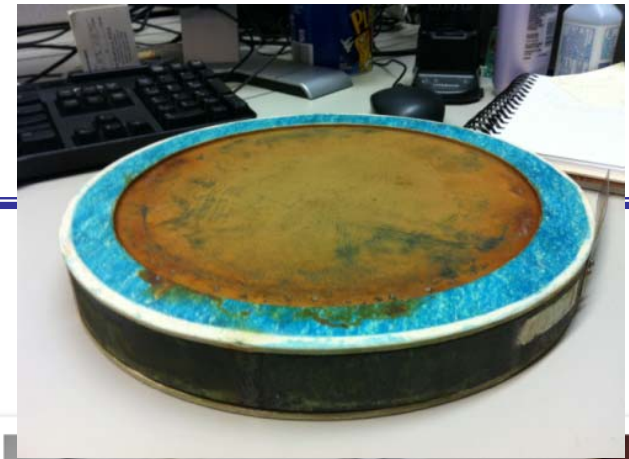
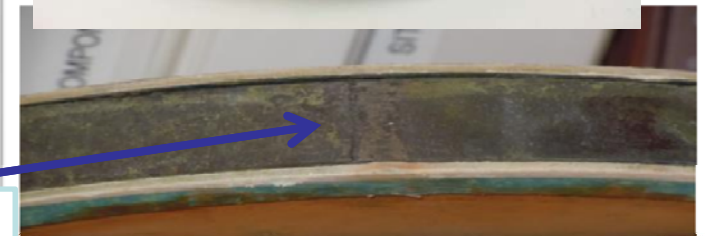
- Rupture disc #1 was identified to be leaking via bagging since cracks not visible when installed
- Rupture disc was removed and found to be cracked
- Rupture disc holder was made of graphite and installed in 2003.
- Companion flange was heavily corroded
 - Wire brushing of flange was unsuccessful
 - Flange was sent to machine shop and faced for improved finishing and sealing
- Companion flange and new rupture disc installed
- 2nd rupture disc also leaking but could not be removed due to leaking isolation valve. Utilized Kenny Seal to stop leak.
- No leakage detected via bagging method

Cracks in Graphite Holder

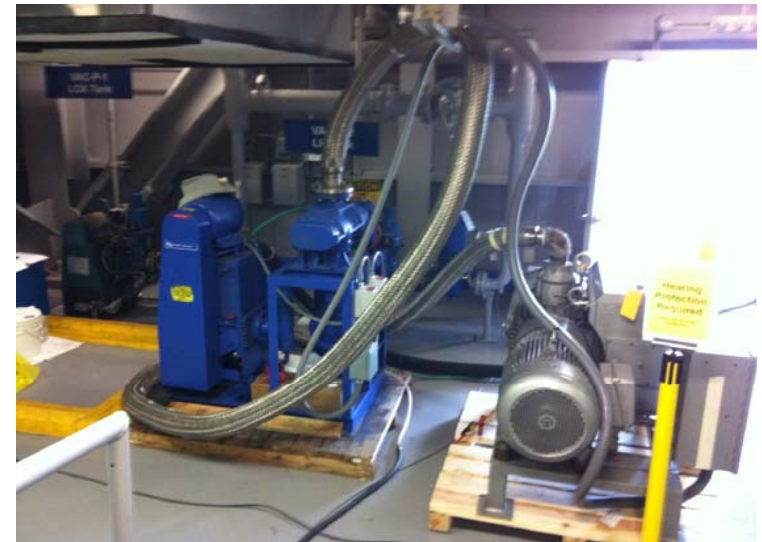
- Customer required one more engine hotfire test prior to a three month scheduled outage
- Attempted to remove air (nitrogen and oxygen) in annulus by vaporizing frozen air in annulus:
 - Rented large blower vacuum pump
 - Pressurized inner tank to warm-up tank wall
 - Frozen air sublimated as vessel wall temp rose
 - Monitored/controlled top annulus pressure
- Discovered elevated O₂ in vacuum pump discharge. Rented O₂ rated pump.
 - After ~24 hrs top annulus pressure dropped
- Conducted tank pressurizations tests to show minimal top annulus vacuum rise (< 5 psia)
- Filled run tank to 100%...top annulus dropped from 1.4 psia (~70,000 microns) to 23 microns
- Set observer cutoff limits on top annulus readings
- Successfully completed two engine hotfires
 - November 2nd
 - November 10th

**Rental
Pumps**

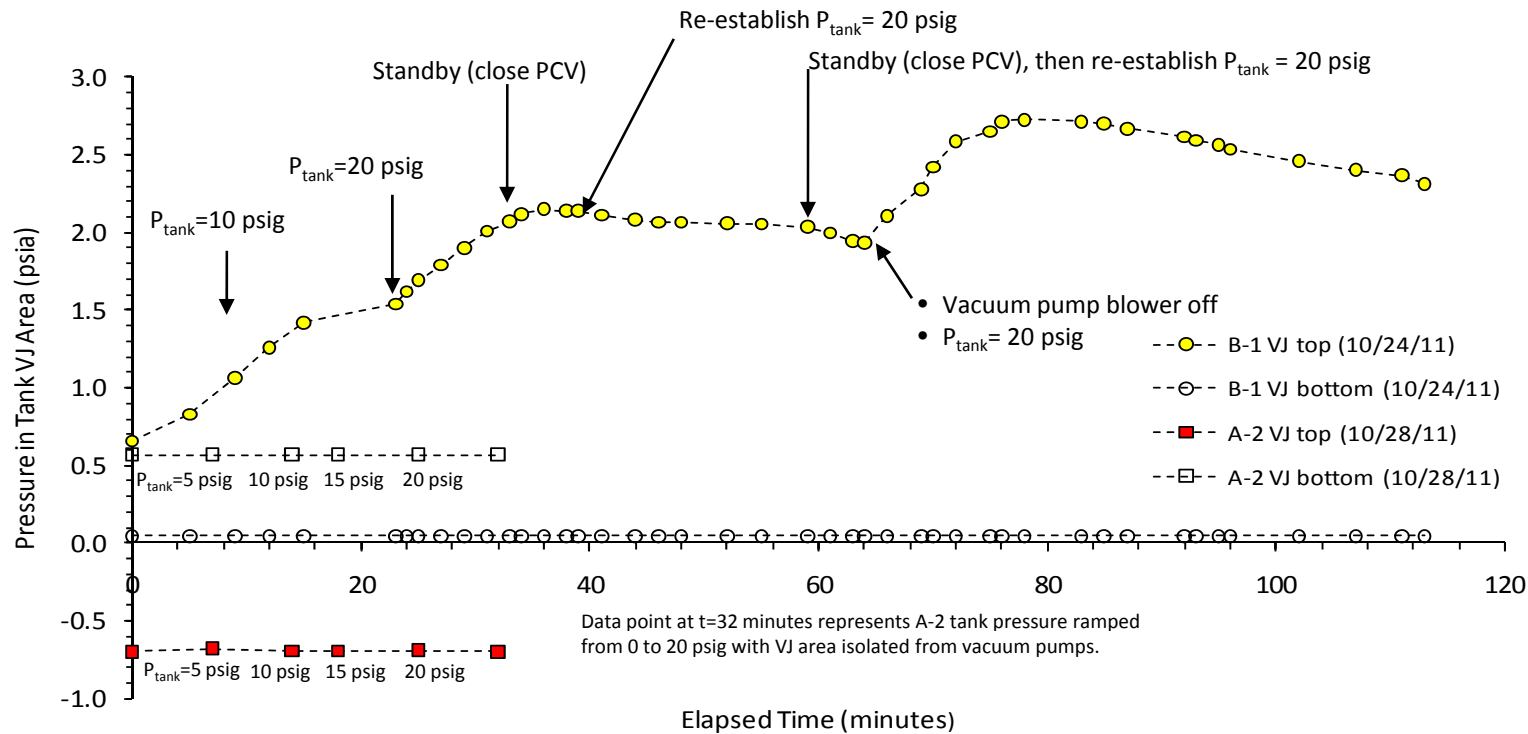
- The B-1 and A-2 LH run tanks were pressurized in a series of controlled steps (5 psig, 10 psig, 15 psig & 20 psig) while monitoring the pressures in the vacuum jacket (VJ) area

- The pressures in the A-2 LH tank VJ area did not change as the LH run tank was pressurized from 0 to 20 psig
- The A-2 results significantly differ from B-1 adding evidence of a air filled annulus
- Care and precautions must be taken during detanking due to the frozen annulus

- A-2 test completed on 10/28/11 using TPS A2-00891; A-2 LH Tank Level ~ 56% full & B-1 LH Tank Level ~ 44% full.
- Vacuum pump exhaust before and after test contained ~ 10.2% O_2 ; 0% LEL.

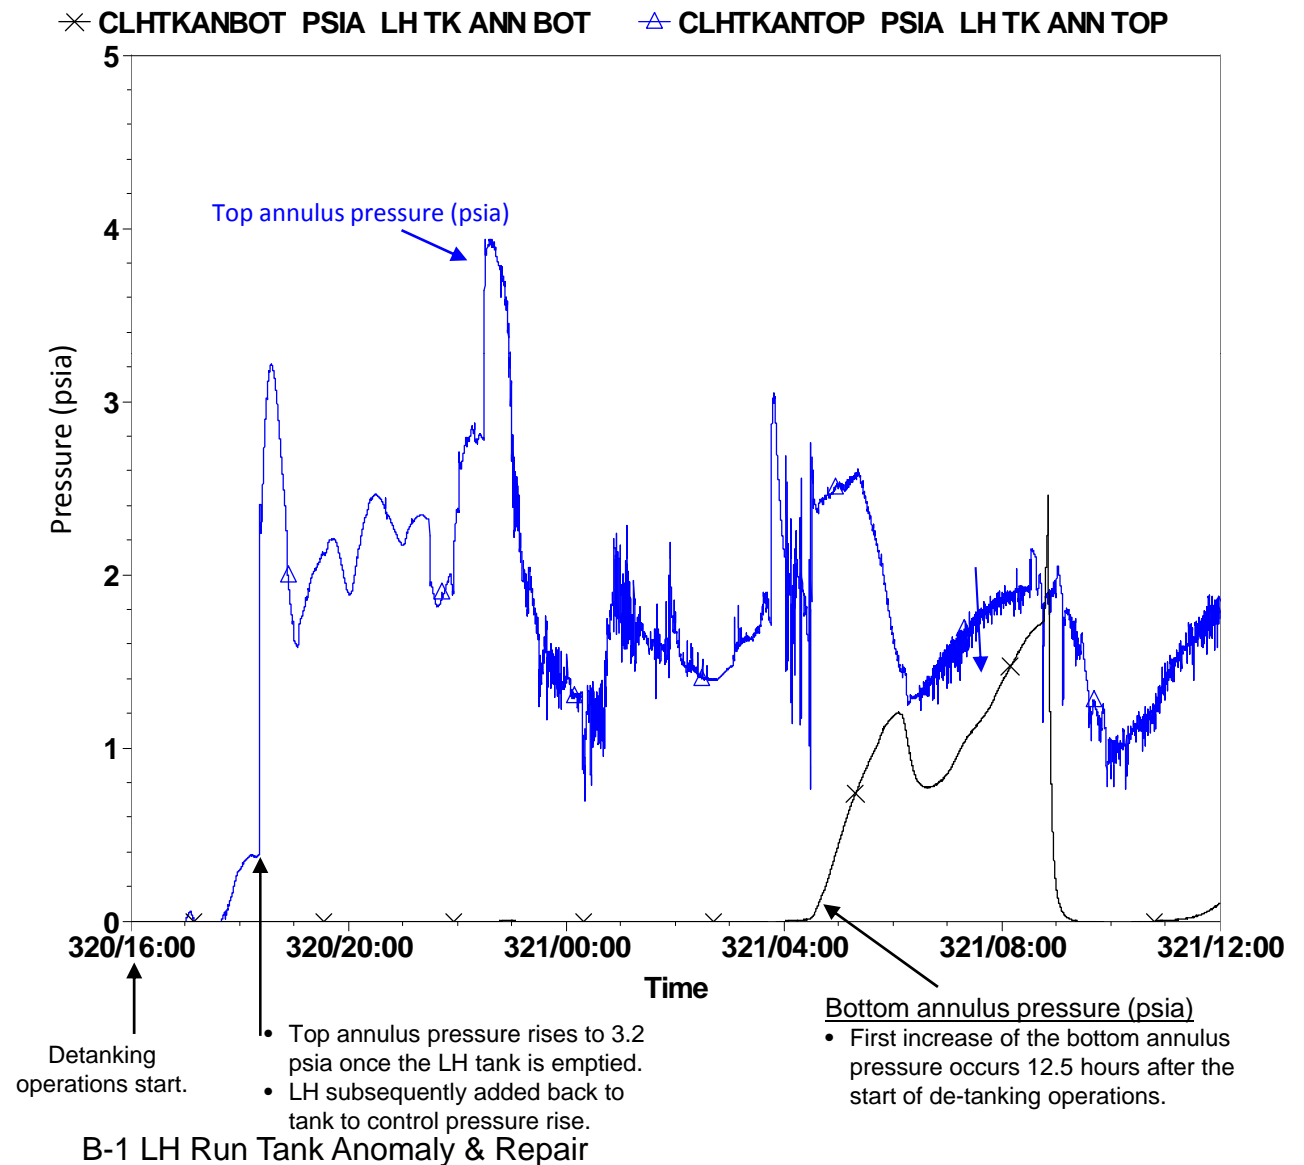
Annulus Pressures During Detanking

- B-1 LH detanking operations commenced on 11/16/11 (day 320) at 4:00 pm.
- Generally, pressure-vent cycles were performed in addition to emptying the inner tank of LH.
- During the first day of detanking, the top annulus pressure rose sharply to 3.2 psia once the LH tank was empty while the bottom annulus pressure remained at 0 psia.
- The first increase of the bottom annulus pressure occurred on 11/17/11 at 4:30 am, 12.5 hours after the start of de-tanking operations.
- Pressure-vent cycle at 10:45 am (11/17/11) yielded a vent gas temperature of $\sim 140^{\circ}\text{R}$.

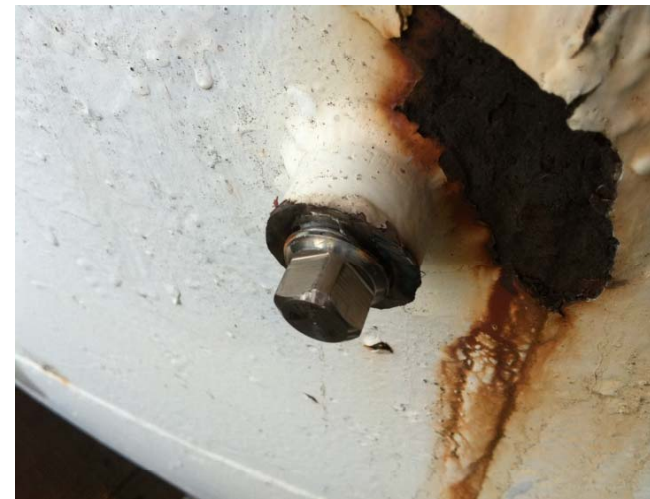
- AE port
- Upon initiation of pumping vacuum, large amounts of perlite were pumped from the annulus resulting in continuous cleaning of facility vacuum system filters

**Plug Removed for Vacuum
Connection to AE port**

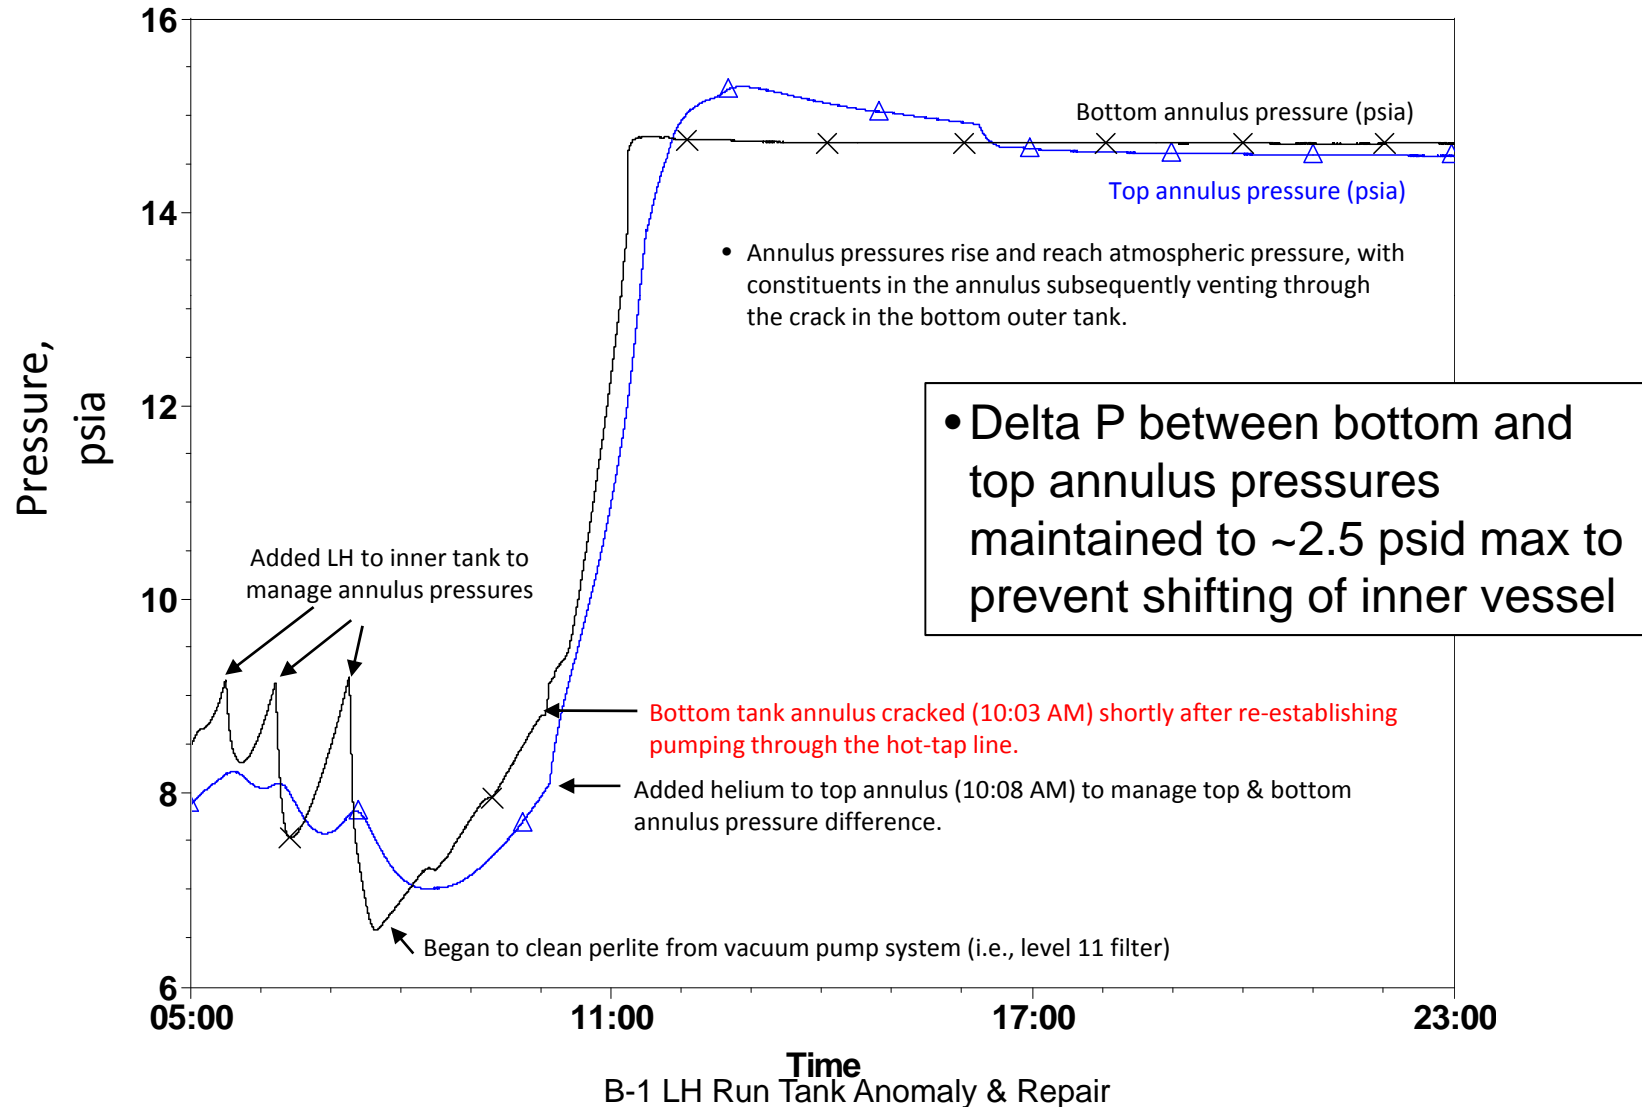
Crack in Outer Tank Timeline

✕ CLHTKANBOT PSIA LH TK ANN BOT
△ CLHTKANTOP PSIA LH TK ANN TOP

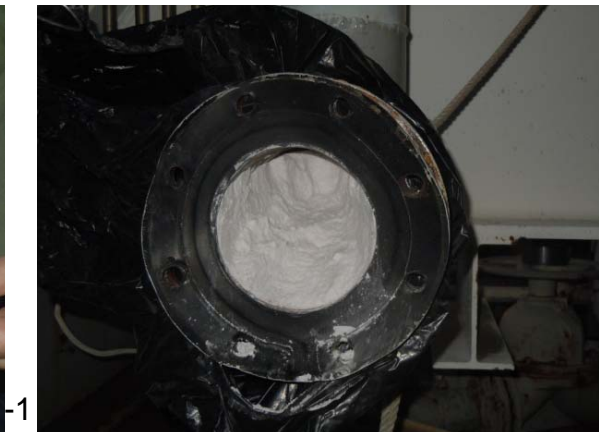
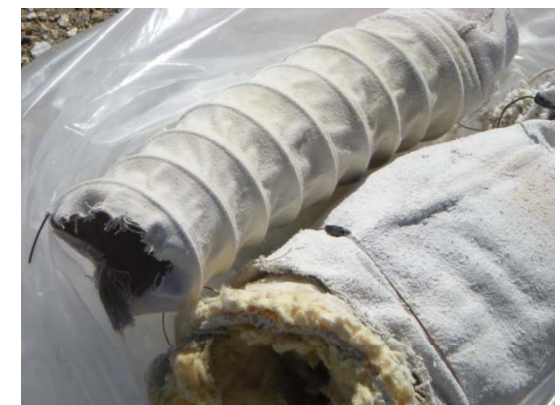
- Lower Vacuum Header
 - Physically disconnected inside annulus
 - Made from flexible hose
 - Lower witch's hat screen plugged
- Previous Issues with Tank at SSFL (prior to 1970)
 - Vacuum issues: 6000 micron minimum
 - Iced over vessel bottom during detanking
 - Cracked bottom head area
- Compacted Perlite
- Full vessel will cryopump annulus and show good vacuum
- Inner Vessel
 - Successful Acoustic Emissions test
 - Successful structural support inspections
- Outer Vessel
 - Numerous cracks identified in smaller lower head
 - No issues found in main lower head

Witch's
Hat
Screen

Vacuum Header Flexible Hose

- Rupture disc replaced by lift plates
- Preventative maintenance on lift plates
- Weld or install weld caps on mechanical joints where possible (i.e., perlite fill nozzles)
- New vacuum header design
 - Allow better top/bottom communication (i.e pressure can equalize in the annulus)
 - Better accessibility to components
- Prior to future detankings
 - Verify no massive air in leakage by monitoring top annulus pressure while performing pressurization cycles
- Better vacuum monitoring
 - Remote top and bottom readings
 - Automated alarms
- Standardize pumping operations
 - Isolate vacuum system post LH loading
 - If pumps are needed then investigate for air in leakage

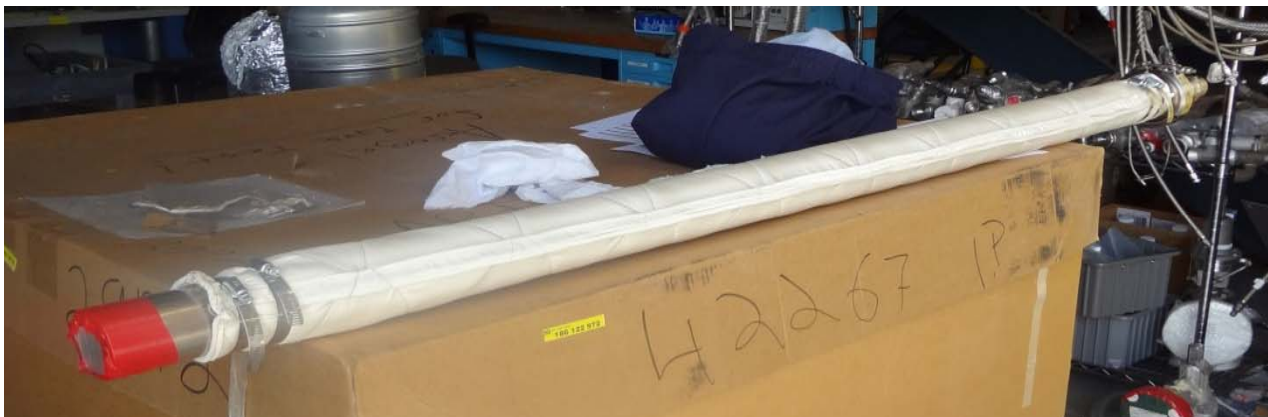
B-1 LH Tank Vacuum System Internal Manifold Redesign

- 4 internal vertical manifolds
- Suspended on spring on one end, welded on other end
- Sections of perforated or slotted tubing covered with sock filtration material

- High surface area (greater than current B-1 system)
- Manifold traverses tank vertically allowing internal equalization of pressure on top and bottom
- Significantly fewer tank penetrations (less expensive, faster, and few welds that could leak)

- No experience on site with vertical vacuum manifold
 - Industry contacts confirm use of vertical vacuum manifolds is not uncommon
