NASA/TM—2012-217688

MISSE 6 Polymer Film Tensile Experiment

Prepared for the
2010 National Space and Missile Materials Symposium (NSMMS)
sponsored by General Dynamics Information Technology
Scottsdale, Arizona, June 28–July 1, 2010

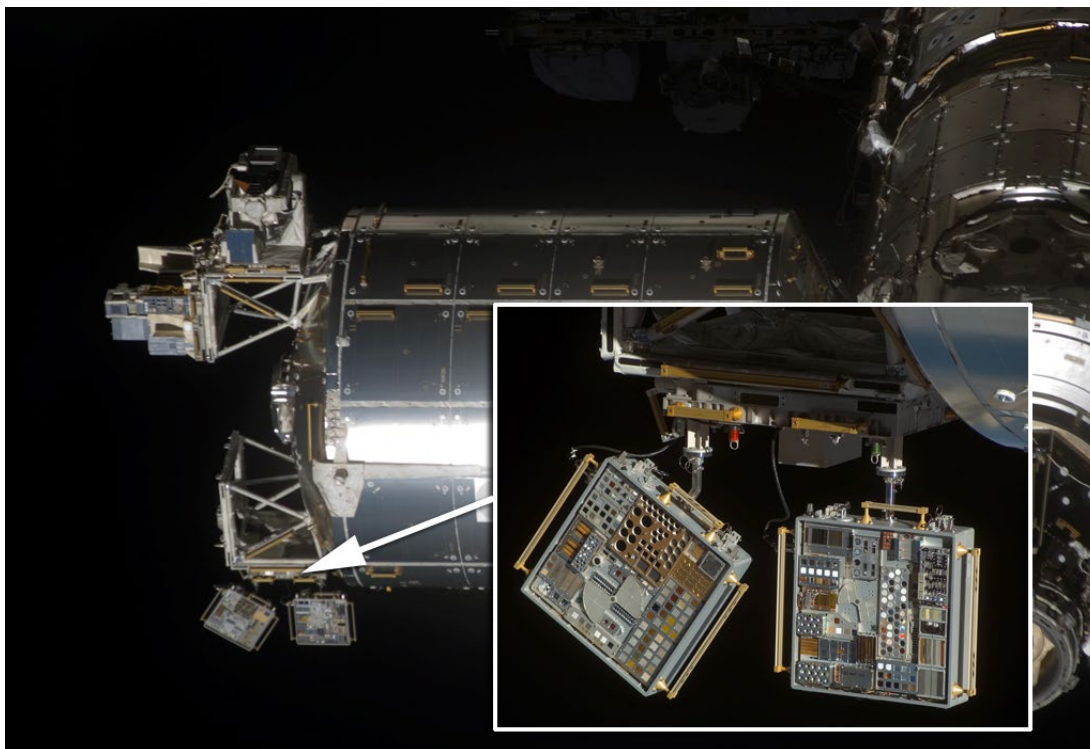
Figure 1.—Photograph of MISSE 6 location on the end of the Columbus module on ISS and a photo enlargement showing the ram side of MISSE 6A (left) and 6B (right).

MISSE 6 was composed of two Passive Experiment Containers (PECS), 6A and 6B. Both PECS had one side of the suitcase style containers facing ram and the other side facing wake. They were both installed by astronauts on the European Columbus module of the International Space Station (ISS) on March 22, 2008 during the flight of STS-123. They were retrieved on September 1, 2009, by the crew of STS-128 after slightly over 17 months in low Earth orbit (LEO). Figure 1 shows a photo and close-up image of the ram side of the MISSE 6 PECS on ISS. Environment exposure conditions that have been determined to date are the atomic oxygen exposure level on each side and the UV radiation level. M. Finckenor (NASA MSFC) (Ref. 4) and K. de Groh (NASA GRC) (Ref. 5) provided estimates of the atomic oxygen arrival based on erosion of samples of Kapton HN that were flown as fluence monitors on individual experiments, there were also two Kapton HN/VDA tensile dogbones that were flown as part of this experiment on the wake side of MISSE 6A from which scanning electron microscope images of protected locations on the surface were used to determine the erosion depth and ultimately the atomic oxygen fluence. All of the data seemed in good agreement with an estimate of the atomic oxygen arrival fluence for the ram side of 6A and 6B of approximately 2×10^{21} atoms/cm², and for the wake side approximately 1.2 to 1.4×10^{20} atoms/cm². This indicates that the wake side of MISSE 6, which was to

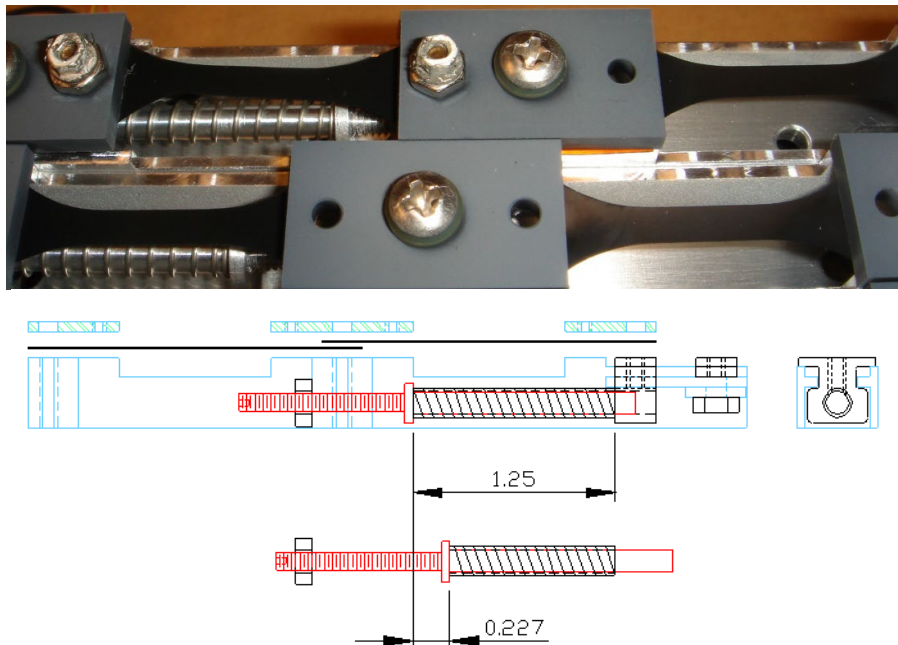
Figure 2.—Photo of stressed (left) and unstressed (right) sample holders from above, and a side view drawing of a holder showing the unstressed sample position on the left and the stressed on the right. (Dimensions are in inches.) The stressed sample is fixed on the left side and allowed to move to the right by having the mount hole on the right slotted. Tension is supplied by compression of the spring.

The experiment was designed to allow some of the polymer dog-bone type samples to be exposed under a tensile load typical of expected conditions for the James Webb Space Telescope sunshield. The tensile load of approximately 0.5 lb (~2.22 N) was applied by mounting the sample in a holder similar to that shown on the left side of the photo in Figure 2 and then compressing a spring with a spring constant of 2.2 lb/in. (~385 N/m) by approximately 0.227 in. (~0.0058 m) to put the sample under a tensile load. The drawing in Figure 2 shows a double sample holder where the sample on the left did not have an applied tensile stress and the one on the right did. Originally, the experiment was designed to have eight of the ram and 11 of the wake samples exposed under tension, but difficulty in applying tension to some of the samples resulted in only three of the ram facing and seven wake facing samples exposed to the environment under stress. For the exposed samples, the resulting stress was dependent on the polymer film thickness per equation 1 with an average gage width of approximately 0.126 in. (0.0032 m).

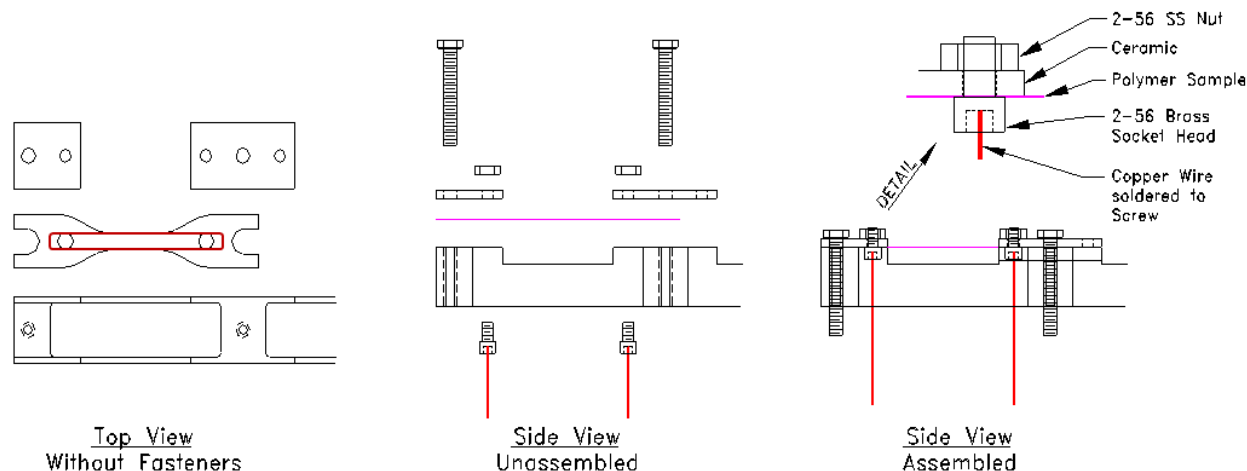
Figure 3.—Drawing on the left shows the top view of the clamping plates and support and a bottom view of the dog-bone sample with vapor deposited aluminum contact shown as a rectangular box on the sample. Drawings at center and right show an expanded and assembled side view with the electrical contacts to the sample back.

Active monitoring of some of the tensile samples to determine the time on orbit to sample break was attempted using electrical continuity. Samples that were insulating on the side not exposed to space were coated with vapor deposited aluminum through a mask as shown on the far left of Figure 3. Black Delrin clamping plates were used to provide electrical insulation from the aluminum sample support underneath while a second set of screws inside the mount screws made electrical contact with the aluminum coating on either end of the back side of the sample. A 5 V power supply was used to supply current to the dog-bones and the voltage drop across the samples was monitored and stored in a series of dataloggers that were on MISSE 6. The data recorded was designed to indicate failure by a change in the voltage across the sample. Due to difficulty in wiring the samples without shorting, only three stressed samples on the ram side and one on the wake side were wired for flight. All three stressed samples on the ram side broke during flight but the change was not evident in the data from the dataloggers. All channels including ones that were unused registered approximately 1 V for the entire flight so the data were not usable to determine the time on orbit at which the samples on the ram side broke.

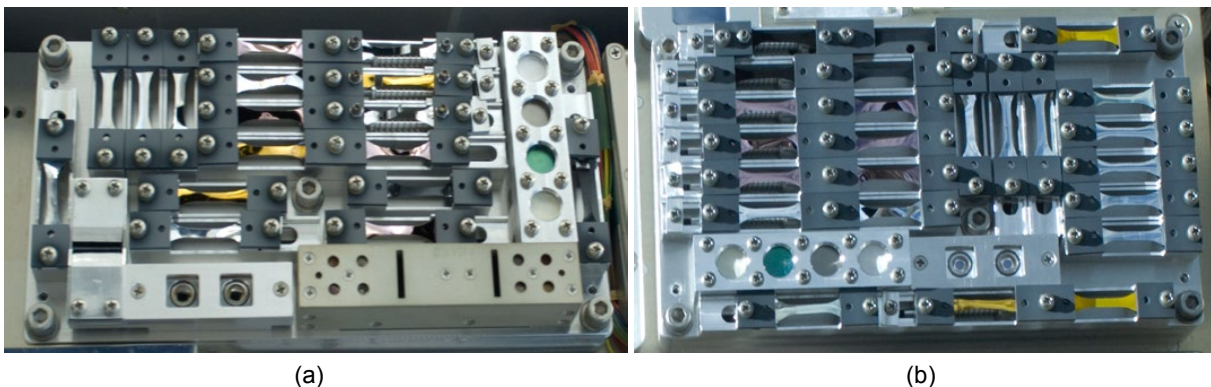
Figure 4.—(a) On-orbit photo of ram facing tray G3 on MISSE 6 prior to retrieval. (b) On-orbit photo of wake facing tray G2 on MISSE 6 prior to retrieval

Close-up on orbit photos of the ram tray G3 and wake tray G2 just prior to retrieval are shown in Figure 4(a) and (b), respectively. On the ram facing tray all of the stressed samples showed evidence of breaking and curling up of the tensile dog-bones, while none of the stressed samples on the wake side were broken. Also, there was a noticeable change to the black Kapton XC sample AO-S-1 which is shown on the far right of Figure 4(a). The sample appeared to be longer than when initially installed and had a silvered appearance on the end that was stretched. This sample was in a sample holder initially designed for putting the sample under a tensile load so the holder on the top side of the sample had a slotted mount hole. It appears that the sample was inadvertently bumped and the one end of the holder moved putting the sample under a tensile stress even though it was not initially intended to be stressed. There was a cable that was passed up between the G3 tray and the neighboring tray which was very close to this sample which may have provided the opportunity for inadvertent bumping of the one end of the sample holder during experiment installation.

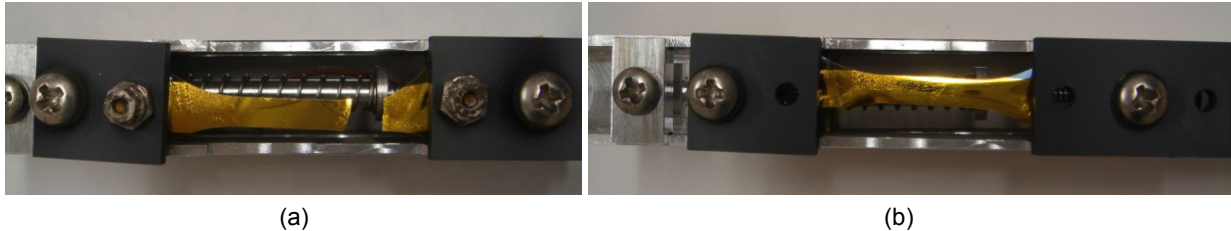
Figure 6.—(a) SiO_x/Kapton HN stressed sample AO-S-6 from ram side tray G3 showing break. (b) SiO_x/Kapton HN stressed sample UV-S-8 from wake side tray 62 showing coating cracking.

The stressed samples (with ~ 2000 psi ($\sim 1.38 \times 10^7$ N/m²)) applied stress which is about 6 percent of the ultimate tensile strength for Kapton HN (33,500 psi (2.31×10^8 N/m²)) both on the ram and wake sides showed evidence of coating cracking. The ram side received enough atomic oxygen arrival that the sample weakened and broke at what appears to be a line of defects that extended across the width of the dog-bone sample as shown in Figure 6(a). The amount of atomic oxygen arrival would have been enough to erode completely an unprotected 2 mil (5.08×10^{-5} m) sample of Kapton HN. Figure 6(b) shows the wake facing sample which was also under stress but received much less atomic oxygen exposure (~ 7 percent that of the ram side). Even though the sample is not broken, the coating itself appears damaged. For both samples the strain (stress divided by the modulus of elasticity (379000 psi (2.61×10^9 N/m²)) for Kapton HN)) was about 0.005 or about 0.7 percent of the maximum strain for Kapton HN. Even though the level of stress and strain the samples were subjected to is low for Kapton HN, the stressed sample on the ram side still failed. It is believed that the failure is primarily due to atomic oxygen erosion at coating defect sites for this material.

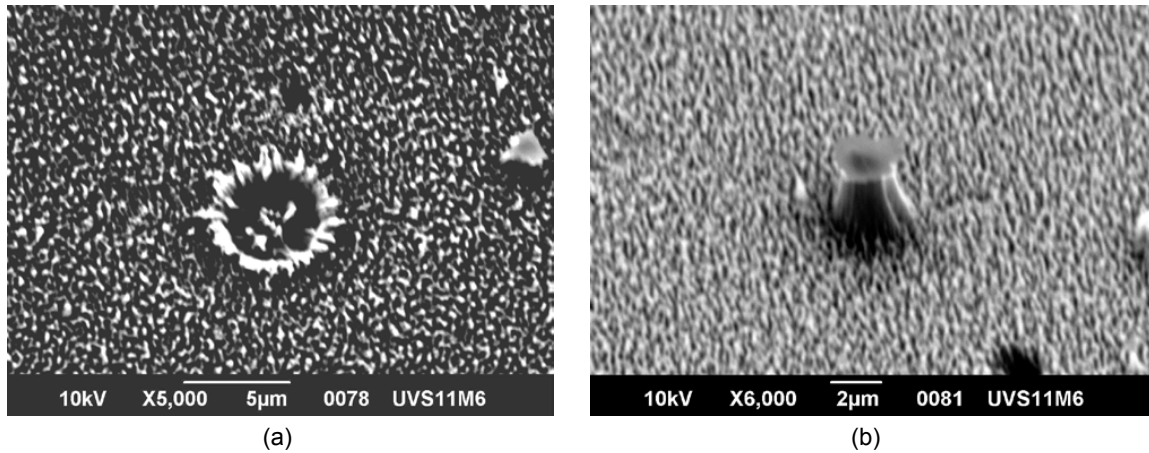
Figure 7.—(a) Kapton HN/VDA sample UV-U-13 after exposure on the wake side of MISSE 6 showing texturing due to erosion by atomic oxygen and a micrometeoroid or debris impact. (b) Kapton HN/VDA sample UV-U-13 after exposure on the wake side of MISSE 6 showing a particle on the surface that protected the sample from erosion in one spot creating a butte.

There were only two samples of Kapton HN/VDA flown on the wake side of MISSE 6. Both were flown unstressed and had a matte appearance post flight but no evidence of sample failure. The matte appearance was due to atomic oxygen texturing of the Kapton HN as evident in the scanning electron microscope (SEM) photos shown in Figure 7(a) and (b). Figure 7(a) shows a textured area including a micrometeoroid or debris impact and Figure 7(b) shows a butte where there was a particle on the surface that protected the Kapton HN from erosion underneath it. This area and others like it were used to determine an estimate for the atomic oxygen fluence. The erosion depth (cm) multiplied by the erosion yield (cm³/atom) for Kapton HN gives the atomic oxygen dose or fluence in atoms/cm². One interesting thing to note about the texture is that for the most part it is very vertical which indicates that the wake side was close to being directly ram oriented for most of the time it was exposed to atomic oxygen.

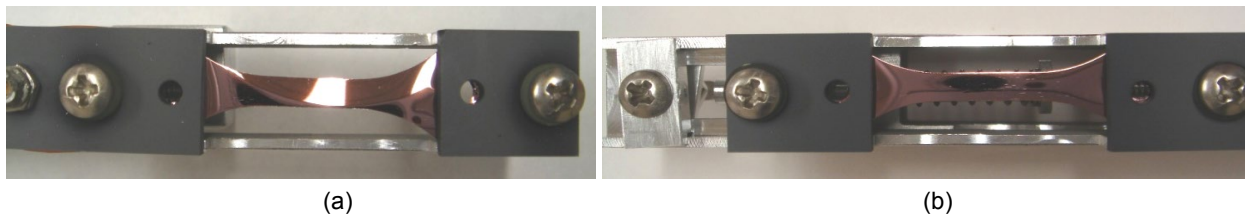
Figure 8.—(a) Si/Kapton E/VDA/Inconel/VDA sample AO-U-4 exposed on ram side of MISSE 6 unstressed. (b) Si/Kapton E/VDA/Inconel/VDA sample UV-S-4 exposed on wake side of MISSE 6 under stress showing some evidence of coating cracking

This material was identified for the James Webb Space Telescope sunshield, which will not be flown in low Earth orbit and will, therefore, not be exposed to significant amounts of atomic oxygen. Thus, the results most pertinent to its JWST application are those from samples flown on the wake surface. There were four unstressed samples of this material flown on the ram facing side of MISSE 6 and three unstressed samples on the wake facing side. All appeared typical of pre-flight samples and had no visual evidence of failure or change as shown in Figure 8(a). The three stressed samples were only flown on the wake facing side. They were stressed to a level of ~ 2000 psi ($\sim 1.38 \times 10^7$ N/m²) which represents about 4 percent of the ultimate tensile strength for Kapton E (50000 psi (3.45×10^8 N/m²)). The strain level (stress /modulus (800000 psi (5.52×10^9 N/m²))) was 0.0025 which was about 0.5 percent of the maximum strain for Kapton E. The stress and strain again were low but there was some slight evidence of cracking of the Si coating for these samples as shown in Figure 8(b) but no failure of the polymer.

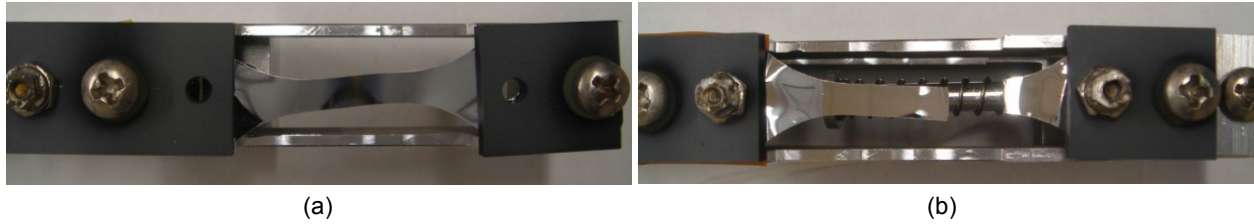
Figure 9.—(a) Unstressed VDA/CP1 sample AO-U-7 flown on the ram facing side of MISSE 6. (b) Stressed VDA/CP1 sample AO-S-5 flown on the ram facing side of MISSE 6. Sample broke sometime during the exposure on ISS.

The two unstressed samples of this material on the ram side and the three unstressed samples on the wake side all appeared typical of the pre-flight samples as did the one sample flown purposely in reverse (CP1/VDA) on the wake side which was also flown unstressed. Figure 9(a) shows one of the unstressed VDA/CP1 samples (AO-U-7). The two stressed samples on the ram side broke during the MISSE 6 exposure, while the stressed sample on the wake side did not. Figure 9(b) shows one of the broken samples of VDA/CP1 from the ram side (AO-S-5). The wake side stressed sample appeared typical of pre-flight samples like that shown in Figure 9(a). The stress on these samples during the flight was ~ 4000 psi ($\sim 2.76 \times 10^7$ N/m²), which was about 28 percent of the ultimate tensile strength (14,500 psi ($\sim 1 \times 10^8$ N/m²)). The strain (stress/modulus (315000 psi (2.17×10^9 N/m²))) was 0.013.

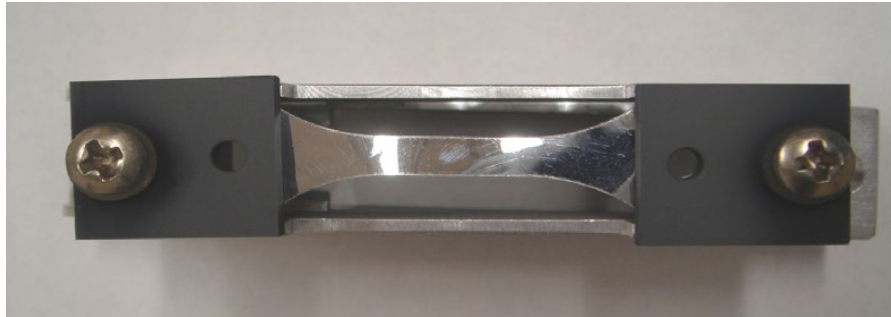
Figure 10.—FEP/VDA exposed on MISSE 6 ram side in unstressed condition (AO-U-8).

Both 2 and 5 mil samples of FEP/VDA were flown on the ram and wake sides. All were flown unstressed, but one of each of the 2 and 5 mil samples were flown pulled taut on the ram side. All looked very similar in appearance with scratches and scuff marks on the surface but there was no evidence of failure or a difference in the loosely held versus taut samples that could be visually observed. Figure 10 shows a typical FEP/VDA sample flown on the ram side of MISSE 6 (AO-U-8).

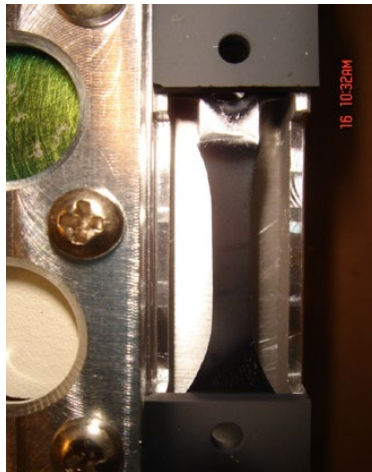
Figure 11.—Kapton XC flown on ram side of MISSE 6 (AO-S-1) showing stretching of sample at silvered area at the top.

Two unstressed samples of black Kapton (XC) were exposed on the ram side of MISSE 6. Both samples appeared to show evidence of texturing of the surface with a darker appearance near each end of the dog-bone sample. One of these samples was inadvertently put under stress when one end of the sample holder was moved and changed the overall sample length by ~ 0.068 in. (~ 0.0017 m). This put a strain on the sample (for an undetermined length of time) which could be calculated by dividing the change in length (0.068 in. (0.0017 m)) by the original length (~ 0.934 in. (0.0237 m)) to result in a strain of ~ 0.07 . This represents approximately 26 percent of the maximum strain for Kapton XC. The resulting stress on the sample could be determined by multiplying the strain by the elastic modulus (480000 psi (3.31×10^9 N/m²)) which gives a stress of 33,600 psi (2.32×10^8 N/m²) which is greater than the yield strength of Kapton XC. This is also evident from Figure 11 by the distortion and stretching of the top end of the sample as shown in the photograph.

The appearance of the sample raises several questions. The first is why the stretched end appears silver and the second is why the black Kapton appears to be darker in the region of higher stress? In order to try to answer these questions, SEM and EDAX analysis was performed on the sample at selected locations shown in Figure 12 and Figure 13 after applying a light gold coating to the sample to reduce charging during examination at 10 kV.

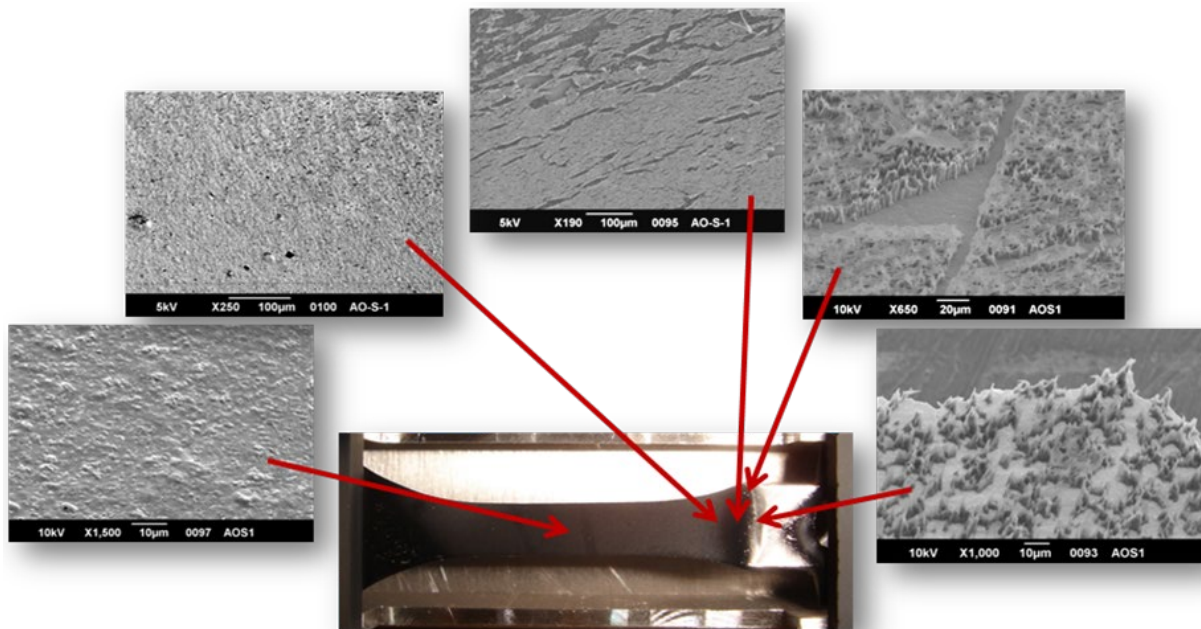
Figure 12.—SEM images of selected positions on sample AO-S-1 exposed on the ram side of MISSE 6

SEM images shown in Figure 12 show a significant change in surface morphology from the center to the edge. The center portion has a smooth lumpy appearance typical of black Kapton which progresses to an area which looks as if it had a thin film gossamer coating on it with many cracks perpendicular to the pull direction. There are fine cone-like peaks in areas where there is cracking which progresses to almost all peaks with thin wisps of film on the surface nearer to the silver area. At the edge where the sample separated, there are only a few short peaks remaining. EDAX scans shown in Figure 13 indicate mostly carbon and oxygen signals in the central region progressing to a high concentration of aluminum near the stretched end. This sample was originally intended to be put under stress and wired so there was a vapor deposited aluminum coating on the back side. It appears that as the stress on the sample is increased, the erosion rate of the black Kapton increases which results in first development of surface texture cones and a thin film of ash from oxidation of the black Kapton. This progresses to loss of ash and erosion of the

mostly carbon cones to the point at which the vapor deposited aluminum is predominantly what is left looking like a blanket of snow at the base of the remaining carbon peaks. If erosion of the Kapton XC is dependent on the level of stress, then there should also be a difference in the samples that are under stress compared to those that are not under stress on the wake side.

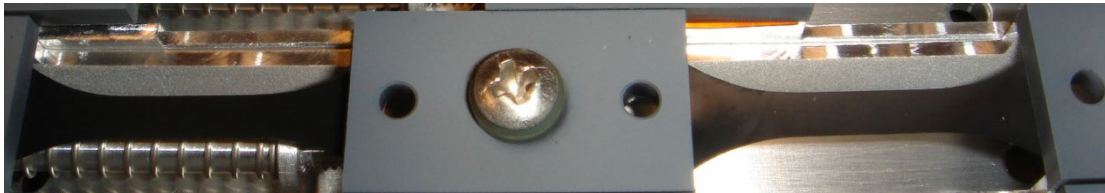
Figure 14.—Stressed (left) and unstressed (right) black Kapton XC flown on the wake side of MISSE 6

The two unstressed samples on the wake side appeared to show slight evidence of texturing of the surface with the samples appearing slightly darker towards each end, while the 2 stressed samples were very dark matte black in appearance. Figure 14 shows a side-by-side comparison of one pair of the stressed and unstressed Kapton XC samples exposed on the wake side of MISSE 6.

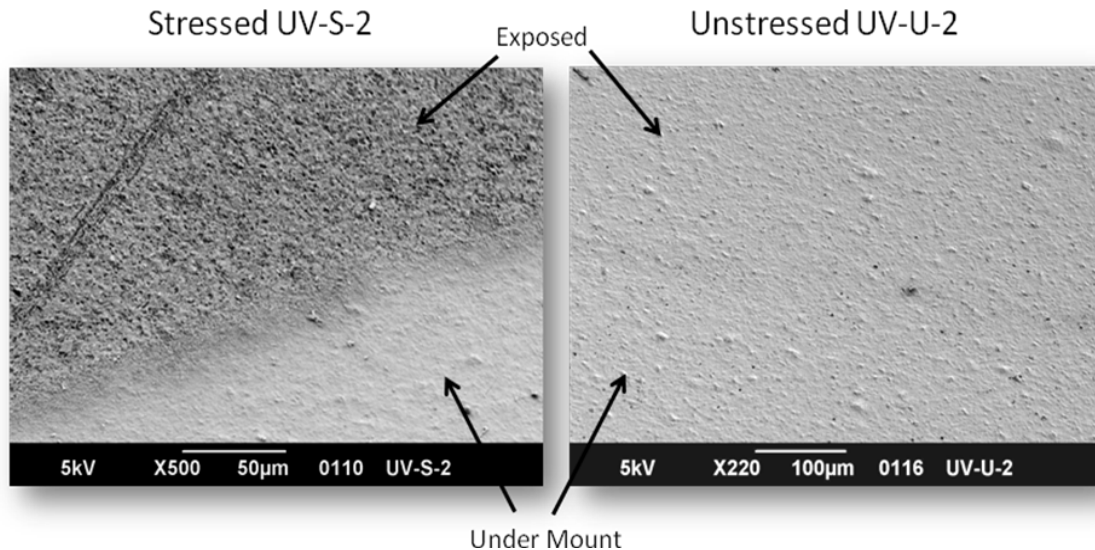
Figure 15.—Scanning electron microscope images of stressed (left) and unstressed (right) Kapton XC at 45° tilt. Top approximately 2/3 was exposed to the space environment on the wake side of MISSE 6 while the bottom ~1/3 was protected by the clamp holding the sample in place.

The stress level during exposure was ~4000 psi ($\sim 2.76 \times 10^7$ N/m²). The strain (stress/modulus (480000 psi (3.3×10^9 N/m²))) for the black Kapton XC was ~0.008 which represents about 3 percent of the maximum strain. The stress on the sample was about 24 percent of the tensile strength. This does not appear to be a significant amount of strain on the material but it is enough to cause a difference in the appearance of the erosion of the material due to oxidation by atomic oxygen. Figure 15 shows side-by-side SEM images at 45° tilt of the stressed (UV-S-2) sample of Kapton XC on the left and the unstressed

(UV-U-2) sample of Kapton XC on the right. There is more surface texturing occurring on the stressed sample than the unstressed sample as can be seen in the top 2/3s of the image. The bottom 1/3 was under the sample mount and protected from erosion by atomic oxygen. As can be seen from the image, the unstressed sample is only slightly different in appearance to the unexposed surface, while the surface of the stressed sample has undergone very noticeable erosion.
