NASA's Evolutionary Xenon Thruster (NEXT) Power Processing Unit (PPU) Capacitor Failure Root Cause Analysis

**AIAA / IECEC 2012
Atlanta, Georgia
August 1, 2012**

James F. Soeder, Luis Pinero – NASA Glenn Research Center

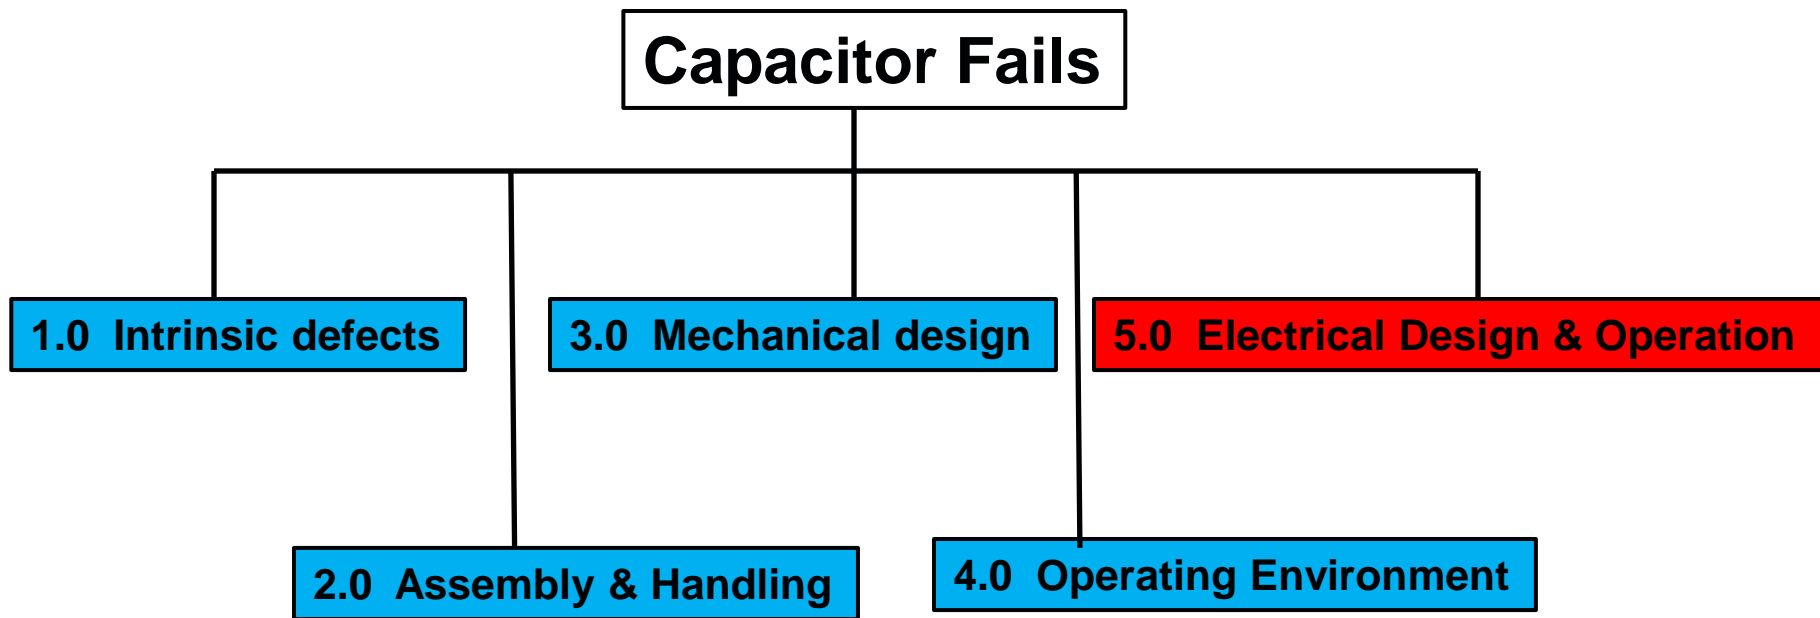
PPU Capacitor Failure Tree

Color Code

Very Likely	Red
Likely	Yellow
Not Likely	Green
Cleared	Blue

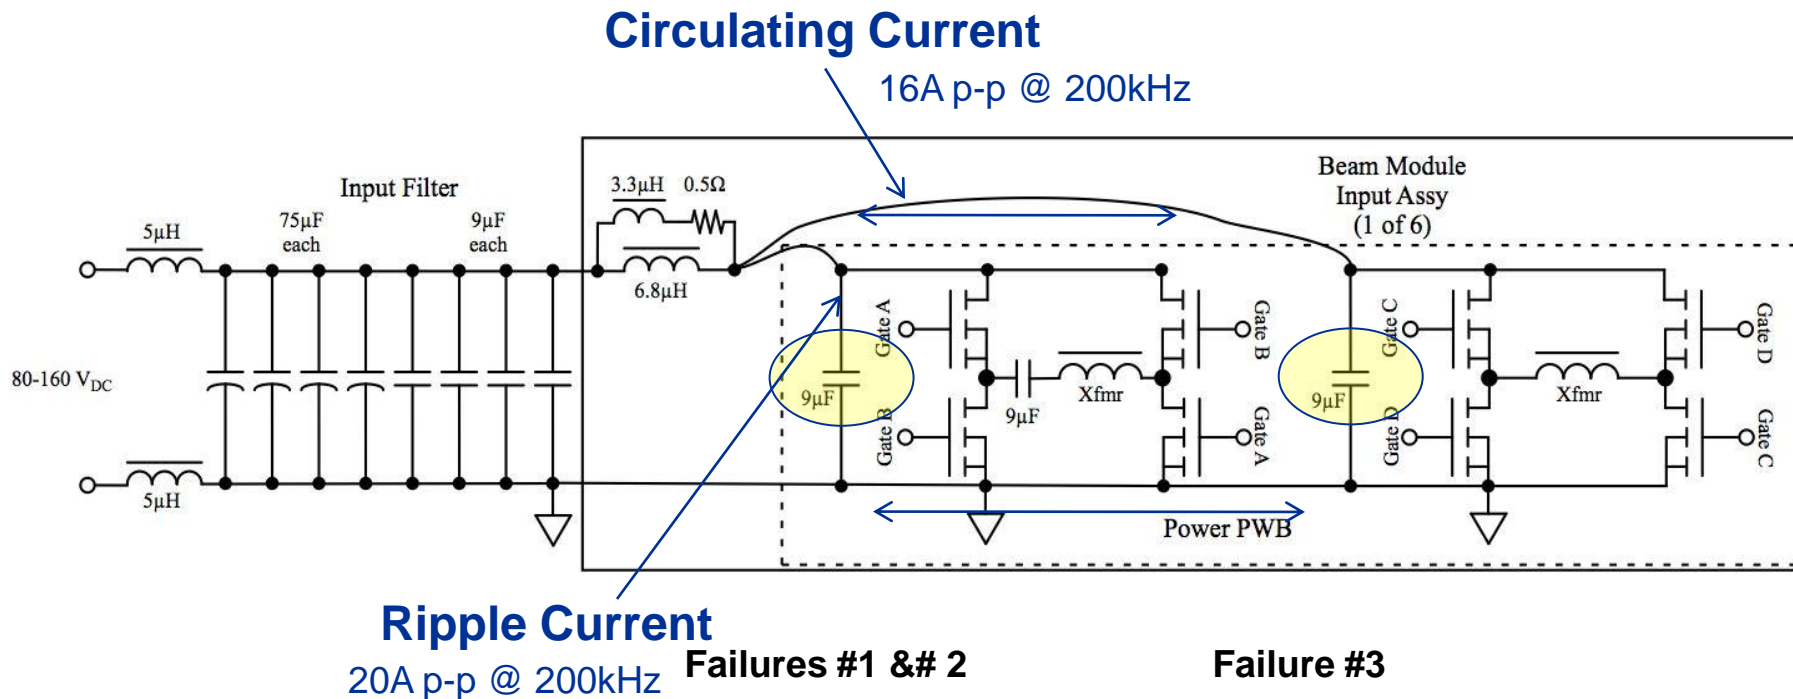
Beam Supply Simplified Schematic

**Circulating Current between Two Capacitors
In Phase Shift Mode**

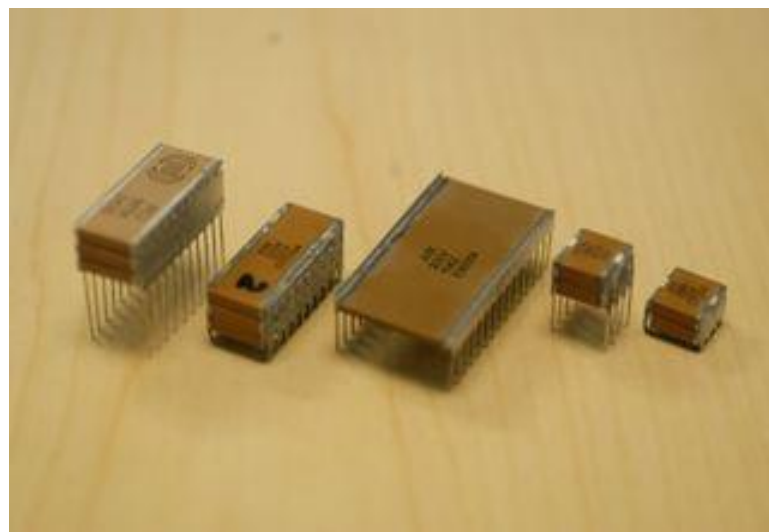
Ceramic Capacitors

- A ceramic capacitor is constructed of alternating layers of metal and ceramic, with the ceramic material acting as the dielectric.
- A typical dielectric material is X7R – a form of Barium Titanate
 - Minor Dopants change the electrical and mechanical properties
- Barium Titanate can be highly piezoelectric based on the additives used

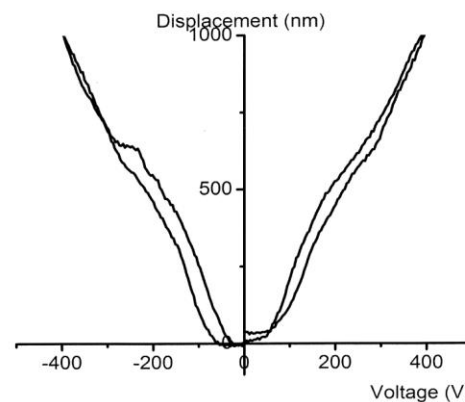
GRC Measured Data
on Custom Capacitor

Piezoelectricity is a form of electricity created when certain crystals are bent or otherwise deformed. These same crystals can also be made to bend slightly when a small current is run through them,

Barium Titanate (the capacitor dielectric) is piezoelectric

Displacement = f (Electric Field)

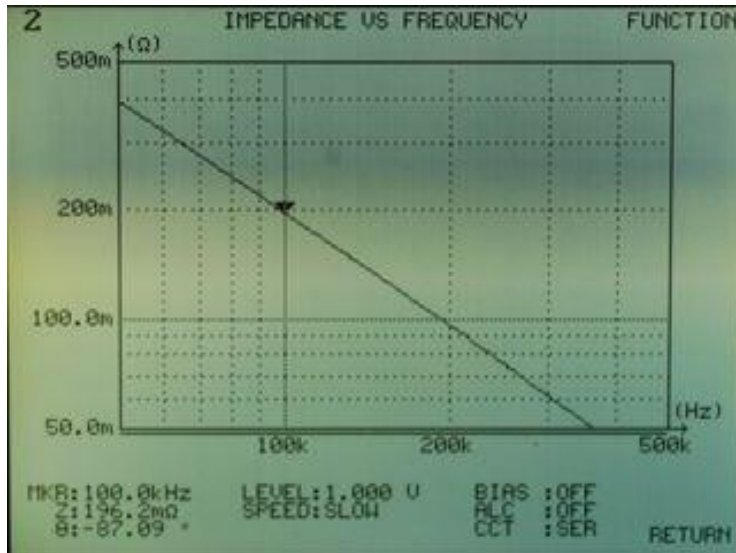
New Custom Caps from Stock

Not subjected to temperature or voltage

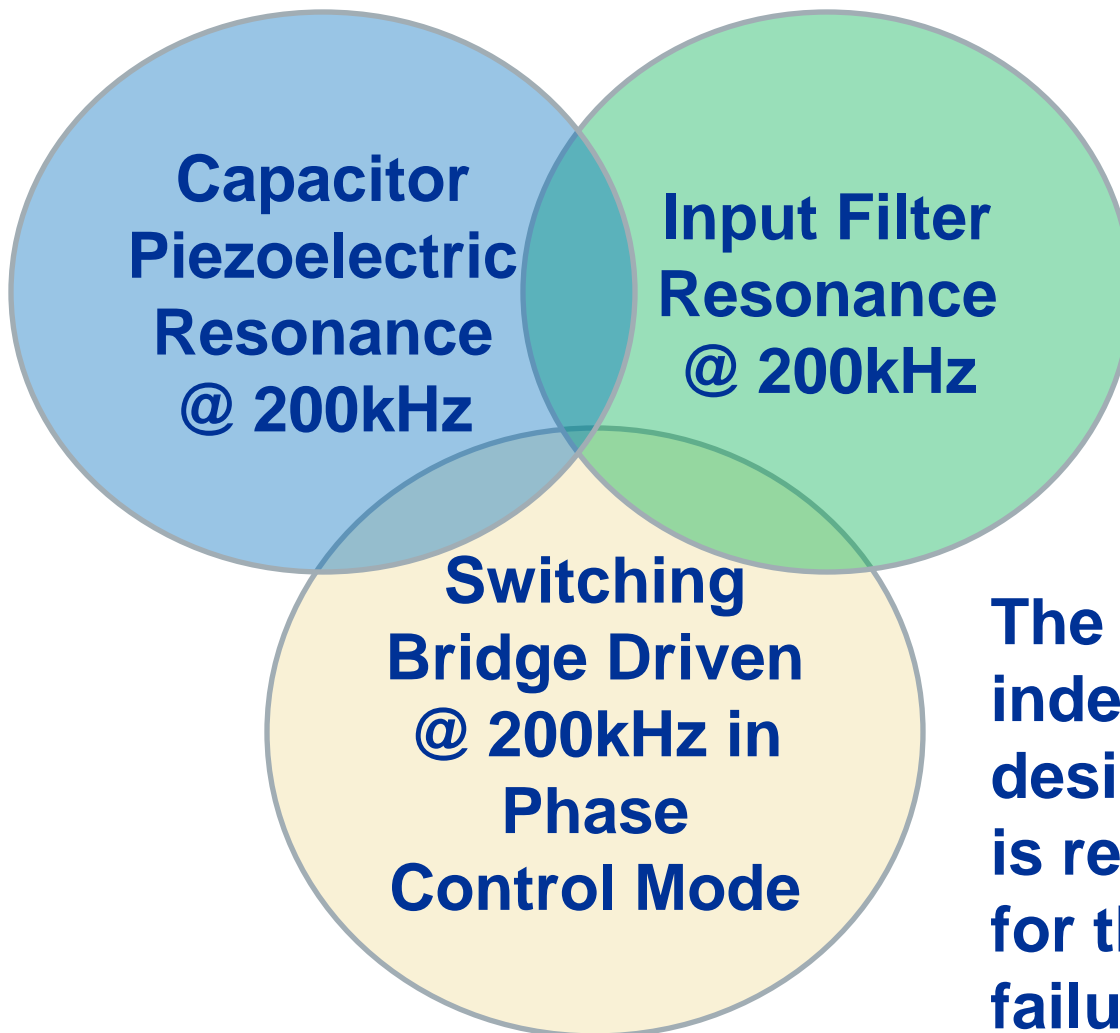
Summary of Failure Mechanism

The confluence of 3 independent design elements is responsible for the capacitor failure

- **Piezo-electric characteristics of the Custom Capacitor at the operating frequency of the beam power supply led to its failure in this application**
- **Circulating currents at the operating frequency within the bridge aggravated the problem**
- **Recycle of the beam supply may be final trigger of the failure but is not the primary cause**
- **Replace capacitors with a non-piezoelectric capacitor**
- **Add MPP Core to eliminate circulating current**

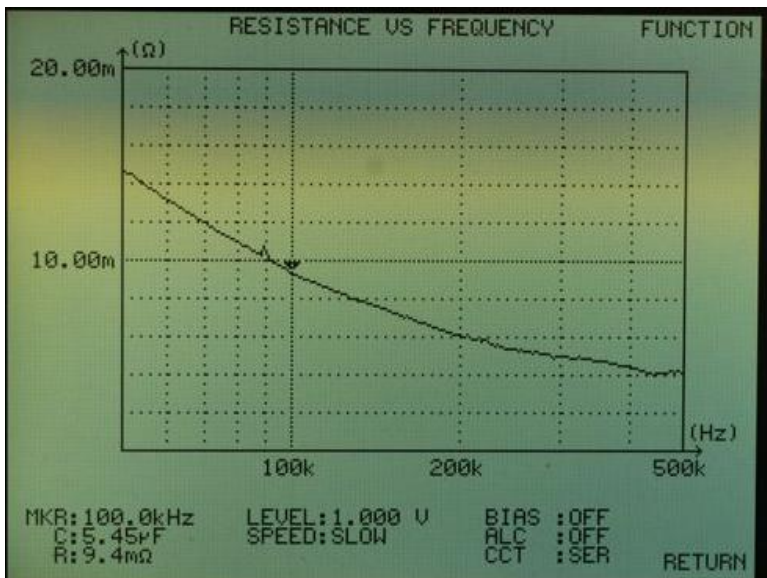
Replacement 5.6 μ F/500V 0 volt Bias

Custom 9 μ F/300V
