A STUDY OF MICROCRATERS IN MATERIAL SAMPLES AFTER LONG DURATION EXPOSURE ON ISS KOMPLAST PANELS

S.K. Shaevich¹, N.G.Aleksandrov¹, A.E. Shumov¹
L.S. Novikov², V.N. Chernik², M.S. Samokhina²
J. L. Golden³, R. F. Graves³, M. Kravchenko³
E. L. Christiansen⁴, J. A. Henkener⁴

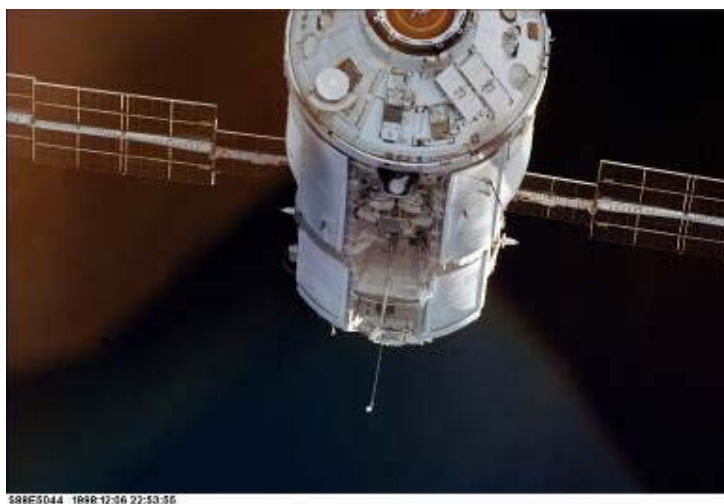
Fig. 1 FCB with Komplast Panels Installed - 1998

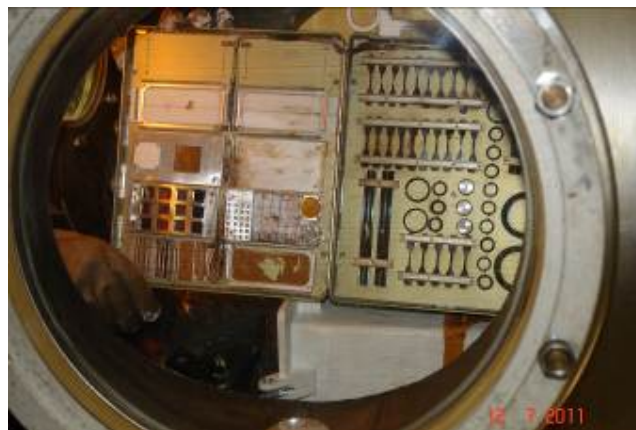
Fig. 4 Komplast Experiment Panel # 2 After Opening on July 12, 2011 at NIIYF, MSU

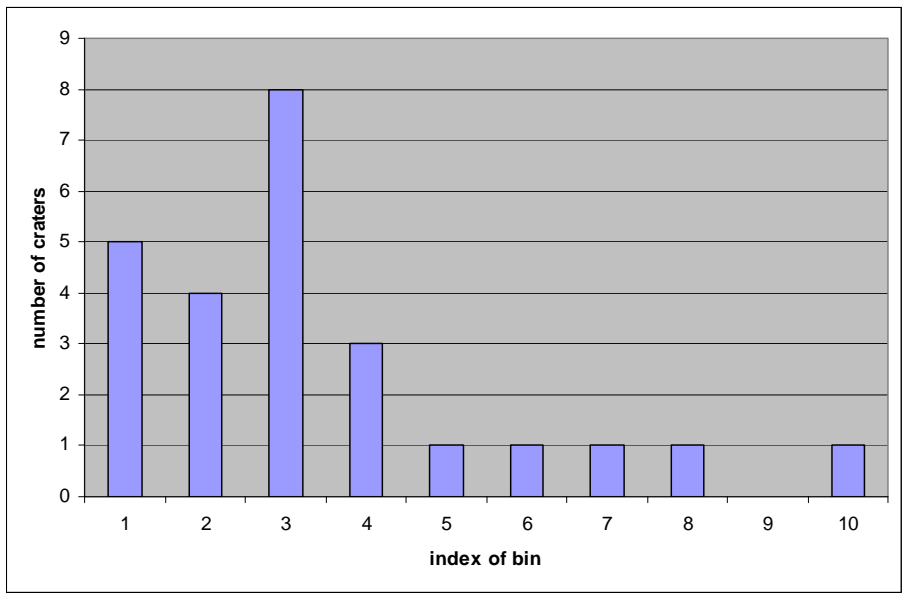
In addition to performing microscopy on the material samples, the exposed surfaces of the panel #2 hardware structure (727.34 cm² in area) were examined. Figure 7 shows the distribution of particle sizes for the Komplast hardware structure itself. In this case, 25 microcraters were observed, which is a much lower impact concentration than observed on the sensor materials themselves.. Such a difference in the number of detected microcraters on the panel hardware surface, which is many times larger in area than the sensor sample surfaces, is explained by the

fact that the panel hardware surfaces were not polished or otherwise treated prior to launch, since they were not initially part of the experimental investigation. Therefore, in order to remove this effect from the influence on the study of the number of microcrater defects, it was decided to include only craters with distinctive crater-like characteristics. These craters were 34 to 1000 μm in size.

Fig. 7 Distribution of Craters Detected on Panel #2 Surface into Sizes. Spacing is 100 μm

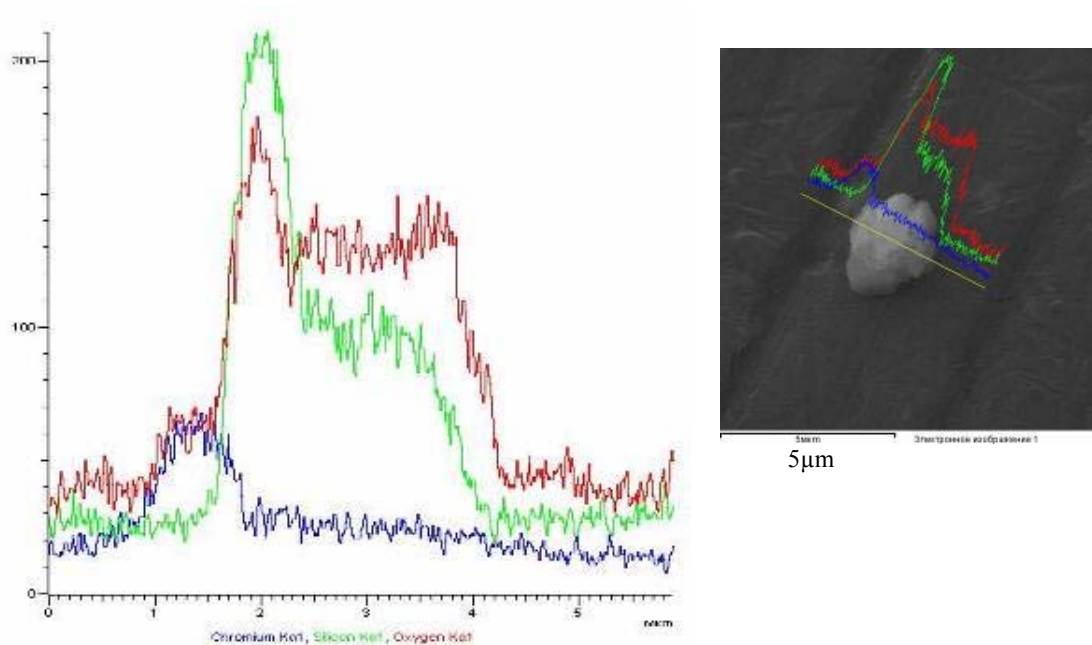
Figure 11 shows a photograph of a low velocity microparticle that was found embedded in one of the material samples. The elemental composition of the substance was also determined by energy dispersive spectroscopy, and indicates that it is a SiO_2 microparticle. This data permits the particle to be distinguished from naturally-originating space particles and identifies it with human-generated space debris. Figure 12 shows a photograph of another low velocity microparticle that was found embedded in the titanium sample and the chemical analysis allowed it to be identified as CrO_x .

Fig. 11 Low-Velocity SiO₂ Microparticle on Sensor Surface and Its Spectrum

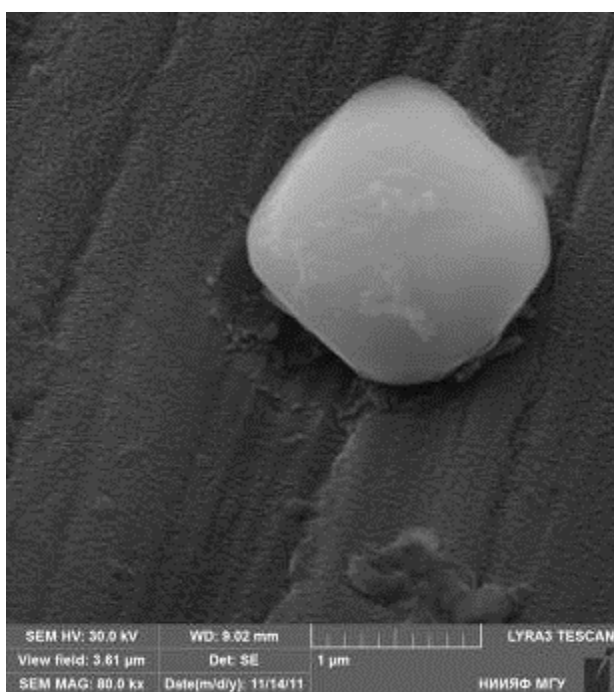
Fig. 12 Low Velocity CrO_x Microparticle on Surface of Titanium Sample
