## “Establishing a Ballistic Test Methodology for Documenting the Containment Capability of Small Gas Turbine Engine Compressors”

Joel Heady, J. Michael Pereira, Chuck Ruggeri and George Bobula

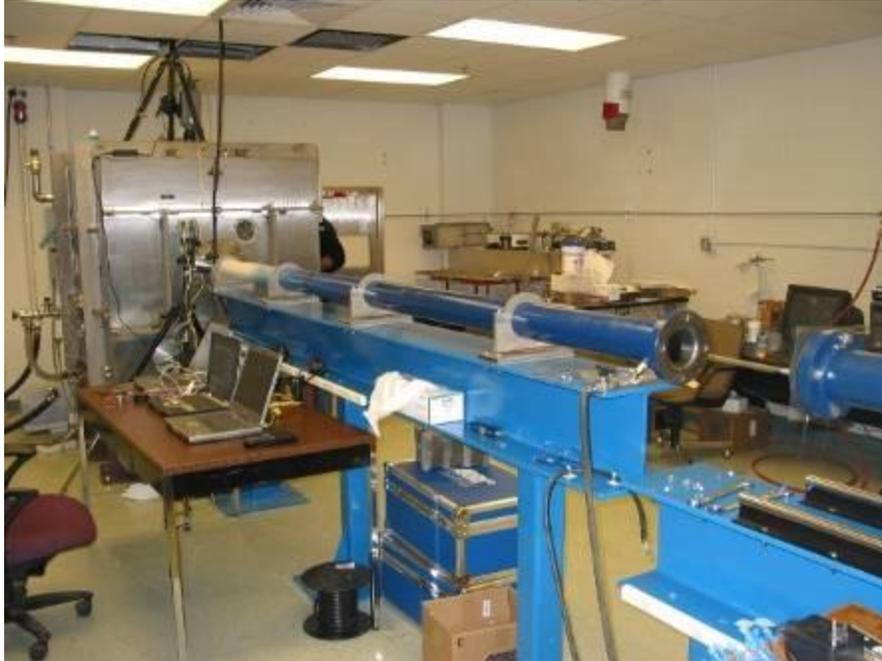
Figure 1.a. Large Vacuum Gun at the NASA GRC Ballistic Impact Facility.

Impact tests were conducted using the Large Vacuum Gun facility at the NASA GRC Ballistic Impact Laboratory (Figure 1.a). A schematic of the test installation is shown in Figure 1.b. This facility consists of a gun barrel connected to a vacuum chamber in which the test fixture is located. For these tests a 3 in diameter gun barrel with a length of 22 ft was used. The pressure vessel has a volume of 1644 in<sup>3</sup> and a maximum pressure of 300 psi. Because of the relatively high speeds required in these tests, compressed helium was used as the propellant.

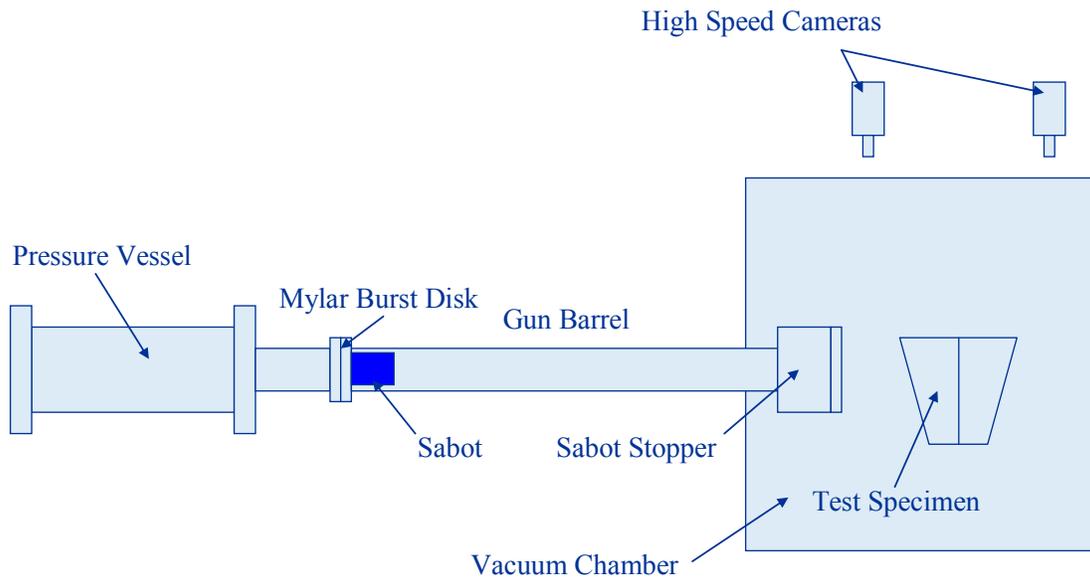
Figure 1.b. Schematic of Large Vacuum Gun Facility.

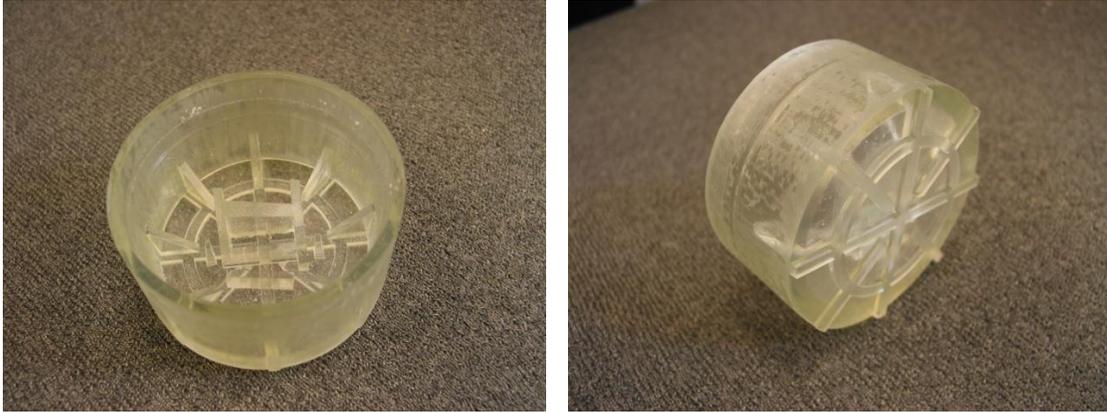
Figure 2.a. Sabot used for Stage 2 blades.

The projectiles used in these tests were actual blades machined from stage 1 and 2 integrally bladed rotors. The projectile was supported in a specially designed sabot (Figure 2) which carried it down the gun barrel. The sabot was designed to be light weight, strong enough to withstand the pressure loads and to support the blade in an orientation representative of engine operation. The blade support conforms to the low pressure profile or suction side of the blade. The sabot was stopped at the end of the gun barrel by a sabot stopper (Figure 3) in the form of a diverging cone designed to deflect the majority of the sabot material away from the target and allow the projectile to continue on its path toward the target.

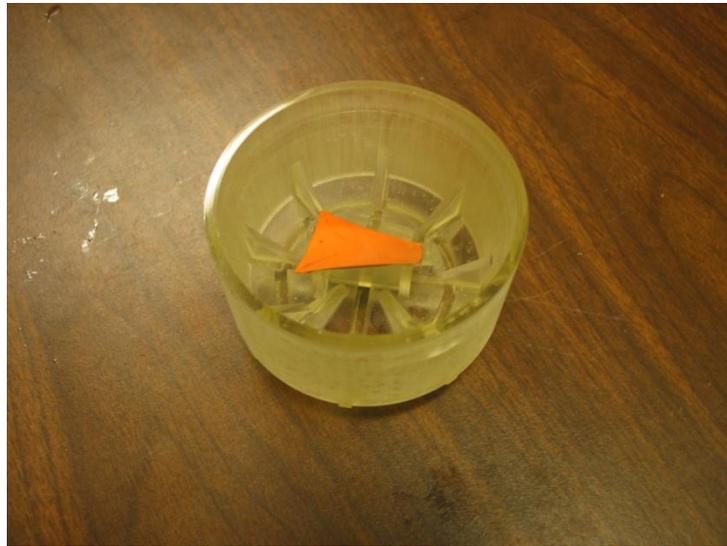
Figure 2.b. Stage 2 blade mounted in sabot.

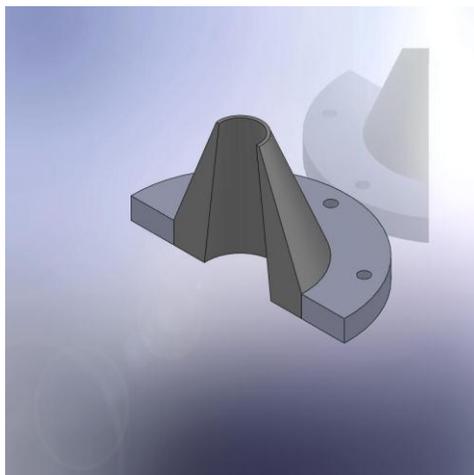
Figure 3. Schematic of the cross section of the sabot stopper. In this view the sabot would be traveling from top to bottom and the blade would pass through the center hole.

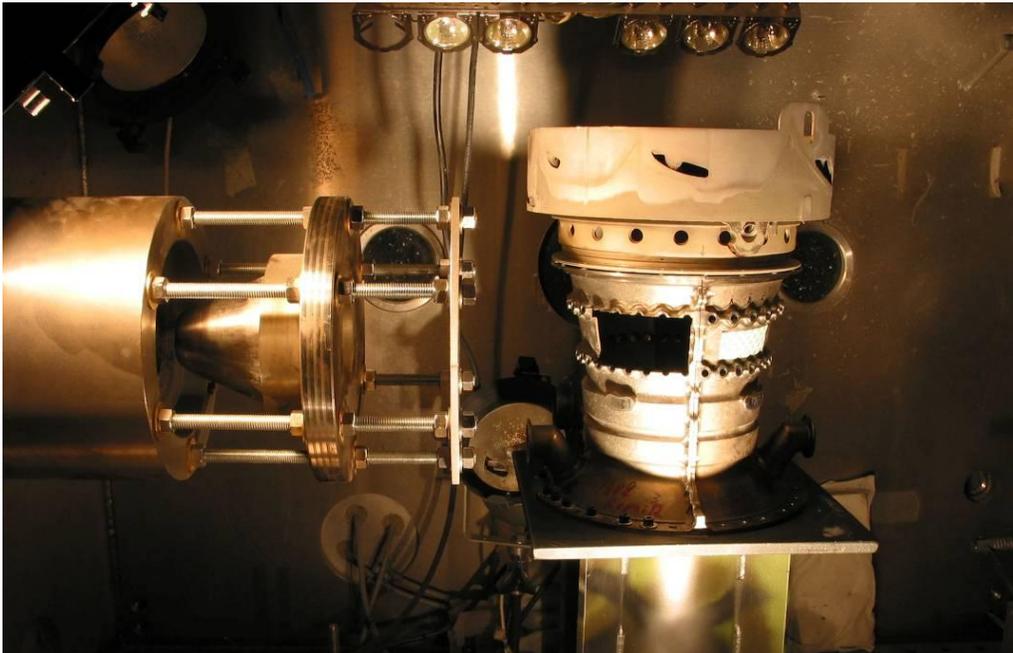
Figure 4. Test article shown in vacuum chamber in front of the gun barrel. The figure shows the sabot stopper on the left and the window in the test article through which the blade travels before impacting the back half (on right) of the case from the inside.

The test articles were compressor cases from a small gas turbine engine. In the particular engine tested the case is split axially, and the two halves are bolted together. It was important that the test article configuration incorporate stiffnesses representative of the actual engine hardware. To accomplish this, the full compressor case was mounted on a stiff fixture in front of the gun barrel such that its centerline was vertical and the plane in which the two case halves are joined was normal to the path of the projectile. A portion of the engine main frame was bolted to the compressor front flange. A window was machined in the half of the case closest to the gun barrel (the front half) so that the projectile could travel through the window and impact the back half of the case. The case was offset laterally so that the radial location of the projectile at impact was the same as would occur if a blade separated from the rotor near the split line of the case. The test setup is shown in Figure 4.

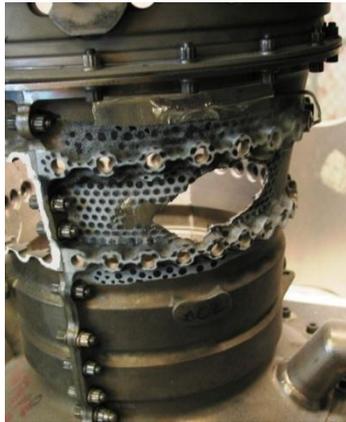
Figure 5. Uncontained impact with no blade exit.

As a result, no blade impacts resulted in a blade exiting through the case thickness, even when a large fragment of the case was punched out or when the front flange failed (Figure 5).

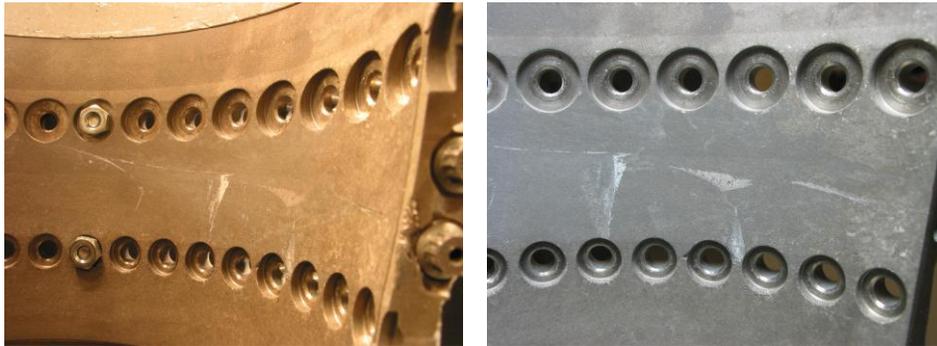
Figure 6. Damage on case before impacting with sabot only (left) and after impacting with sabot only (right) at a speed of 2197 ft/sec. Case had been previously impacted by a stage 2 blade at a low velocity.

The test articles were illuminated with high intensity lights that made the cloud of remaining sabot material that traveled with the blade to the impact site appear to be very large. There was a concern that this material might invalidate the results of these tests. Therefore, separate, sabot only tests were performed on cases that had already been used in impact tests. In one of these tests, the sabot was fired at a velocity greater than 2000 ft/sec. Before and after photos indicated no noticeable increase in damage to the case (Figure 6). In addition, the maximum strain measurement during the impact showed a peak strain of 2.6 % at the sabot material impact location. This is less than 1/3 of the ultimate strain of the case material at the test temperature. It was concluded that the remaining sabot material that traveled with the blade to the impact site had no impact on test results.

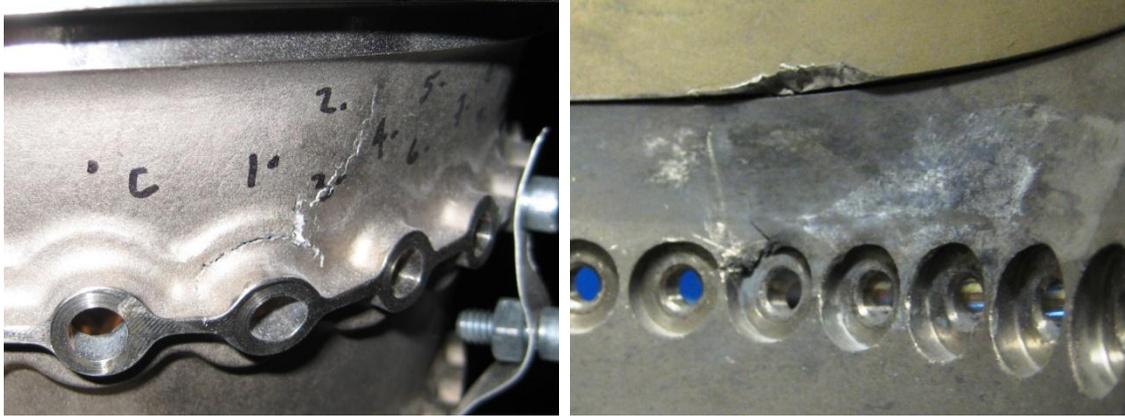
Figure 7. Stage 1 contained boundary point.

Fifteen impact tests were conducted on cases at the stage 2 location and 18 tests at the stage 1 location. Impact velocities ranged from approximately 1000 ft/sec to 2200 ft/sec. As discussed previously, the blade did not completely penetrate through the case wall in any test. However in a number of cases the damage was severe and portions of the case were ejected. In several tests, cracks due to the blade impact extended through the compressor case front flange and through the mating flange of the main frame. While the blade did not pass through the case in any test, many of the tests were labeled as uncontained based upon the US Army definition for the containment boundary. Photographs of the contained stage 1 boundary points are shown in Figure 7 below and the uncontained stage 1 boundary points are shown in Figure 8. In addition, a non-dimensional plot of the kinetic energy of the projectile as a function of thickness is shown in Figure 9. This plot includes the critical stage 1 and stage 2 test points. As seen below, a form of equation 2 resulted in a good fit through the critical points for both stages.

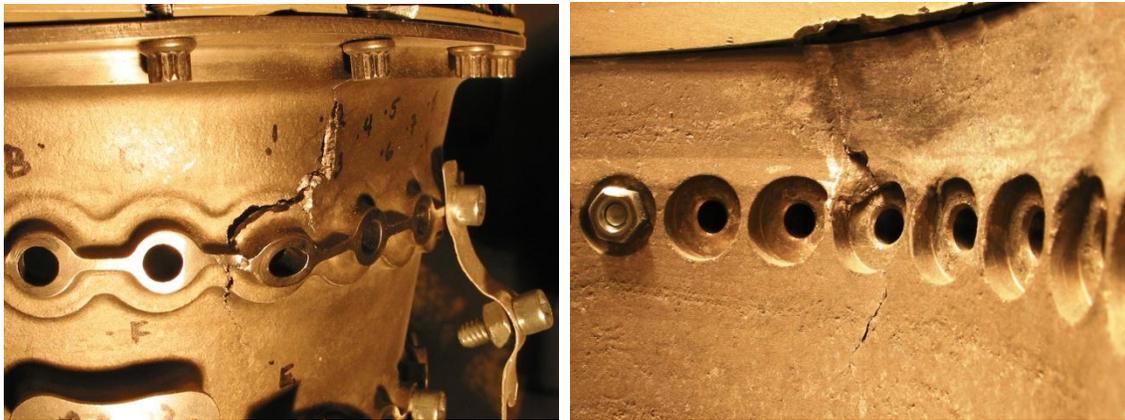
Figure 8. Stage 1 uncontained boundary point.

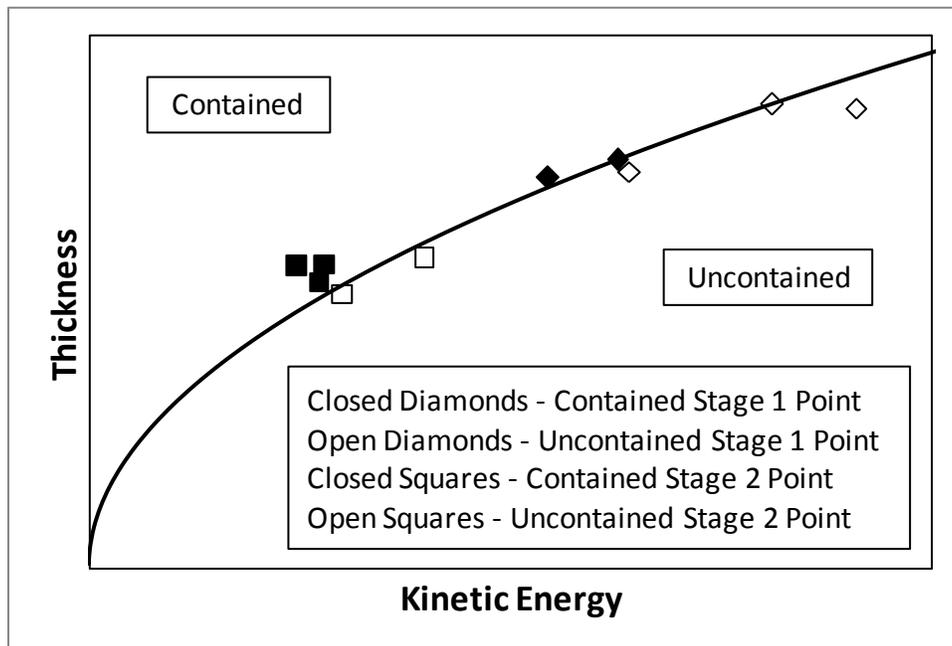
Figure 9. Plot of thickness versus kinetic energy.
