Electrostatic Evaluation of the ARES I FTS Antenna Materials

ESPL-TR10-002

August 27, 2010

NASA
Electrostatics and Surface Physics Laboratory

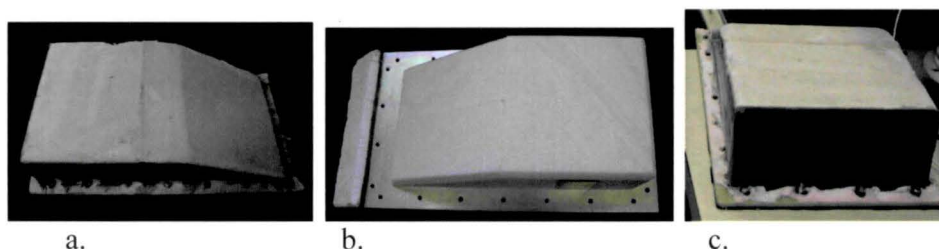
Figure 1. a) FTS antenna exterior showing the white SLA-220 foam. b) FTS antenna with outer SLA-220/fiberglass cover removed showing the rigid Eccofoam. c) Rear view of FTS antenna outer housing showing the phenolic rear cap.

The Electrostatics and Surface Physics Laboratory was asked by USA and ATK engineering to evaluate whether ice crystal tribocharging on the Ares I FTS antenna housing during launch could cause damage to the antenna. The concern is that electrostatic discharge (ESD) can either make the antenna non-functional or the RF output of an ESD event may interfere with signals to the antenna. An FTS antenna and its housing assembly were provided to the ESPL for evaluation. The housing is shown in Fig. 1. The housing consists of a white foam (SLA-220) outer layer over a fiberglass frame with a phenolic piece on the vertical downstream portion of the antenna. Inside, the four vane FTS antenna is enclosed with a rigid, pink Eccofoam. Also, bare, primed with DC-1200 primer, and primed and coated with Sylgard 186.3 samples of the SLA-220 foam were provided for testing. These foam samples are shown in Fig. 2.

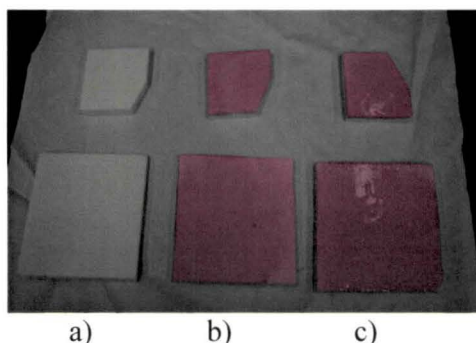
Figure 2. Samples of the SLA-220 foam. a) Bare, b) With DC-1200 primer, c) With DC-1200 primer and Sylgard 186.3 overcoat.

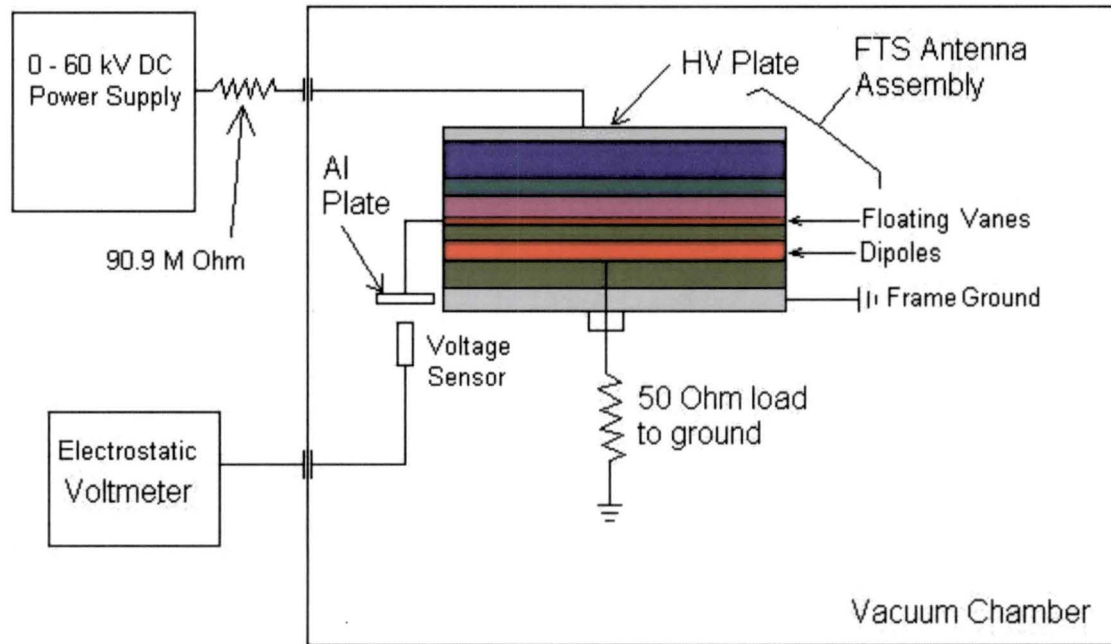
Figure 3. Ares I FTS Antenna Electrostatic Test Schematic.

Experiments were performed to determine how much voltage an exterior surface charge density on the FTS antenna housing will induce on the electrically floating antenna vanes. A square Aluminum plate (approximately 5.0 in \times 5.0 in \times 0.125 in), attached to a HV power supply, was used to model an exterior electrostatic charge density caused by triboelectrification. Two test locations on the FTS antenna housing were used. The test positions were the top flat portion of the housing (location 1) and the slanted, forward facing, portion of the housing (location 2). Fig. 3 shows a schematic of the test set-up.

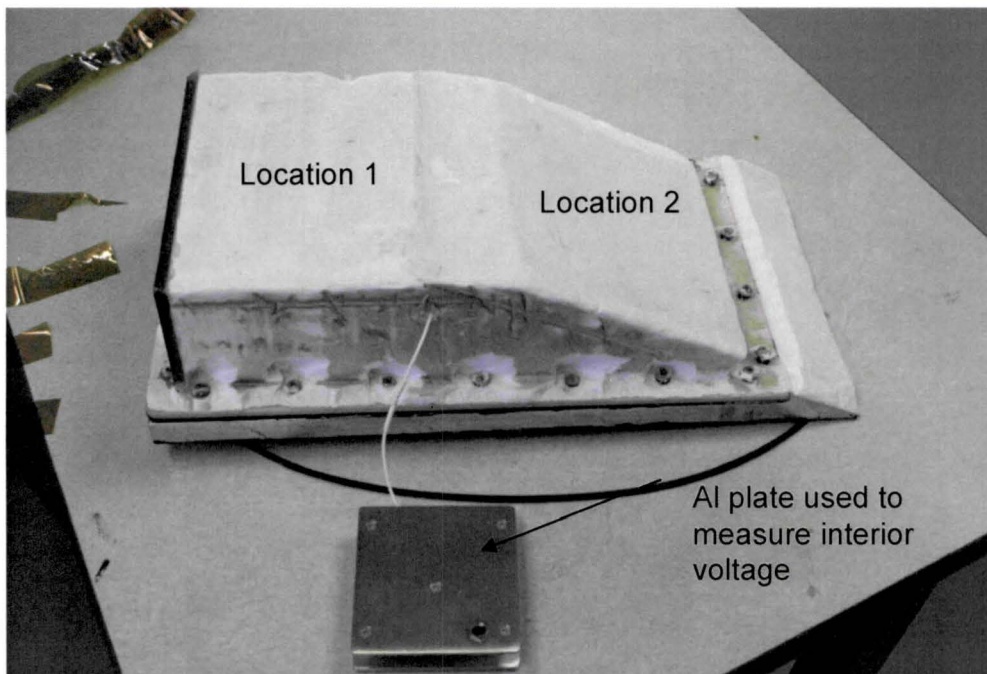
Figure 4. Test locations for the Aluminum plate used to model exterior surface charge on the Ares I FTS housing. Shows Aluminum plate used for interior voltage measurements.

The housing was modified to attach a wire to one of the four antenna vanes. This wire was then attached to an external electrically floating Aluminum plate positioned below the housing. This test set-up is shown in Fig. 4. A Trek high speed electrostatic voltmeter was used to measure the voltage on the sense plate as voltage was applied to the exterior source plate. The tests were performed in the ESPL's large vacuum chamber. Fig. 5 shows the applied voltage on the exterior Aluminum plate versus the measured voltage on the interior antenna vanes.

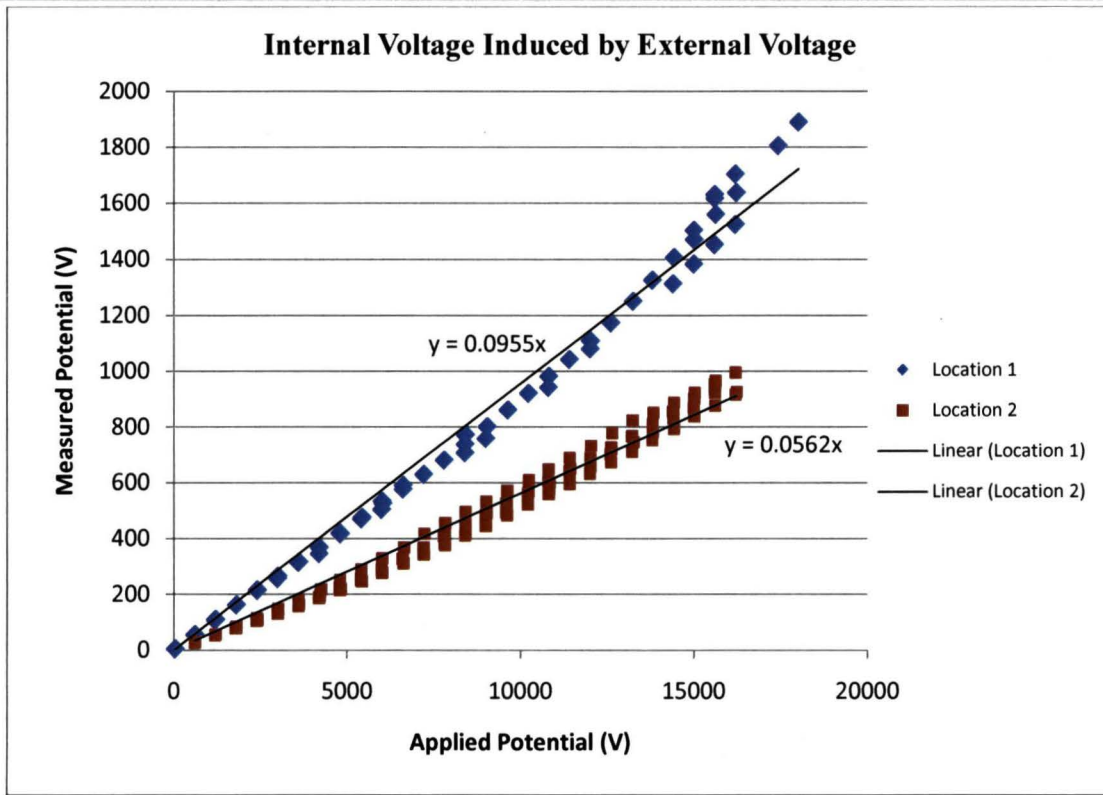
Figure 5. Measured voltage on the external Al plate versus the measured voltage on the internal antenna vane. Curve fits were calculated to get the slopes (correction factors).

The factors relating external voltage to internal induced voltage are ~ 0.1 for location 1 and ~ 0.06 for location 2. Since location 2 will receive most of the ice crystal impingement, 0.06 will be used for determining the worst case charge build-up on the vanes. Data from Patch 2 location from the 1.6 Mach flight of December 30, 1070 in the Air Force study [3] showed that the worst external charging due to ice crystal impingement was on the order of 10^5 V (100 kV). With this voltage applied to the external plate, the induced charge on the vanes will be on the order of 6000 V.

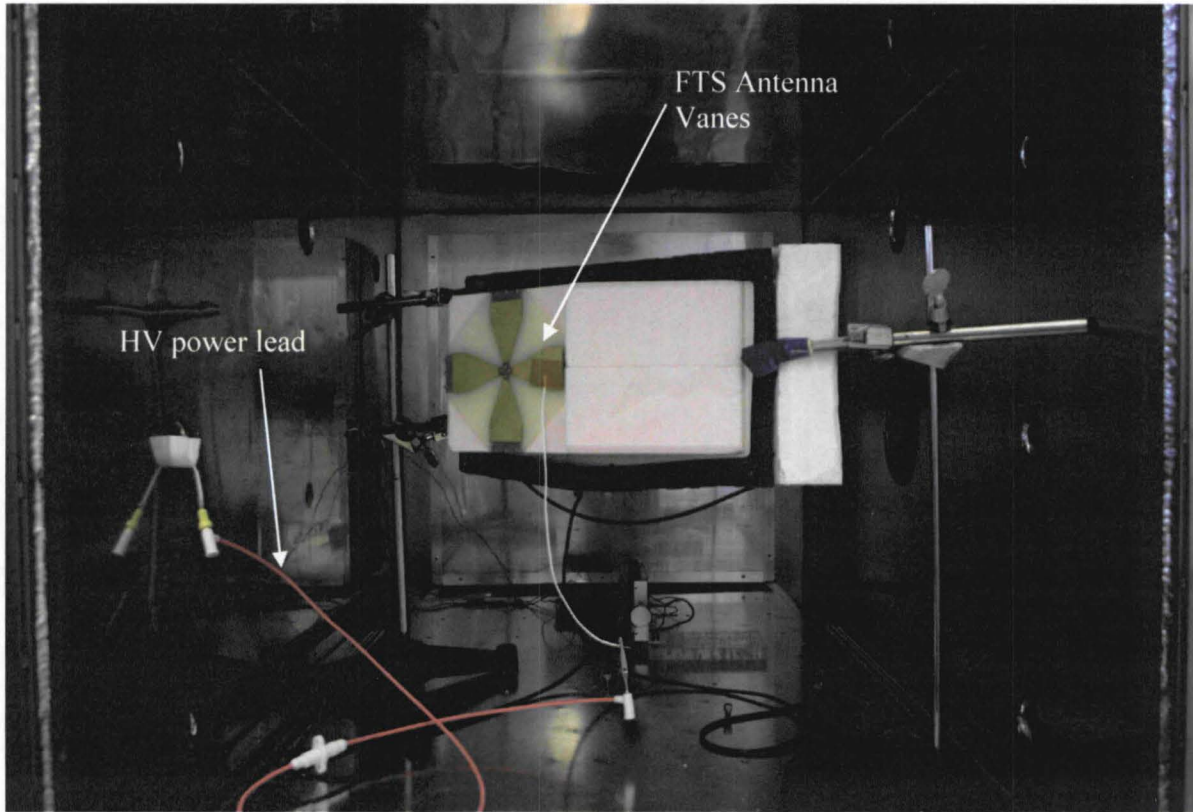
Figure 6. Test set-up inside the ESPL high vacuum chamber that was used to apply voltage directly to antenna vane modeling induced charge from external triboelectric charging.

Knowing the required voltage range to apply to the antenna vanes, the next step is to determine, at the different significant atmospheric pressures, whether or not sparking would occur. Fig. 6 shows the experimental set up for this test.

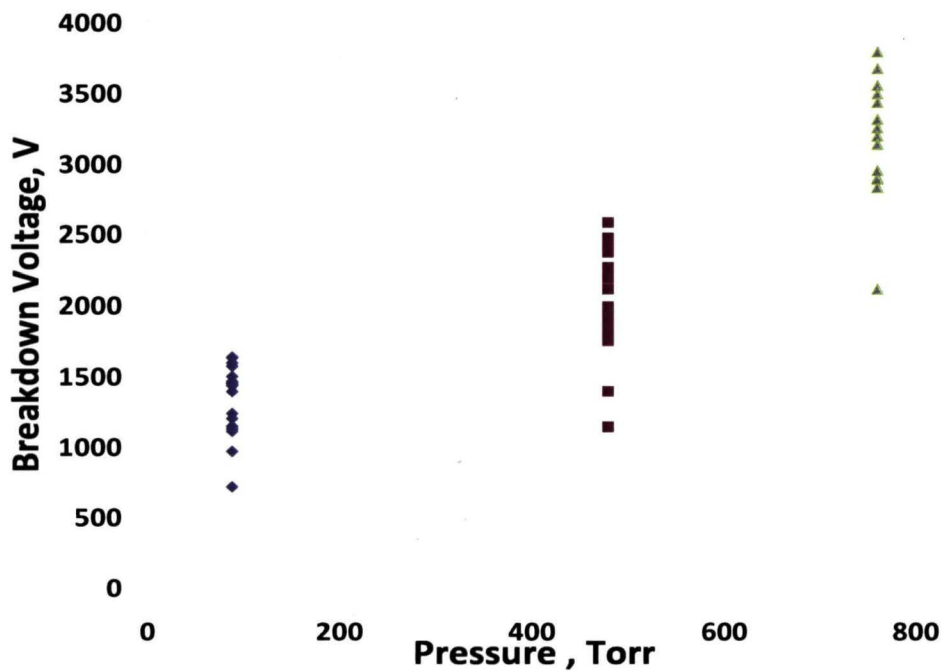
Figure 7. Breakdown voltage as a function of atmospheric pressure, based on an electrostatic discharge sensor.

At the test pressure, voltage on the vane with the HV lead was slowly increased until a discharge was recorded. As can be seen in Fig. 7, the range of discharge voltages are lower for lower pressures which is consistent with Paschen's curve [4] for sparking voltage versus pressure. A similar test was run where the voltage was raised until a visible discharge was observed, which

Tests were run at 760, 480, and 88 Torr, the atmospheric pressure values for sea level and the upper and lower boundaries of the interested flight path. The voltage was turned progressively higher until an electrostatic discharge sensor (EMeye by Credence Technologies, Inc.) recorded a hit. The voltage where the hit occurred was recorded and the data was compiled to show where the lowest set of electrostatic discharges occurred, seen in Figs. 7 and 8.

For both sets of data, the relationship between decreased pressure leading to decreased threshold was anticipated due to the Paschen’s law and having a set distance between the two points where discharge is occurring. Knowing that it was possible for the UHF antenna array to spark, under the estimated worst case conditions; the need arose to determine the characteristics of the discharge events. This information could be very vital to understanding possible damages to any of the communications equipment or any effects on signals being sent or received. Using an oscilloscope attached to the antenna output allowed analysis of the lower threshold discharges; primarily those invisible discharges observed using the EM Eye. While recording the potential going through the antenna in real time, the discharges were observed and recorded. Various configurations of the test were used from adding a 50 load and or a lightning stub to the antenna output. From this raw data, the peak-to-peak voltage and, more importantly, a Fast Fourier Transform (referred to as a FFT) analysis were performed, which determined the strengths of the radio-frequency noise created by the discharge.

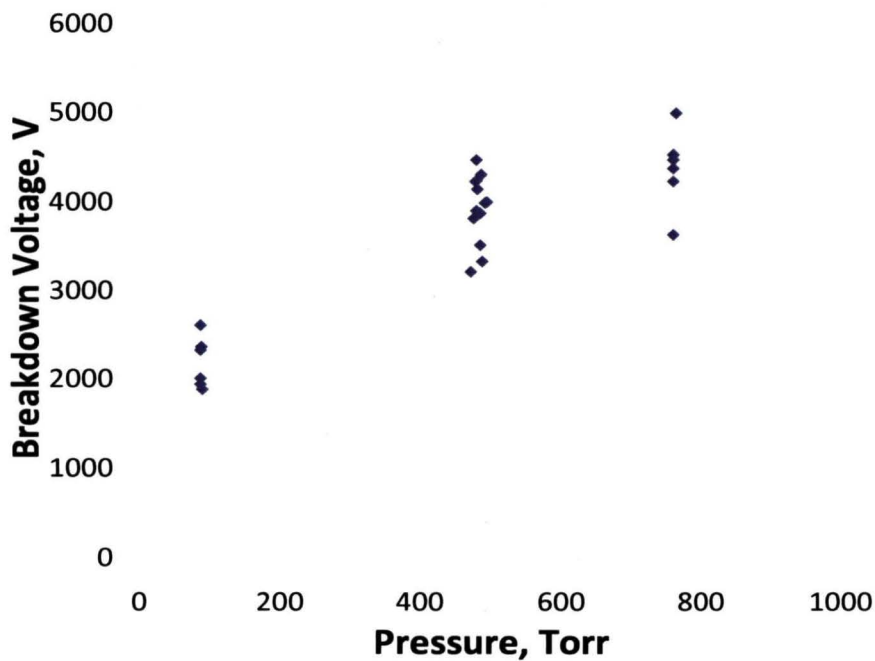
Figure 8. Breakdown voltage as a function of atmospheric pressure based on visual observations.

was at a higher potential as was expected. This voltage threshold was recorded at the same three atmospheric pressures and plotted in Fig. 8.

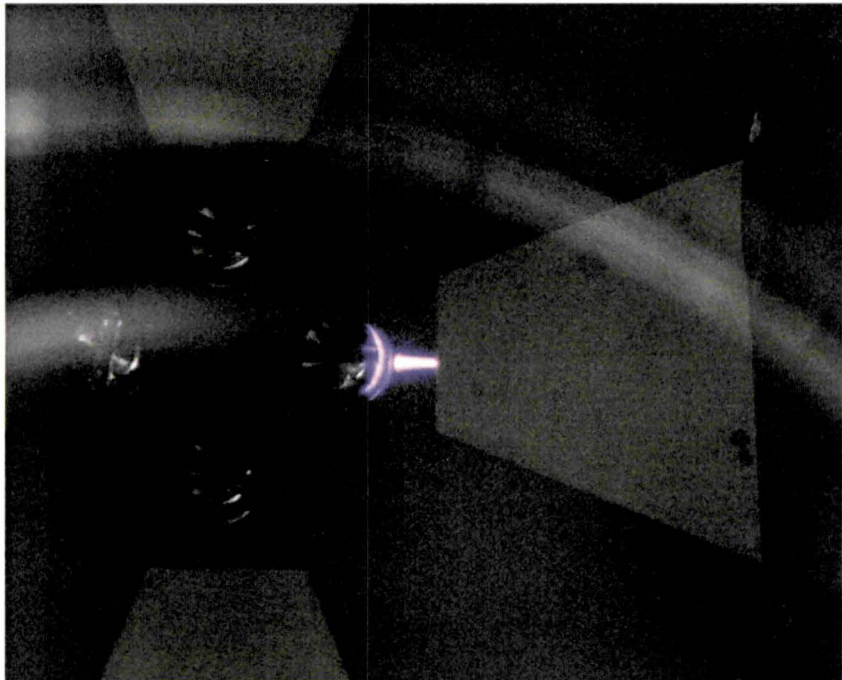
Figure 9. Electrostatic discharge between an FTS antenna vane at ~ 6 kV and a grounded center screw head.

At the 6000 V level, several visible discharges were noted between the energized vane and the nearest center screw head. An example of this discharge is shown in Fig. 9. Many discharges of this magnitude were generated in the course of this testing and resulted in only superficial damage to the outer edge of one of the vanes. This superficial damage is shown in Fig. 10.

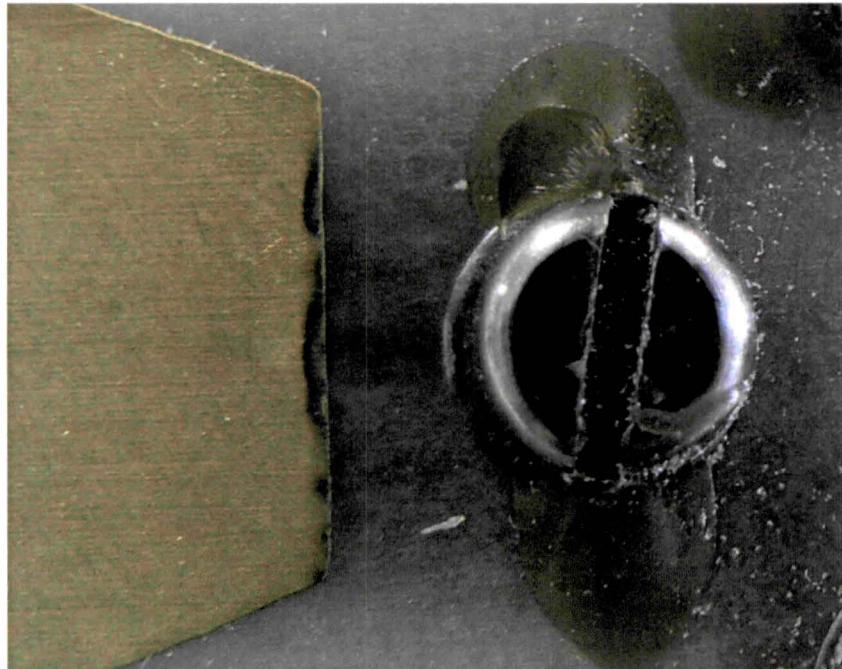
Figure 10. Superficial damage to an FTS antenna vane edge due to repeated electrostatic discharges in the 6 kV range.
