NASA/TM—2012-217823

Contamination Control Assessment of the World's Largest Space Environment Simulation Chamber

Prepared for the
27th Space Simulation Conference
cosponsored by the IEST, NASA, CSA, AIAA, ASTM, and JHU/APL
Annapolis, Maryland, November 5–8, 2012

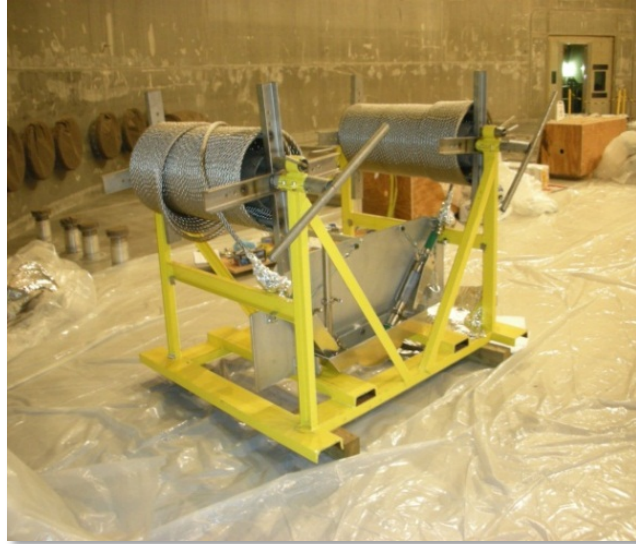
Figure 10.—Arrangement for applying low vapor pressure oil to hoist wire ropes.

Prior to installation, the new stainless steel wire ropes were cleaned and then re-lubricated with a low-outgassing fluorocarbon polymer lubricant. The first step in cleaning the wire ropes was performed by a commercial vendor where they had been shipped to remove the greases and oils applied during fabrication. This cleaning process comprised three cycles. Each cycle consisted of a submersion of a wire rope into a trichloroethylene (TCE) ultrasonic bath followed by raising it into the TCE vapor and spraying using distilled TCE. After this TCE cleaning process, the wire ropes were heated under vacuum at SPF to remove remaining volatile residues. Following these processes, the wire ropes were lubricated with the low-outgassing perfluoropolyether lubricant. The application of this oil used a special framework, which is shown in the picture given in Figure 10. This arrangement allowed the cleaned cable to be uncoiled from one drum, immersed for a controlled amount of time within a circular conduit containing the oil and solvent bath, and then coiled onto another drum where it remained until the bulk of the solvent evaporated. Lubrication of wire ropes is necessary to maintain their safety load margin and to ensure the ropes do not become damaged during use.

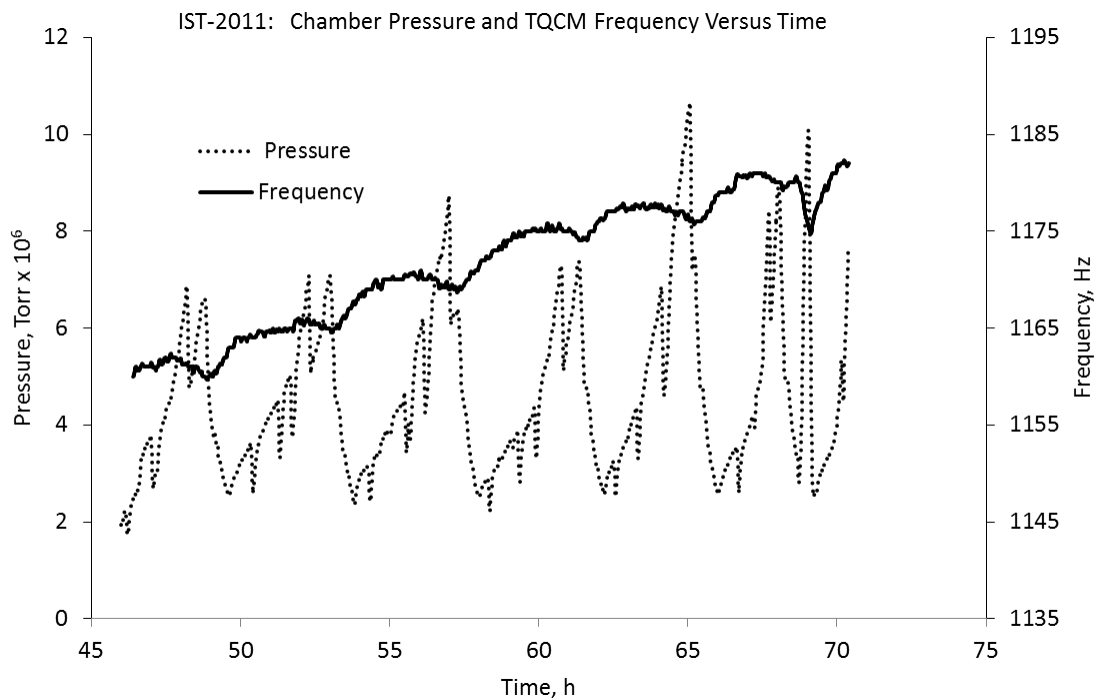
In order to examine contamination in more detail, the last interval presented above is shown in Figure 21 with an expanded scale. In this figure, the TQCM frequency and chamber pressure are plotted on separate axes as a function of time. The major chamber pressure swings evident are due to the pressure swings in the annulus. The smaller and more frequent variations in chamber pressure were caused by an independent leak source that fluctuated with the opening and closing cycles of a scavenger system valve. The large peaks in chamber pressure occur just as the annulus pressure reaches a maximum, i.e., immediately before annulus pumping is increased. However, it can be seen by examining the cusps in the contamination curve of Figure 20 that the contamination rate increases abruptly as chamber pressure begins to decline. Conversely, the contamination rate decreases as the pressure rises, and becomes negative, forming the initial portion of a cusp, when the pressure approaches a maximum. In general, an increase in N_2 concentrations results in lower contamination rates, because the contaminant species are minority constituents, for which the concentrations decrease with increasing nitrogen concentration.

Figure 21.—Correspondence between TQCM data and chamber pressure for IST-2011.
