The Komplast Experiment: Space Environmental Effects after 12 Years in LEO (and Counting)

S.K. Shaevich¹, N.G. Aleksandrov¹, A.E. Shumov¹, L.S. Novikov², J.A. Alred³, D.J. Shindo³, M. Kravchenko⁴, and J. L. Golden⁴

¹Khrunichev State Research and Production Space Center (KhSC), Moscow, Russia

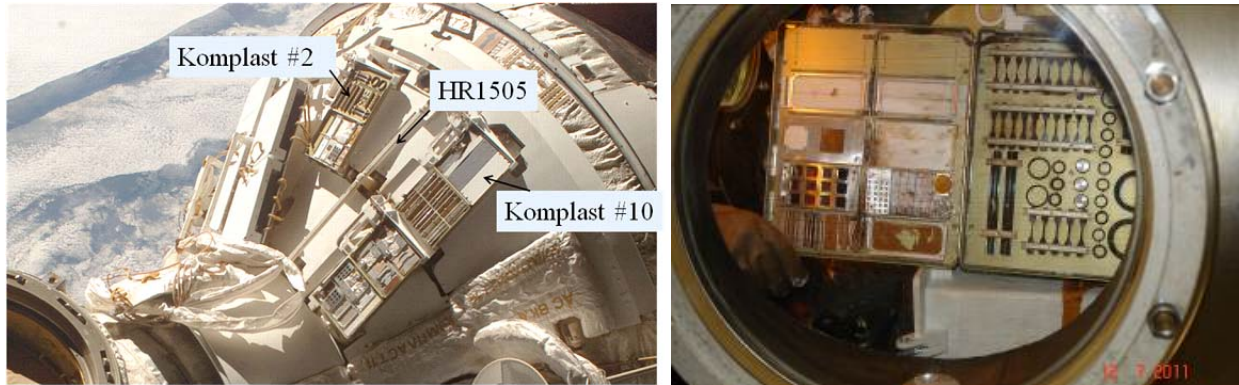
FIG. 1.A) Komplast Panels #2 and #10, located either side of handrail 1505 on the aft endcone of the FGB module, prior to retrieval; and FIG. 1.B) Komplast #2 just opened in the environmental control chamber at Moscow State University, after removal from its transportation canister.

The Komplast materials experiment was designed by the Khrunichev State Research and Production Space Center, together with other Russian scientific institutes, and has been carried out by Mission Control Moscow since 1998. Komplast panels fitted with material samples and sensors were located on the International Space Station (ISS) Functional Cargo Block (FGB) module exterior surface. Within the framework of this experiment, the purpose was to study the effect of the low earth orbit (LEO) environment on exposed samples of various materials. The panels were sent into orbit with the FGB when it launched on November 20, 1998. Panels #2 and #10 were retrieved during Russian extravehicular activity in February 2011 and sealed within cases to temporarily protect the samples from exposure to air until they could be studied on the ground. Panel #2 contained an experiment to detect micrometeoroid and orbital debris (MMOD) impacts, radiation and UV sensors, several pieces of electrical cable, and samples made from elastomeric and fluoroplastic materials. Panel #10 contained a temperature sensor, and both carbon composite and adhesive-bonded samples. Figure 1.A shows the location of panels #2 and #10 on the FGB module aft endcone. The panels were subsequently returned to Earth by Space Shuttle Discovery on the STS-133/ULF-5 mission after 12 years of LEO exposure and opened in an argon chamber at the Institute of Nuclear Physics at Moscow State University in July 2011 (see figure 1.B.)

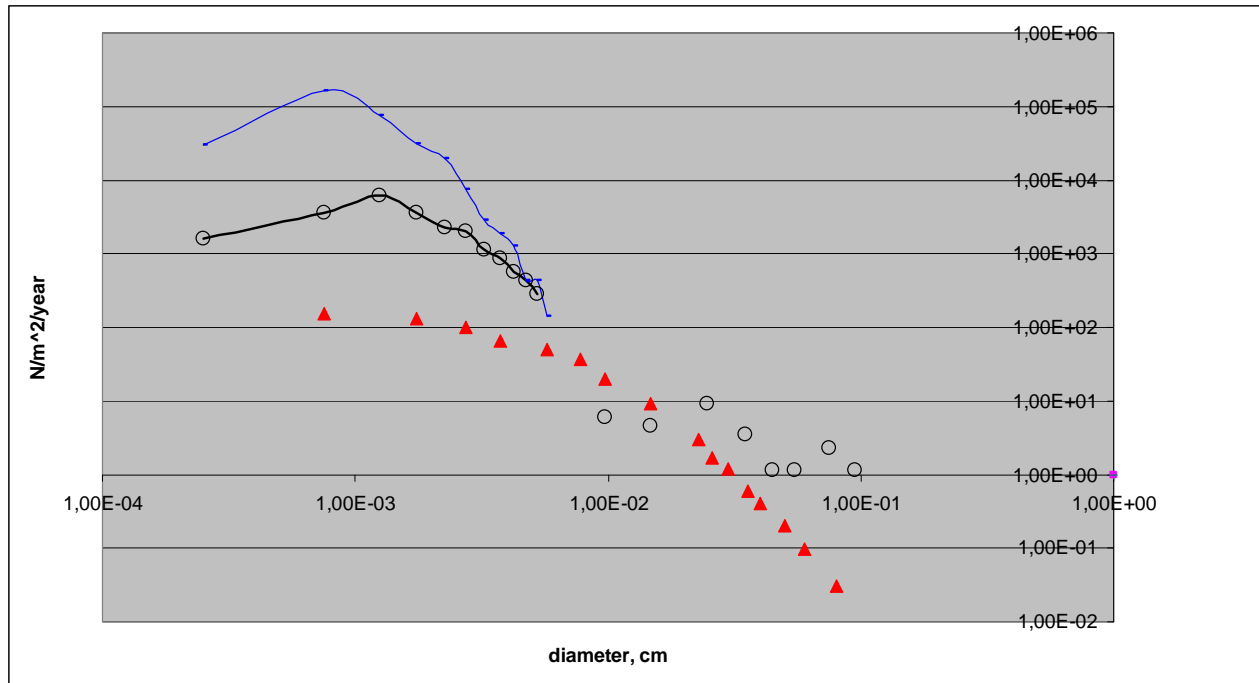
- ▲ ORDEM2000 predictions
- ⊙ Craters on aluminum and copper surfaces and Panel 2
- Total number of craters and particles on aluminum and copper surfaces

FIG. 2. Distribution of crater diameters obtained from Komplast in comparison with ORDEM2000.

The MMOD environment was determined [1], as is shown in figure 2. Interestingly, the distribution of craters and low-velocity impact particles observed in the 5-50 μ m size range was ~2-3 orders of magnitude higher than that predicted by the ORDEM2000 model of natural and artificial origin microparticles in the ISS orbit.
