Experimental Design for the Evaluation of Detection Techniques of Hidden Corrosion Beneath the Thermal Protective System of the Space Shuttle Orbiter

Catherine C. Kammerer¹, Janice K. Lomness², Paul E. Hintze²,
Joseph A Jacoby¹, and Richard W. Russell³

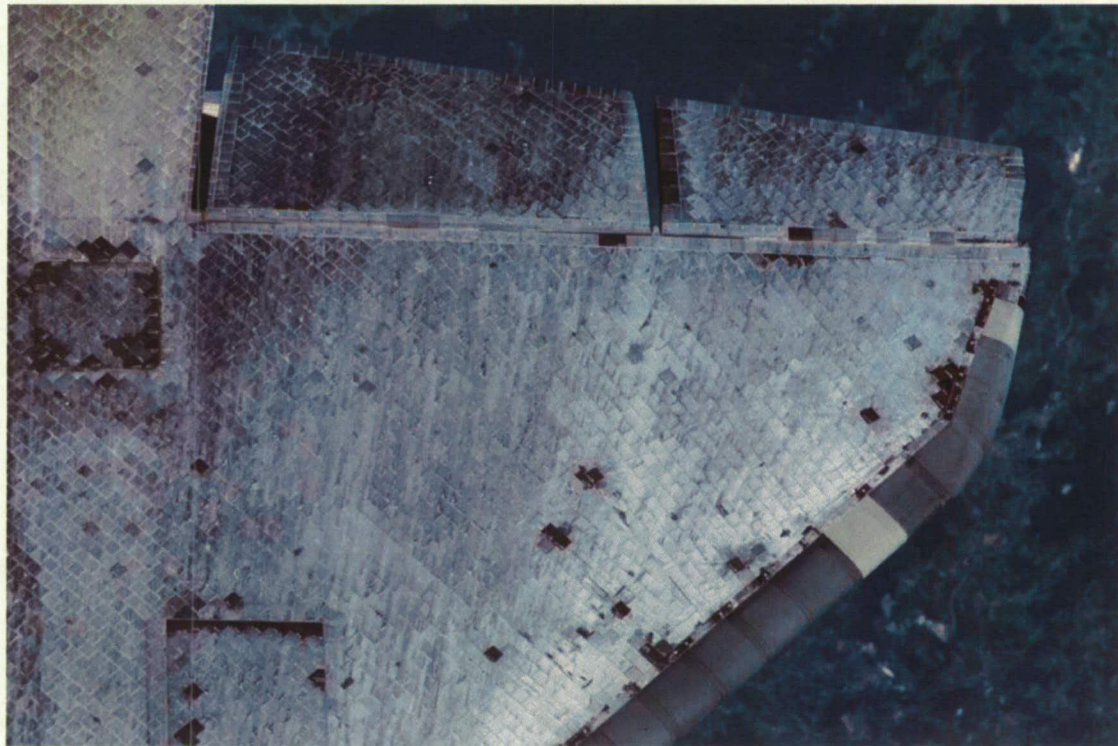
- Thermal Protection System Components
 - Panels
 - Blankets
 - Tiles

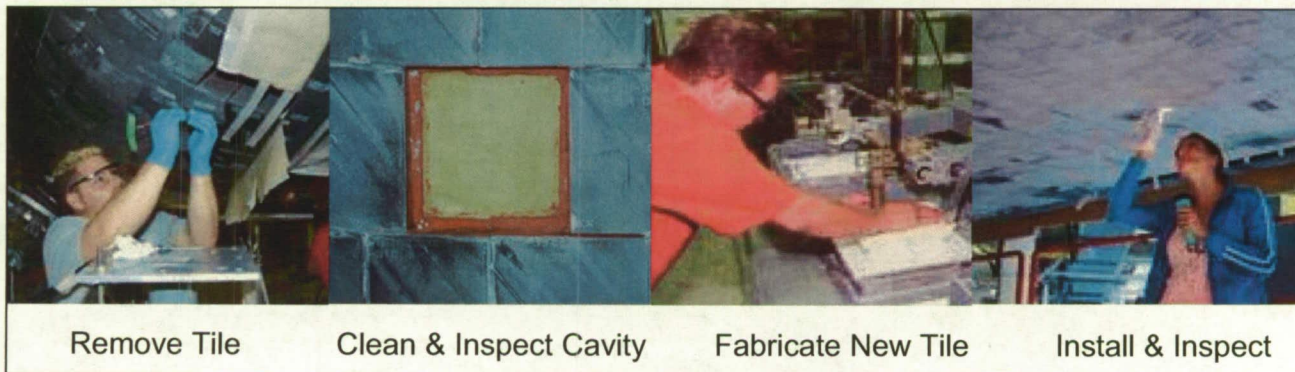
- 1) Removal of Tile
- 2) Visual Inspection
- 3) Corrosion Rework (if applicable)
- 4) Corrosion Protection Reapplication
- 5) Rebonding of Tile

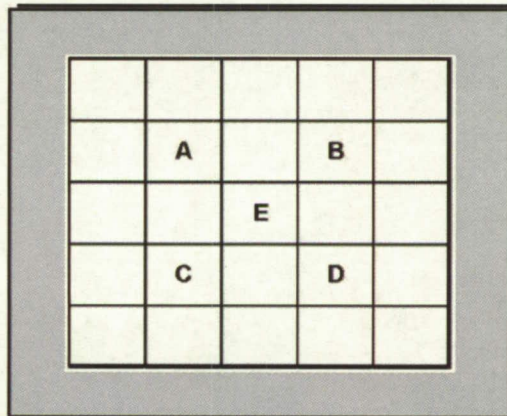
Calibration Panel

Pit Location	Pit Depth (inches)	Pit Diameter (inches)
Site A	0.0031-0.0056	0.1
Site B	0.0023-0.0031	0.6
Site C	0.019-0.023	0.1
Site D	0.191-0.219	0.6
Site E	0.0132-0.0146	0.3

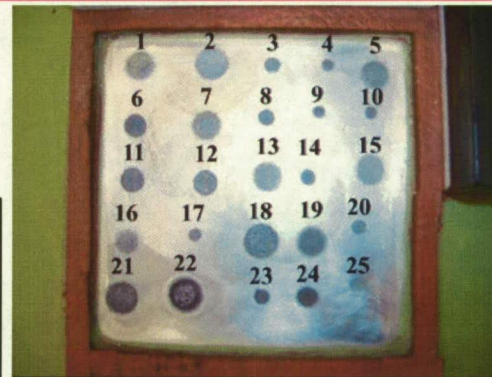
Site	Pit	Approximate Pit Depth, inches	Pit Diameter, inches
1	B	0.0015-0.0021	0.6
2	D	0.0198-0.0243	0.6
3	C	0.0144-0.0174	0.1
4	A	0.0030-0.0036	0.1
5	B	0.0014-0.0029	0.6
6	E	0.0074-0.0082	0.3
7	B	0.0021-0.0032	0.6
8	C	0.0112-0.0124	0.1
9	A	0.0022-0.0024	0.1
10	A	0.0017-0.0039	0.1
11	E	0.0043-0.0044	0.3
12	E	0.0072-0.0087	0.3
13	B	0.0018-0.0036	0.6

B	D	C	A	B
E	B	C	A	A
E	E	B	C	B
E	A	D	D	C
D	D	C	E	A

Size	Pit	Approximate Pit Depth, inches	Pit Diameter, inches
14	C	0.0256-0.0293	0.1
15	B	0.0018-0.0021	0.6
16	E	0.0098-0.0124	0.3
17	A	0.0033-0.0052	0.1
18	D	0.0119-0.0128	0.6
19	D	0.0085-0.0109	0.6
20	C	0.0104-0.0131	0.1
21	D	0.0199-0.0247	0.6
22	D	0.0173-0.0191	0.6
23	C	0.0117-0.0164	0.1
24	E	0.0053-0.0066	0.3
25	A	0.0025-0.0030	0.1

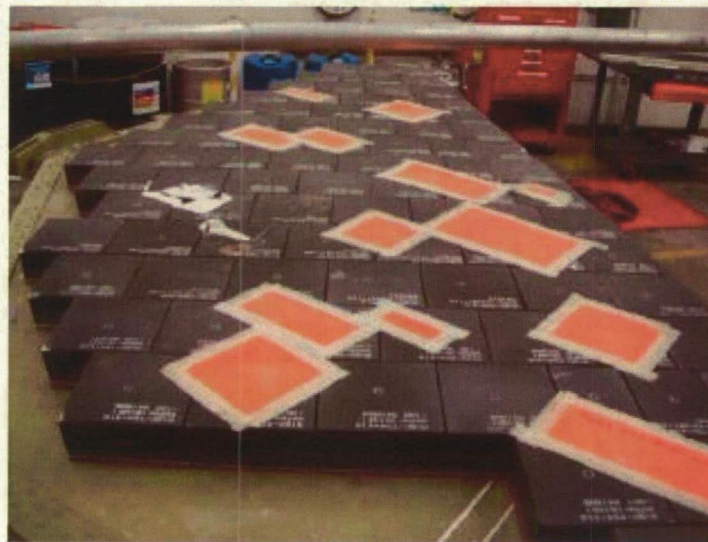
Because of the success on the test panels, the THz System was used to scan a mock wing section

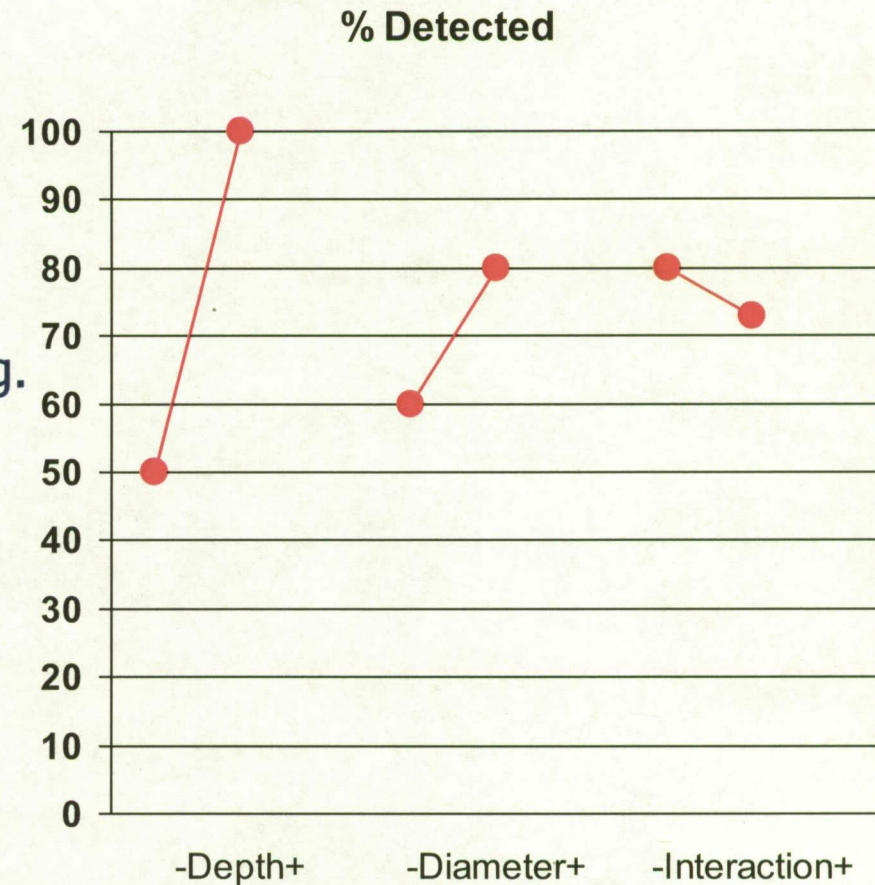
Main Effects Mean Plot

- Qualitatively, the depth of the corrosion pit is the most important factor effecting the ability to detect corrosion with terahertz and millimeter imaging.
- The interaction between corrosion area depth and diameter is not a key factor.
- As expected, the greater the depth and diameter, the more detectable the area of corrosion is.

- The test panels proved to be beneficial for proof of concept testing
- Inspection of the corrosion panels showed that corrosion on bare aluminum could easily be detected, however when a tile covered the corrosion, the corroded areas were more difficult to detect.
- Detection is primarily dependant on corrosion pit depth
- Measurements and analysis indicate that artificially induced corrosion areas hidden by HRSI tile with depths greater than 0.005" are detectable with Terahertz Imaging.
