## Characterization of Monomethylhydrazine (MMH) Non-Volatile Residue

Chuck Davis and Philip M. Howard  
 NASA  
 Kennedy Space Center, FL

#### LT-90 MMH NVR FAILURE

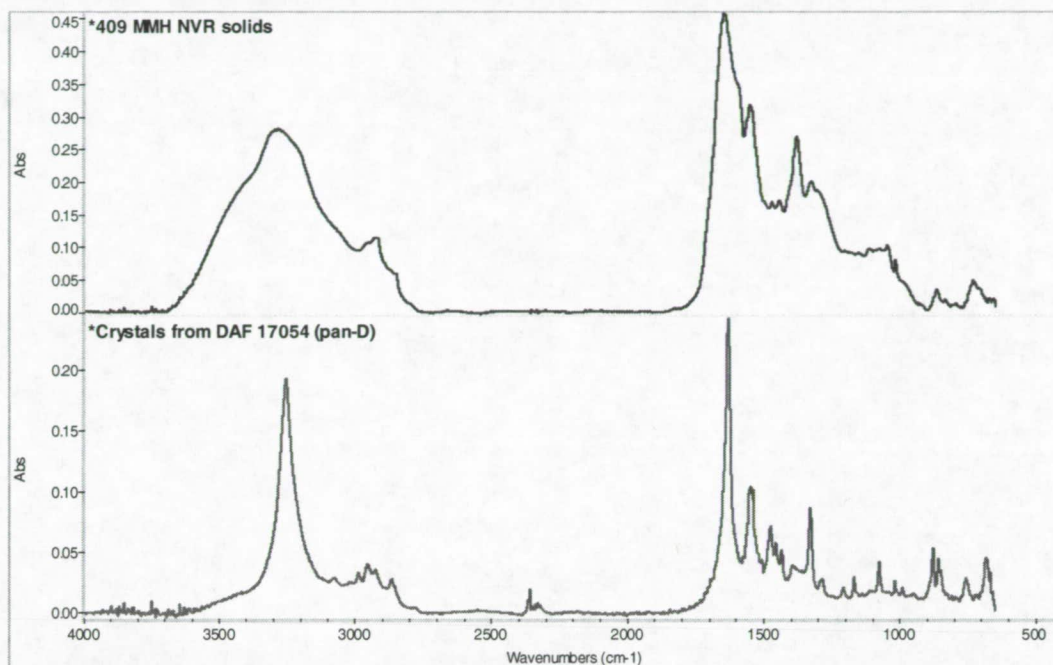
Fourier transform infrared spectroscopy (FTIR) is the primary instrument for molecular structure identification. Typical MMH NVR is characterized as a polymerized by-product of MMH. The FTIR

spectra of the typical MMH NVR is compared to the unknown crystals as shown in Figure 8. The unknown NVR found in tanker LT-90 and the railcar DFA 17054, was characterized as an aromatic amine. The proposed chemical structure shown in Figure 9.

Figure 8. FTIR Spectra of typical MMH polymerized NVR, top (blue), as compared to the crystals found in both LT-90 and DAF 17054, bottom (red).

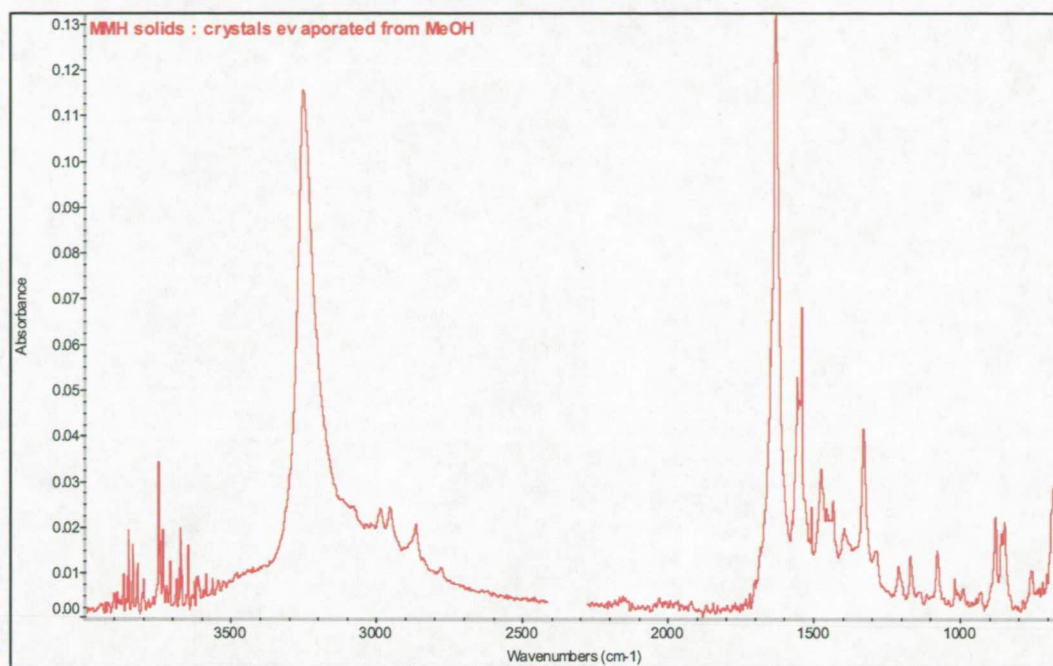
FTIR of amine crystals from MMH (LT-90).

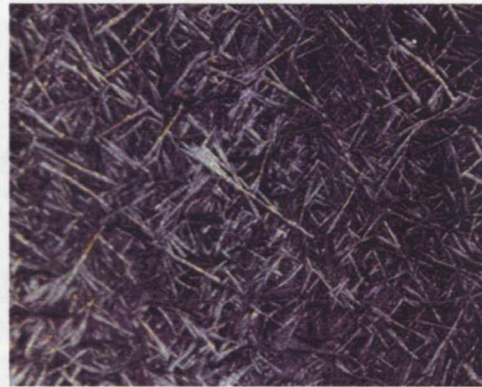
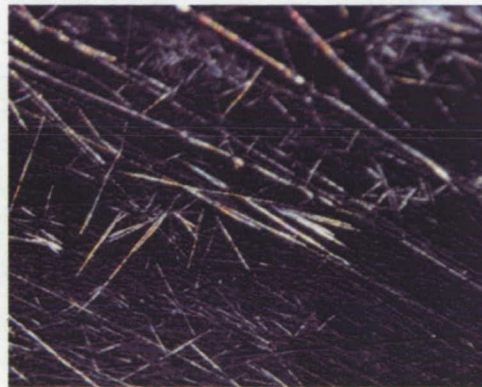
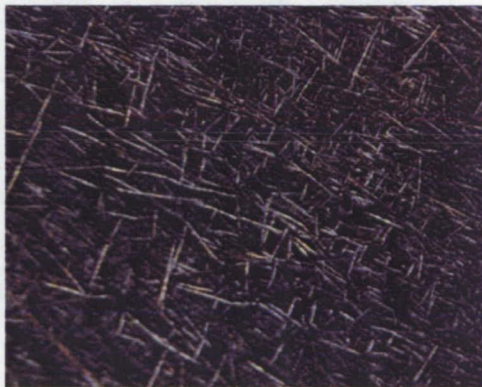
3.1. Inspection of the NVR dishes with OM identified birefringent needle crystals in all samples as shown in Figures 1 through 4 below.

Figure 1. NVR Pan G

Figure 2. NVR Pan D

Figure 3. NVR Pan #3

Figure 4. NVR Pan # 5

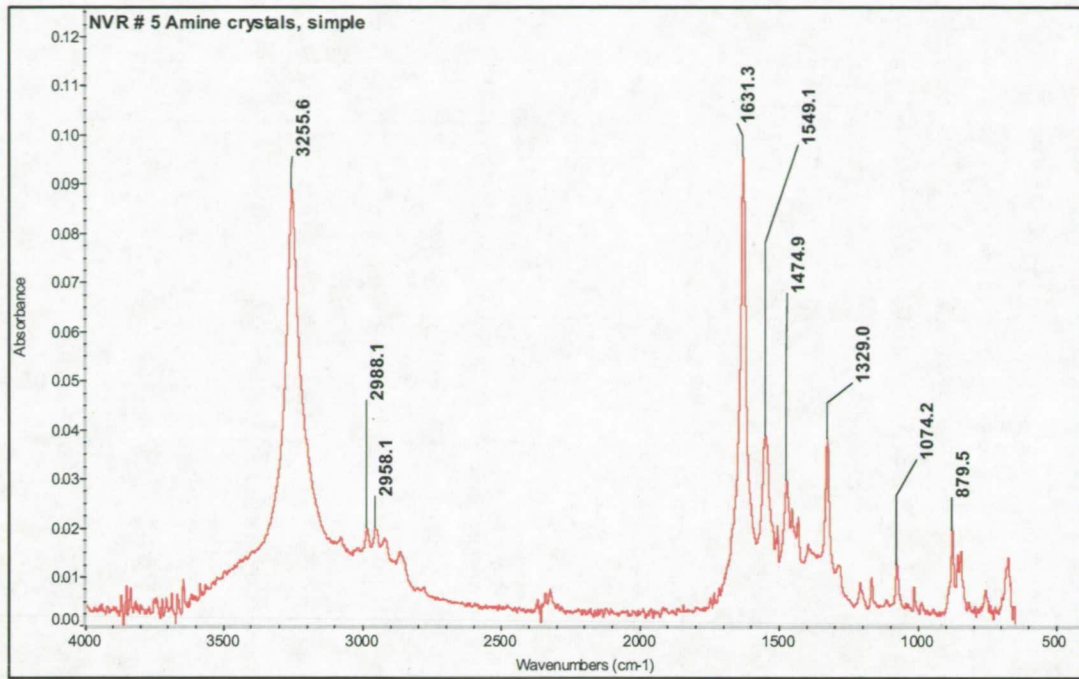
3.2. FTIR analysis of the crystals identified them as a simple amine, potentially a polymerization by-product. See appendix for spectra.

FTIR of Amine crystals.

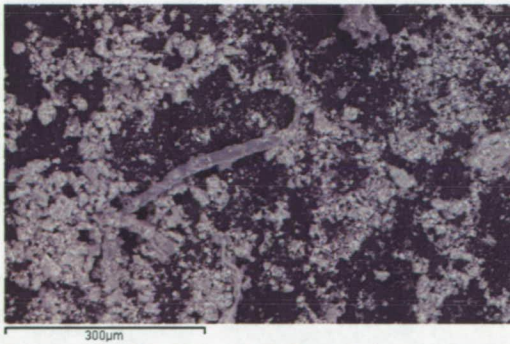
- 3.2. SEM/EDS analysis of the NVR solids identified the majority of the materials to be organic (carbon, oxygen, and nitrogen) associated with stainless steel corrosion by-products of iron and nickel oxides.
- 3.3. Micro-extraction of the MMH solids displayed limited solubility in n-nonane, amyl acetate, Fluoroclean X-100, methanol and water. The limited solubility with a wide range of solvents is consistent with an organic polymer.

3.5. The SEM four quad back scatter electron detector (QBSD) was used to observe the atomic contrast of iron and nickel solids. The iron and nickel solids appear as the brighter areas Figures 4 and 5.

Figure 5. QBSD of NVR debris solids.

Figure 6. QBSD of the blister.

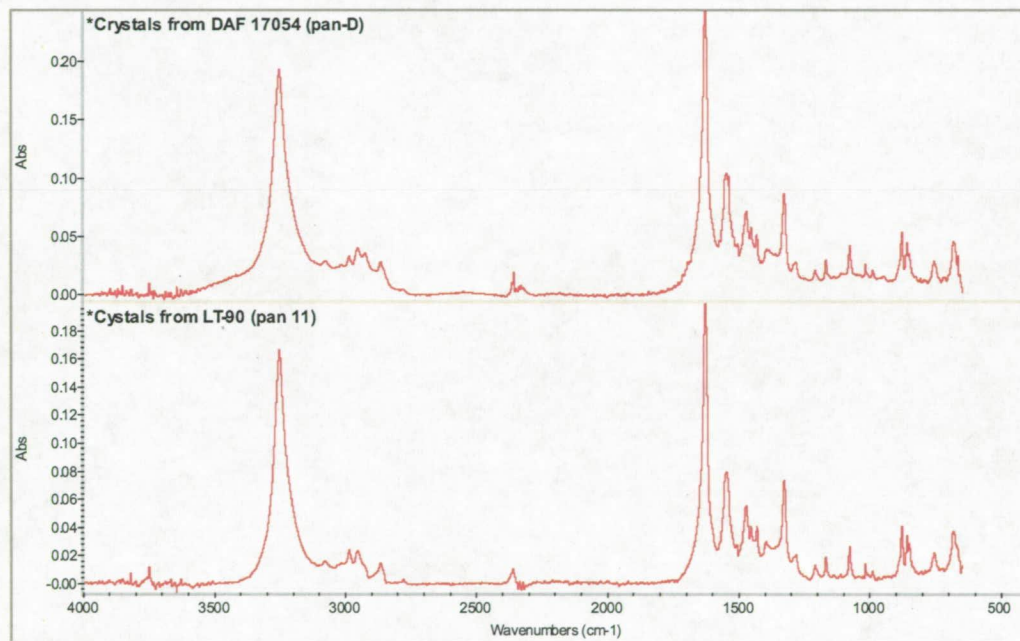
3.2. FTIR confirmed that the molecular composition of the crystals from DAF 17054 and LT-90 were identical as show in Figure 3.

Figure 3. FTIR of the crystals from DAF 17054 and LT-90 NVRs.
