## **ARCHITECTURAL EXPRESSION OF SEISMIC STRENGTHENING**

(Published in Earthquake Spectra, Vol. 17, No. 3, 2002, pp. 417-426.)

**Andrew Charleson, Julieanna Preston and Mark Taylor**

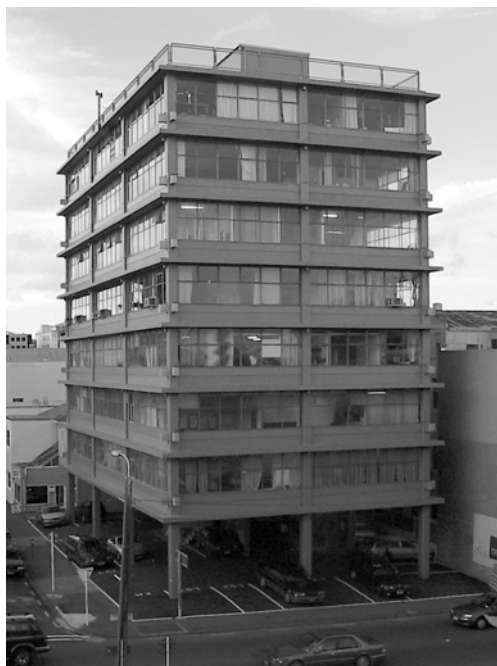
high, and rectangular in plan and elevation, it stands well above its adjacent and even more distant neighbours. Apart from a high ground floor, the elevation is regular, and so is the plan, defined by two structural bays 6.9m wide, and by three 8.1m bays long. Reinforced concrete is the predominant construction material except for the ground and first floor columns that consist of concrete filled steel box sections. As a consequence of its lift-slab construction technique, the shallow post-tensioned flat slab floors that were originally cast one on top of another at ground level, are now chocked in place up the columns by steel pins. Cast-in-situ perimeter upstand beams post-tensioned between columns form earthquake and wind load moment resisting frames (Figure 1).

**Figure 1.** Existing Pre-1976 Building

Like many buildings of the same era it was designed prior to enlightened yet demanding Standards Association of New Zealand 1976 seismic requirements. In the light of this Code and its subsequent revisions, the fragility of the building is exposed. It was designed for a relatively low seismic load level (0.06g) when compared with today's standards, and several building configuration defects known to be problematic in damaging earthquakes are observed; a soft storey, short-columns caused by partial height infill walls, weak columns and strong beams, and torsional asymmetry. Detailed study of reinforcement detailing might possibly reveal other problems expected in a building of this vintage.

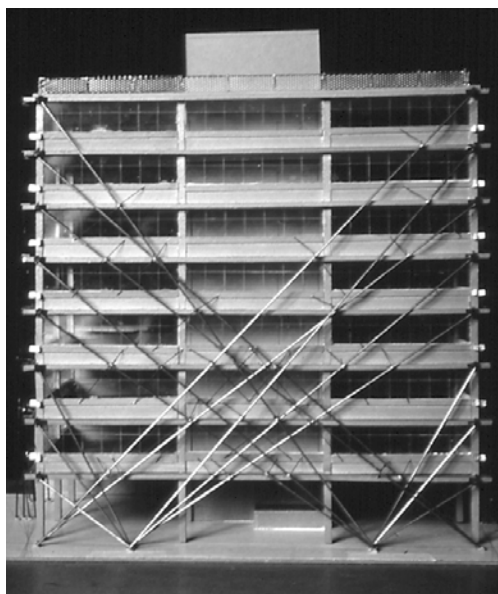
The concept was developed using a small physical model of the building on which were applied wooden kebab skewers that simulated steel props. The props were assumed to connect to the building for load transfer only at their ends, where they met their uppermost floor slabs and foundations. After considerable refinement, one scheme warranted further structural investigation and became the final design solution (Figure 2). As expected, a plane frame linear elastic analysis confirmed that the most steeply inclined props were not very effective. Alternative schemes characterised by fan shaped prop configuration that optimised structural efficiency were deemed aesthetically unsuitable, given their visual links to the bygone handcrafts of string art and fan making. An unambiguous expression of the ruggedness and rawness of props against a building staggering from the punishment of a recently damaging earthquake was the essence of the final design concept.

**Figure 2.** Proposed Pre-1976 Building strengthening scheme

Given the chosen structural form, all design aspects, including the lateral design load of 0.1g that is appropriate for an equivalent new building, comply fully with relevant NZ Standards. Props are fully ductile in tension and compression in order to achieve maximum slenderness. This minimises obstructions to views and is sensitive to the aesthetics of the elevations. Ductile 'fuses' are placed at the bottom ends of each brace. A 50mm maximum diameter mild steel bar within the 219mm dia.

prop tube absorbs inelastic tension and compression strains over a maximum 3.4m length. Incompressible material that fills the annulus between bar and tube restrains the bar from buckling. Struts with high levels of ductility have been described before (Matthewson and Davey, 1979), and one technique is patented (Kalyanaraman et al, 1998). The authors had hoped to express the fuse region, but its mechanical complexity and sensitivity to corrosion sees it 'referenced' by architectural detailing rather than being exposed to view. Bracing is proposed along the main street elevation and the two side elevations. Work to the rear of the building comprises forming separation gaps between partial height masonry infill walls to prevent a short column effect.

For the purpose of structural design the existing overall building lateral strength is neglected. However, some individual members are utilised where they contribute to the new bracing scheme. For example, corner column tension strength is mobilised, and in fact requires supplementing to resist tension forces arising from biaxial seismic attack. Some columns require fibre wrapping or equivalent treatment to enhance their shear and inelastic rotational capacity. Existing foundations require significant upgrading, especially to resist tension uplift and resist prop loads.

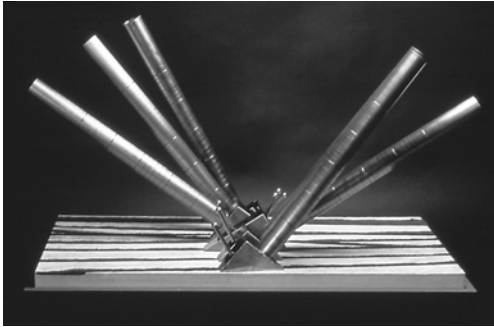
Three architecturally significant structural details emerge: the shoe (ground level), the corner clamp and the prop lateral restraints. The shoe, consisting of steel encased concrete wedges and stainless steel pins speaks of the shunting of wooden stakes at the ends of traditional timber shoring props (Figure 3). This detail epitomises the temporary nature of traditional shoring and expresses its structural action.

**Figure 3.** Shoe model

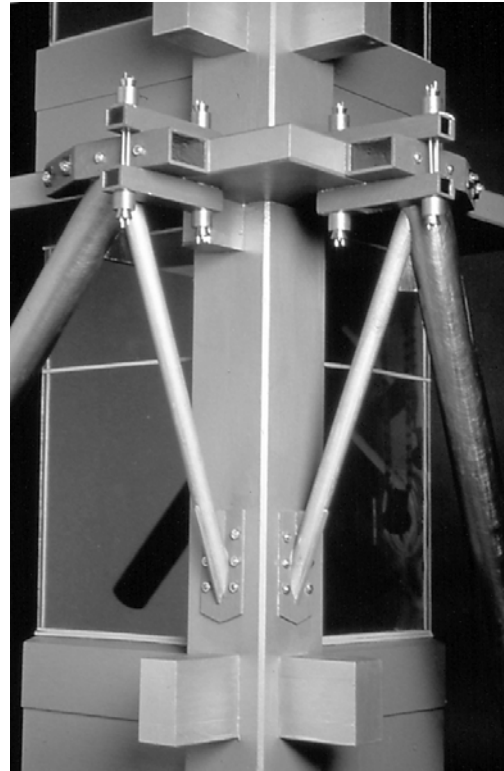
Long slender steel props stretch from the shoes across the building face. They terminate at the outside corner of each floor slab where they are clamped and pinned (Figure 4). It was not possible to re-enact the gestural action of jamming or notching the props into place. The acuteness of their angles in relation to the boundary line was too great. The method of fixing accounts for the unique angles in three dimensional space of each prop. It also speaks of temporary fixing of scaffolding and building construction, and responds to the ideal of structural reversibility.

**Figure 4.** Clamp at corner floor slab

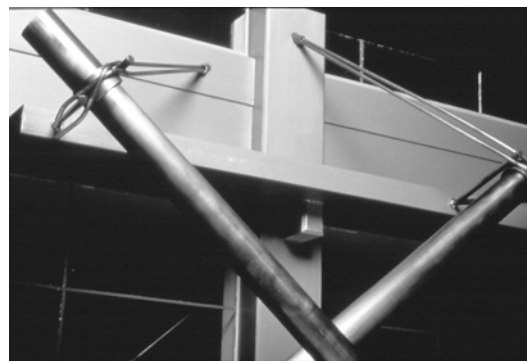
Props are tied back to the building face along their lengths. As well as to prevent buckling, these lateral restraints carry an additional non-structural responsibility of stitching the external steel structure into the existing concrete frame. This detail grew out of an appreciation of New Zealanders' use of number eight wire to string fences, and to bind and tie anything together, literally anything (Figure 5).

**Figure 5.** Prop lateral restraint model

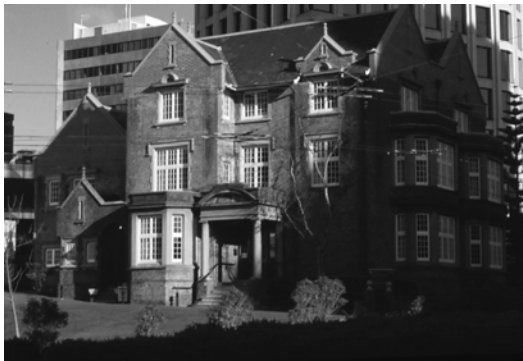
Turnbull House, a brick revivalist building completed in 1917, is a typical example of Victorian architecture imported into New Zealand (Figure 6). It differs from many similar domestic residences in that it was both a home and library. It is an historic landmark building. Unreinforced brick masonry load bearing walls form the primary structural elements of Turnbull House. They support a timber roof structure and two levels of timber floors, except in the dining room (formerly a stack room) in the south-western corner, where reinforced concrete floors supported heavy book loads.

**Figure 6.** Turnbull House

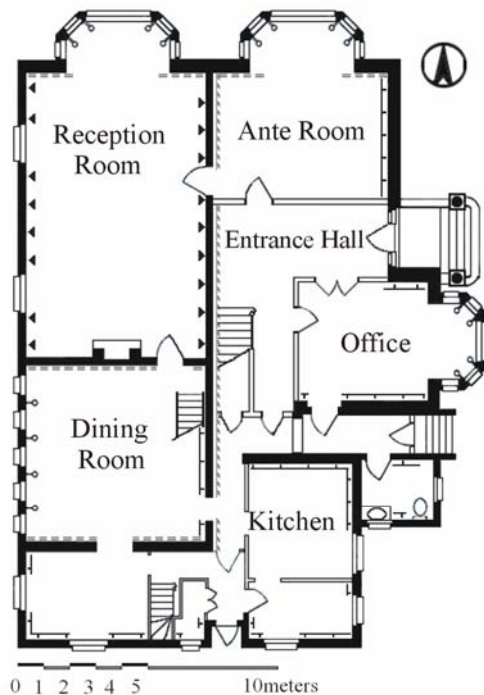
**Figure 7.** Ground floor showing strengthening work

Earthquake resistance is provided by new structure in both orthogonal directions (Figure 7). In the transverse direction three lines of new structure are needed. The inside surface of the north facade bearing wall is lined with plywood and framed with steel members to form a two-bay moment resisting frame. Beam and column shear forces are resisted by 25mm thick plywood. Column bending strength is provided by vertical 230\*75mm steel channel chords or flanges. Two new structural walls of similar construction are placed inside the dining room. In the longitudinal direction, the existing masonry spine wall is strengthened in-plane by a perforated sheet steel shear wall (Figures 8 and 9). With similar aesthetic and structural properties to the web of a lattice truss, lateral loads are transferred through 50mm by 15mm diagonal steel compression and tension members. They are prevented from buckling by closely spaced bolts fixed into the face load restrained masonry walls behind.

New vertical steel mullions at 1.2m maximum centres are fixed to all existing masonry walls to resist face loads and transfer them to existing plywood floor and roof ceiling diaphragms. These, in turn, are connected to the new structural walls and frame. The steel mullions take three different architectural forms (Figure 10): first, a timber clad steel mullion located inside the bay windows. The second mullion type is a steel rib and timber panel lining to the Reception Room walls. A series of steel stressed skin panels, with pattern cut perforations and internal acoustic material line all

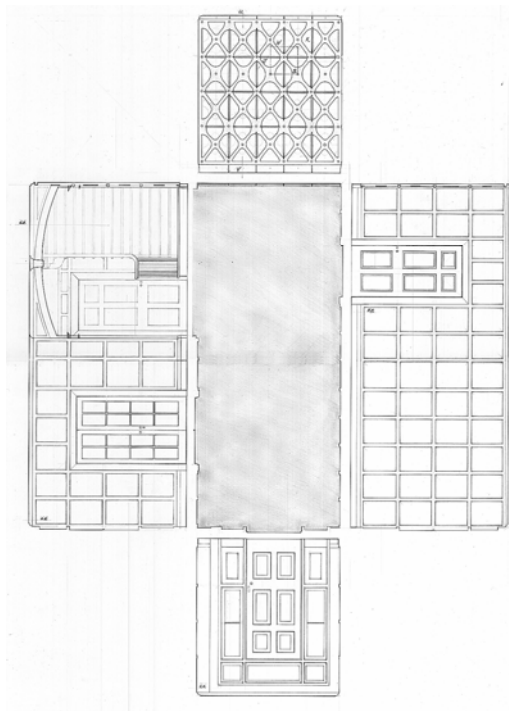
**Figure 8.** Entrance hall plan and wall elevations

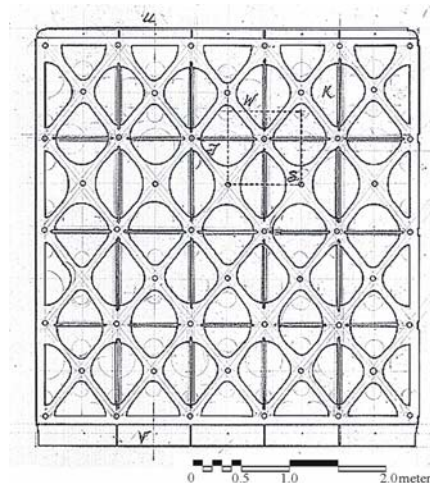
**Figure 9.** Part elevation of perforated sheet steel shear wall

In Turnbull House the strengthening not only respects the cultural heritage but enhances it by introducing detailing of Victorian origins. The new mullion patterns reflect the former lining geometry and material qualities. In other areas, the perforated sheet steel shear wall and stressed skin panels overlay a previously painted plaster finish. New intricately detailed structural layers replace bland wall surfaces.
