Mahaarachchi, Dhammika P. and Mahendran, Mahen (2009) *A strain criterion for pull-through failures in crest-fixed steel claddings*. *Engineering Structures*, 31(2). pp. 498-506.

# **A Strain Criterion for Pull-through Failures in Crest-fixed Steel Claddings**

By Dhammika Mahaarachchi<sup>1</sup> and Mahen Mahendran<sup>2</sup>

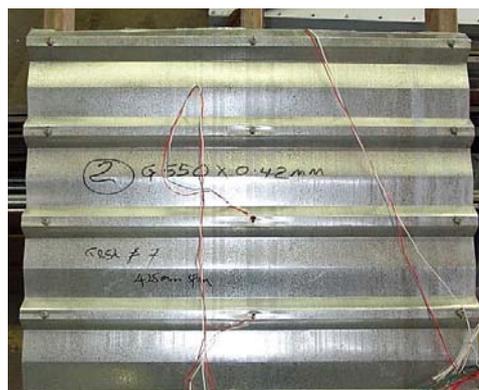
(c) Two-span trapezoidal Type A sheeting with 425 mm span

criterion, many non-standard Type A roofing sheets were made in the university workshop and were used in the tests with a shorter span of 425 mm and also in some small scale tests (see Tables 1 and 2). The No.14-10x50 mm Type 17 self-drilling screws with neoprene washers were used to secure the test sheet to the timber supports. The No.14 screws have head and shaft diameters of 14.5 mm and 5.1 mm, respectively and the 2 mm thick neoprene washers have outside and inside diameters of 11 mm and 5 mm, respectively. All the screws were centred at the crests, set perpendicular to the plane of the sheet and tightened until the neoprene washers were just prevented from rotating to avoid over-tightened or loose screws.

The results from single and two-sheet roofing assemblies were approximately the same as shown in Figure 6. This observation is an important and useful result. It meant that the structural continuity was absent in the lateral direction because of the presence of longitudinal laps. The single sheet roofing assembly provided a more uniform load distribution among the fasteners, and eliminated the additional stiffening problem caused by the lap and simplified the test procedure. Therefore a single sheet roofing assembly was used in most of the tests (see Figure 3).
