Experimental Studies of Gypsum Plasterboards and Composite Panels under Fire Conditions

Prakash Kolarkar and Mahen Mahendran

Abstract: Gypsum plasterboards are commonly used to protect the light gauge steel framed walls in buildings from fires. Single or multiple plasterboards can be used for this purpose while recent research has proposed a composite panel with a layer of external insulation between two plasterboards. However, a good understanding of the thermal behaviour of these plasterboard panels under fire conditions is not known. Therefore 15 small scale fire tests were conducted on plasterboard panels made of 13 mm and 16 mm plasterboards and four different types of insulations with varying thickness and density subject to standard fire conditions in AS 1530.4. Fire performance of single and multiple layers of gypsum plasterboards was assessed including the effects of interfaces between adjacent plasterboards. Effects of using external insulations such as glass fibre, rockwool and cellulose fibre were also determined. The thermal performance of composite panels developed from different insulating materials of varying densities and thicknesses was examined and compared. Th

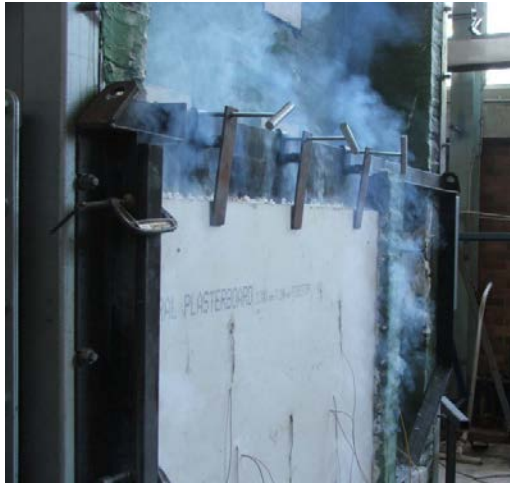
Figure 2: Fire Testing of Test Specimens 1 to 4

(a) Test after 3 Minutes.

Clamps permitting vertical movement of the specimen

Uniform discolouration of paper

K type thermocouple wires

(b) Thermal Bowing at the End of Test

Smoke was observed at the edges of the specimen after three minutes due to the burning of the plasterboard paper on the exposed side. The smoke subsided after the paper was completely burnt. After six minutes steam escaped from the specimen and condensed on the top of the furnace adapter (Figure 2(a)). By the end of 12 to 13 minutes the steam subsided and the specimen burnt steadily without releasing smoke or steam. After 18 minutes the ambient side paper started to discolour and the specimen was seen to bow outward (Figure 2(b)). This was caused by the shrinkage of the exposed surface following the expulsion of water. The outside paper started burning after 33 minutes and the test was stopped.

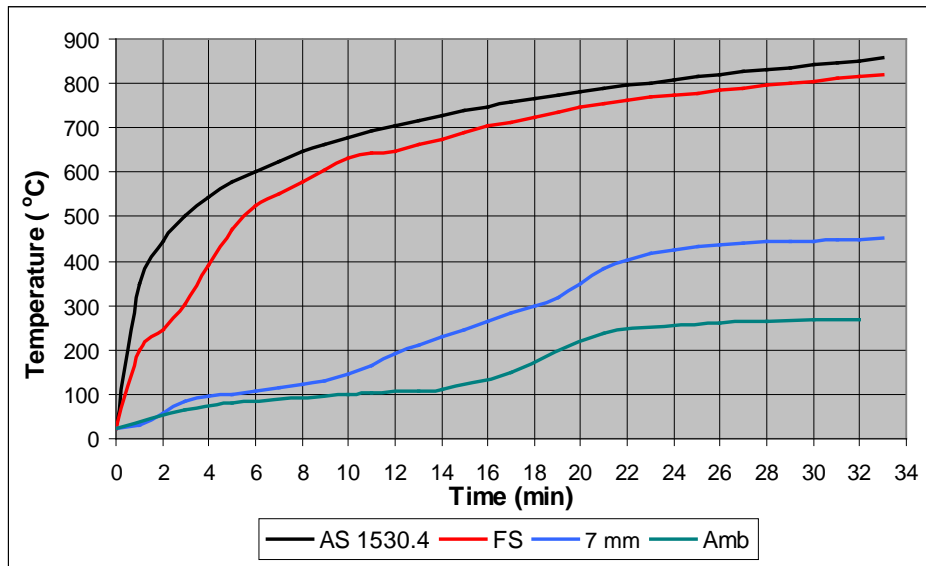
(a) Time - Temperature Profiles

7 mm: Temperature profile at a depth of 7 mm from the exposed surface

Amb: Temperature profile of the unexposed surface of the specimen

Figure 3(a) shows the measured time-temperature profiles across the plasterboard thickness. The time-temperature profiles obtained within the thickness of the specimen at a distance of 7 mm from the fire side and on the ambient surface show the development of the temperature in three phases. The first phase displayed a steady rise in temperature from the ambient temperature to about 100°C. This was followed by the second phase where the temperature was maintained close to 100°C thus giving a plateau. In this phase the heat energy was primarily used in converting the free and chemically bound water in the plasterboard to steam. The 7 mm and 13 mm depth profiles have their second phase extending to approximately 6 and 12 minutes, respectively. The third phase started when moisture in the plasterboard was no longer available for conversion into steam. The temperature in the third phase increased gradually reaching 450°C at 7 mm depth and 275°C on the ambient surface by the end of the test, ie. when the ambient side plasterboard paper started burning.

The thermocouple at 7 mm depth from the exposed surface did not record any sudden temperature rise in the third phase until the end. This implies that the plasterboard up

to 7 mm depth, although calcinated, was still intact and prevented any sudden ingress of heat. A temperature difference of about 350°C was observed from the exposed surface to a depth of 7 mm. With a further drop of approximately 200°C from 7 mm to 13 mm depth it gave a temperature of 275°C on the ambient surface.

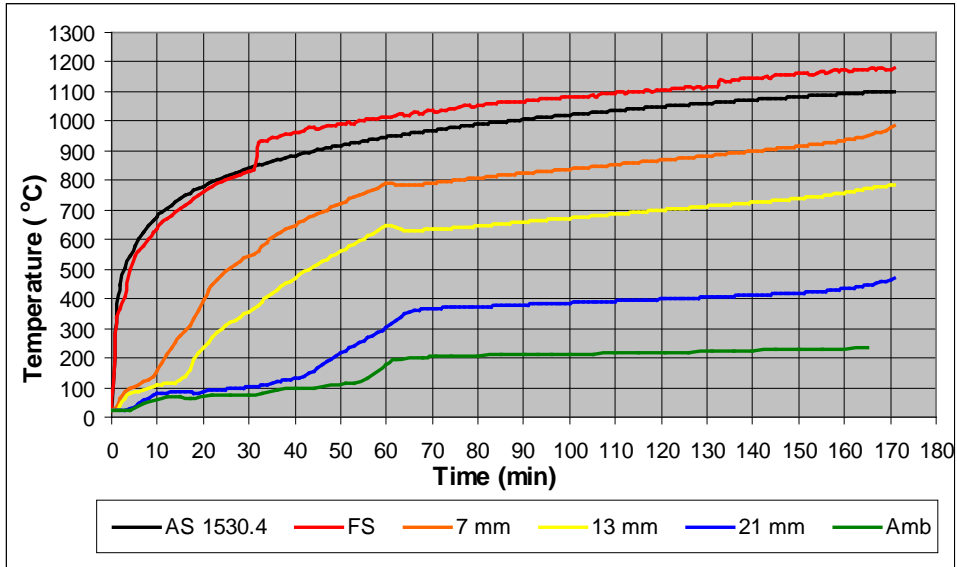
Figure 5: Temperature Profiles of Test Specimen 3

(a) Time - Temperature Profiles

(b) Temperature - Depth Profiles

In Figure 5(a) the plateaus for the 7, 13, 21 and 29 mm depth profiles extended to about 6, 14, 31 and 54 minutes, respectively. Plasterboard 2 showed extended periods of plateau as explained for the last test. Since the 29 mm depth profile had a larger calcinated thickness than the 7 mm depth profile, the plateau for the former is longer than in the latter (54 versus 6 minutes). The 13 mm curve in Figure 5(a) shows the time-temperature profile of the interface (Pb1-Pb2). A temperature drop of approximately 400°C was observed from the exposed surface to the ambient side of Plasterboard 1 (i.e. Pb1-Pb2 interface) and a further drop of about 550°C to the unexposed surface by the end of the test. Both plasterboards remained intact.

faster. The observations based on Figure 5(b) are similar to those made for Specimens 1 and 2.

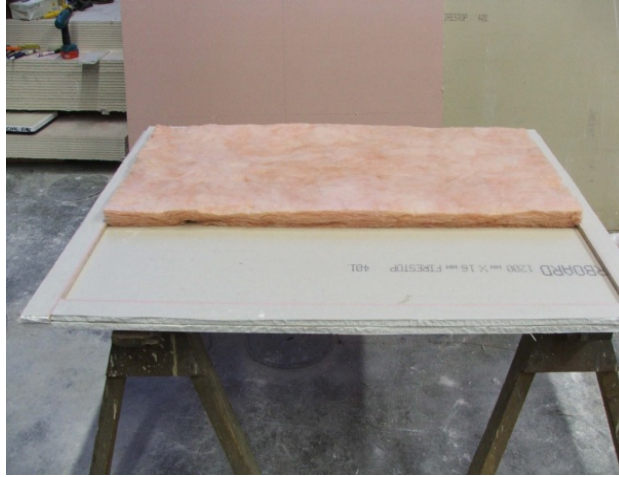
Figure 8: Construction of Test Specimen 6

Test Specimen 6 is a composite panel formed by sandwiching a layer of insulation between two 16 mm plasterboards. This was achieved by first fixing 16 mm plasterboard strips of 50 mm width along the periphery of the exposed plasterboard (Pb1) to form a cavity (Figure 8). The desired cavity depth was obtained by using the appropriate thickness and number of plasterboard strips along the border. In this test specimen a 32 mm cavity was provided using two 16 mm strips. The strips were then fixed to Pb1 using 50 mm long screws at 300 mm centres. Glass fibre insulation in the form of a 50 mm thick mat of 13.88 kg/m^3 density was then laid inside the cavity (Figure 8), and compressed to a thickness of 32 mm by firmly pressing it with the second 16 mm plasterboard (Pb2). This plasterboard was then screwed to the frame by 70 mm long screws at 300 mm centres. Compressing the 50 mm thick glass fibre mat to 32 mm thickness increased its density from 13.88 to 21.68 kg/m^3 . Thermocouple wires were carefully installed in the interfaces between plasterboard and insulation to obtain the temperature profiles on either side of the insulation.

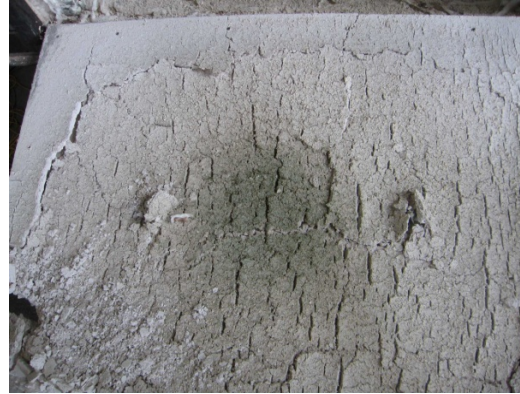
Figure 9: Fire Testing of Test Specimens 6 to 9

(a) Uniform Discolouration of Paper on Ambient Side

(b) Glass Fibre Insulation is totally burnt Leaving a Dark Stain Behind

Test Specimens 6 to 9 were exposed to the standard fire for about three hours. Their initial behaviour was similar to the previously tested specimens. All the specimens displayed a small amount of thermal bowing near the end of the test. The ambient surface showed uniform discolouration after about 110 minutes (Figure 9(a)). The glass fibre insulation in all the specimens was almost completely consumed by heat with only small amounts still visible along the edges of the specimens (Figure 9(b)). Figures 10 (a) to (d) show the time-temperature graphs of Specimens 6 to 9.

The time-temperature graphs show that the interface between Plasterboard and Insulation (Pb1-Ins) in all the specimens showed a very rapid rise in temperature in the third phase crossing 600°C at about 35 minutes. The temperature profile of Pb1-Ins tended to become horizontal when its temperature approached 700°C. The glass fibre insulation at this temperature began to disintegrate and lose its insulating properties as seen from the temperature-depth profiles in Figure 11. The central parts of the graphs representing the insulation tended to become horizontal from 90 minutes onwards for Specimens 6 to 8 and 109 minutes for Specimen 9 indicating that the insulation was no longer capable of causing a temperature drop across its thickness.

As the heat energy was used in disintegrating the glass fibre insulation, the temperature on the ambient side of Pb1 (i.e. Pb1-Ins) did not rise. Also less heat was getting redirected due to the continuous loss of insulation. These factors kept the temperature on the ambient side of Pb1 steady (under 700°C) almost until the end of the test. The temperatures of the two interfaces, Pb1-Ins and Ins-Pb2, merged together soon after the disintegration of the glass fibre insulation due to direct transmission of heat by radiation. Regardless of insulation thickness and density, the glass fibre insulation became ineffective at about 700°C making the composite panels follow similar time-temperature profiles until the end of the test. In all the specimens Pb1 and Pb2 remained intact until the end.

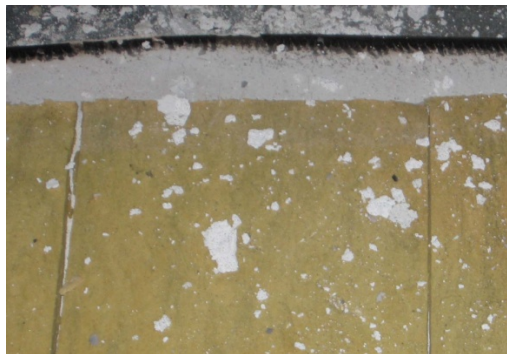
Figure 14: Fire Testing of Test Specimen 11

Rockwool Insulation Intact even after the Fire Test

Contrary to glass fibre insulation, the rockwool insulation showed greater resistance to disintegration (Figure 14). Its physical presence was blocking and redirecting the heat flow to Plasterboard 1. This resulted in the rise of the temperature of Pb1-Ins to values beyond 700°C and steadily kept rising up to 900°C when Pb1 started to breach. Even after being directly exposed to fire following the collapse of Pb1, the insulation remained intact and continued to offer protection to Pb2. Table 3 shows the temperature profile of the ambient side of the insulation in Test Specimens 10 and 11. The thermal performance of both insulations is nearly the same despite the different thicknesses. It was different only after 145 minutes following the collapse of Pb1 in Test Specimen 10.

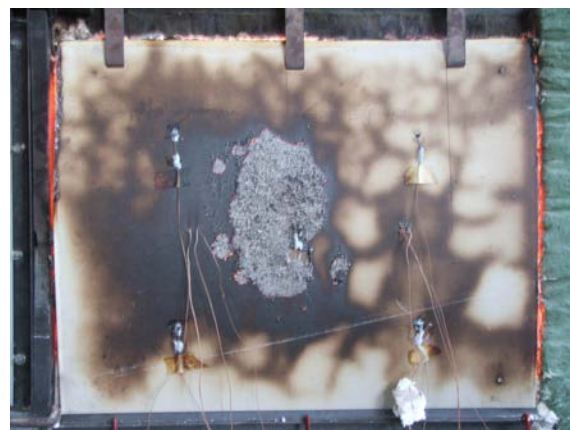
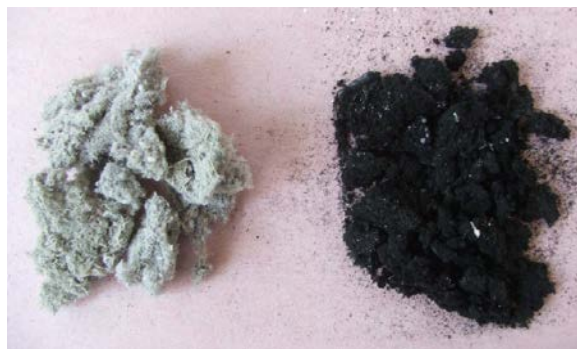
Figure 15: Fire Testing of Test Specimen 12

(a) Non-Uniform Discolouration of Paper on the Ambient Side

(b) Burning of Ambient Side Paper

(c) Cellulose Fibre Sample Before and After the Fire Test

Tests for the cellulose fibre composite panels lasted slightly over two hours. The ambient side paper started to discolour after 100 minutes. The discolouration in all three specimens was observed to be non-uniform (Figure 15(a)) indicating the burning of cellulose fibre within the specimen in certain areas creating pockets of high temperature. This allowed the heat to penetrate the insulation compromising the integrity of the composite panel. The test was stopped soon after the burning of the ambient side paper (Figure 15(b)). In all the test specimens Pb1 had collapsed fully or partially and the cellulose fibre had completely burnt out at the end of the test leaving behind traces of ash sticking to the fire side of Pb2 (Figure 15(c)).
