REINFORCEMENT DESIGN AND CONTROL OF ROCK SLOPES ABOVE TUNNEL PORTALS IN NORTHERN ITALY

Abstract: The stability features of slopes located above the portals of tunnels along important roads are here presented, together with two examples for reinforcement and protection works. The investigation phase and the reinforcement works have considered also the purpose of avoiding the interruption of the traffic when this would cause unacceptable consequences. The first case refers about the construction of a portal along a narrow and steep valley in a volcanic rock formation. The control of the vibration of the blasting action has been carried out for the period of the excavation in order to foresee the occurrence of potential dangerous situations. The second is the case of the portal of the East access to the Highway n.10. Even though the adits are protected by two portals, the occurrence of rock and debris falls from the upper part of the mountain could create a dangerous situation. Above the portals the morphology of the slope is characterized by two subvertical rock slopes, which are separated by an intermediate zone of debris material.

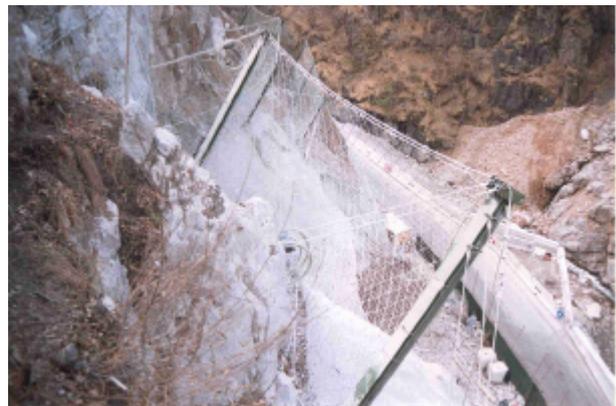
Figure 1. *View from the upper part of the rock slope: some net fences are visible and in the right side the existing road.*

One of the adits was arranged with limited excavation at the external part of the steep and high rock slope, with heavy reinforcement of the rock mass and with the installation of passive protection; the rock reinforcement has been made by means of rock bolting and wire mesh, sometime coupled with shotcrete, while the passive protection has been made of net fences.

In the area surrounding the adit also some detritic surface formation occurred and for this reason the remedial works were made of wire mesh and bolting (for the fractured rock mass) and net fences (for the debris protection).

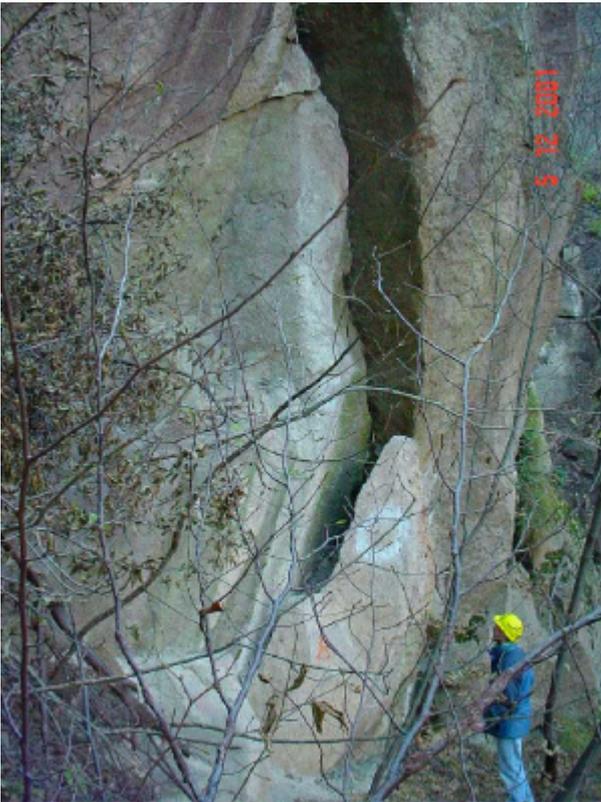
Figure 2. Detail of the rock mass structure 30 m above the tunnel portal.

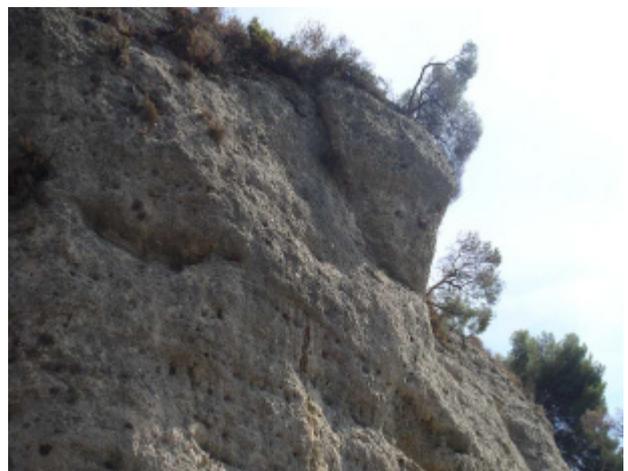
Figure 5. Detail of the unstable element (ref.3 in fig.4)

The surface of the 110 m³ rock volume will be temporarily consolidated with a harness of cables and will also be arranged for the possible removal of the blocks through slice cutting using a diamond wire cutter and removal with hoists towards the summit of the slope; this choice was made to allow a progressive improvement of the safety of the slope.
