[Article] Detachment analysis of dehumidified repair mortars applied to historical masonry walls

Bocca P.; Valente S.; Grazzini A.; Alberto A. (2014). *Detachment analysis of dehumidified repair mortars applied to historical masonry walls*. In: [INTERNATIONAL JOURNAL OF ARCHITECTURAL HERITAGE](#), vol. 8 n. 3, pp. 336-348. - ISSN 1558-3058

# DETACHMENT ANALYSIS OF DEHUMIDIFIED REPAIR MORTARS APPLIED TO HISTORICAL MASONRY WALLS

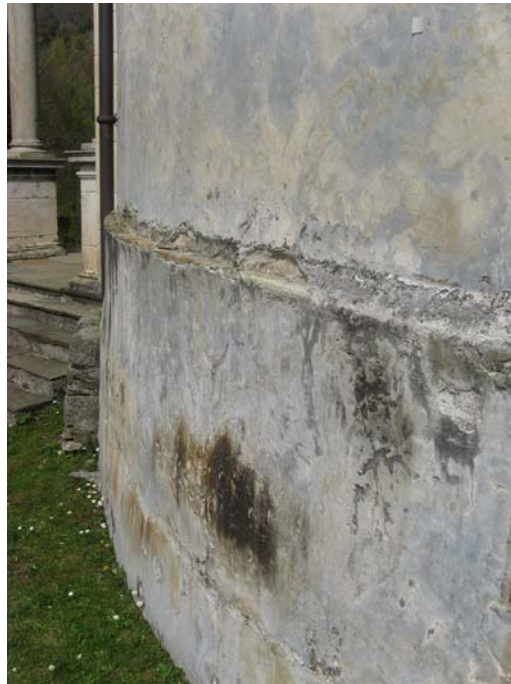
**Figure 2.** Detachment of historical exterior plasters at Transfiguration Chapel because of the rising damp effects due to capillary action or rain infiltration

Because of the rising capillary damp, the freeze-thaw cycles and the abundant rain and snow precipitations that characterize this mountain area, the historical plaster of the chapels has been subjected to progressive material decay over the long term (Figures 2-3).

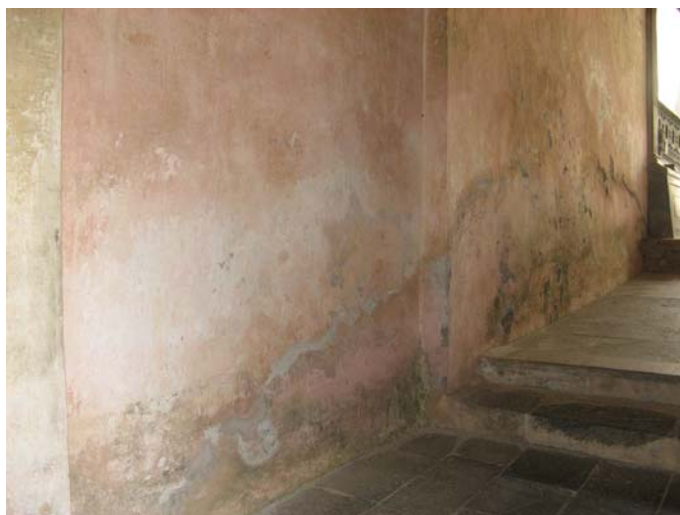
**Figure 3.** Detachment of historical plasters because of the rising damp effects due to capillary action at Sacro Monte di Varallo

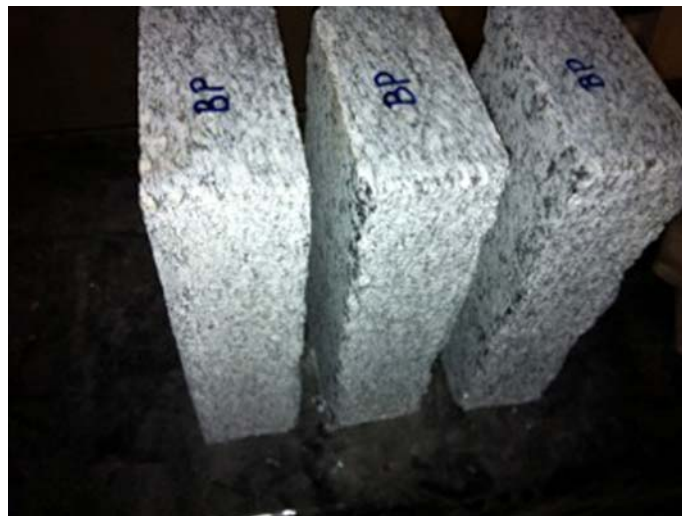
**Figure 5.** Adherence surface of stone treated by pneumatic drill

Four assembled specimens have been tested in compressive static load. This composite specimens were prepared by joining a stone block (similar to that of the Sacro Monte masonry) to symmetrical layers of repair mortar on the two shorter vertical sides of the stone block. It was obtained from cut stone placed in designed steel mould and joined to 40 mm thick layer of strengthening mortar cast onto it (Figure 4). This particular typology of assembled specimen has been tested already in precedents experimental researches to appraise the mechanical compatibility between strengthening mortars and historical masonry (Grazzini, 2006). The ad hoc geometry of this stone block-mortar specimens was able to test the adherence between the repair mortar and the masonry structures. The stone surfaces in contact with the mortar were treated by a specific pneumatic drill in order to improve the adherence (Figure 5).
