Cutting performance and wear characteristics of PVD coated and uncoated carbide tools in face milling Inconel 718 aerospace alloy

In this paper, cutting performance and failure characteristics of two PVD TiN coated and an uncoated tungsten carbide grades with identical geometry are presented. Face-milling tests of Inconel 718 superalloy were performed to investigate the effect of cutting speed and feed rate on tools performance under wet conditions. Tools were thoroughly examined under SEM at two stages in order to reveal the failure modes and wear mechanisms. These stages were after cutting for 5 s and when the tool failed. It was noted that the coating resulted in a marginal improvement, as it was delaminated by adhering workpiece material at the beginning of the cut, impeding the performance of the tool for the rest of the experiment. A combination of progressive chipping and flank wear was the general mode of tool failure, former being dominant at high speeds and the latter at the low speed region. Results showed that uncoated tool performed better than coated tools at low cutting speeds while coated tools gave slightly better performance as the speed was raised. © 2001 Elsevi

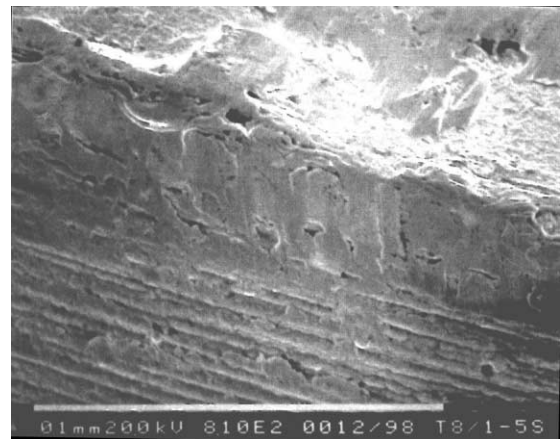
Fig. 5. An SEM image of Tool A after cutting for 5 s, showing galling and pitting on the rake and flank faces (at 25 m/min and 0.14 mm per tooth).

SEM micrographs in Figs. 5–7 clearly show the presence of galling on the rake and flank faces in addition to the adherence of small chip particles at the sharp section of cutting edge of coated tools (Tools A and B) and uncoated tool (Tool C) after cutting for 5 s.

The adherence of the workpiece material can be attributed to its austenitic f.c.c. structure that work hardens rapidly and also to the reactivity of nickel-based material with the tool material [14]. The grinding marks left on the rake (Figs. 6 and 7) and flank (Fig. 5) faces of the tools may have cause the initiation of workpiece adhesion in the form of galling within the ridges. This phenomenon became more significant when the grinding marks were not parallel to the direction of the chip flow, which will then act as mechanical barriers.

Figs. 5 and 6 suggest that the PVD-TiN coating was removed from the contact zone over the rake face of the

tools by the removal of strongly adhered workpiece layer causing separation at coating/substrate interface. This separation was so obvious at the back region of the tool–chip contact zone when grinding marks on the substrate were easily distinguished. While in the front region next to the cutting edge, substrate pitting or plucking were observed as shown in Figs. 5 and 6.

The rough and uneven characteristic of the plucked tool surface (Figs. 5 and 7) and clear separation of the coating from the substrate (Fig. 6) were possibly due to attrition wear mechanism whereby fragments of tool material were removed from the contact zone of the tool face. The main reason for this kind of wear mechanism appears to be the localised tensile stresses imposed on the tool by intermittent chip flow [18] during interrupted cutting. The tensile stresses are imposed by the chip detachment during the tool exit and by the sudden ejection of the adhered chip on the next entry.

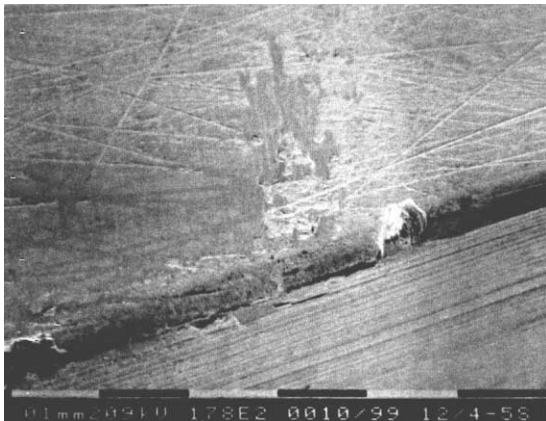
Fig. 7. Galling and pitting on the rake face of Tool C after cutting for 5 s. Adhesion of relatively large chip particles at the cutting edge was also observed (at 50 m/min and 0.14 mm per tooth).

The second type of adhesion was the welding of relatively large chip particles to the sharp sections of the cutting edge and the chipped areas, this is shown in Figs. 6 and 7. Based on the size and shape of the adhered material at the tool edge, it is most likely that the end section of the chip had remained attached when the main body was torn away. This type of adhesion can be very detrimental if it stays at the tip of the cutting edge. The new cutting edge adversely affects the chip flow and the shear pattern in the primary and secondary deformation zones [17]. This kind of adherence was observed during the entire cutting period which increased gradually towards the end of tool life.

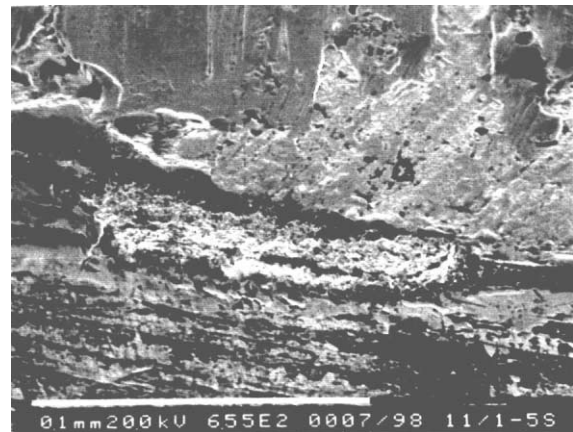
Fig. 12. An SEM image of the worn region of Tool B after cutting for 5 s, showing micro-chipping at the main cutting edge (at 25 m/min and 0.08 mm per tooth).

Micro-chipping was observed to occur in a discrete manner on both coated and uncoated tools along the cutting edge after 5 s of cutting, an example is shown in Fig. 12. However, the occurrence of micro-chipping was relatively more frequent on the PVD-coated tools and it became very severe when cutting speed and feed rate were increased (Fig. 13). The lack of chipping resistance of the PVD-coated tools when compared to uncoated tool could be attributed to its sharp cutting edge which was more sensitive to stress concentration and to cyclic impacts and vibration generated during the milling process. The honed edge combined with a cutting edge radius of ~ 0.02 mm (Fig. 1) increased the chipping resistance of uncoated tool (Tool C) in addition

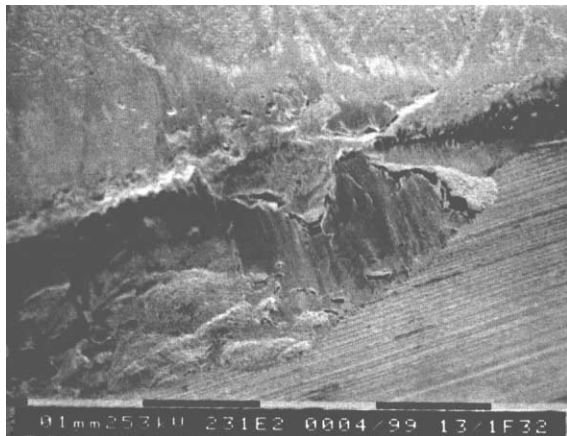
Fig. 14. An SEM image of the worn region of Tool C, showing severe chipping and galling on the main edge flank (at 25 m/min and 0.08 mm per tooth).
