# Dry turning of tempered martensitic stainless tool steel using coated cermet and coated carbide tools

M.Y. Noordin\*, V.C. Venkatesh, S. Sharif

*Department of Manufacturing and Industrial Engineering, Faculty of Mechanical Engineering,  
Universiti Teknologi Malaysia, 81310 UTM Skudai, Malaysia*

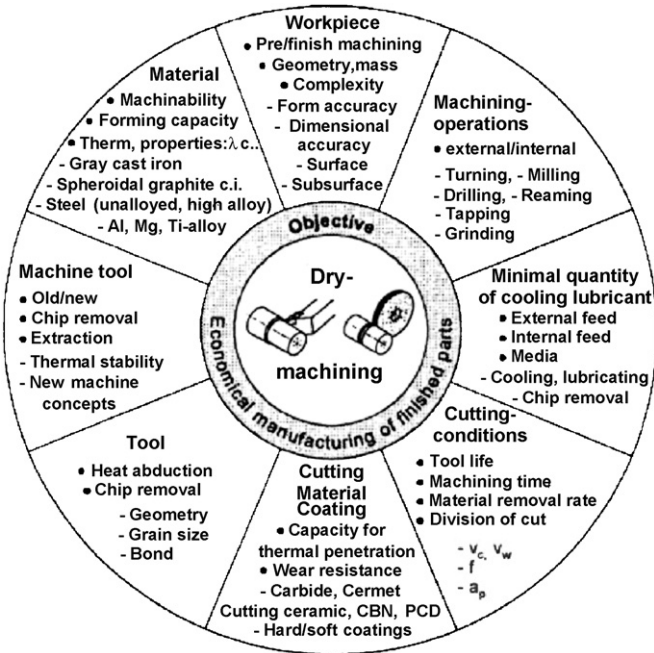
Fig. 1. Variables influencing dry machining.

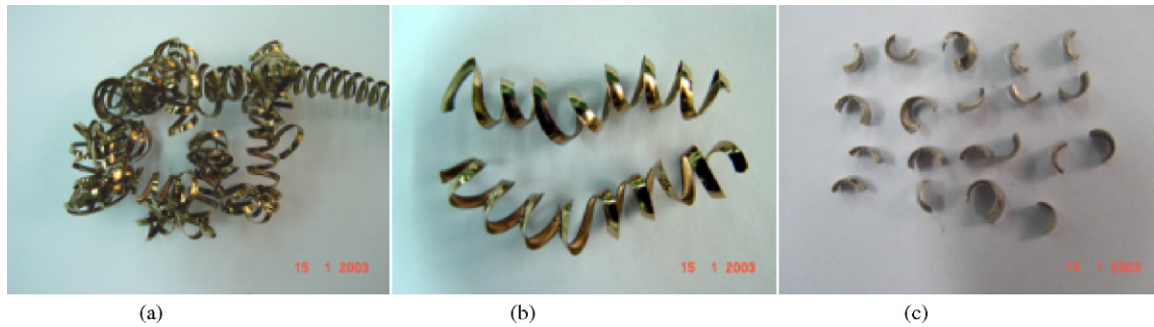
Fig. 2. Chip-form for  $-5^\circ$  SCEA when using KC 9110 at (a) 100 m/min, 0.09 mm/rev; (b) 130 m/min, 0.16 mm/rev; (c) 100 m/min, 0.28 mm/rev.

The physical appearance or chip form of the chips collected during the machining tests performed using KC 9110 is observed using a digital camera and presented in Fig. 2. In general, the resulting chip-form is strongly influenced by feed rate. Referring to the ISO-based chip-form classification [13], at high feed rate, loose arc chips are produced regardless of the cutting speed and

the SCEA used. On the other hand, at low feed rate, snarled cock screw chips are produced regardless of the cutting speed and the SCEA used. When cutting at 0.16 mm/rev, long, cock screw chips are obtained. In all instances similar trends are generally obtained when using KT 315.

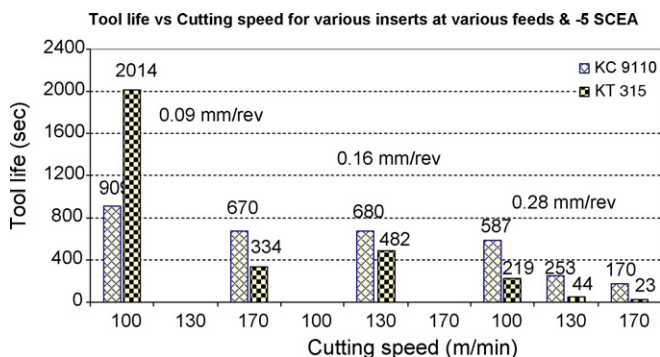
Fig. 3. Histogram of tool life for KT 315 and KC 9110 at various feeds, cutting speeds and  $-5^\circ$  SCEA.

The results on tool life ( $T$ ) and failure modes for the turning tests are shown in Table 1. It can be clearly seen that the tool life decreases with increasing cutting speeds and feeds. The longest tool life of 2104 s is obtained when cutting with KT 315 at low cutting speed (100 m/min) and feed (0.09 mm/rev) using  $-5^\circ$  SCEA. The histogram in Fig. 3 compares the performance of KT 315 and KC 9110 in terms of tool life when cutting with  $-5^\circ$  SCEA. It can be seen that KC 9110 consistently outperformed KT 315 except when cutting under low feed and low cutting speed conditions. Additionally, at high feed of 0.28 mm/rev, the tool life for KT 315 is extremely short (less than 60 s) when machining at medium and high cutting speeds regardless of the SCEA used. This is consistent with observation made by Dawson and Kurfess [14] whereby in general, tool life increases as feed rate reduces. The histogram in Fig. 4 confirms that even for  $-3^\circ$  and  $0^\circ$  SCEA, KC 9110 outperformed KT 315 when cutting at high feed and cutting speed. This figure also revealed that the best performance is attainable with  $-5^\circ$  SCEA as its use resulted in the longest tool life. This confirms the superiority of tools with  $-5^\circ$  SCEA when cutting hardened Stavax ESR tool steel with KT 315 and KC 9110 cutting tool material. This is because for a given feed and depth of cut, the area of cut is approximately constant, whilst the area of tool-chip engagement increases as the SCEA is changed from  $0^\circ$  to  $-5^\circ$  [15]. This results in higher

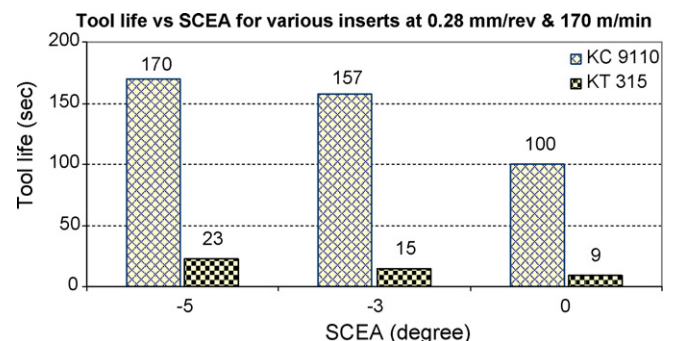
Fig. 4. Histogram of tool life for KT 315 and KC 9110 at various SCEAs, 0.28 mm/rev and 170 m/min.

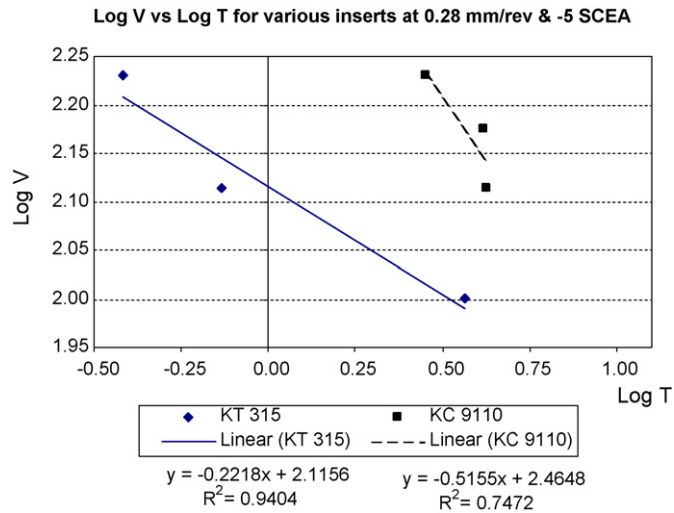
Fig. 5. Graphical representation of Taylor tool life equation for KT 315 and KC 9110 at 0.28 mm/rev and  $-5^\circ$  SCEA.

Fig. 5 attempts to compare the relationship between tool life and cutting speed for KT 315 and KC 9110 under similar cutting condition of 0.28 mm/rev and  $-5^\circ$  SCEA. It is clear that the linear trendlines for KT 315 and KC 9110 were not parallel and the  $n$  values were 0.22 and 0.52, respectively. This confirmed the assertion made by Degarmo et al. [21] that the value of  $n$  depends mostly on tool material. The extent of the difference in the  $n$  values obtained for the various cutting conditions tested also indicate that the feed rates have a primary effect on the relationship between the tool life and cutting speed. The rather small  $n$  values for KT 315 indicate that cutting speed has greater effect on tool wear and tool life. This is unlike KC 9110 where the  $n$  values were bigger. An examination of the Taylor constant values revealed that the  $C$  values were 131 and 292 m/min and therefore the use of KC 9110 generally resulted in longer tool life.

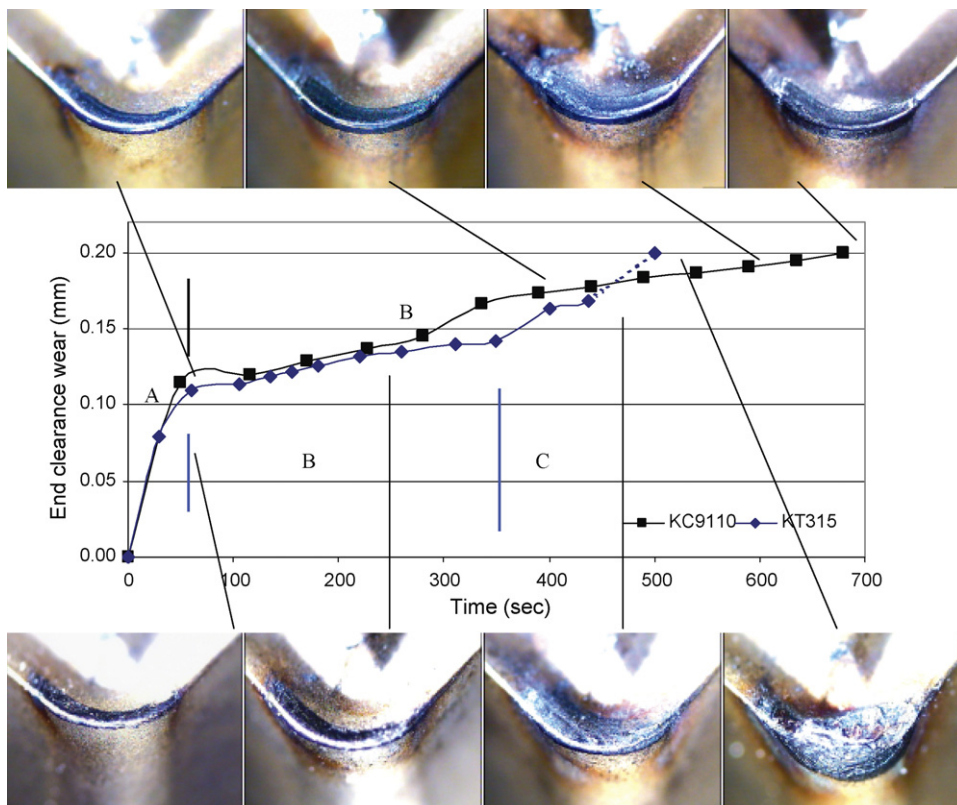
Fig. 6. End clearance wear growth comparison between KT 315 and KC 9110 when using  $-5^\circ$  SCEA at 130 m/min and 0.16 mm/rev.

The typical rapid-uniform-rapid wear profile corresponding to zones A–C can be observed when using both KT 315 and KC 9110. Fig. 6 attempts to compare the wear profile of KT 315 and KC 9110 when using  $-5^\circ$  SCEA at 130 m/min and 0.16 mm/rev. It can be seen that KC 9110 outperforms KT 315. Upon entering zone C after approximately 350 s, KT 315 wears rapidly and the weakened tool fails catastrophically with the work material being welded at the cutting edge (Figs. 6 and 7a). The relative positions of the curves depend on cutting conditions and the cutting tool material. Rapid wear rates are initially experienced possibly due to the running-in process caused by a very small area of contact between the tool and the work material, the presence of extraneous substances at the interface and a transient surface roughness.

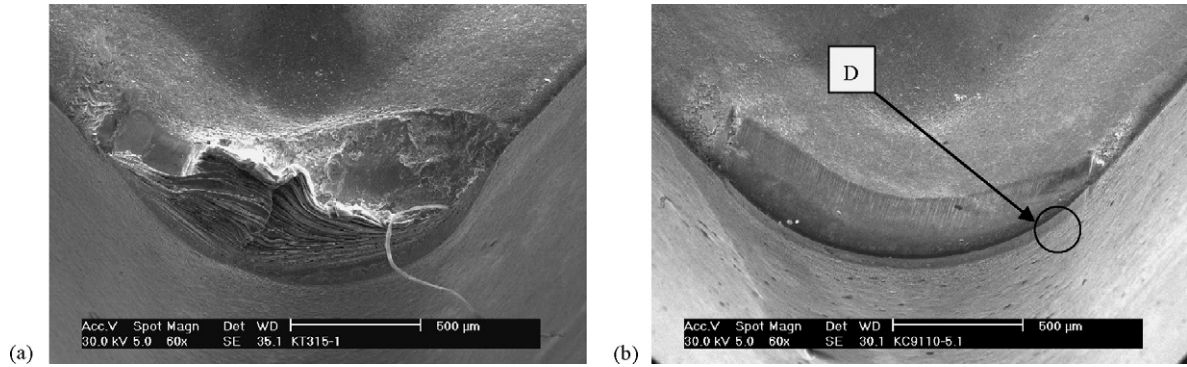
Fig. 7. SEM image of inserts (a) KT 315 (b) KC 9110 at the end of their tool life corresponding to final optical micrograph images for the respective cutting tool materials of Fig. 6.

End clearance wear is generally the dominant failure mode at low and medium feed rates (0.09 and 0.16 mm/rev), particularly when using KC 9110 (Fig. 7b), regardless of the cutting speed used. At a high feed rate of 0.28 mm/rev, it is dominant only at low cutting speed of 100 m/min. End clearance wear determines the tool life for KT 315 for one of the conditions tested (100 m/min, 0.09 mm/rev,  $-5^\circ$  SCEA). The end clearance wear land developed is generally uniform regardless of the cutting speeds and feeds used. Catastrophic failure of the cutting tool determines the tool life for three of the cutting conditions tested. In two of the cases, flank wear is the most prominent tool wear form prior to failure whilst in the other case it is the end clearance wear. In both instances, the width of flank wear prior to failure were well below the criteria values used confirming that the deterioration of the cutting edge was rapid and resulted in the catastrophic failure on the major flank side (Fig. 10b)/minor flank side of the cutting tool as well as in the adjacent areas. Catastrophic failure is seen to occur exclusively when using KT 315.

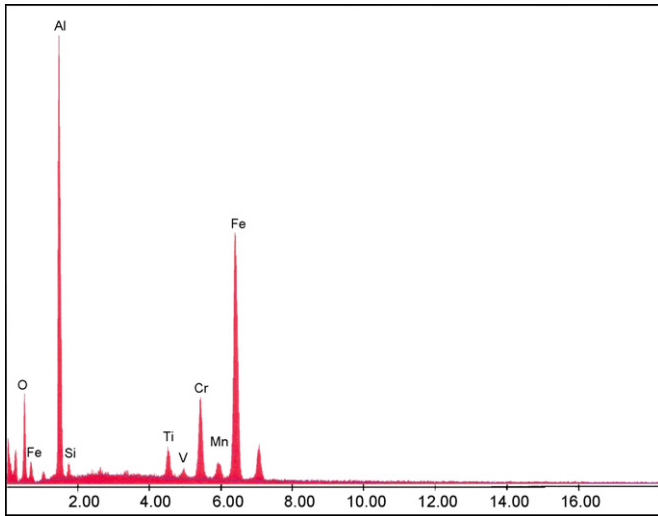
Fig. 8. EDAX analysis after cutting for 680 s at 130 m/min, 0.16 mm/rev,  $-5^\circ$  SCEA when using KC 9110 whereby Al and Ti from the coated tool are mainly detected at location D of Fig. 7b.

eventual failure of the cutting tool. Profiles limited to zone A are obtained in a number of instances when using KT 315. This indicates that the wear undergone is rapid where a single pass of cutting results in the wear criterion being exceeded or results in catastrophic failure and is not associated with the running-in process described previously. On the other hand, when using KC 9110, profiles with only zones A and B are obtained in most of the instances even though the tool life criteria has been exceeded (Fig. 6). This suggests that the tools can still be use, as the substrate has not been penetrated (Fig. 7b). The EDAX analysis in Fig. 8 confirms that apart from work material, elements associated with the coating materials such as Al and Ti predominate and elements associated with the substrate material is absent.

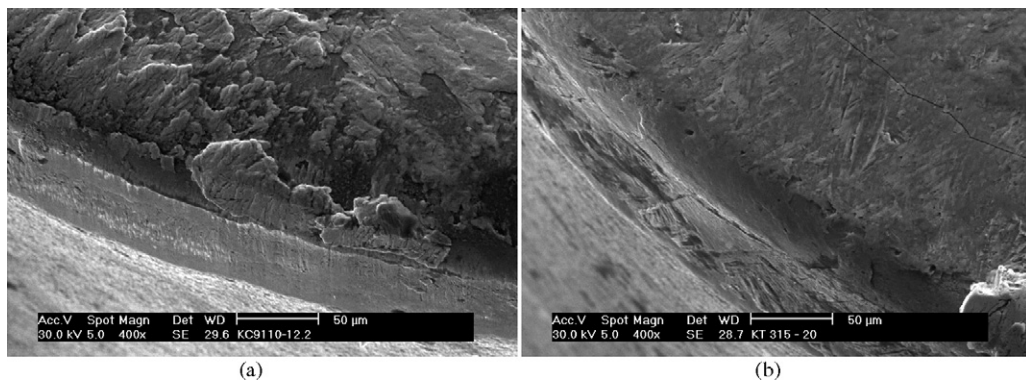
Fig. 9. Flank wear when cutting at 170 m/min, 0.28 mm/rev,  $0^\circ$  SCEA using (a) KC 9110 after 104 s and (b) KT 315 after 10 s.

At a high feed rate of 0.28 mm/rev, flank wear was generally the dominant failure mode regardless of the cutting tool material used (Fig. 9a). The development of flank wear land was

generally gradual and uniform. However, when cutting with KT 315 using  $0^\circ$  SCEA resulted in the flaking of the cutting edge (Fig. 9b). When using KC 9110 at 130 m/min, 0.28 mm/rev,  $-5^\circ$  SCEA, flaking on the rake face extended into the flank wear land (Fig. 10a) revealing the substrate. It is observed that there is localized adherence of workpiece material on the cutting edges. Localized adherence also occurred when cutting at 170 m/min, 0.28 mm/rev, using  $-5^\circ$  and  $0^\circ$  SCEA (Fig. 9a) and also when cutting with KT 315 (Fig. 9b).

The presence of hairline cracks (Fig. 9b) on the rake face even before the substrate is being penetrated seems to suggest the coming into play of fracture mechanism, particularly through coating fracture resulting in edge chipping, flaking and rapid growth of crater wear, which considerably weaken the tool, accelerate the wear process and consequently lead to the catastrophic failure of the tool. The fracture observed may be due to the extremely high shear stresses produced by the moving chips or because of thermal stresses generated by the steep temperature gradient experienced by the tool as a result of cutting the hardened steel or even as a result of a defect in the substrate.

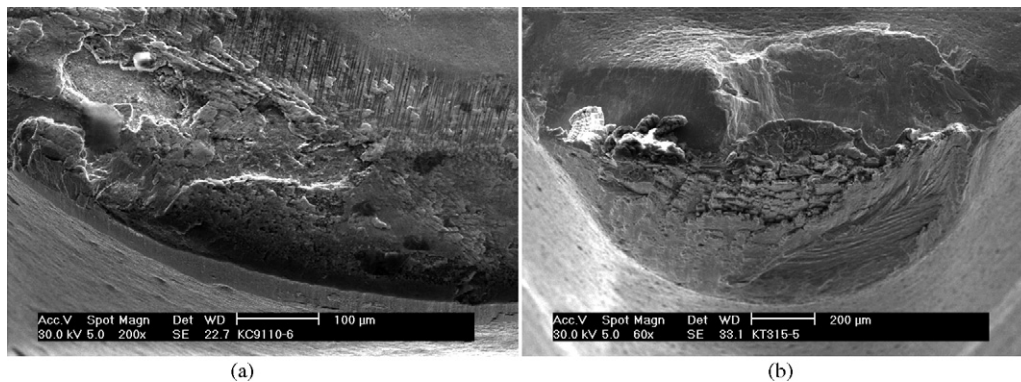
Fig. 10. (a) Flaking on the rake face extending into the flank wear land after cutting for 257 s at 130 m/min, 0.28 mm/rev,  $-5^\circ$  SCEA using KC 9110. (b) Catastrophic failure when using KT 315 after cutting for 25 s at 170 m/min, 0.28 mm/rev,  $-5^\circ$  SCEA.

The combination of adhesion and diffusion wear mechanisms is particularly active on the rake surface. Crater formation due to adhesive wear process is believed due to the chip which alternately slips and sticks on the rake face. During the sticking phase, interdiffusion of Fe and Co occur resulting in the weakening of the binder. When the chip breaks free, it is able to fracture segments of the tool and subsequently small chunks of the tool are being removed resulting in the formation of a rough or irregular profile in the crater (Fig. 10a).
