Popping Noise in Household Refrigerators: Fundamentals and Practical Solutions

Daniel HARTMANN, Cláudio MELO*

POLO Research Laboratories for Emerging Technologies in Cooling and Thermophysics
Department of Mechanical Engineering, Federal University of Santa Catarina
88040-900, Florianópolis, SC, Brazil, +55 48 3234 5691

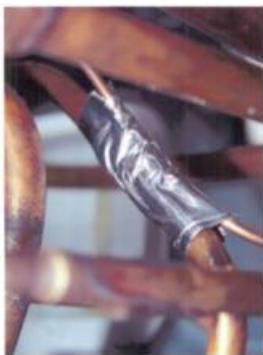
Figure 4: Capillary tube-discharge line heat exchanger

The capillary tube-discharge line heat exchanger is shown in Figure 4. It is mounted placing the initial portion of the capillary tube in contact with the discharge line. Since the discharge line is the hottest tubing of a refrigerator the use of this heat exchanger decreases the temperature difference between the vapor bubbles entering the capillary tube and the liquid surrounding them. Thus, there is a decrease in the bubble collapsing rate, which avoids the shockwaves and the noise. The effect of this heat exchanger is illustrated in the P-h diagram for HFC-134a in Figure 5, where the dashed lines represent the regular cycle and the solid lines represent the cycle with the above-mentioned heat exchanger. It is worth noting that the specific refrigerating effect and the cooling capacity decrease and the compressor power increases, all with a negative impact on the system performance.

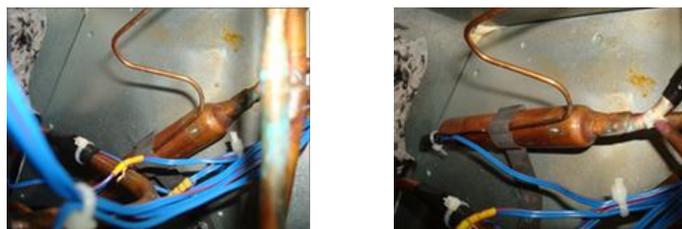
Figure 6: Filter dryer in original (left) and horizontal (right) positions

Placing the filter dryer in the horizontal position, as shown in Figure 6, is an attempt to increase the liquid level at the capillary inlet as fast as possible, in order to avoid the vapor entraining vortices. This solution, however, does not apply to all appliances, being very much dependent on the manufacturing process level, dryer geometry and refrigerant mass flow rate.

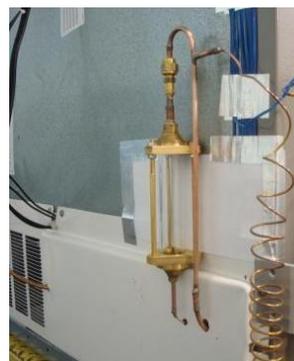
Figure 8: Sight glass at the capillary inlet

Visualization studies were also carried out, using a cylindrical sight glass with the same internal volume of the original filter dryer, as illustrated in Figure 8. The flow images at the capillary inlet were taken by a high speed video camera, allowing comparisons with the flow patterns shown in Figure 3.

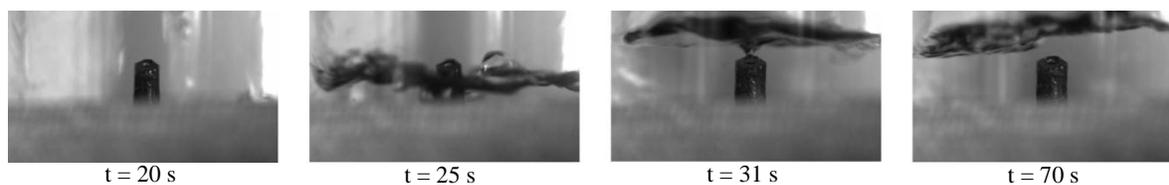
Figure 11: Liquid level in the glass sight: baseline system

Figure 11 shows the liquid level behavior in the dryer a few instants after compressor start-up. There clearly is a resemblance with the illustrations in Figure 3, particularly between the condition shown in Figure 3C and the image taken at 31 seconds. The images also corroborate the behavior predicted by the thermodynamic analysis. Soon after compressor start-up the liquid level increases rapidly until it reaches the edge of the capillary tube. At this moment the capillary tube mass flow rate begins to equal the compressor mass flow rate, and the liquid level exceeds the capillary edge by a few millimeters, reaching a steady condition at 70 seconds. Although there are bubble entraining vortices up to this instant the noise ceased 10 seconds prior to this, most probably because the capillary cooling rate was not high enough to cause CIS.
