HYDROGEN EMBRITTLEMENT OF HIGH STRENGTH STEEL ELECTROPLATED WITH ZINC-COBALT ALLOYS

E.M.K.Hillier⁺ & M.J.Robinson

**School of Industrial & Manufacturing Science
Cranfield University**

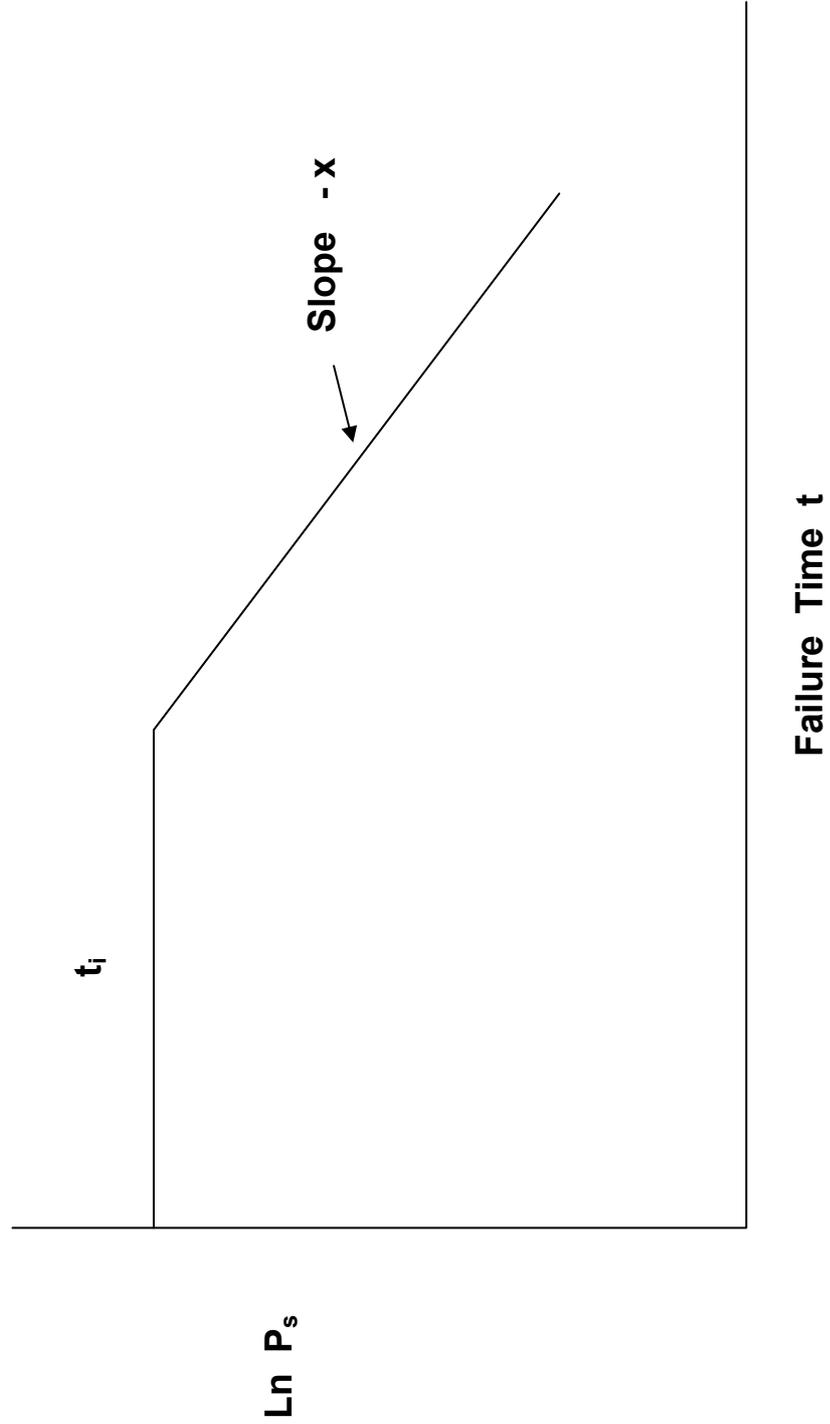
Fig 1 Schematic Weibull plot showing the probability of survival, P_s , against failure time, t

Where P_t is the probability of failure and x is a shape parameter termed the Weibull slope⁽⁵⁻⁷⁾. In the present context x represents the probability per unit time that during time, t , a crack will form in the specimen of sufficient size to cause failure. The value of x can be obtained from the negative gradient of a graph of $\ln P_s$ against t . A schematic Weibull plot of failure times is shown in Fig 1. The graph is displaced along the time axis by the amount t_i , known as the minimum crack incubation time. (When $P_s = 1$, then $\ln P_s = 0$ and $t = t_i$).

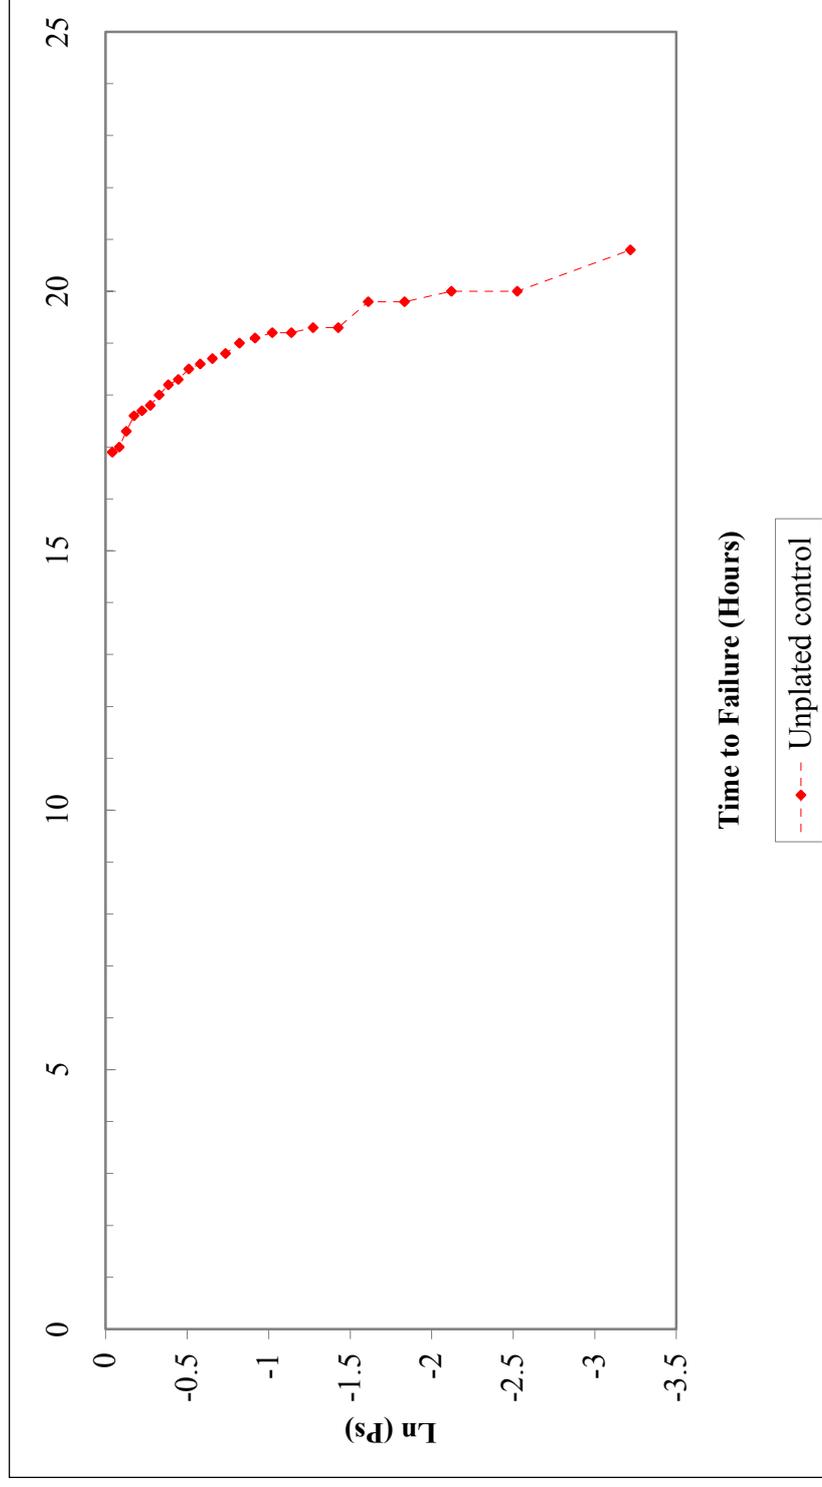
Fig 2 Weibull plot of failure times in the slow strain rate test for unplated control specimens

A Weibull plot of the times to failure in the slow strain rate tests for specimens that had been quenched and tempered but not electroplated is shown in Fig 2. All of the specimens failed in times ranging between 17 and 21 hours with a mean time of 18.9 hours.

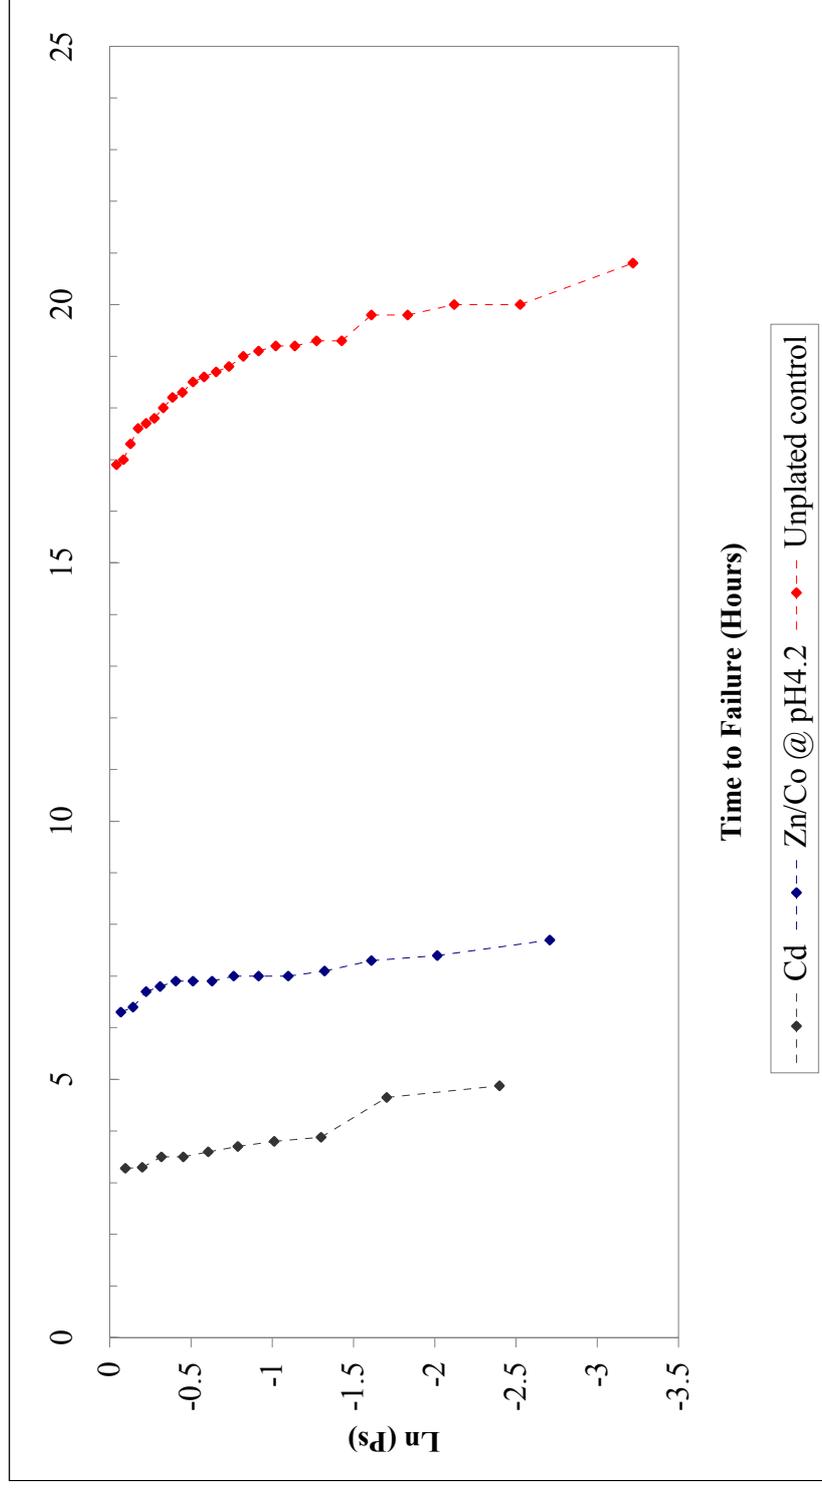
Fig 3 Weibull plot showing the effect of cadmium and zinc-1%cobalt plating on the time to failure

The effect of electroplating specimens with 8 microns of cadmium or zinc-1%cobalt was to promote hydrogen embrittlement of the steel and reduce the times to failure. The results for these two coatings are compared in Fig 3. The cadmium caused more embrittlement with a mean time to failure of 4.2 hours compared to 7.0 hours for the zinc-cobalt.

The results show that electrodeposited Zn-1%Co coatings promote high levels of hydrogen embrittlement in a susceptible high strength steel substrate (Fig 3). This embrittlement was much greater than that caused by Zn-10%Ni plating but not quite as severe as that for pure zinc or cadmium (Figs 3,5 & Table 5).

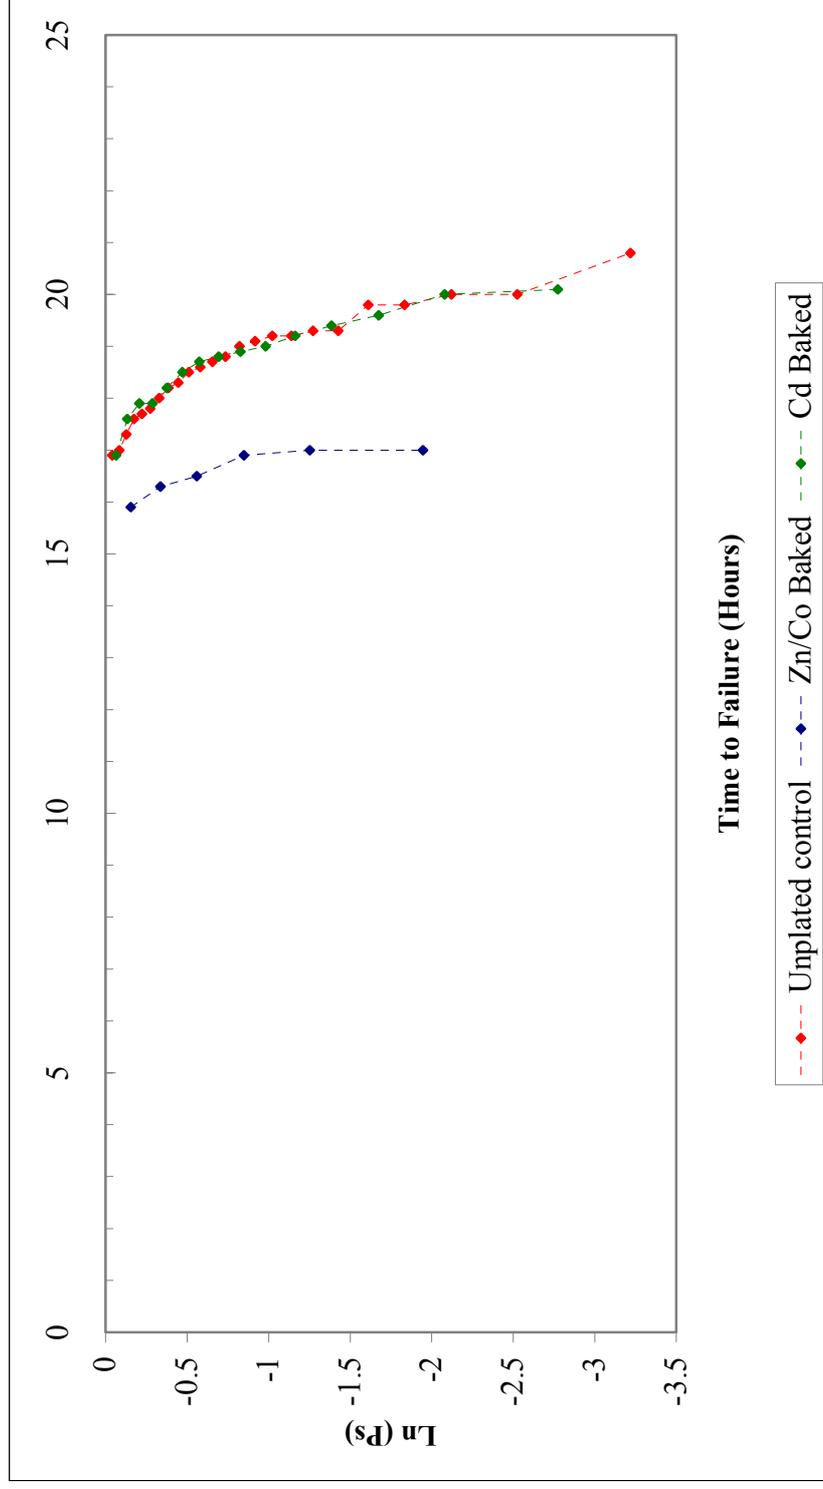
Fig 4 Weibull plot showing the effect of baking on the failure times of cadmium and zinc-1%cobalt plated specimens

After baking at 200°C for 24 hours to promote loss of hydrogen from the surface, specimens that had been plated with cadmium showed full recovery of mechanical properties and the mean time to failure was restored to that of the unplated controls (Fig 4). The statistical Student t-test⁽⁸⁾ was used to confirm (95% confidence) that the failure times of the baked cadmium plated specimens and the control specimens were part of the same population. Similarly, it was demonstrated that the baking heat-treatment did not affect the times to failure of the control specimens. In contrast, baking the zinc-cobalt plated specimens for 24 hours gave incomplete recovery and the times to failure were still only 89% of those for the controls. Additional tests were performed in which the baking time was increased to 48 hours but their recovery only increased to 91%.

The results in Fig 4 showed that although the baking treatment was effective in removing absorbed hydrogen and reducing the risk of embrittlement in cadmium plated steel it did not give full recovery with zinc-cobalt alloy coatings. The specimens still failed in 89% of the time of the unplated controls, which was similar to the behaviour of specimens plated with pure zinc. Even after baking, the risk of an embrittlement failure in a zinc-cobalt plated specimen was greater than that for zinc-10%Ni plating without a baking treatment (Table 5).

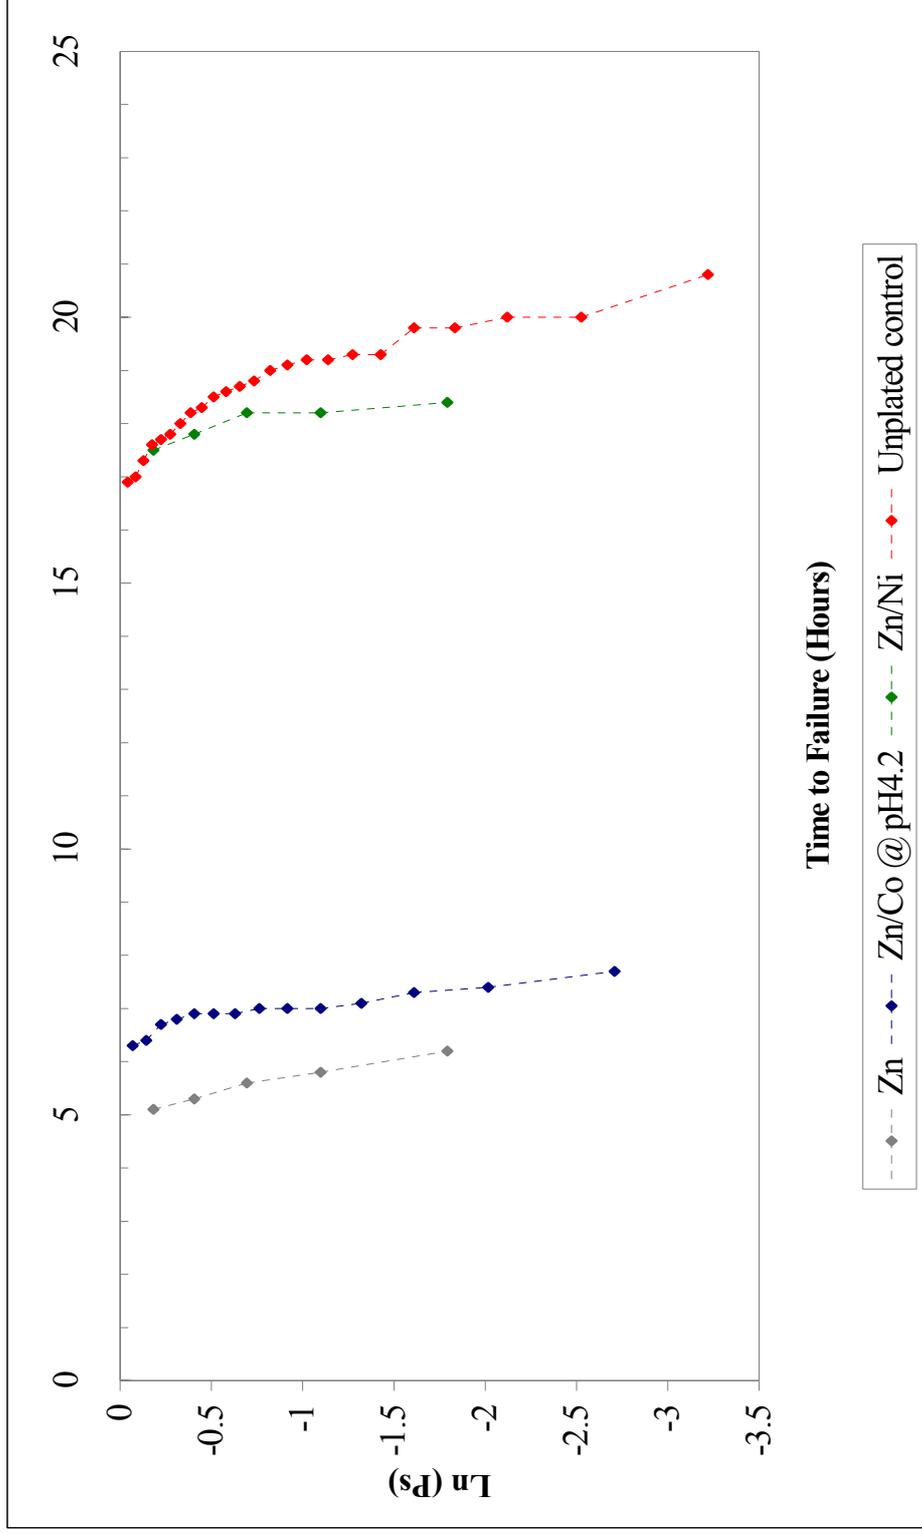
Fig 5 Weibull plot comparing the failure times of specimens plated with Zn-1%Co, zinc and Zn-10%Ni

In order to investigate the embrittlement promoted by zinc-cobalt coatings in more detail, comparison was made with the times to failure of specimens electroplated with pure zinc. It was found that pure zinc promoted more embrittlement than zinc-1%cobalt, with a mean time to failure of 5.6 hours, as shown in Fig 5. The presence of just 1%Co in the zinc-cobalt alloy was beneficial in reducing the extent of embrittlement. Like the zinc-1%cobalt coating, baking the pure zinc plated specimens did not fully restore their mechanical properties and they failed in 87% of the time of the unplated controls.

The results for electroplated Zn-10%nickel are included in Fig 5. The mean time to failure of 18.2 hours indicates that very little hydrogen embrittlement was promoted by this coating. It had been shown in an earlier study ⁽⁹⁾ that the reason that zinc-nickel alloys cause only a low level of embrittlement is that the first material to deposit on the surface of the steel has a higher nickel content than the remainder of the coating. Nickel has a very low diffusion coefficient for hydrogen ⁽¹⁰⁾, in the order of $8 \times 10^{-10} \text{ cm}^2\text{s}^{-1}$, and the nickel-rich interlayer acts as a barrier to the diffusion of hydrogen from the coating into the steel.

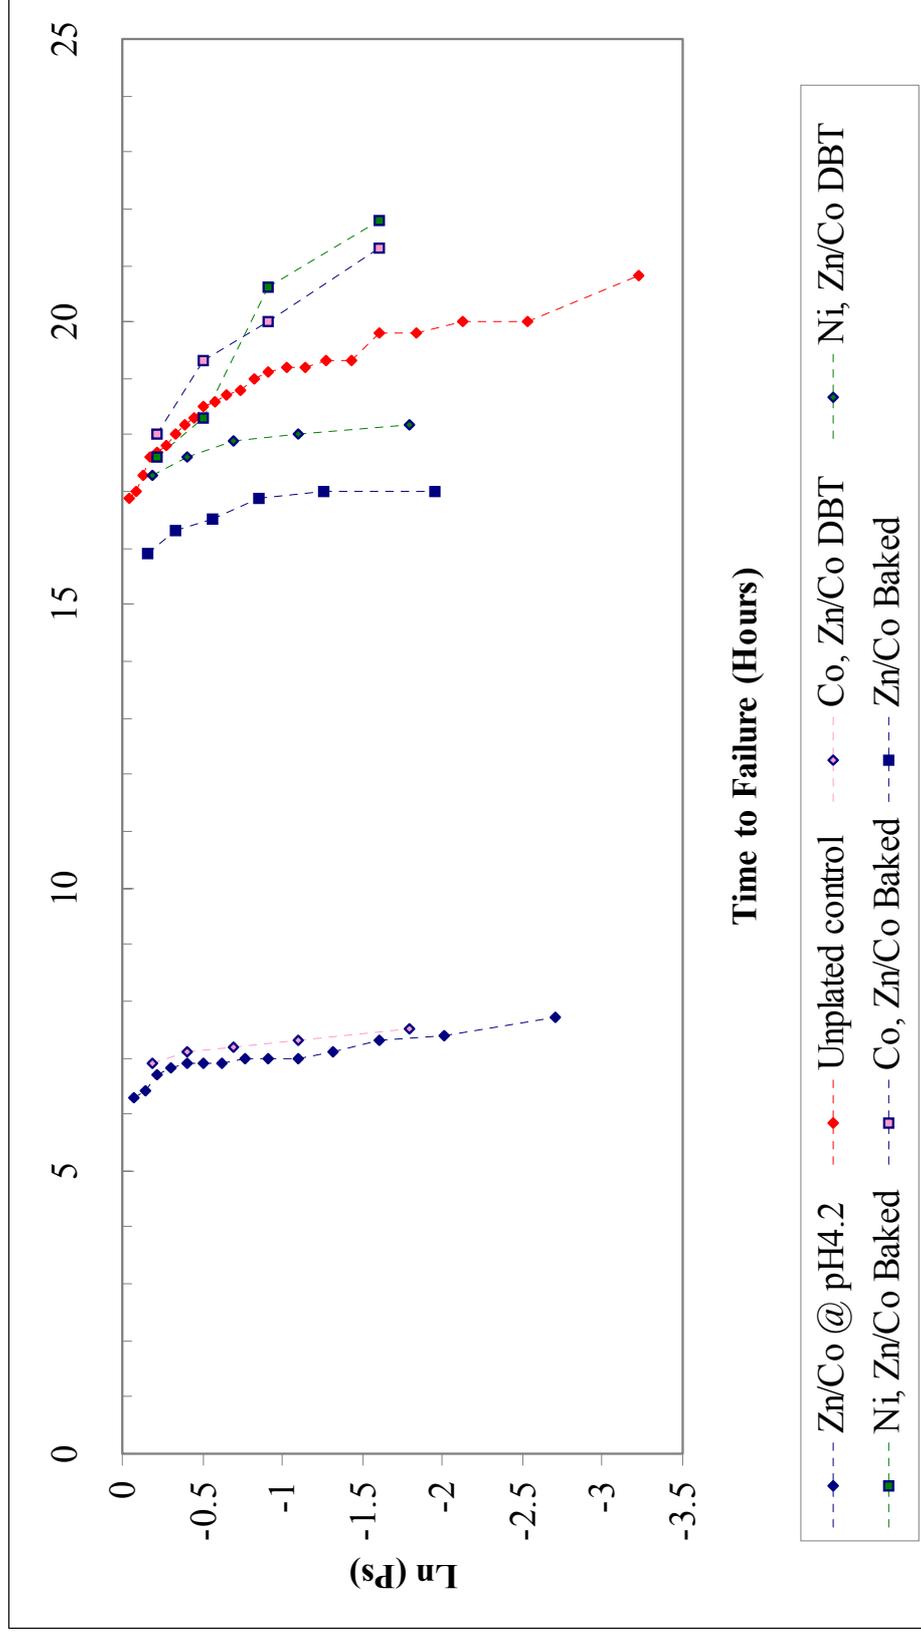
Fig 7 Weibull plot showing the effects of baking on the times to failure of zinc-cobalt coatings with nickel or cobalt interlayers

The effects of baking the zinc-cobalt coatings with the cobalt and nickel interlayers are shown in Fig 7. An important observation was that in both cases virtually full recovery was achieved. As baking the zinc-cobalt coating that did not have an interlayer failed to restore its properties to those of the unplated controls it is assumed that the presence of a thin layer of cobalt can have a significant effect. It is thought that a cobalt interlayer acts as a sufficient barrier to hydrogen that during baking the hydrogen in the coating escapes to atmosphere rather than diffusing into the steel.

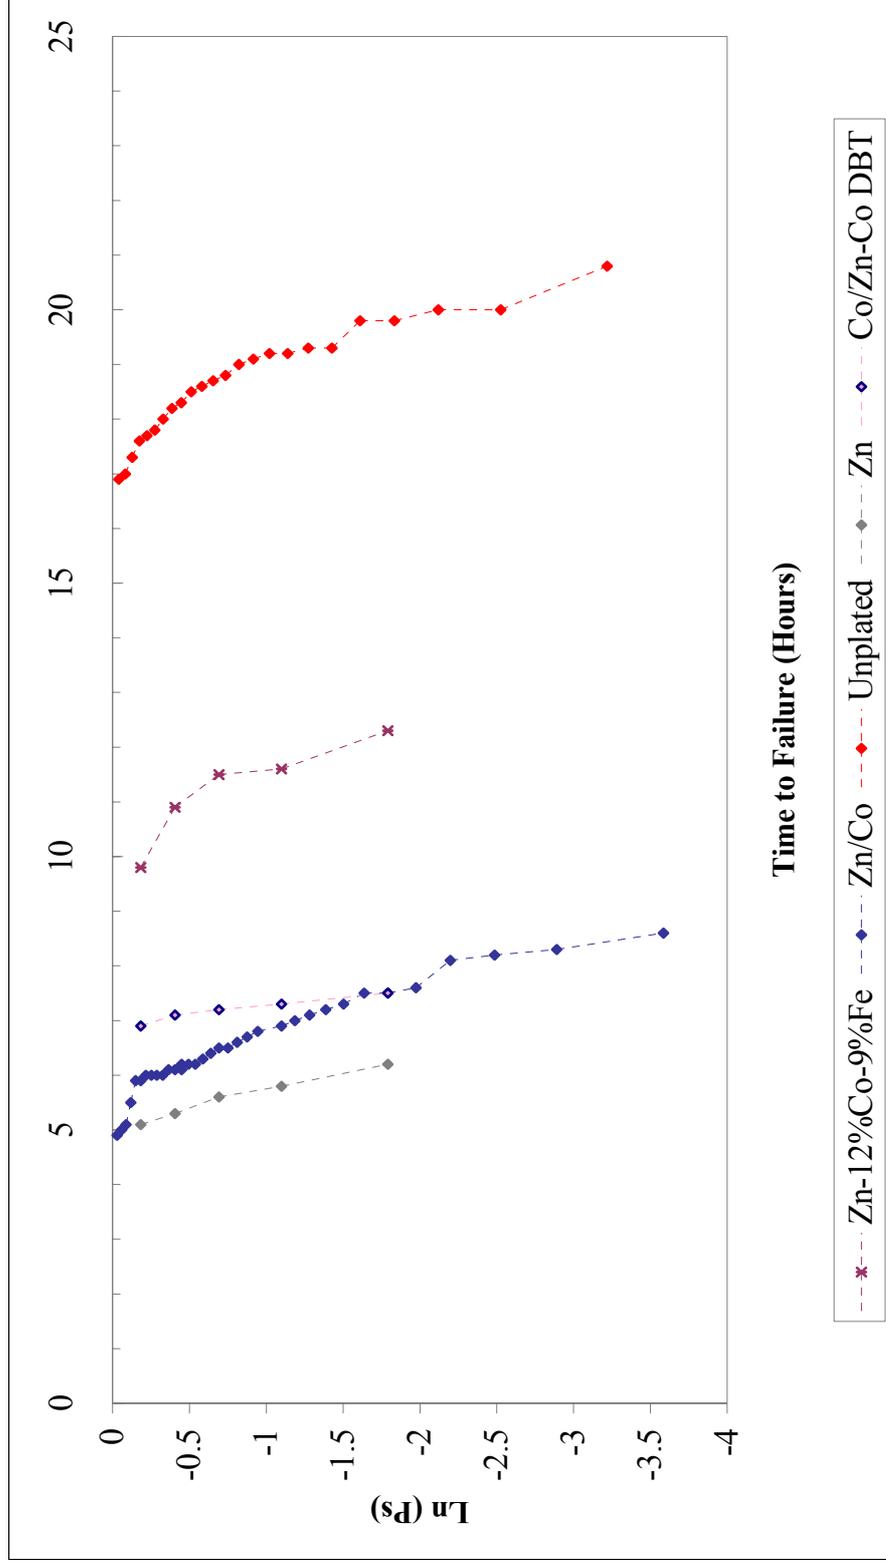
Fig 8 Weibull plot comparing times to failure of specimens plated with zinc-cobalt-iron, zinc and zinc-cobalt

The results for the zinc-12%cobalt-9%iron alloy were very promising as shown in Fig 8. This coating was the least embrittling of the zinc-cobalt alloys tested with a mean time to failure of 10.8 hours compared to 5.6 hours for zinc, 7.0 hours for zinc-1%cobalt and 7.2 hours for zinc-cobalt plated over a cobalt interlayer.
