Application of Acoustic Emission to seeded gear fault detection

Tim Toutountzakis, Chee Keong Tan, David Mba

School of Engineering, Cranfield University, Bedfordshire. MK43 0AL, UK

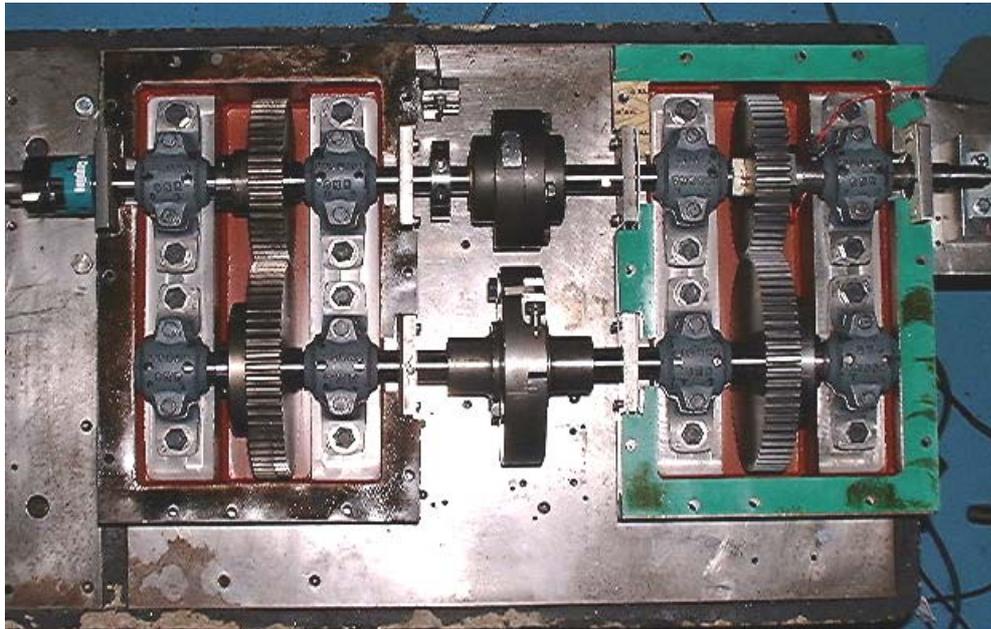
Figure 1 Test-rig gearboxes in back-to-back arrangement.

The test-rig consisted of two identical oil-bath lubricated gearboxes, connected in back-to-back arrangement, see figure 1. The gears employed were made of 045M15 steel without any heat treatment. The gears (49 and 65 teeth) used had a module of 3 mm, a pressure angle of 20° , and surface roughness of between 2-3 μm . Each gearbox had four identical ball bearings. A simple mechanism that permitted a pair of coupling flanges to be rotated relative to each other, and locked in position, was employed to apply torque to the gears. The effect of this process was to twist the shafts and lock in the torque within the loop of the back-to-back gearbox. The effective torque loading was a combination of the static and dynamic (inertia) loading. Three sets of torque were used for the experiment: 0 Nm, 55 Nm and 110 Nm. The contact ratio of the gear was 1.77. It must be noted that the 0 Nm condition is not literally '0 Nm'. There exists a light load at this condition due to the bearing friction and losses/resistance associated with the rubber seals, gear churning and windage. If a true '0 Nm' condition was obtainable, the gear would run in a non-linear manner. An AC three-phase electrical motor (1.1 KW)

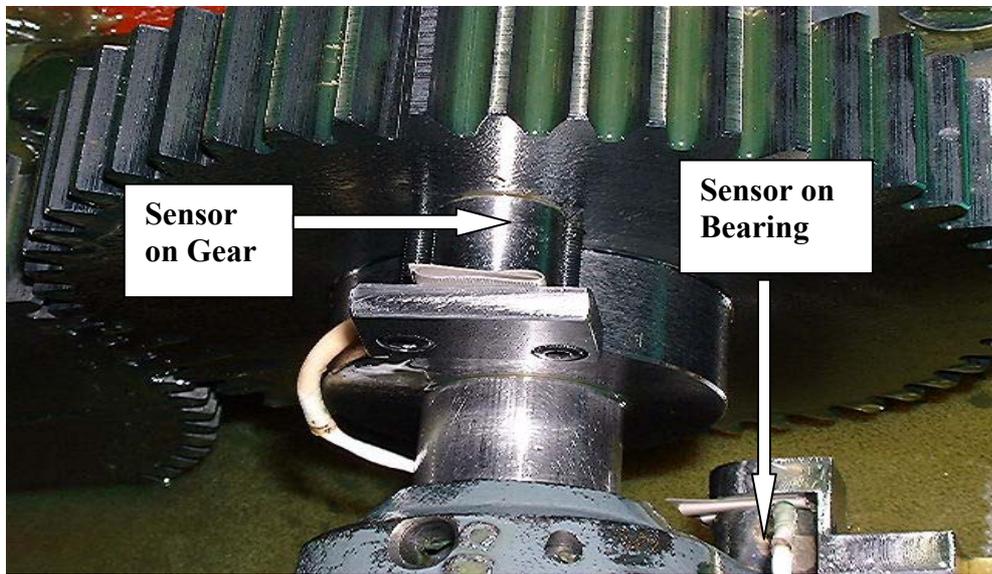
Figure 2 AE sensors located on the pinion and bearing casing.

The AE sensors used for this experiment were broadband type sensors with a relative flat response in the region between 100 KHz to 1MHz (Model: WD, ‘Physical Acoustics Corporation’). One sensor was placed on the pinion (49 teeth) and the other on the bearing casing (figure 2) of the pinion shaft. The cable connecting the sensor placed on the pinion with the pre-amplifier was feed into the shaft and connected to a slip rig, see figure 3. This arrangement allowed the AE sensor to be placed as close as possible to the gear teeth. Both sensors were held in place with mechanical fixtures. A

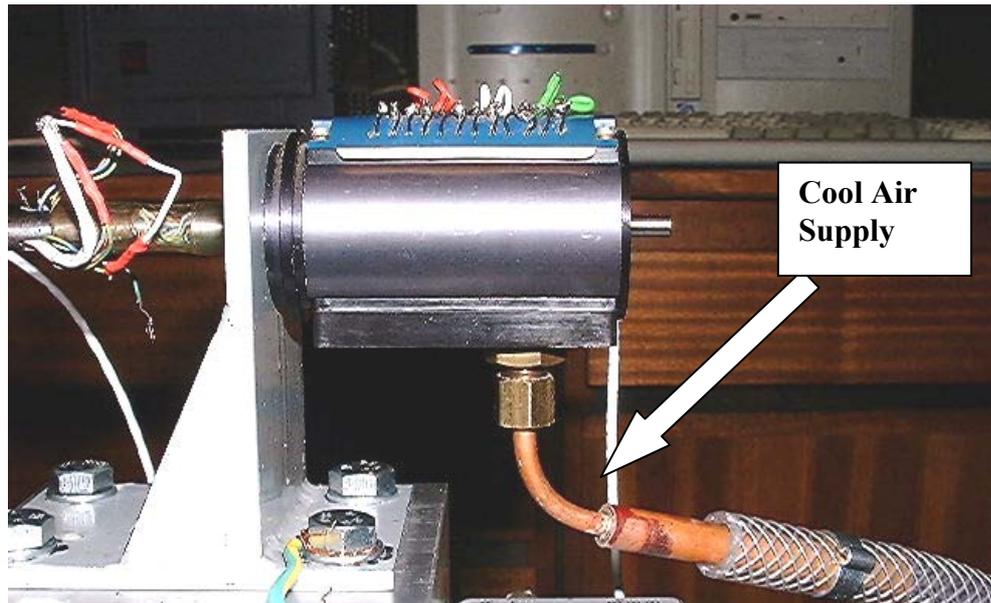
Figure 3 Slip ring coupled with cool compressed air supply.

PH-12 slip rig manufactured by 'IDM Electronics Ltd' was employed. The slip rig used silver contacts and could accommodate up to 12 channels. The slip rig had an air intake where pressurised air was fed for cooling and cleanliness purposes at a rate of 0.014kg/mm^2 (figure 3). The output signal from the AE sensors was pre-amplified at 40dB. The signal output from the pre-amplifier was connected (i.e. via BNC/coaxial cable) directly to a commercial data acquisition card where a sampling rate of 10MHz was used during the tests.

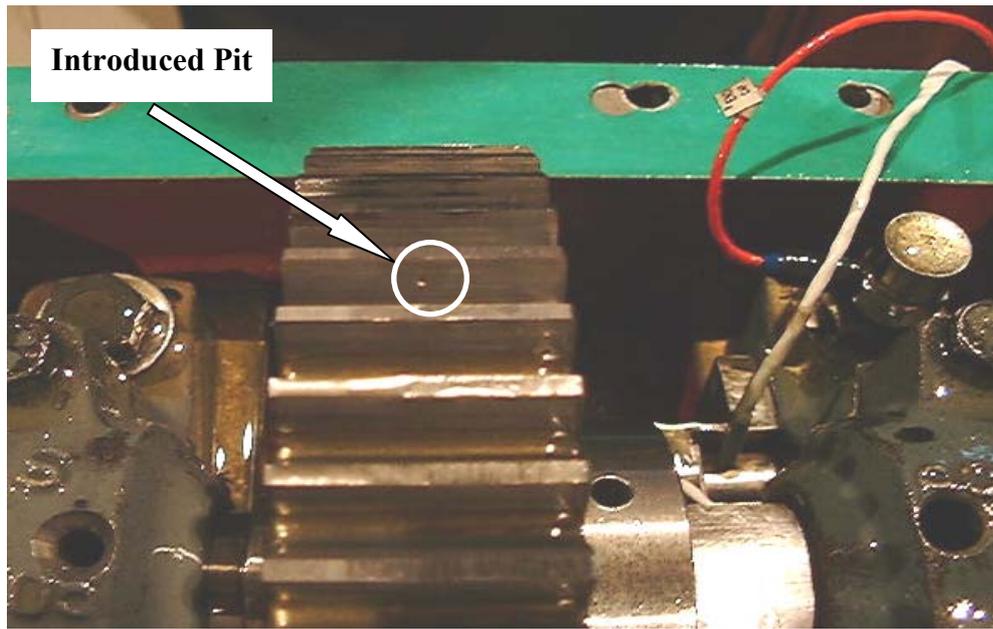
Figure 4 Seeded small pitch-line defect.

For the seeded defect condition, a pitch-line defect of 1 mm in diameter (see figure 4) was introduced and AE data was collected by repeating the loading procedures detailed in the former paragraph. Lastly, the test was repeated for a large addendum defect (extended from the pitch-line) measuring 12 mm by 3 mm (see figure 5). Based on the sampling rate of 10 MHz, the acquisition time available for recording was 0.0256 seconds which represented 0.31 revolutions (16 teeth) of the pinion at 745 rpm. The seeded defects were introduced on the tooth flank of a tooth using an engraving machine. By employing a trigger mechanism, only AE data from the portion of the pinion gear wheel where the defect was located was acquired. The trigger system was set such that the defective gear tooth was at the mid point of the acquisition window (0.0256 seconds), see figure 6.

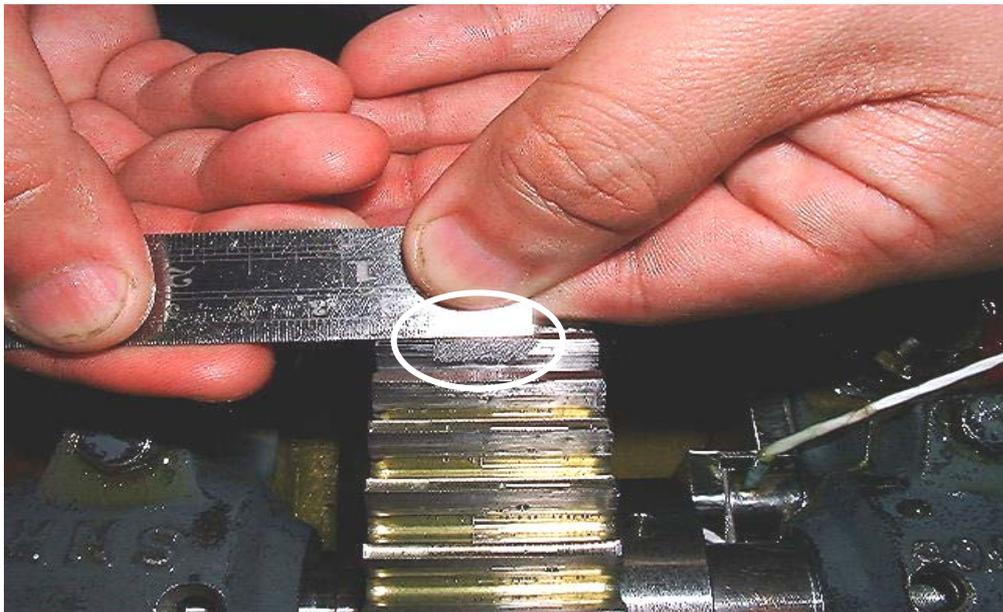
Figure 5 Seeded large addendum defect.

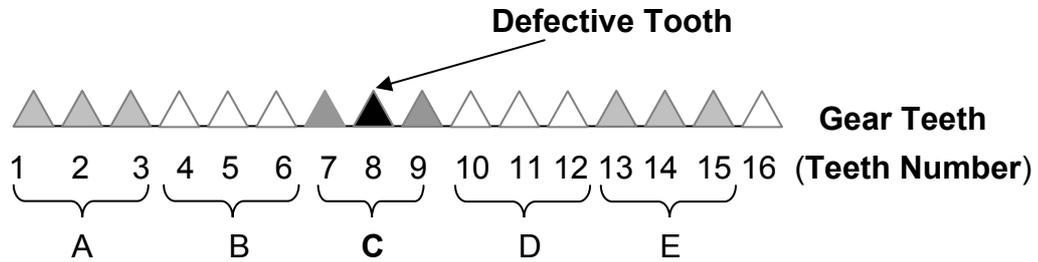
Figure 6 Sectioning of gear teeth for analysis, 16 teeth captured over 0.0256 seconds.

The recorded AE time waveform acquired for defect and defect free simulations were split into five different regions with each region representing 3-teeth, see figure 6. The r.m.s. value of each region was computed and plotted against the three loading conditions. It was thought that this method of grouping the data would enhance the possibilities of detecting the seeded defect particularly as the defect has been seeded in the centre of the acquisition window. A total of 50 data sets, each equivalent to a time frame encompassing sixteen teeth, were acquired and averaged in each region. The

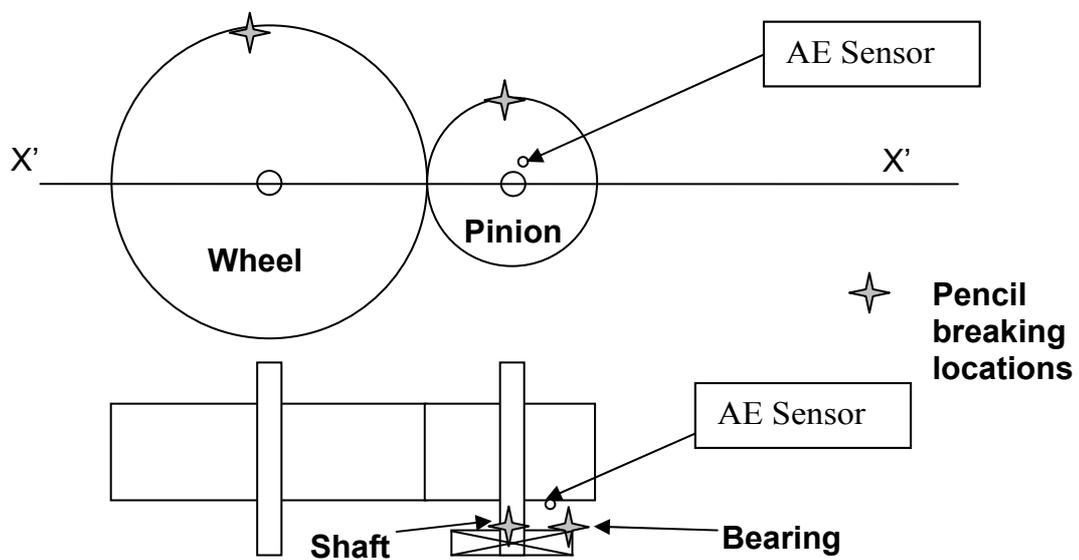
Figure 7 Schematic Diagram for the attenuation test displaying different interfaces

A 0.5 mm diameter and 3 mm length 2H lead pencil was broken at different positions in order to establish the attenuation of the AE signal. This technique is known as the Nielsen source test. Figure 7 presents the schematic diagram for the attenuation test displaying the different simulation positions and different interfaces the AE signatures would have to propagate across. Table 1 and figure 8 show the relative attenuation values. The reference signal employed for the attenuation calculations was the AE response from a lead break next to the AE sensor on the pinion gear. Five pencil breaks were acquired from each position and averaged.

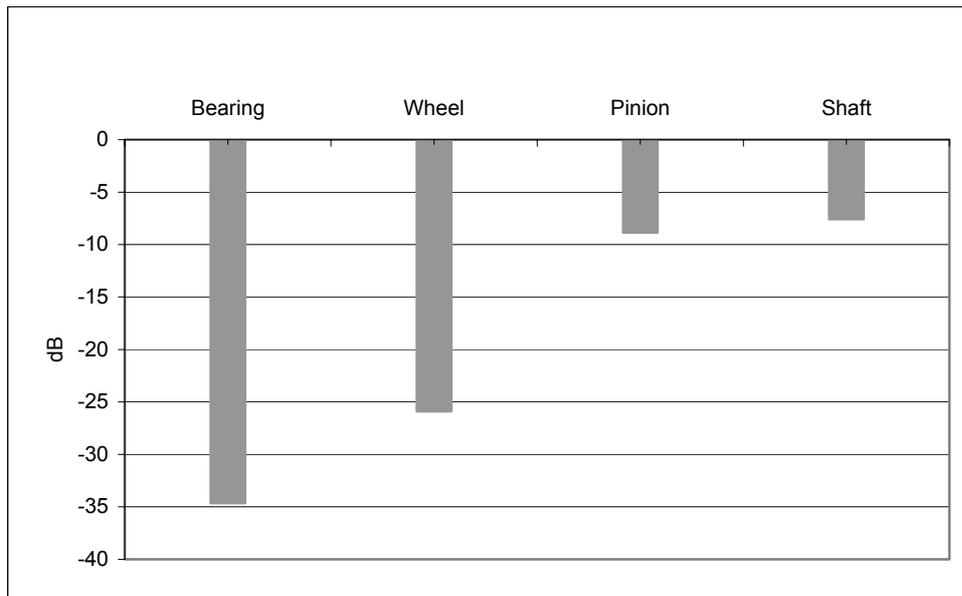
Figure 8 Relative attenuation values for sensor on the pinion.

The greatest attenuation of simulated AE signatures was observed on the bearing. This was expected due to the number of interfaces the AE signature would need to propagate across. The position of the balls in the loaded zone affects attenuation of the AE signal. If a ball is in the loaded zone while the AE waves were travelling through, better transmissibility can be expected. Relatively high attenuation was also observed for lead

breaks on the wheel (big gear). This was expected as the wheel is furthest away from the sensor; however, the attenuation values of lead breaks on the pinion and shaft were similar. It was expected that the attenuation would be greater on the shaft due to the interface between the shaft and the pinion gear but this was not the case. This is attributed to experimental errors and the close proximity at both locations.

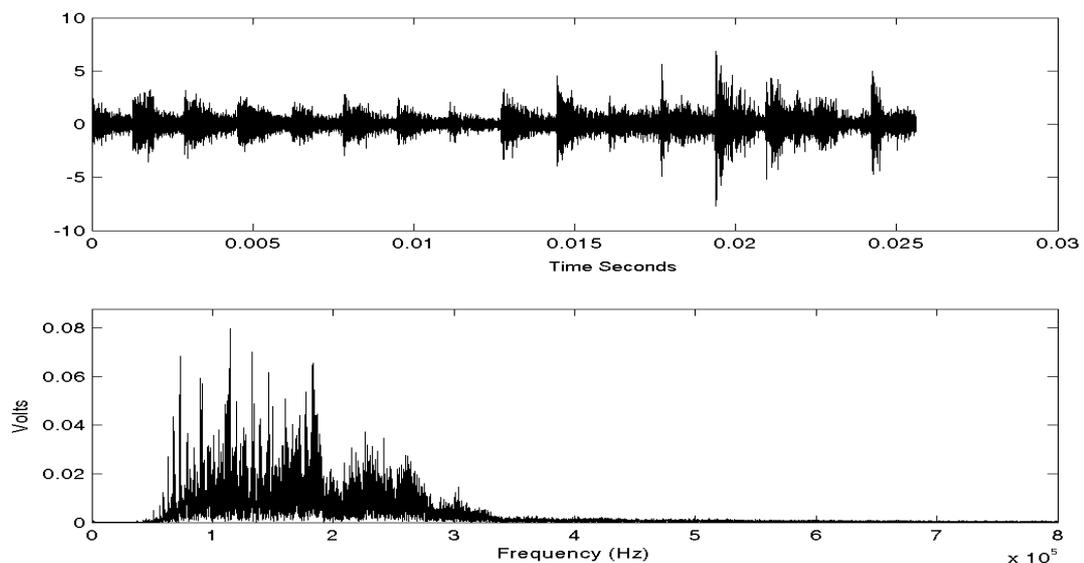
Figure 9 Time and frequency domain of an AE signature showing clearly the AE transient response associated with gear meshing of 16 teeth.

Figure 9 displays a typical AE signature with corresponding frequency spectrum associated with a defect free condition (operational noise). Figure 10 illustrates the time domain signatures for the load cases considered. It clearly shows 16 meshing teeth that

included the defective tooth. This is the first known published document that presents the gear meshing AE transient response in the time domain. The gear mesh frequency can also be calculated from the time domain AE signal by inverting the periodic time between two subsequent AE bursts. The frequency range of the transient and continuous AE signals associated with these tests ranged from 25 kHz to 350 kHz.

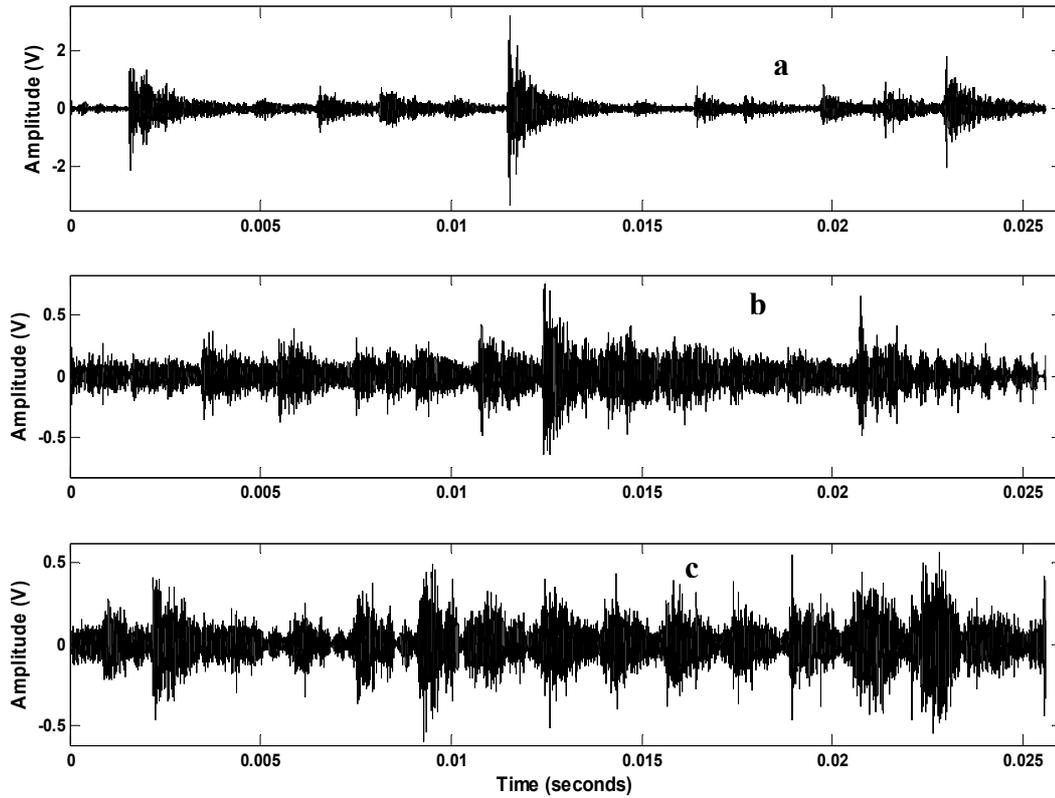
Figure 10 Raw AE signal for small pitch-line defect for (a) no load, (b) 55 Nm load and (c) 110 Nm load.

The raw AE signal from small pitch-line defect is displayed in figure 10. This shows the non-consistent observation of AE bursts in relation to the defect position. The biggest burst of the AE signal did not always occur in the centre region of the window where the seed fault was located. Hence, it was not possible to detect the seeded defect using the AE r.m.s. This contradicts the work of a few researchers [8, 10, 11] whom claimed AE energy, which is proportional to r.m.s, could clearly identify a simulated pit. Based on these observations the authors undertook further experiments in an attempt to understand the reasons for this, see section on discussions.

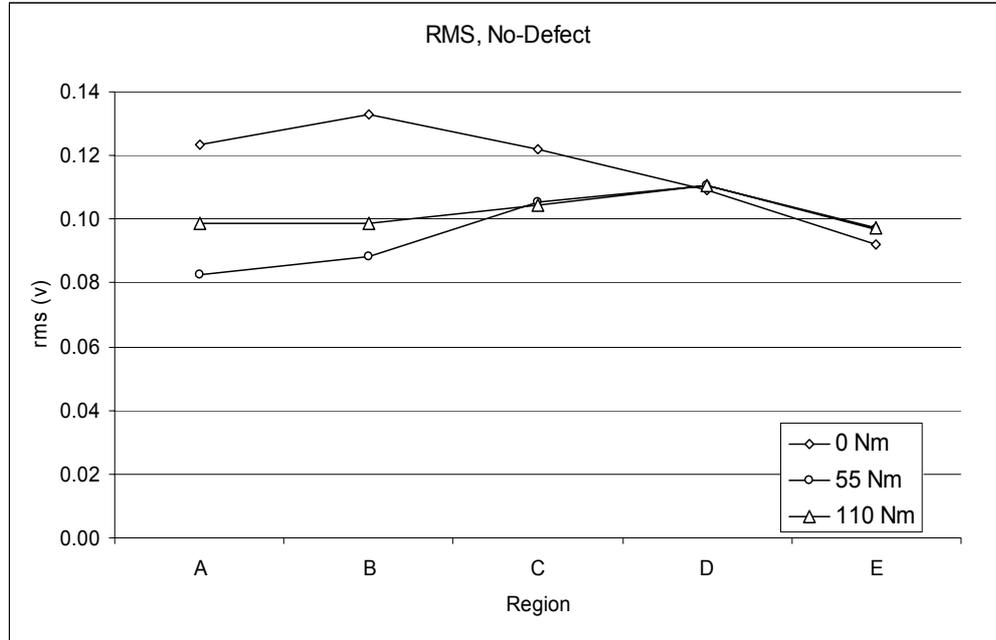
Figure 11 r.m.s. against load for defect free condition. (5 regions).

For the defect free simulation r.m.s values calculated showed no discernible trend for the three loading conditions, see figure. For the small pitch-line defect condition, the centre region C, where the seeded defect was introduced, exhibited the highest r.m.s values (figure 12). However, similar observations were not present for the large addendum defect (figure 13). It was also noted that for the small defect condition only the r.m.s levels increased with increasing load. Furthermore, it was observed that r.m.s levels for the large fault condition were relatively lower than defect free and small defect conditions. The latter two had similar r.m.s values. These observations were rather puzzling, as the literature to date had advocated an increase in AE r.m.s/energy with defect size and load.

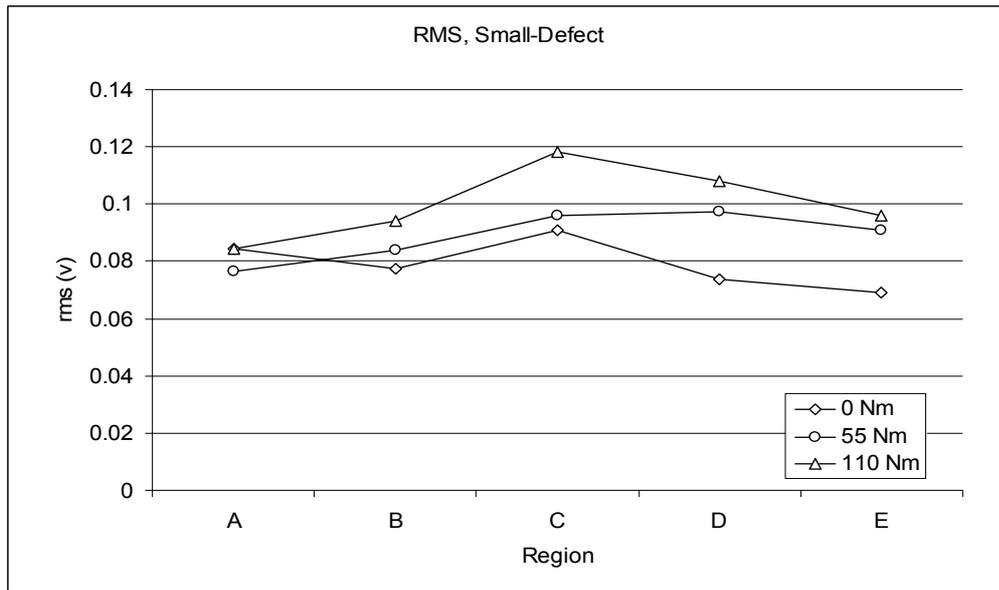
Figure 12 r.m.s. against load for small pitch-line defect condition. (5 regions)

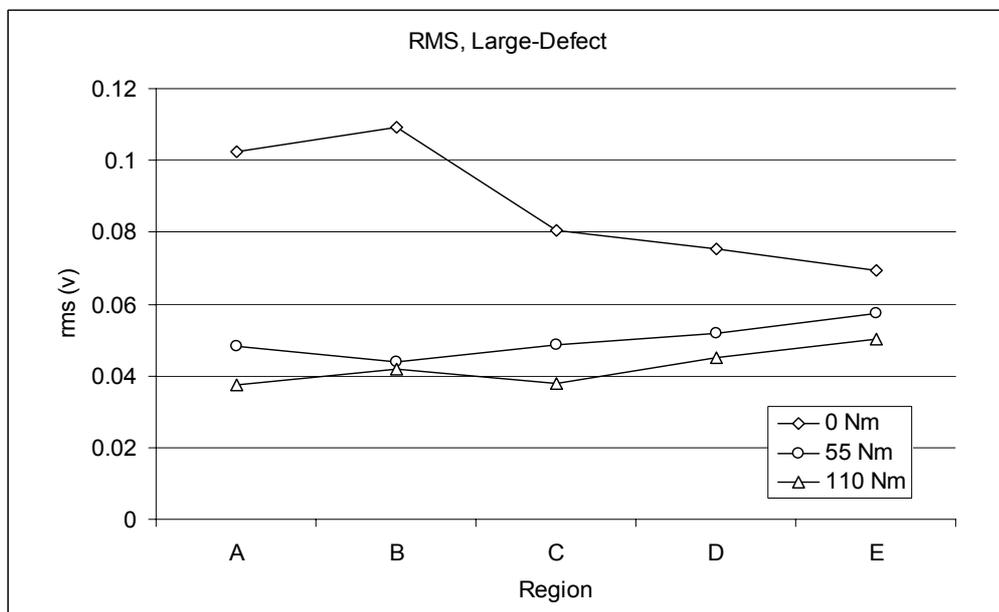
Figure 13 r.m.s against loads for large addendum defect condition. (5 regions)

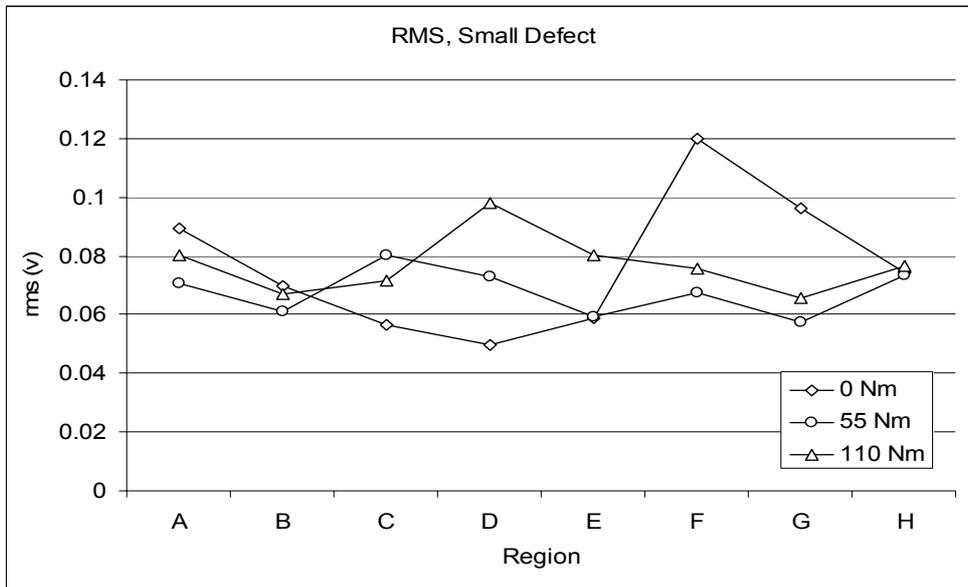
Figure 14 r.m.s against loads for small pitch-line defect condition. (8 regions)

In order to confirm the authenticity of these results recorded AE data was split further into eight and sixteen different regions with each region representing 2-teeth and 1-tooth respectively. This was a similar procedure to that shown in figure 6. The r.m.s. value of each region was computed and plotted against the three load conditions for the small defect condition, see figure 14 and 15. The small defect condition was specially chosen as this showed the most promising results when the teeth were grouped in three's. From figure 14, it was observed that the maximum r.m.s. values did not occur at region D where the seeded defect was located based on a grouping of two teeth. From figure 15 similar observations were noted, the r.m.s. value at the seeded fault tooth, H (based on a single tooth demarcation), was not the highest value. The same observations were noted for the large defect condition. The inconsistency between the single tooth, 2-teeth and 3-teeth analysis revealed that either the AE r.m.s or/and the potential for the AE technique for defect identification was inappropriate. The results would have been conclusive had the r.m.s. levels for the defective tooth been higher than other regions within the acquisition window.

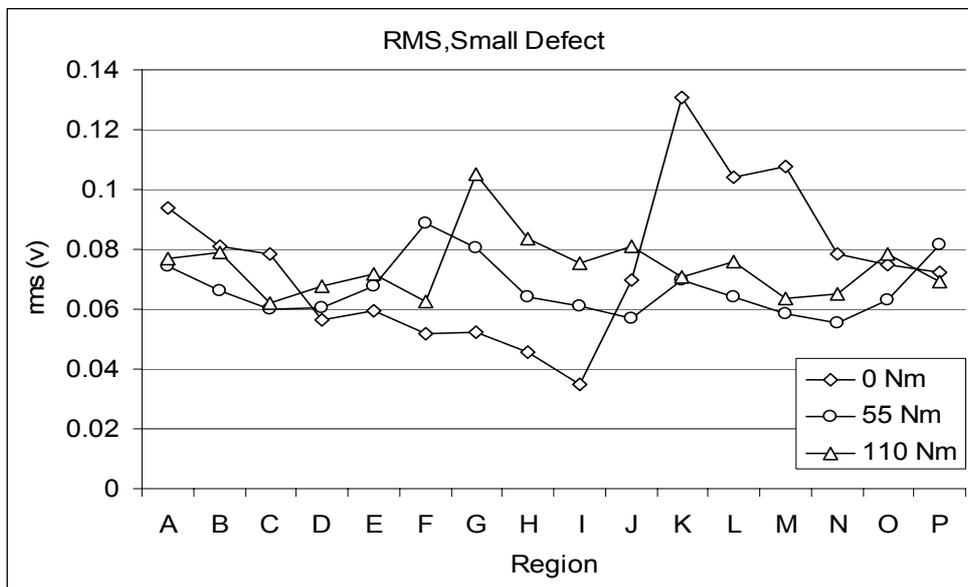
Figure 15 r.m.s against loads for small pitch-line defect condition. (16 regions)

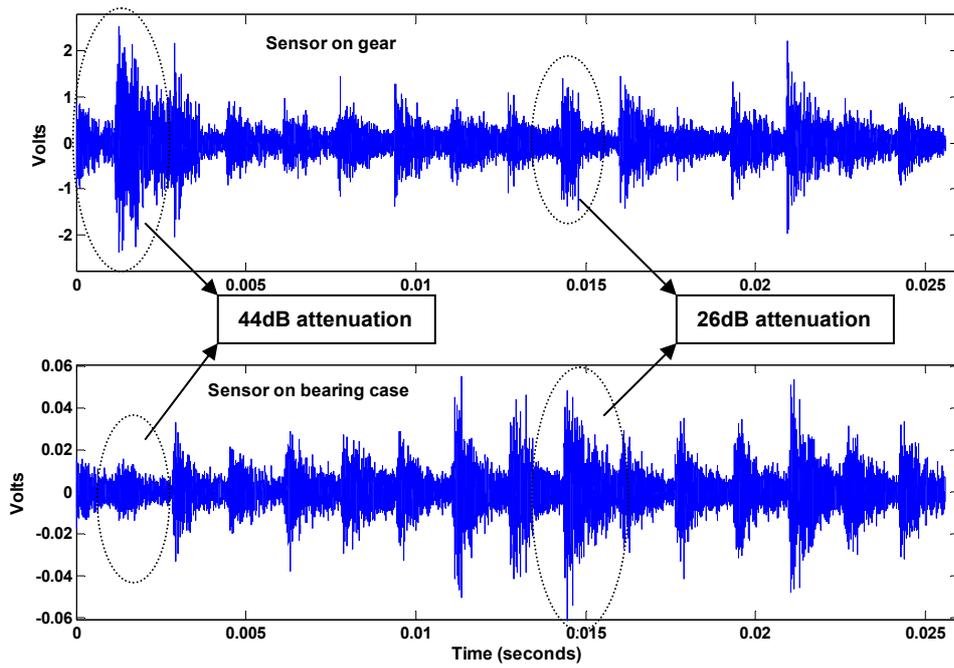
Figure 16 AE bursts detected on pinion sensor were observed on bearing casing sensor, load 55Nm.

During the test, it was noted that the AE bursts relating to the gear mesh, as detected on the sensor fixed onto the pinion, were also observed from the sensor on the bearing casing, see figure 16. However, continuous observations of the AE sensor on the bearing casing showed intermediate loss of the AE bursts associated with the gear mesh. The reason for this is attributed to the position of the bearing ball/roller elements during rotation. It is postulated that when the ball/roller is at bottom dead centre, i.e. directly in the load path, transmission of the AE bursts to the sensor on the bearing casing was achievable and only under this circumstance. As the relative attenuation ranged from 44dB to 26dB (depending on the particular gear mesh AE burst, see figure 16), in addition to the high probability of loss of transmission path through the bearing, see figure 17, the authors see identifying gear defects from the bearing casing as fraught with difficulties, again contrary to other investigators [6,8].

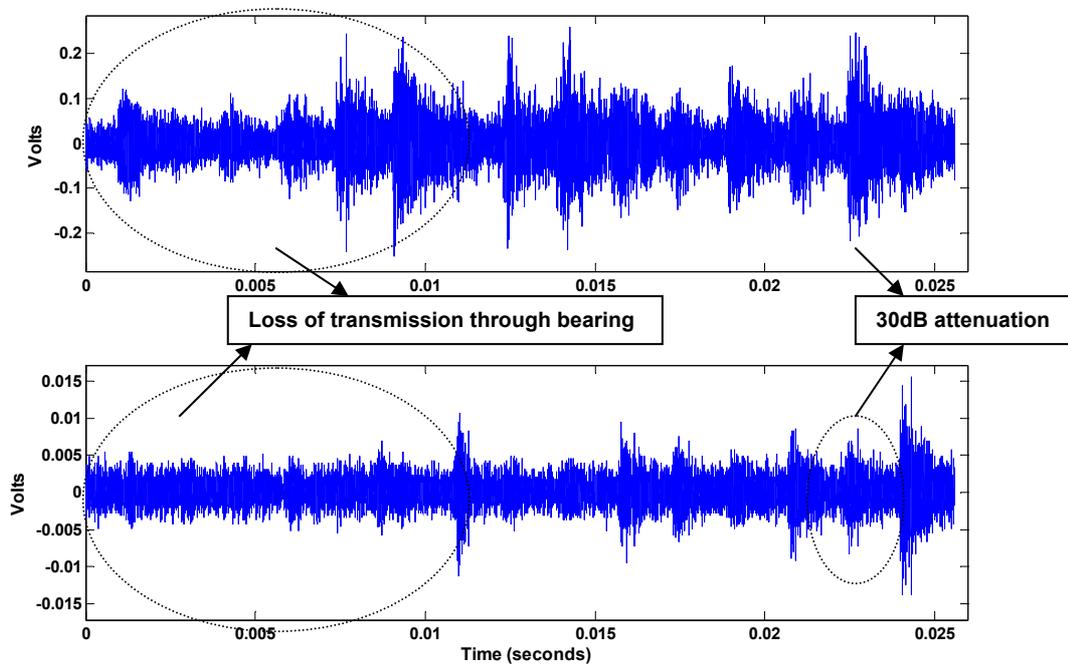
Figure 17 Loss of transmission path at particular gear mesh positions observed on bearing casing sensor, load 55Nm.

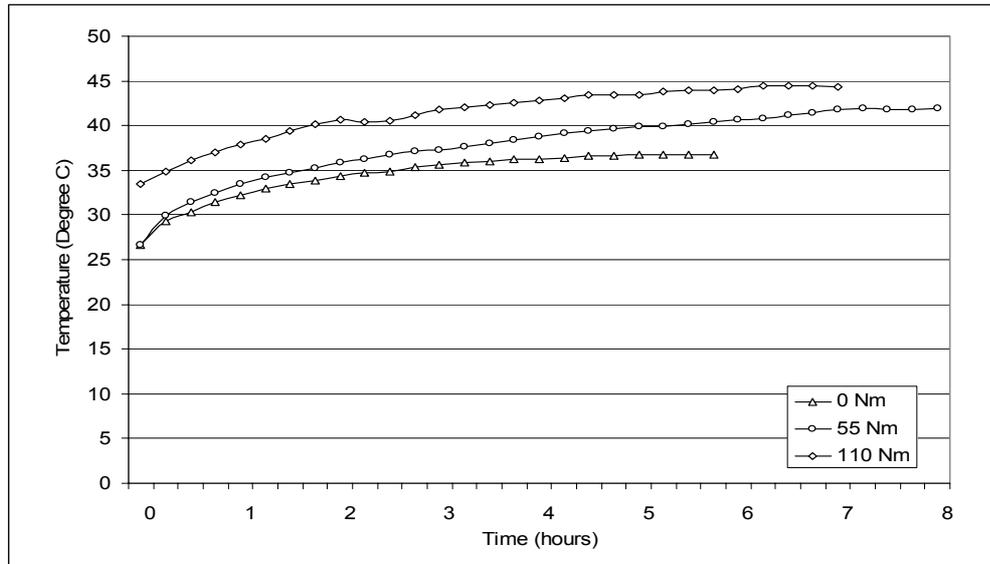
Figure 18 Oil temperatures monitoring with no-load, 55 Nm-load and 110 Nm-load conditions.

Figure 18 illustrates that the gearbox system only reached a stabilised temperature after at least 5 hours of continuous running. The starting point for all three test conditions investigated was dependent on the ambient temperature prior to testing. From figures 19 to 21, it was noted that the AE r.m.s varied with time as the gear box reached a stabilised temperature. This implied that depending on what time the AE data was captured for a given speed and load condition, the variation in AE activity r.ms could be as much as 33%. For these particular tests the point at which the data was captured is highlighted in figures 19 to 21. Thus, the AE signals captured during seeded defect tests were ‘snapshots’ that are largely influenced by load, oil temperature and system dynamics. As ‘snapshots’ only provide information at an instant in time, the consistencies of the derived AE parameters will be subject to considerable variation. The influence of load and oil temperature on AE activity is directly linked to the oil film thickness between the meshing gears. The oil film thickness will influence the rate of wear and asperity deformation, both of which generate the AE activity. Therefore, it is important to determine and establish when the AE signal should be recorded for usage on comparative defect analysis.

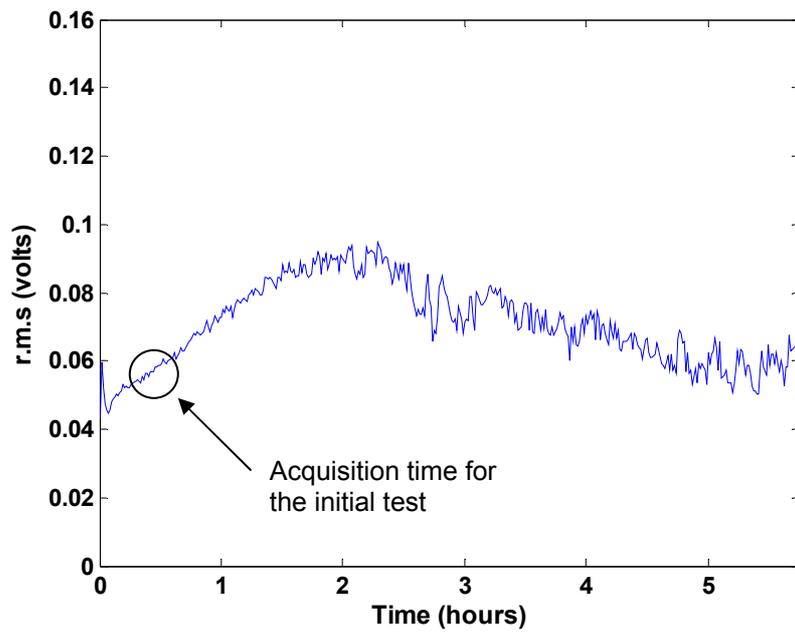
Figure 19 Continuous AE r.m.s values for no-load condition.

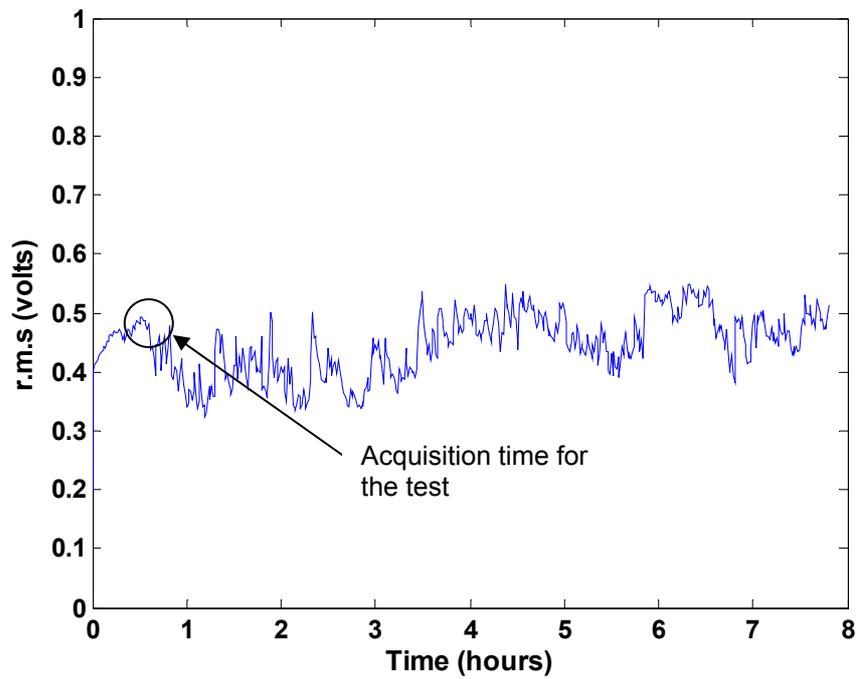
Figure 20 Continuous AE r.m.s values for 55Nm load condition.

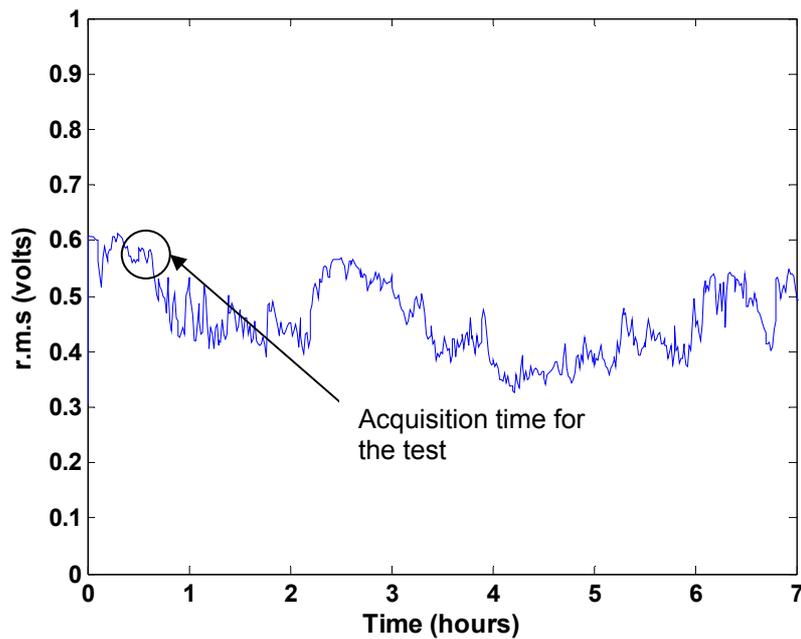
Figure 21 Continuous AE r.m.s values for 110Nm load condition.

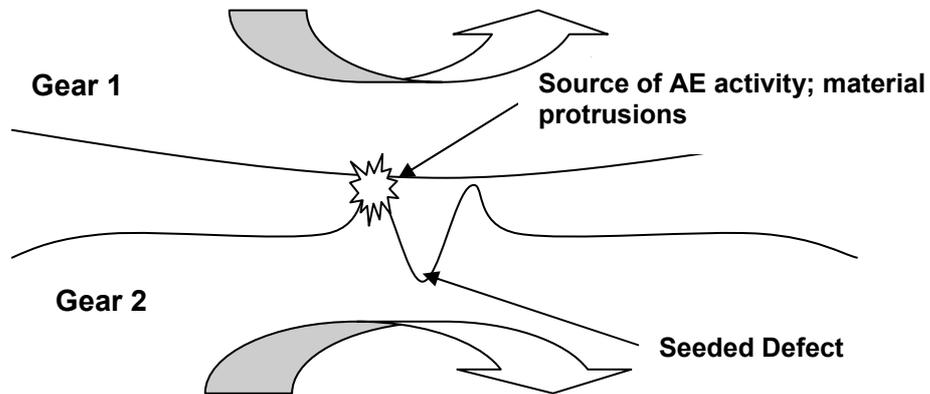
Figure 22 Mounds or Protrusions of the gear surfaces in contact during rotation

Taking cognisance of the fact that AE activity is generated during the sliding and rolling of the gears, principally due to asperity contacts, the introduction of a seeded defect which removes surface material digresses from the basic source of AE generation. Therefore the authors argue that identification of seeded defects of this nature cannot be accomplished with the AE technique. This statement will hold true if the seeded defect involved the removal of material from the surface. However, other authors [8, 10, 11] have claimed success and it is argued that the most likely reason for this is as follows: It is highly possible that in the process of material removal from the gear face ‘mounds’ or ‘protrusions’ will be formed at the boundaries of the seeded defect, see figure 22. These are created due to the displacement of material from the region of material removal. The authors postulate that it is these ‘protrusions’ that were responsible for AE activity. However, this activity will only last until the ‘protrusions’ are flattened during the operation of the gear, see figure 23. In the latter instance, AE will be generated by

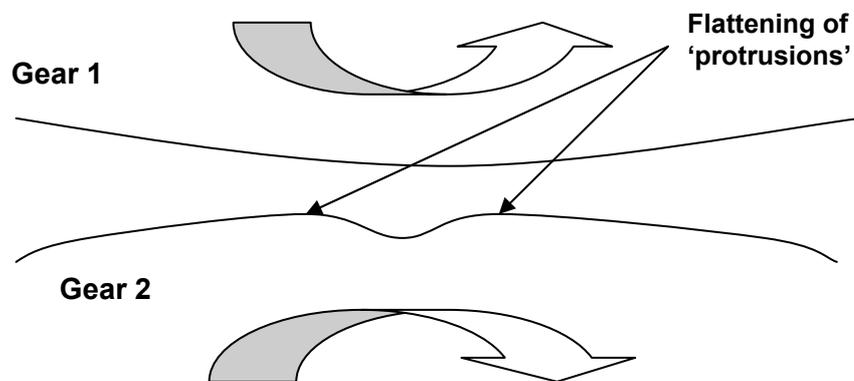
Figure 23 Flattened protrusions of gear surfaces.
