Zeolite Degradation: An Investigation of CO₂ Capacity Loss of 13x Sorbent

System testing of the Carbon Dioxide Removal and Compression System (CRCS) has revealed that sufficient CO₂ removal capability was not achieved with the designed system. Subsystem component analysis of the zeolite bed revealed that the sorbent material suffered significant degradation and CO₂ loading capacity loss. In an effort to find the root cause of this degradation, various factors were investigated to try to reproduce the observed performance loss. These factors included contamination by vacuum pump oil, o-ring vacuum grease, loading/unloading procedures, and operations. This paper details the experiments that were performed and their results. From the experimentation performed, a definitive cause of failure could not be determined, and a more detailed zeolite failure analysis will need to be conducted.

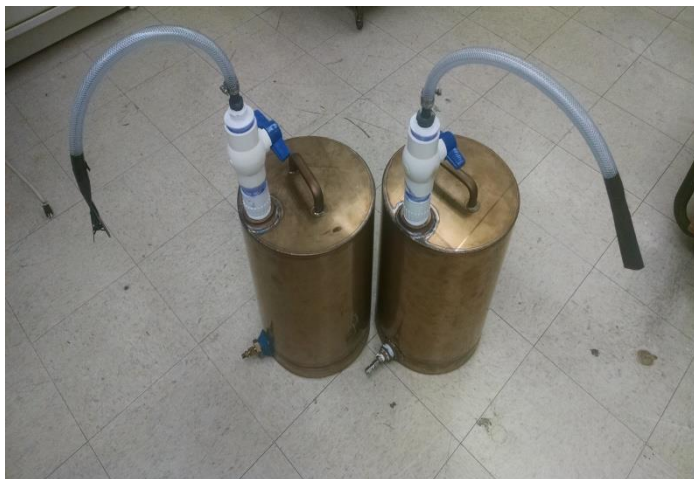
Figure 1: Custom CRCS Bakeout Canisters. These canisters were designed to aid in activating the CRCS sorbent material.

Upon testing of the CRCS, it was found that the Stage 1 mechanical valve seals were prone to failure due to the high operative temperature (280°C) and the nature of their design. Over the period of 8 months in FY2016, the CRCS was disassembled 3 times due to mechanical valve seal failures; each time the sorbent was removed, baked out in an external oven, and reloaded into the CRCS. Data collected with the fully integrated system showed that CO₂ breakthrough occurred much faster than expected in the Stage 1 beds. At first, it was suspected that the beds were not properly baked out during initial regeneration, so measures were taken to improve the initial bakeout and loading procedure. Custom made bakeout canisters (see Figure 1) were manufactured and sorbent was regenerated in a large oven held at 350°C with N₂ purge gas for over 20 hours. In an attempt to load the sorbent into the CRCS

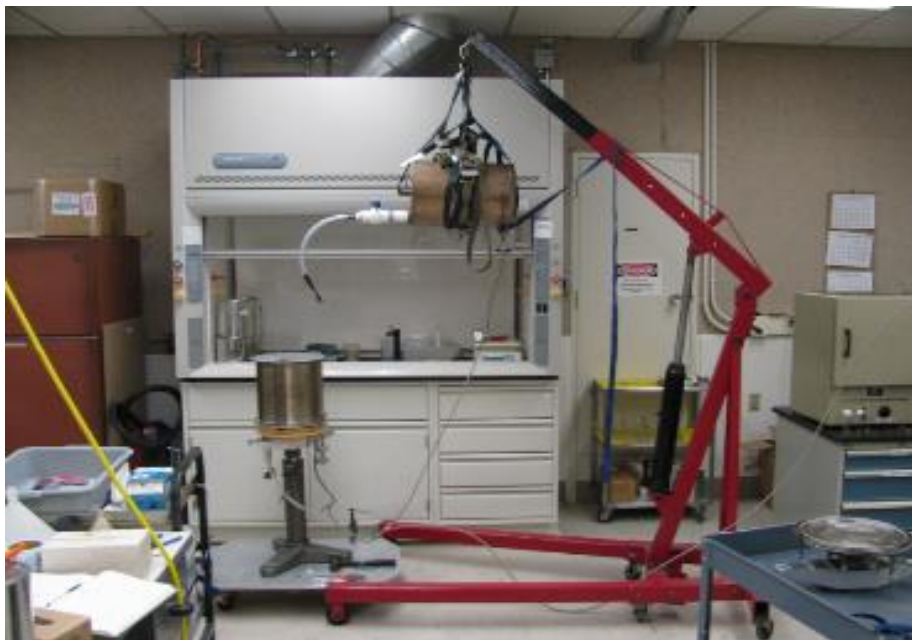
Figure 2. CRCS sorbent loading process. Bakeout canisters hoisted up by crane and manually tilted to pour sorbent. N₂ gas purge flow through bottom of CRCS and bakeout canister.

units as cleanly as possible, purge N₂ gas was flowed through the empty Stage 1 canisters before and during the loading of sorbent (Figure 2). The canisters were closed and sealed as quickly as possible with the combined experiences of multiple repetitions and improvements to the take-down and reload of the CRCS canisters, and in-line integrated bakeout was performed with the regeneration heater coils. Even with the extensive loading procedure improvements, CO₂ breakthrough still occurred faster than expected. At this point, an adsorption capacity isothermal analysis was run on the Stage 1 sorbent and revealed that the sorbent was severely degraded and could only adsorb at 25% of the capacity of fresh sorbent at 2 Torr ppCO₂ (approximately 0.3 kPa ppCO₂, or 2600 ppmCO₂ at 1 atm). This degraded performance was repeatable between four samples drawn from different locations inside the Stage 1 bed. The degradation seemed to be pervasive throughout the Stage 1 beds.

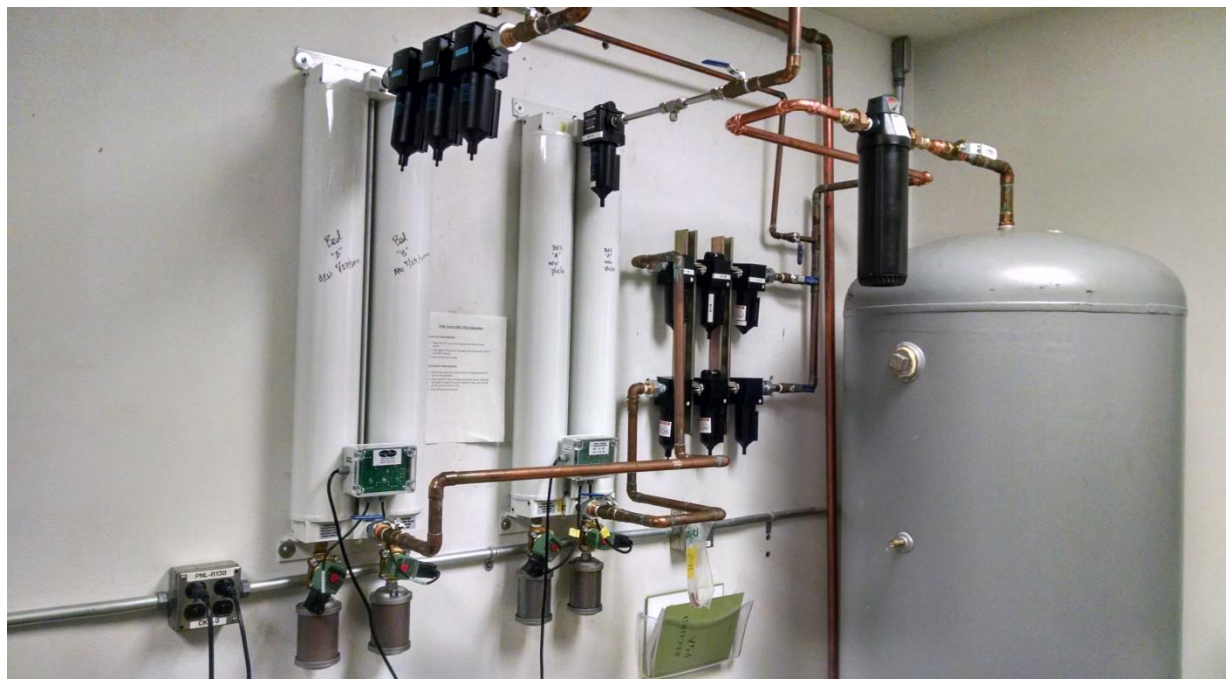
Figure 3: Pressure Swing Adsorption Beds. Twin Towers® pressure swing bed air filtration system provides compressed air to the laboratory.

Another candidate for contamination was the lab air source that was augmented with k-bottle CO₂ to provide the Stage 1 input flow. This air source was provided by a high output compressor that went through various oil filters, including a Pressure Swing Adsorption (PSA) system, see Figure 3. It was thought that perhaps hydrocarbons had made it through the filtration and contaminated the Stage 1 sorbent. Another potential cause of degradation explored was the CRCS unloading and loading procedure. In order to unload the Stage 1 canisters, sorbent was vacuumed out and captured in a large flask, shown in Figure 4. During this vacuum unloading, it was

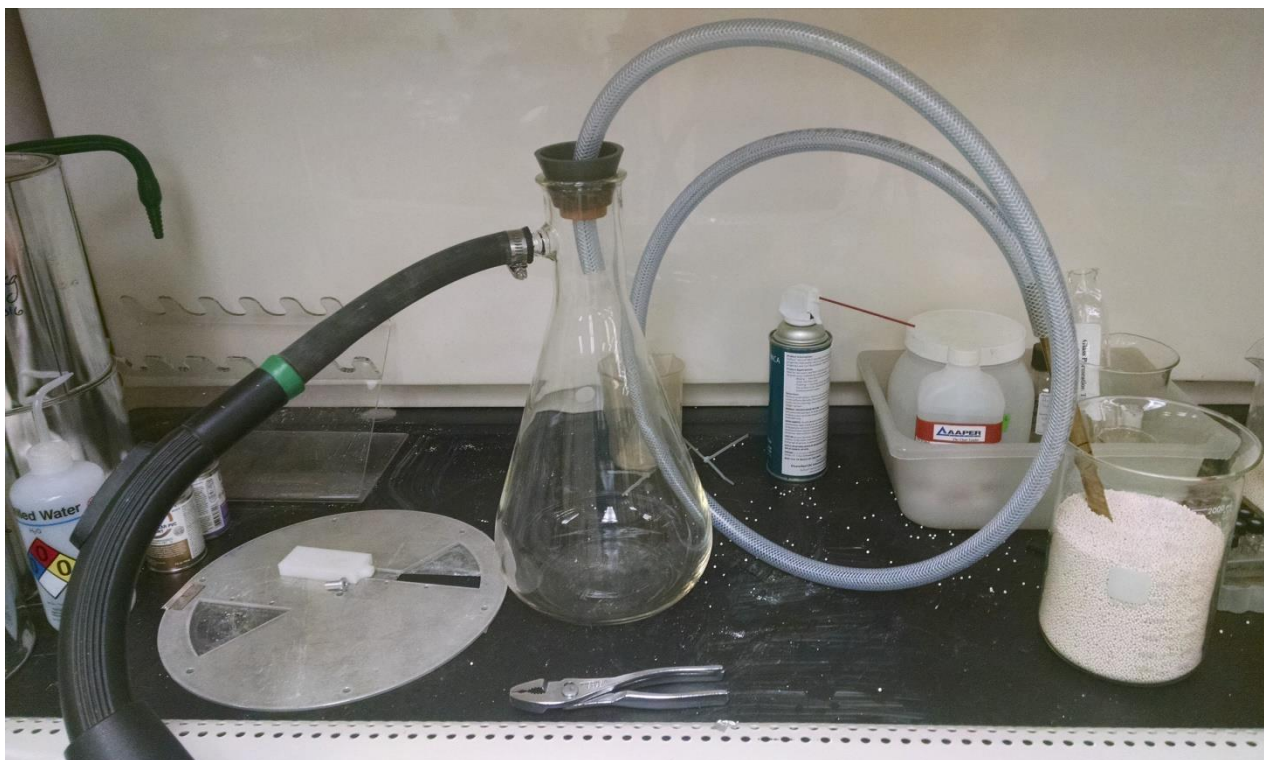
Figure 4: CRCS sorbent unloading system. This flask was used to unload the CRCS Stage 1 and Stage 2 sorbents. The vacuum hose attaches to the flask via the black hose on the left and the hose attached to the top of the flask is used to suck the sorbent out of the CRCS.

observed that the zeolite expelled copious amounts of dust, and it was hypothesized that perhaps the mechanical shock of the unloading procedure somehow could affect the sorbent capacity. It was also a consideration that perhaps the CRCS in-line bakeout was ramped too fast and possibly degraded the sorbent structure. A series of experiments were devised to determine the cause of sorbent failure.

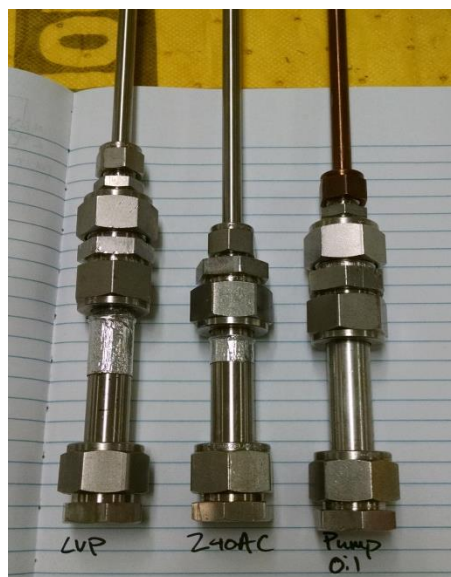
Figure 5: Chemical contamination cells. These cells are filled with Stage 1 sorbent and suspected contaminants – Krytox LVP, 240AC, and Edwards Ultra Grade 19 vacuum pump oil.

vacuum pump oil was dripped into it on top of the sorbent. To apply the two vacuum greases, Krytox LVP and 240AC, a cotton swab was used to apply a generous coating of grease to the inside of empty ½” SS tube sample cells and then sorbent was poured in. See Figure 5. To test the theory of PSA hydrocarbon contamination, a ½” SS tube sample cell was filled with sorbent and placed in a constant flow of PSA air for approximately 120 hours. All experimental samples (and control) were then placed in an oven and baked out a 300°C for 12 hours to simulate the in-line bakeout procedure of the CRCS.

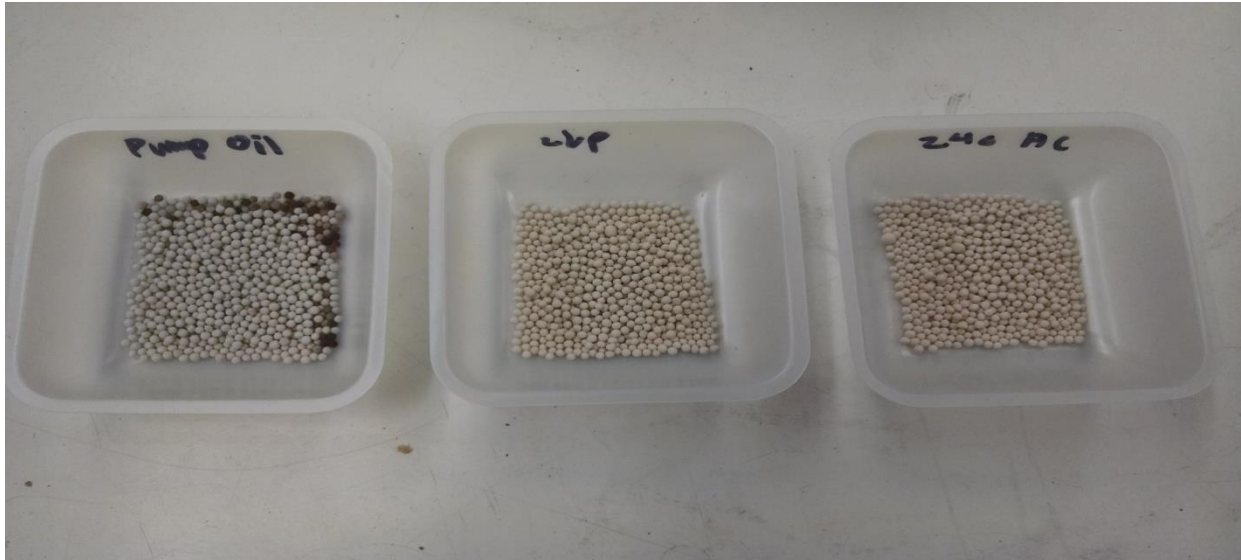
Figure 6: Chemical contamination samples after 12h 300°C bakeout. The pump oil sample shows visible greying, with some of the beads turning very dark in comparison with the LVP and 240AC samples, which did not show significant visible changes from prior to bakeout.

After the LVP, 240AC, and vacuum pump oil contamination cells were baked out at 300°C for 12 hours to simulate the CRCS in-line bakeout process, the pump oil sample showed a visible difference from rest of the samples (Figure 6). The pump oil sample seemed to be much greyer overall, with a few beads showing significant discoloration. The LVP and 240AC exposed samples did not show more discoloration than the control sample. The PSA exposed sample also did not show any visible differences from the Control sample. Upon vacuum activation on the ASAP 2020 at 350°C, the samples showed very interesting developments. Typically the ASAP activated 13X samples develop some light speckling, but the LVP and 240AC contaminated samples showed very pronounced dark speckling (Figure 7). In fact, the sample contaminated with pump oil seemed to show the least change from its pre-activated visible state. All samples followed the same activation procedure: exposure to <10mTorr (1.3 Pa) vacuum, ramp at 3°C/min to 110°C, hold for 5 hours, ramp at 5°C/min to 350°C, hold for 6 hours.

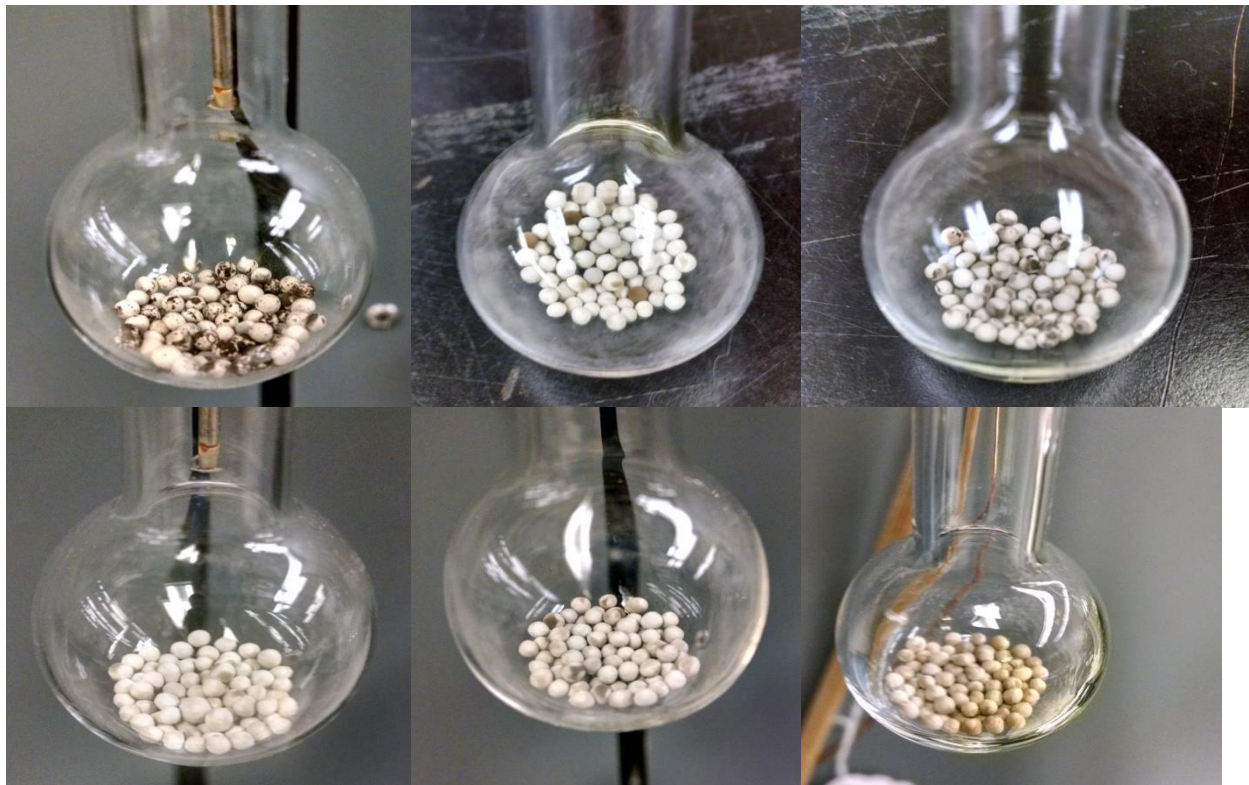
Figure 7: ASAP-activated, chemically contaminated samples. The 240AC and LVP samples developed very dark speckling compared to the Control sample. The PSA sample and the CRCS Stage 1 sample that was loaded in August show very similar speckling that is typical of 13X materials after ASAP activation at 350°C.

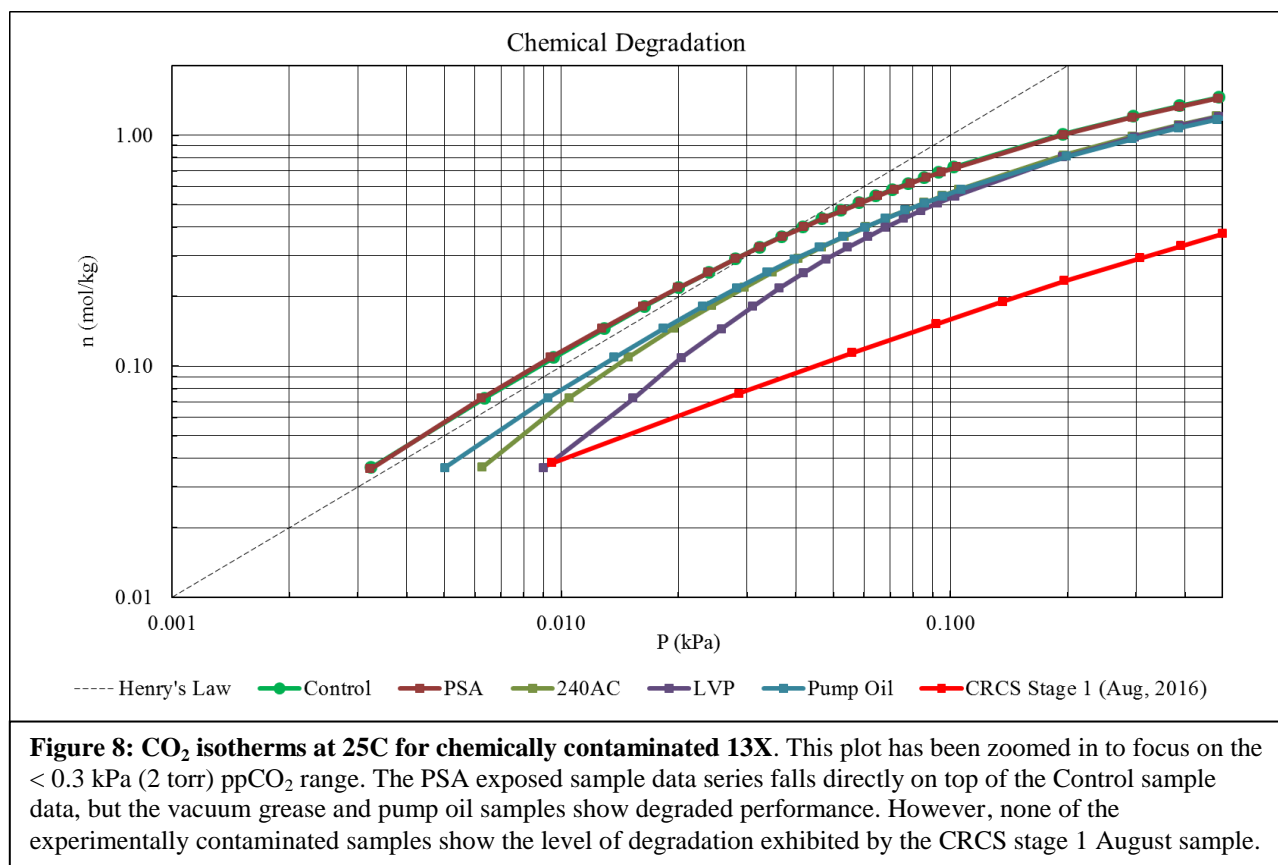
All CO₂ isotherm analysis tests were performed on the ASAP 2020 using the same method and pressure table. Isotherm results are shown in Figure 8. As expected, the chemically contaminated samples (pump oil, LVP, and 240AC) all showed lower adsorption capacity compared to the Control sample. The PSA exposed sample was nearly identical in CO₂ capacity as the Control.

At the 0.3 kPa ppCO₂ loading level, the LVP, 240AC, and pump oil contaminated samples showed about 18%-20% less capacity than the PSA and Control samples. It was also noted that the < 0.1 kPa ranges varied slightly between the three different contaminated samples. This type of fanning was observed in samples that had not been properly activated on the ASAP 2020, and seem to indicate minor pre-loading in the Henry’s Law region of pressure for 13X. In comparison, the PSA and Control isotherms show very agreeable measurements and follow the Henry’s Law slope very closely. Even though the experimentally contaminated samples showed some decreased loading capacity compared to the Control, the level of degradation was not nearly as severe as was observed in the CRCS Stage 1 sample that was taken at the time of loading the CRCS for the final time. The experimentally contaminated

samples showed about ~20% less adsorption capacity at 0.3 kPa, while the CRCS Stage 1 August 2016 load showed ~75% less adsorption capacity. All isotherm analyses were performed three times.

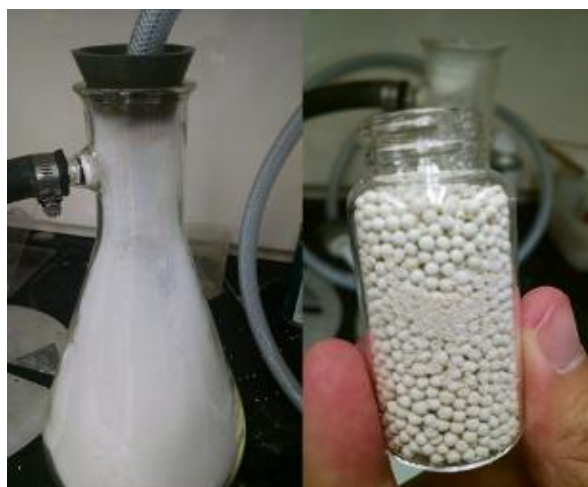
Figure 10. Physical Sorbent Degradation Experiments. The left image was taken during the vacuuming of sorbent from a large beaker into the flask. The zeolite dust coats the inside of the flask, hose, and vacuum line. The right image is a sample removed from the larger volume of sorbent after it has been poured back into a large beaker. Visible chips of sorbent created by the violent nature of the vacuuming process are shown.

showed no degraded performance. The vacuum/bakeout experiment also revealed no conclusive cause of failure. Over the vacuum and bakeout cycles the sorbent dusted and chipped (see Figure 10), but still performed reasonably well in an isotherm analysis.

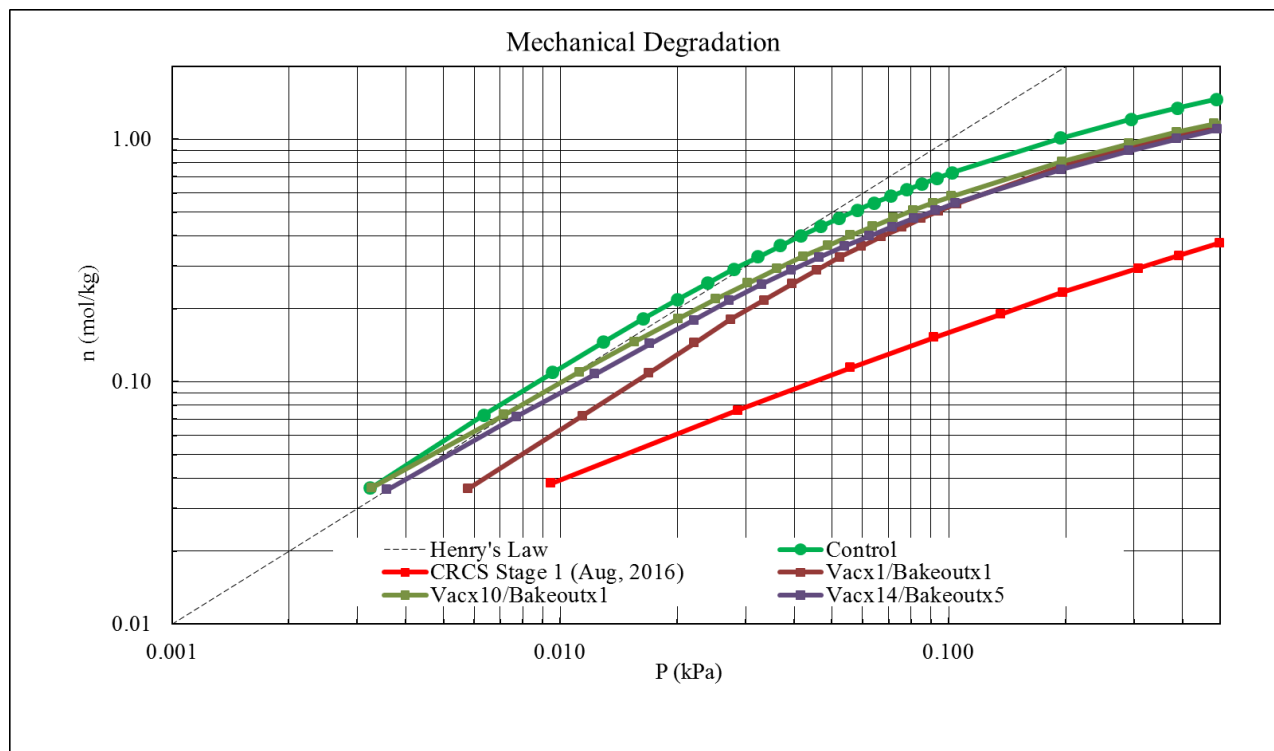
Figure 9: CO₂ isotherms at 25C for Mechanically Degraded 13X. This plot has been zoomed in to focus on the < 0.3 kPa (2 torr) ppCO₂ range. As before, the samples that underwent vacuum and bakeout cycles showed slightly degraded performance compared to the control. However, none of the experimentally degraded samples show the level of capacity loss exhibited by the CRCS stage 1 August sample.

Figure 9 shows the results from the vacuum/bakeout test matrix. The three experimental cases all show slightly lower capacity in comparison with the Control sample, but again, not enough to warrant a definitive conclusion that explains why the CRCS Stage 1 sorbent exhibited such severe degradation. The mechanically degraded samples were prepared on the ASAP 202 in the same way as the chemically degraded samples and the Control sample, and all analyses were repeated three times.
