## EFFECT OF PHOTOCATALYTIC COATINGS ON THE WEATHERING OF ELASTOMERIC ROOFING MEMBRANE

### abstract

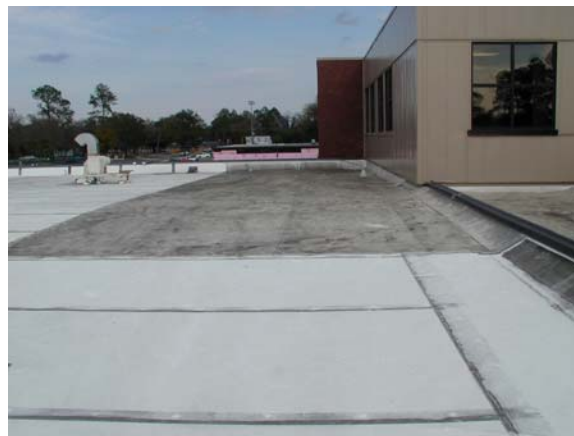
Figure 1. New and Aged Samples of Installed Roofing Membrane.

In Figure 1, newly installed roofing membrane in the foreground contrasts greatly with the same material further back that had been installed a couple years earlier. A typical initial reflectance value for a new installation would be on order of 78-79%. However, once exposed to the elements, most membrane formulations rapidly decay into the 50% range.

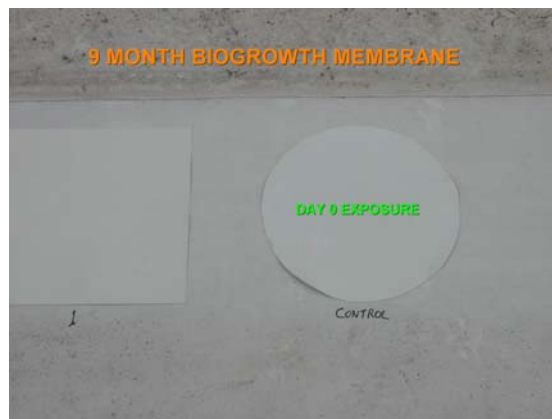
Figure 3. Experimental Installation in Homestead, FL. left: sample with photocatalytic coating; right: control; above: 9 months-aged inoculation membrane.

A variety of photocatalyst formulations were affixed to 929  $\text{cm}^2$  (1.0 square foot) membrane surfaces at a loading of approximately 1  $\text{mg}/\text{cm}^2$ , or 10  $\text{g}/\text{m}^2$ . These samples were taken to Environmental Testing Laboratories in Homestead, Florida, where they were mounted on one of several rooftop test stands. The mountings were done using normal thermoplastic welding, but welded weakly to a dissimilar base membrane. A photograph of test and control samples is shown in Figure 3.
