## WEAR INDUCED HARDENING OF LASER PROCESSED CHROMIUM-CARBON STEEL

H. De Beurs and J. Th. M. De Hosson

Department of Applied Physics, Materials Science Centre,  
University of Groningen,  
Nijenborgh 18, 9747 AG Groningen, The Netherlands

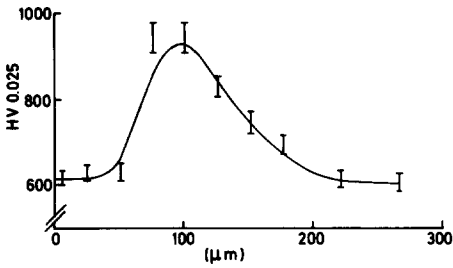
Fig. 3a Hardness profile of a wear track on laser melted chromium steel after 10 000 turns.

Hardness measurements on wear tracks of laser melted chromium steel reveal a wear induced hardening. The hardness is measured across the weartracks with a Vickers hardness tester. A load of 25 grf. is used. In fig. 3a the hardness profile is given after 10000 turns. Fig. 3b shows the wear induced hardnesses of laser treated material as function of turns. An increase in hardness is found from 600 HV up to 900 HV.

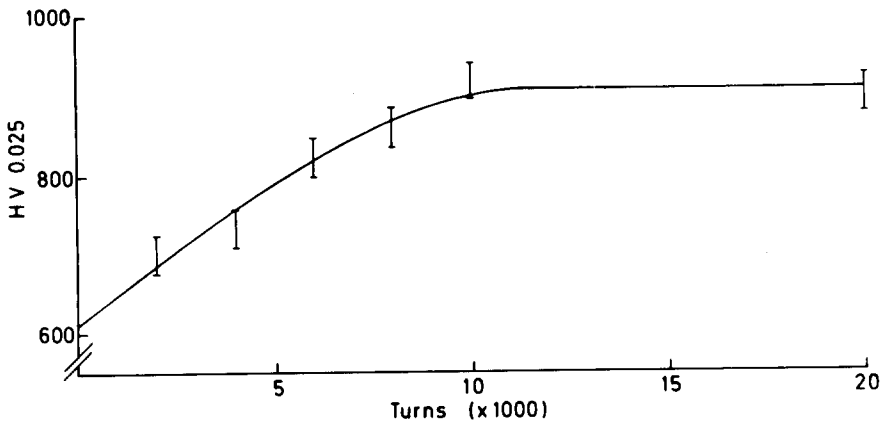
Fig. 3b Wear induced hardening.
