INDOOR AIR QUALITY ASSESSMENT

**Department of Revenue
60 Perseverance Way
Hyannis, MA**

Prepared by:
Massachusetts Department of Public Health
Bureau of Environmental Health
Indoor Air Quality Program
April 2017

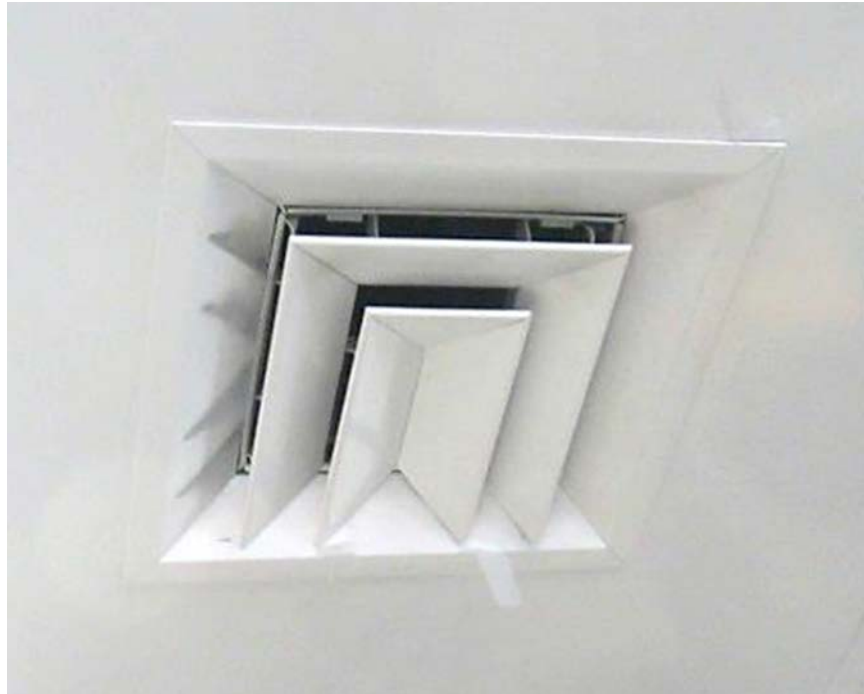
Picture 1

Fresh air is provided by air handling units (AHUs). Air from the AHUs is filtered, heated/cooled, and delivered to rooms via ducted supply vents (Picture 1). Air is returned/exhausted through exhaust grills (Picture 2). Some thermostats examined were operating in fan “auto” mode (Picture 3) which only supplies fresh air when the temperature needs adjustment. It is recommended that during occupied periods, the HVAC system be operated with the fan “on.” Also note from Picture 3 that some thermostats were set to an incorrect time; the correct time is necessary so that temperature and fan settings can be adjusted for occupied versus unoccupied periods to increase comfort and reduce energy use.

Personal fans were observed in a number of areas. Fan blades to some of these units had settled dust, which can be reaerosolized when the fan is activated. Some supply vents were also dusty (Picture 1).

Supply vent

18. Clean the blades of personal fans, supply, and exhaust vents periodically to avoid aerosolizing dusts.
19. Refer to resource manual and other related IAQ documents located on the MDPH's website for further building-wide evaluations and advice on maintaining public buildings. These documents are available at: <http://mass.gov/dph/iaq>.

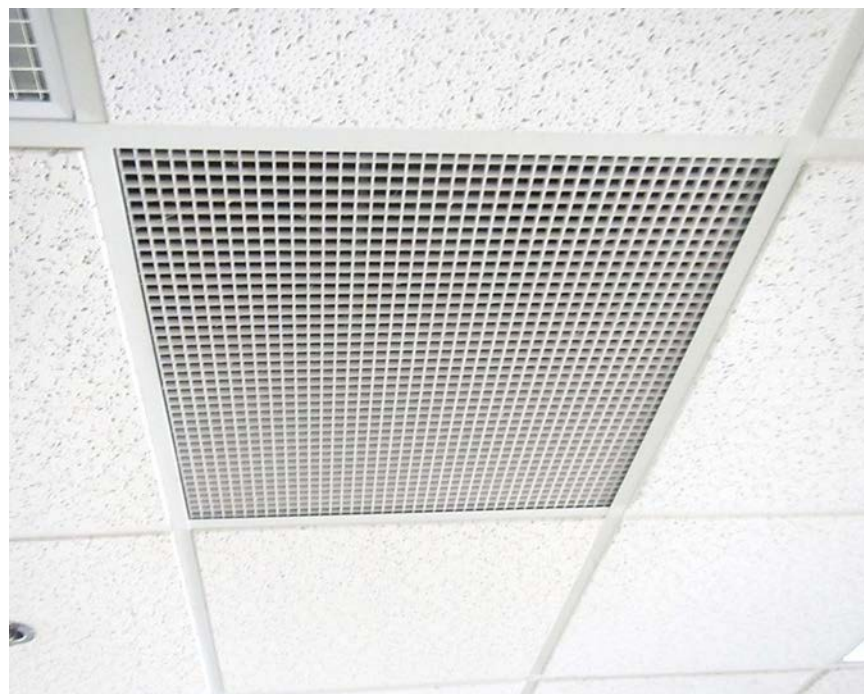
Picture 2

Exhaust grill

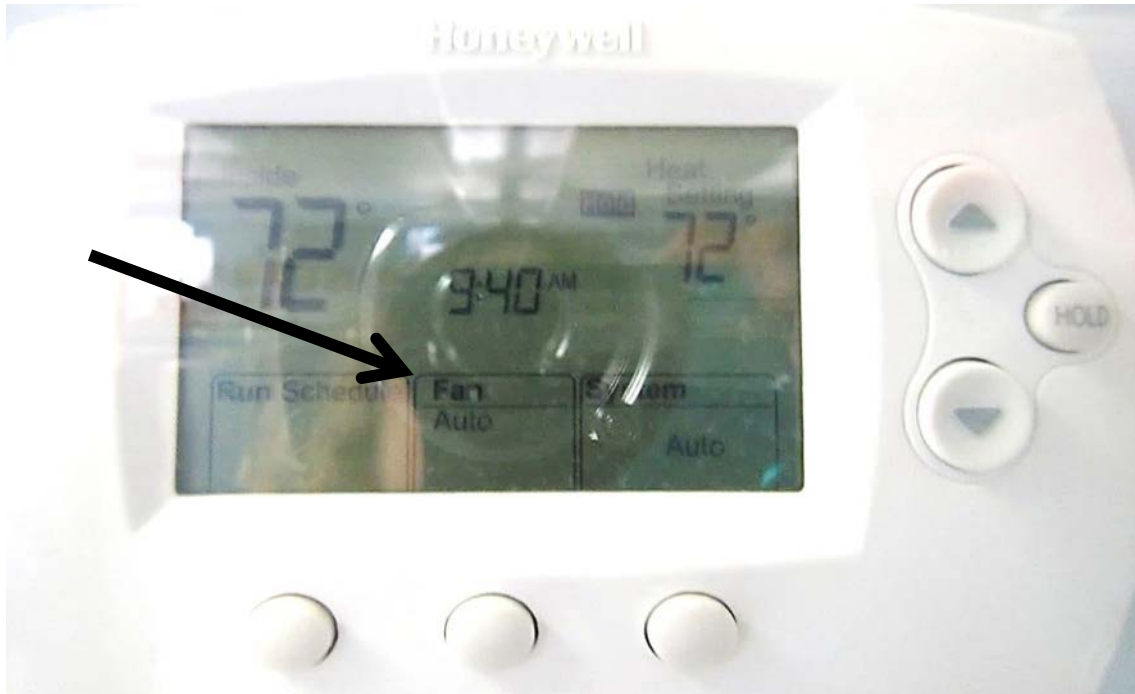
Picture 3

Thermostat showing fan in “auto” mode (arrow) and incorrect time

1. Operate supply and exhaust ventilation in all areas during occupied periods. Ensure that thermostats have the correct time to allow for adjustments for occupied versus unoccupied periods.

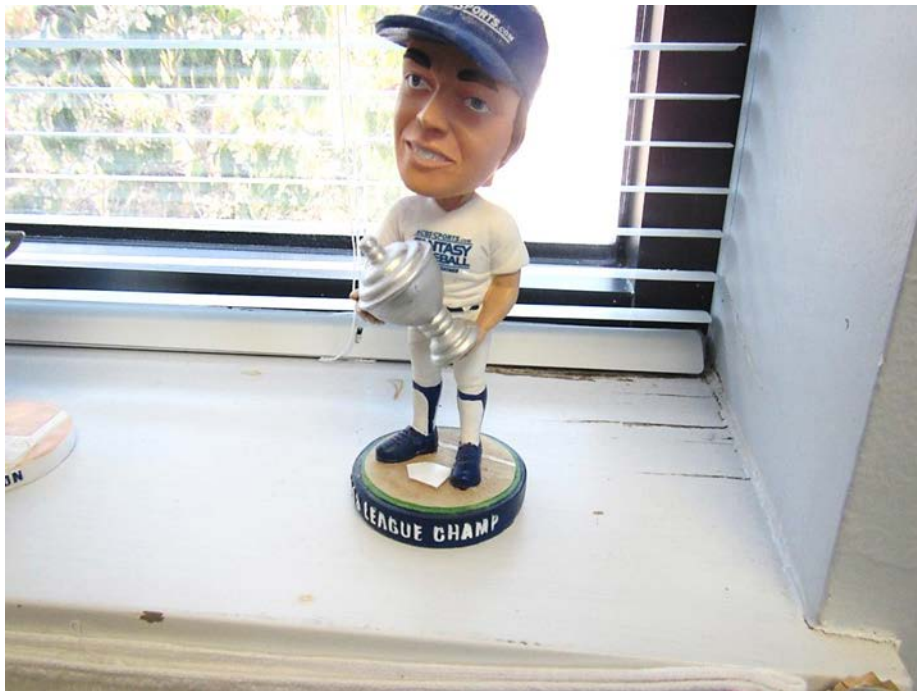
Picture 4

Window leaks had been reported previously in this building, which had reportedly been repaired. A water-damaged windowsill was observed in one office (Picture 4). A few water-damaged ceiling tiles were observed in the Child Support area (Picture 5). These are a result of plumbing or building envelope leaks that should be repaired, and the tiles should be replaced. Work to seal the brick/block façade was being conducted at the time of the visit; this is expected to further reduce water penetration.

Water-damaged windowsill

6. Repair water-damaged windowsill.
7. Replace water-damaged ceiling tiles.
8. Remove coving in sprinkler/janitorial closet and clean the wallboard. If wallboard cannot be cleaned, remove to at least a foot above the floor in the area of the stains and replace, or leave open. Avoid storing porous items in this area.

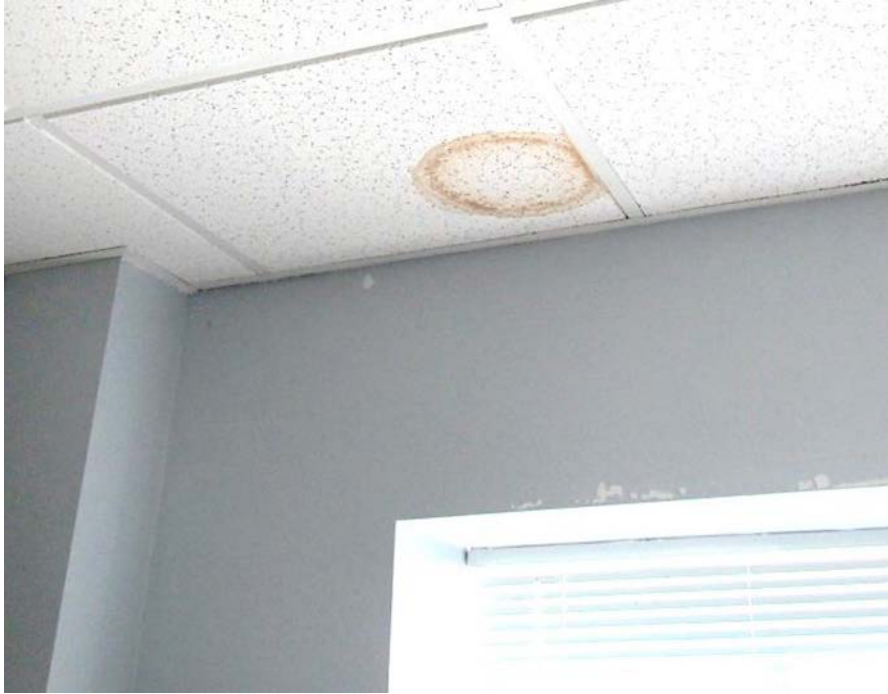
Picture 5

Water-damaged ceiling tile

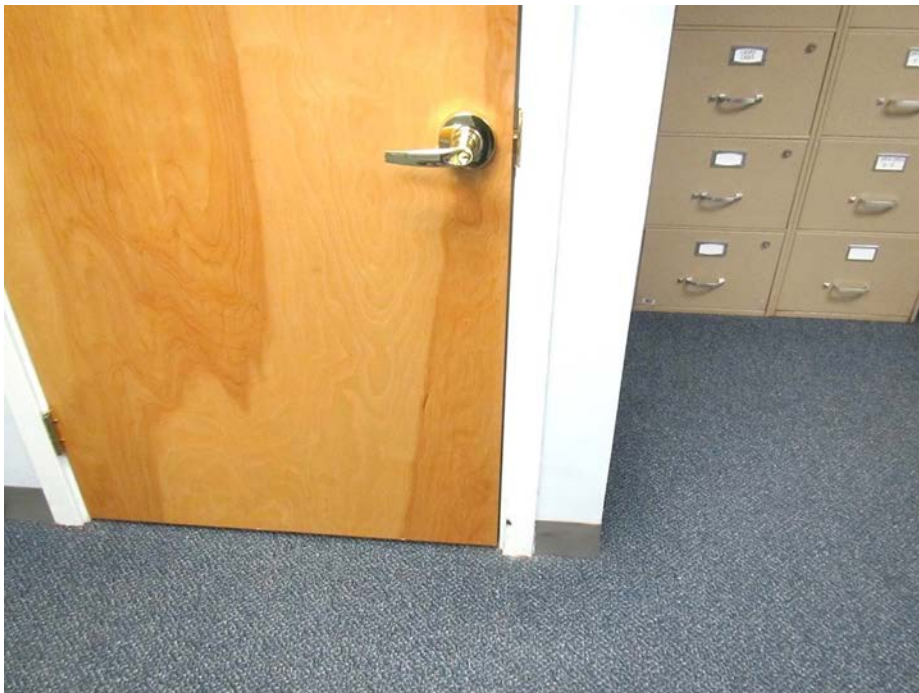
Picture 6

The sprinkler/janitorial closet opens into an occupied area (Picture 6). Some water-damaged materials were present along the bottom edge of the wall inside that closet. The coving at the base of this wall peeled away easily, indicating that it had been wet in the past (Picture 7). The dark staining likely indicates microbial growth. This water damage may be the result of condensation on the sprinkler pipes, or moisture penetrating from outside. All coving should be removed in this area to prevent the build-up of moisture in the wall material and the wall should be cleaned, if possible. If the staining penetrates the wallboard, it should be cut to a level of at least one foot above the floor and either replaced or left as-is to prevent future damage. Porous items should not be stored in this area.

Door to sprinkler closet

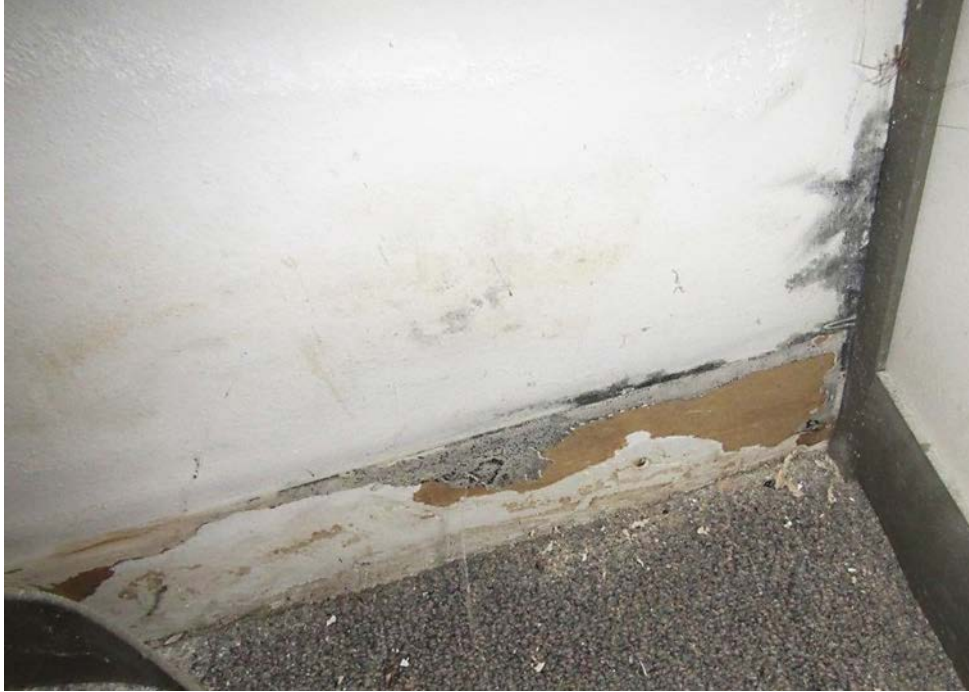
Picture 7

Water-damaged/mold stained wall and removable coving indicating past moisture

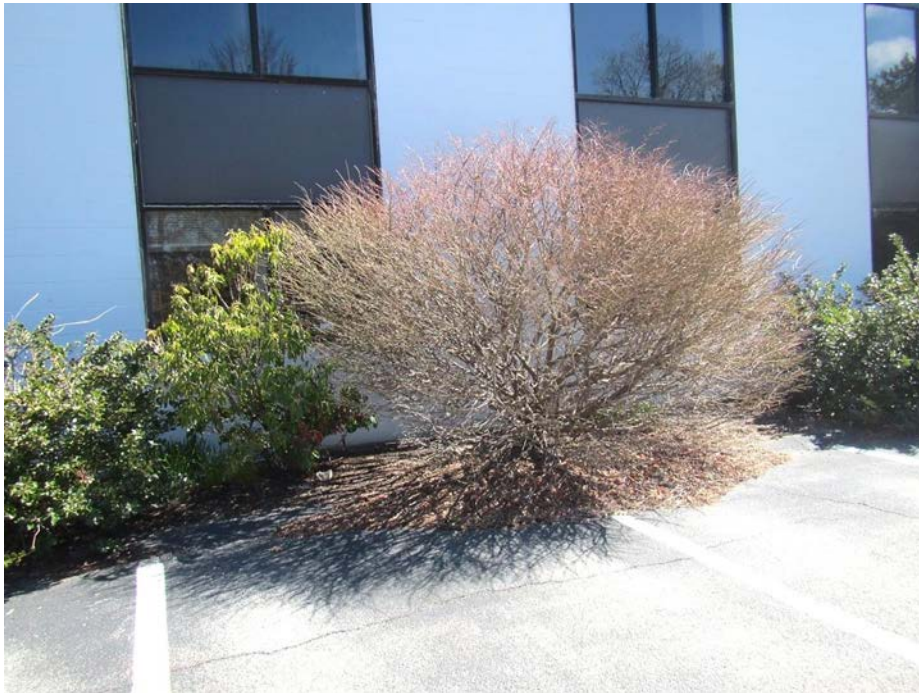
Picture 8

Plants were observed close to the foundation (Picture 8). Plants along the edges of the foundation can prevent walls from drying and lead to drainage problems/deterioration of the building envelope. When near air intakes, they can also be a source of odors, pollen and debris to the inside of the building.

Plants in contact with foundation

9. Remove plants from close to the foundation outside the building.
10. Keep indoor plants in good condition, avoid overwatering, and avoid placing them on porous items such as carpets or paper. Also, keep plants out of the air stream of supply vents.

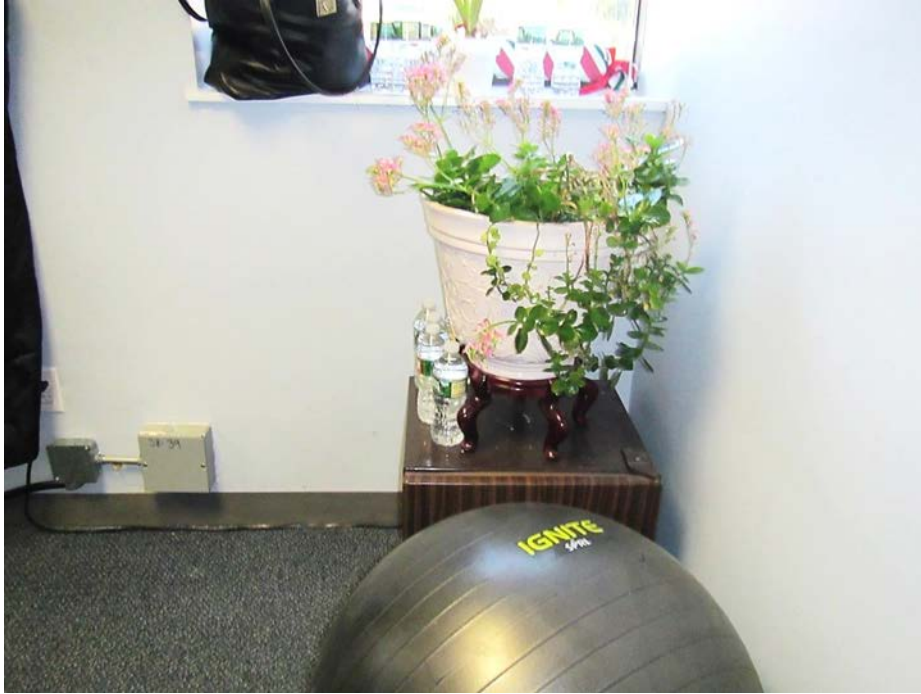
Picture 9

Plants were observed in office areas (Table 1; Picture 9). Plants can be a source of pollen and mold, which can be respiratory irritants to some individuals. Plants should be properly maintained and equipped with drip pans to prevent water damage to porous materials. Plants

should also be located away from air diffusers to prevent the aerosolization of dirt, pollen, and mold.

Small refrigerators and water dispensers were observed in carpeted areas (Table 1; Picture 9). These appliances may spill or leak and lead to carpet damage and microbial growth. It is recommended that these appliances be located in areas without carpeting or on waterproof mats. Carpet squares could also be replaced with tile in areas where water dispensers and refrigerators are located. Refrigerators should be kept clean to prevent odors and microbial growth.

Plant in office, also note refrigerator on carpeted floor

12. Consider locating refrigerators and water dispensers in non-carpeted areas or place on a waterproof mat. Clean refrigerators out regularly to avoid odors and microbial growth.

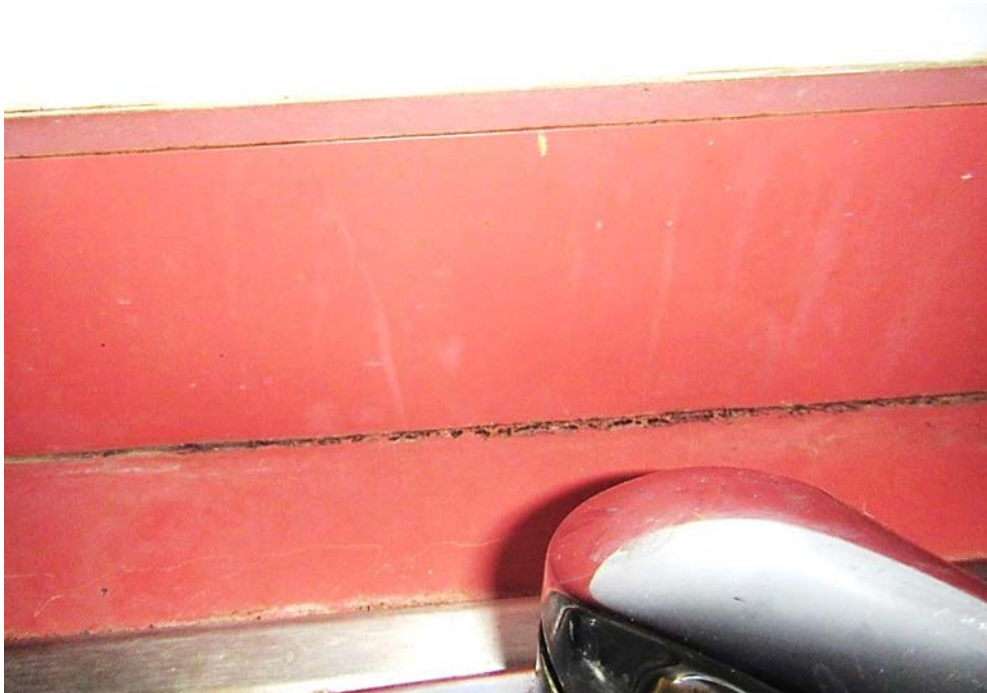
Picture 10

The backsplash of the sink in the kitchen area had an unsealed space (Picture 10) which can lead to water damage of materials, including mold. The dark staining may indicate that microbial growth has occurred. This backsplash should be thoroughly cleaned and resealed with a water-resistance sealing compound or replaced with a one-piece backsplash with no gap.

Open and stained backsplash at kitchen sink

11. Clean and repair or replace the backsplash for the kitchen sink.
