## Lunar Reconnaissance Orbiter: Lessons Learned

## Contamination and Coatings Team

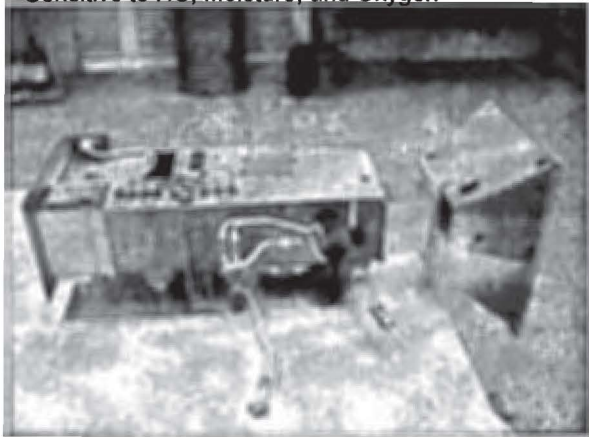
**LAMP Requirements**

Lyman-Alpha Instrument with most contamination critical requirements: Internal Surface Cleanliness 400 A/20  
Sensitive to HC, Moisture, and Oxygen

- LAMP internal molecular requirements were exceeded upon delivery to GSFC. NVR swab yielded Level C.
- LAMP chose to not re-clean their instrument and take the risk because internal witness plates performed at expected levels.
- LL: Ensure risks are discussed and agreed upon with other teams prior to Integration

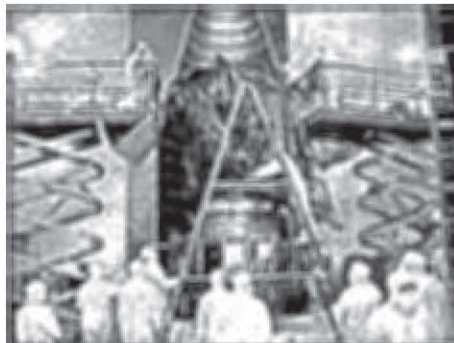
- Bag removal prior to encapsulation was performed in the middle of the night to limit the exposure of the observatory to contaminants
  - Removal of the bag was again challenging due to the stack of two payloads
  - Access was very limited due to risk of contact with either payload or the stand on which the fairing would be placed
- Scheme was designed again using parachute cord to lift the bag vertically off the spacecraft
- There were many meetings to address concerns about removing the bag with the limitations
- Bag removal occurred with minimal difficulties in less than 1 hour

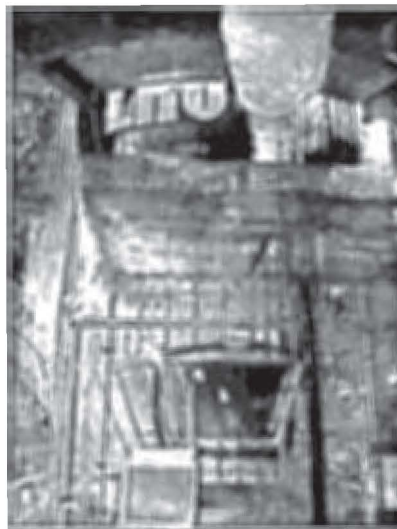
Boatail Door Clean Tent

- LL: The operation of these tents exceeded expectations and enabled the protection of the contamination sensitivities required by LRO
  - Future use of this design is recommended where contamination sensitivity is required
  - These tents exceeded all expectations on cleanliness operations
  - Provision for clean room garment use for these tents should be clearly worked out prior to operations

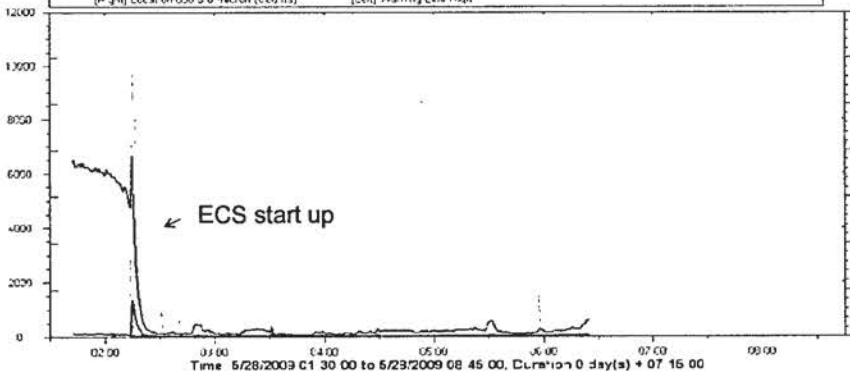
### Actual Transport

[Left] Location 000 0.3 micron (Counts)	[Left] Location 000 0.5 micron (Counts)	[Left] Location 000 1.0 micron (Counts)
[Left] Location 000 10.0 micron (Counts)	[Left] Location 000 3.0 micron (Counts)	[Left] Location 000 5.0 micron (Counts)
[Left] Location 000 5.0 micron (Counts)	[Left] Warning Line High

- Counts show fairing interior met cleanliness requirements after ECS system settled
- New RF capability provided this information/analysis prior to fairing hoist into VIF
- Fairing environment meets cleanliness, caution should be used on ECS startup

- Particle counts were taken within the actual fairing and not just at the air supply
  - Believe this is the first data of this type for this fairing
- Wireless capability provided real time monitoring and saving of the data
  - RF activity was approved for use by ULA, KSC and GSFC safety
- Battery change out was required on a 4 hour basis
  - Safety also approved use of battery system on transporter
  - Transport stop points provided battery change points (5 minutes to change)
- Counts show clean air after ECS system settled

Particle Counter  
Lighthouse's SOLAIR  
3100+ used to monitor  
fairing air during  
transport
