JPL Publication 17-6

Pisgah Lava Cave Communication Test

Science Case Study for the Networked Constellations Initiative

November 2017

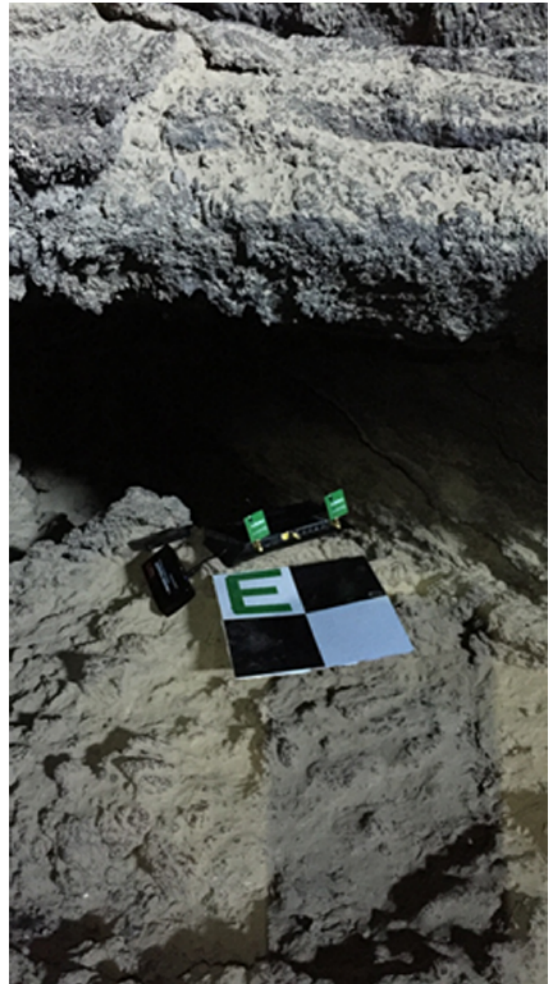
The router was placed at Checkpoint E, under the cave ceiling between the first and second room (see Figure 1). Two 5 GHz chip antennas were connected. Since only two such antennas were available, the router's third antennas input was terminated by a 50 Ohm plug. The laptop was located 4 m from the router in direct field of view. The communication was established initially at 5 GHz, but then the connection was lost.

Figure 1. Router location for Test 1.

#	SETUP	RESULTS: Ping (ms) Rate (MB) 2.4 / 5 GHz
1	R: "E". 10.7 m in cave. On top of the rock. Under low ceiling. L: "D" at entrance. Direct FOV. Liard 5 GHz.	Initially connected. Connection dropped. Moved laptop to ~4 m from Router. No luck connecting.
2	R: Center of room 1 on the rocks. R7000 antennas connected. HDD disconnected. Laptop at "E" on the rocks.	Could only connect at 2.4 GHz initially. Then connected at 5 GHz. P: 22.8/14.8. R: 8.3/16.1
3	R: "E" on top of the rock. R7000 antennas. HDD connected. L: Center of room 1. ~4 m from Router. Direct FOV	Good connection. P: 11.2/17.1. R: 8.3/12.7
4	R: "E". Same as previous test. L: "D" at the cave entrance. ~10.7 m from R. Direct FOV	Good connection. P: 23.0/14.6. R: 9.7/18.6
5	R: In front of "F" on top of the rock in room 2. L: Middle of room 1. Direct FOV through cave narrowing.	Good connection. P: 12.6/14.7. R: 9.0/18.6
6	R: In front of "F" on top of the rock in room 2. L: "D" at the cave entrance. No direct FOV. Router is obstructed by ceiling.	Good connection. P: 15.8/15.0 R: 3.4/1.9

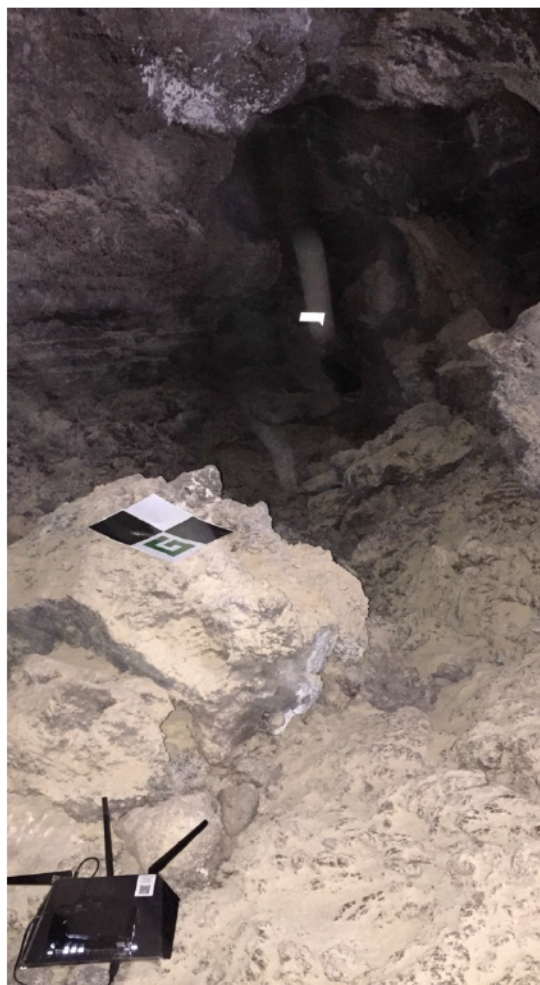
The router was placed behind a boulder at Checkpoint G. The laptop was on the rock next to Checkpoint F with no direct FOV to the router. See Figure 2.

Figure 2. Test 10 setup.

min	avg	max	stddev
5 GHz	0.833	15.736	144.206	31.842
2.4 GHz	1.031	19.864	254.168	45.998

size per sec
5 GHz	16.13 MB/sec
2.4 GHz	6.19 MB/sec

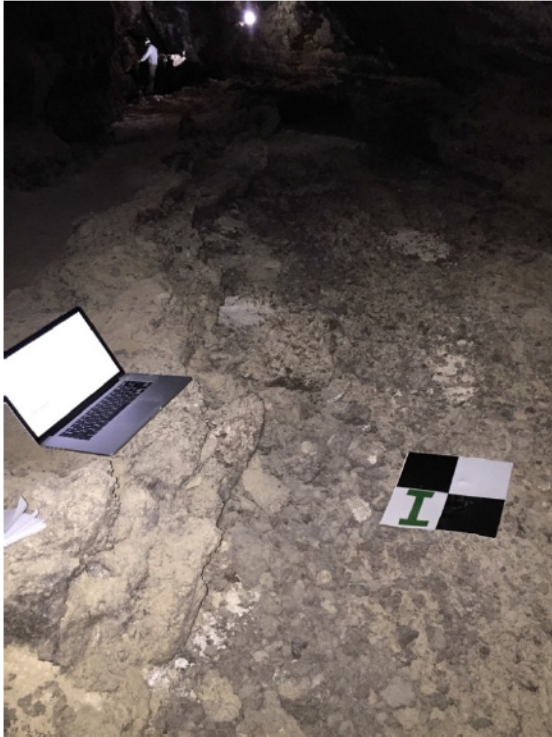
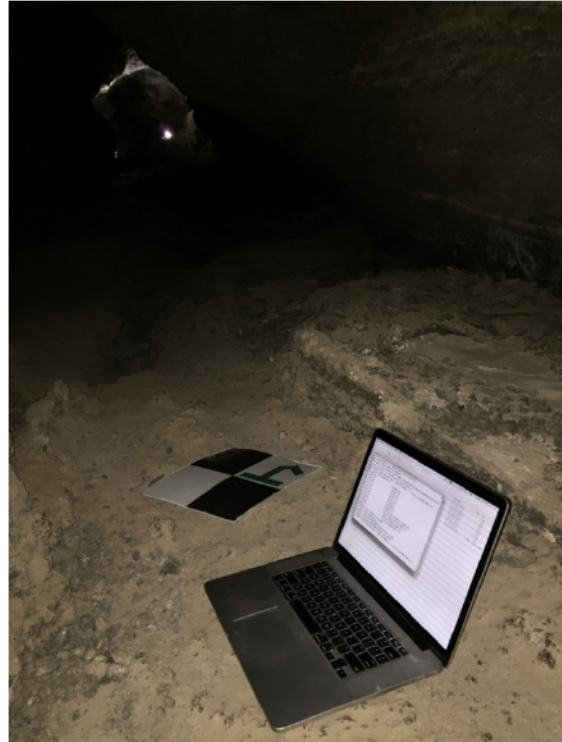
For Tests 11 and 12, the router was placed in the next room inside the cave. In both tests, the router was not in the field of view of the laptop. Test 12 goes deeper into the cave behind the turn. See Figure 3. The results of the tests are in Table 1.

Figure 3. Laptop location for Test 11 (left) and Test 12 (right).

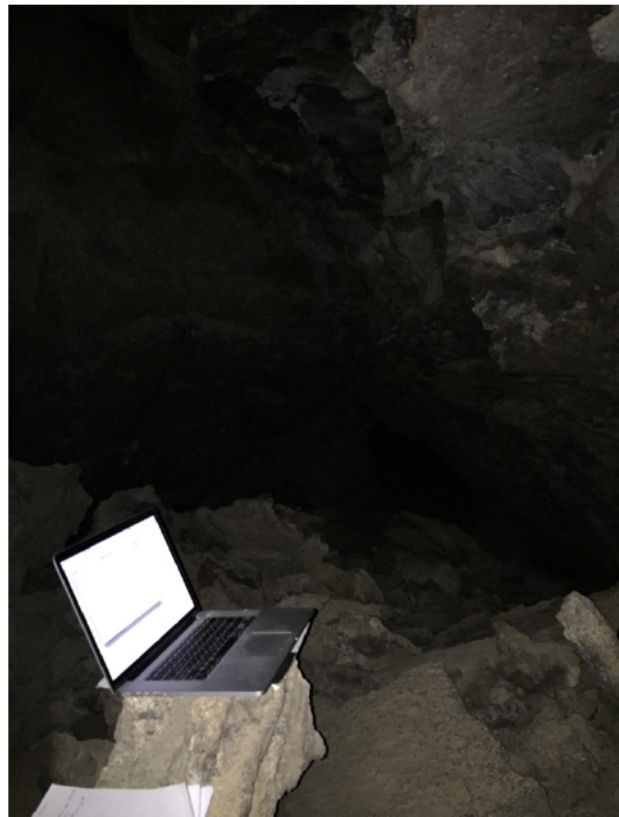
These tests were conducted with the router in the same location as in Tests 11 and 12, but the laptop was placed in the last room of the cave, Room 4. In addition to the previous obstruction by the turn and the elevation change, the narrow passage into the room created an additional obstacle for the signal. For Test 14, the router was moved closer to the laptop, to Checkpoint H, but the wall obstruction was still present.

The results of the test are provided in the Table 1, while the laptop location is shown in Figure 4.

Figure 4. Laptop location for Tests 13 and 14.

13	R: Same location at Tests 10 and 11. L: At mark "A2" in room 4. On top of high rock.	Can only see 2.4 GHz network, but cannot join it. No ping or data transfer possible.
14	R: Next to mark "H" on the floor. Closer than Test 13, still obstructed by turn and elevation change. L: At mark "A2" in room 4. On top of high rock.	Can see 2.4 and 5 GHz networks. Can only join 2.4 GHz. P: 20.1/N. R: 3.6/0.0
