# **Study of New Mid-Pole Bonding Mitigation System to Wooden Pole Ladder Network Model to address Pole-Top Fire Issue**

A thesis submitted in fulfillment of the requirements for the degree of  
Doctor of Philosophy

**Mohd Fadli Rahmat**

School of Electrical and Computer Engineering  
College of Science, Engineering and Health  
RMIT University  
October 2010

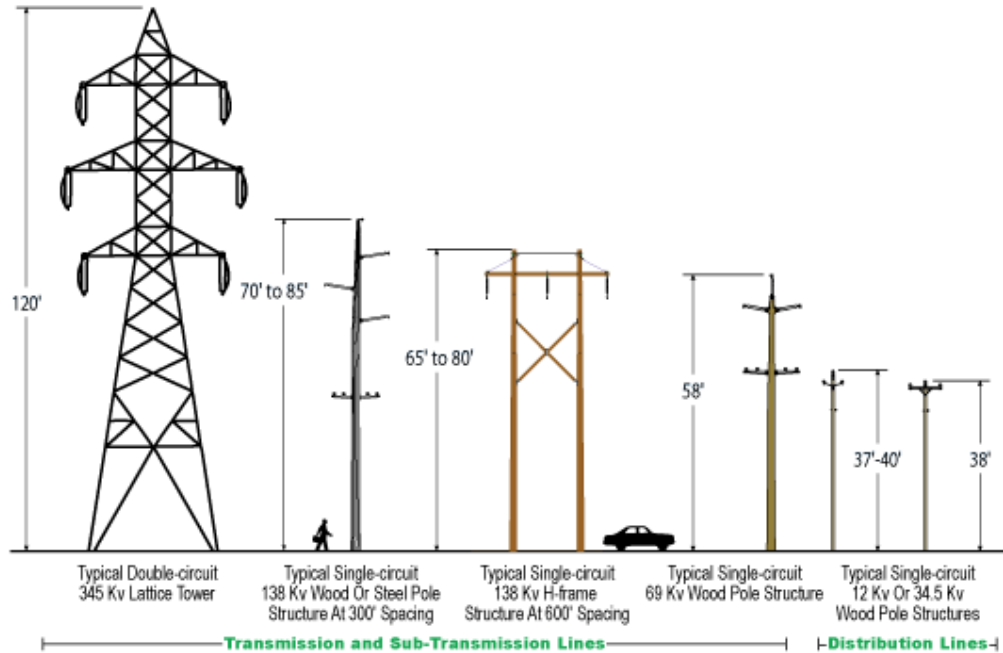
Figure 1.1: Typical transmission and distribution line structures in electrical power network [1]

Technically, wooden poles are used either in the transmission and distribution of electrical power networks as depicted in Figure 1.1. Depending on the placement of wooden poles in the electrical power network, certain overhead lines are used to provide the minimum technical requirement for each design. These include the mechanical design of poles, cross-arms and foundations with weather loads, conductor sags and tension effects, as well as the conductor characteristics and selection according to standard practices [15, 20, 21]. For example, 38-feet (12 meters) wooden poles are used for 12 kV to 34.5 kV distribution overhead lines and up to 85 feet (26 meters) wooden poles are used for 138 kV H frame or single circuit in sub-transmission lines. On top of that, these in-service poles still require protection systems, regular line inspection and maintenance to reduce

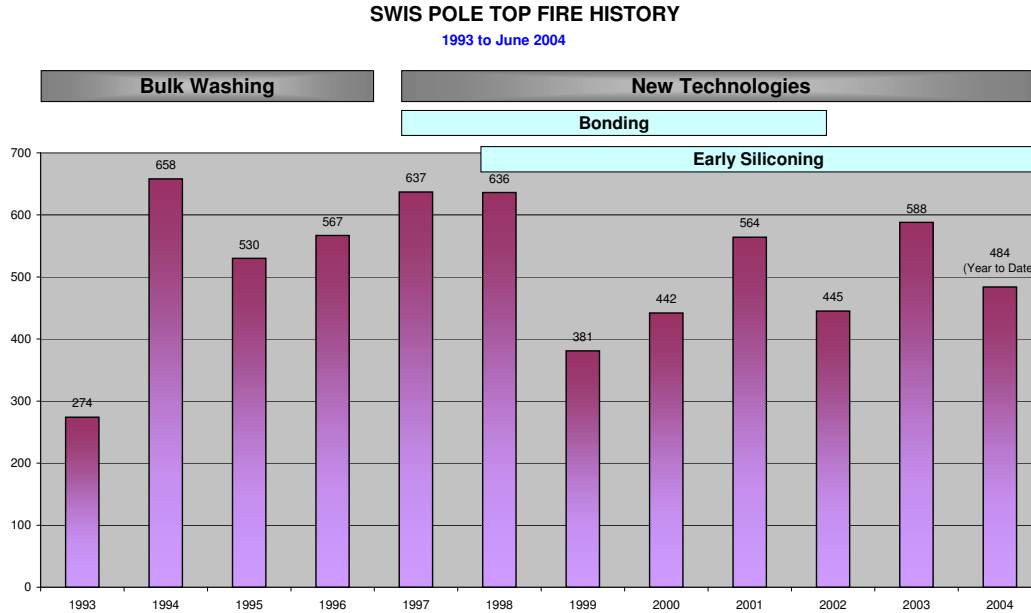
Figure 1.3: Recorded pole-top fire events over South-West Interconnected System (SWIS) in Western Australia from 1993 to 2004 [3]

In addition, hundreds of pole-top fire cases were recorded in the electrical network of SWIS after a change in pole-top fire mitigation techniques during the period 1993 to June 2004, as shown in Figure 1.3. There is still a big number of pole-top fire cases recorded, even though line washing, pole bonding and silicone

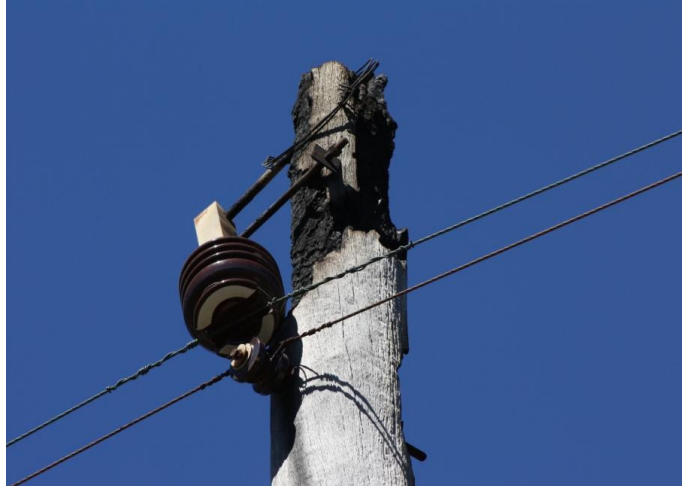
Figure 1.4: Pole-top fire in Dunsborough electrical distribution network [4]

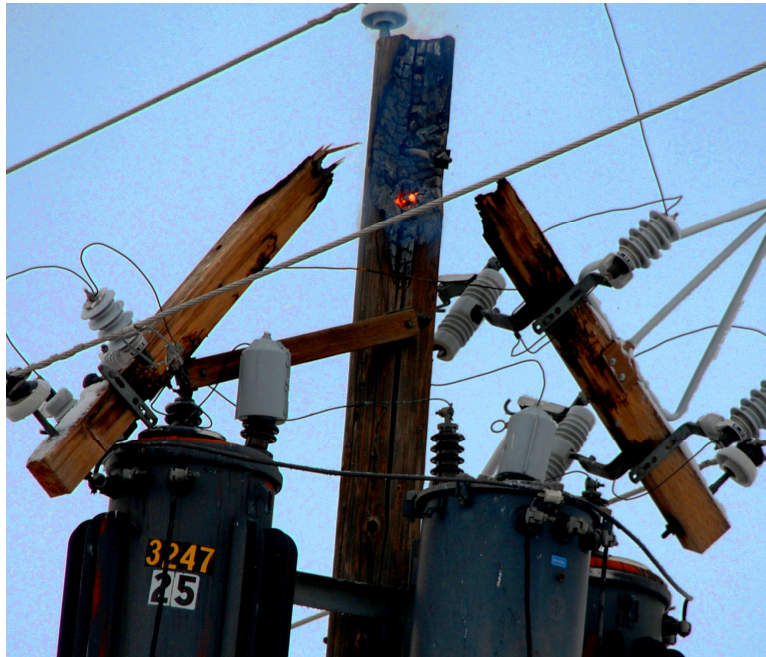
Figure 2.4: Pole-top fire event in Southmoor distribution line [8]

dropped across the uneven wet wooden surfaces. The tree burning type, which is more common than pocket burning, has a tree-like burn pattern on the pole surface and usually the replacement of wooden pole structure member is unnecessary. However, the pocket burning always extends into the wooden pole body and occurs only if a small portion of the pole is dry. Light winds create a dampening condition on the pole and insulator surfaces and produce a “shadow” area. The high resistance of the shadow area in series with low leakage current resistance causes a concentration of voltage across the dry area. A fire will be triggered if the voltage drop is sufficient and causes a short electrical breakdown across the dry zone. The replacement of the wooden pole structure member is needed in this instance. Figure 2.4 shows the failure of the wooden cross-arm due to pole-top fire.

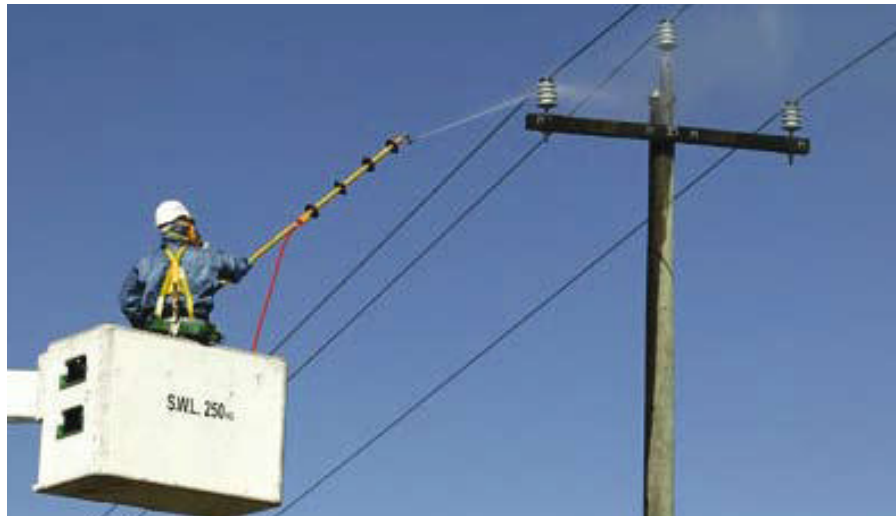
Figure 2.5: Operator spraying silicone compound on pole-top insulators [9]

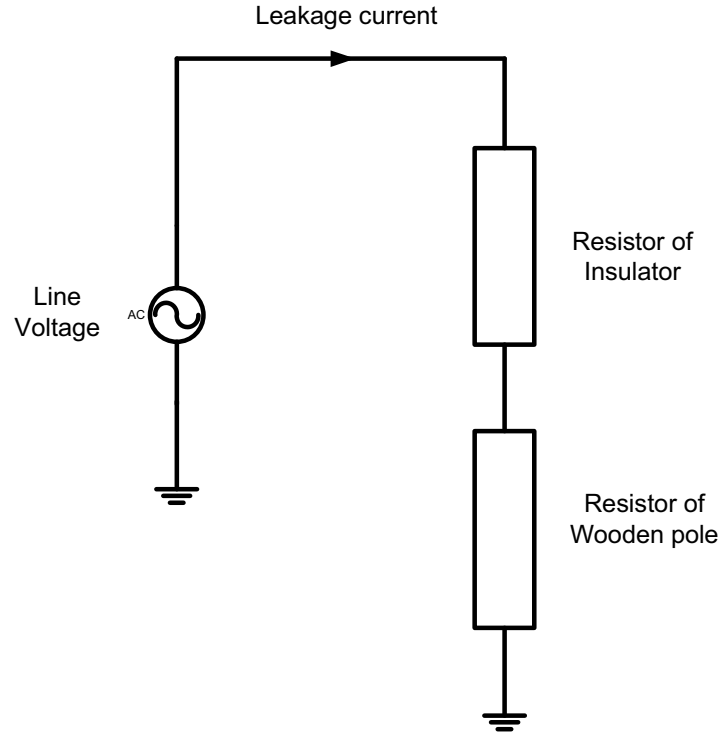
Figure 3.1: A complete leakage current model

The principal objective of the ladder network model development was to determine the hazard of leakage current on humans under a variety of operations and fault

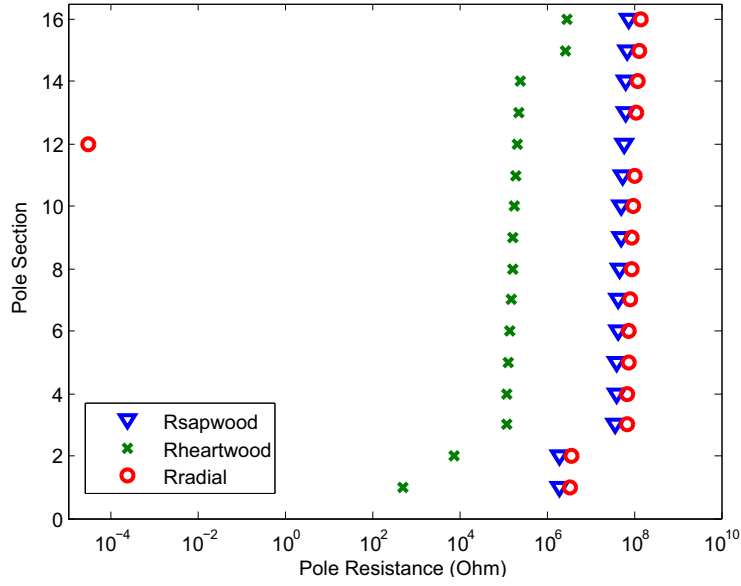
Figure 3.4: Resistance of dry wooden pole

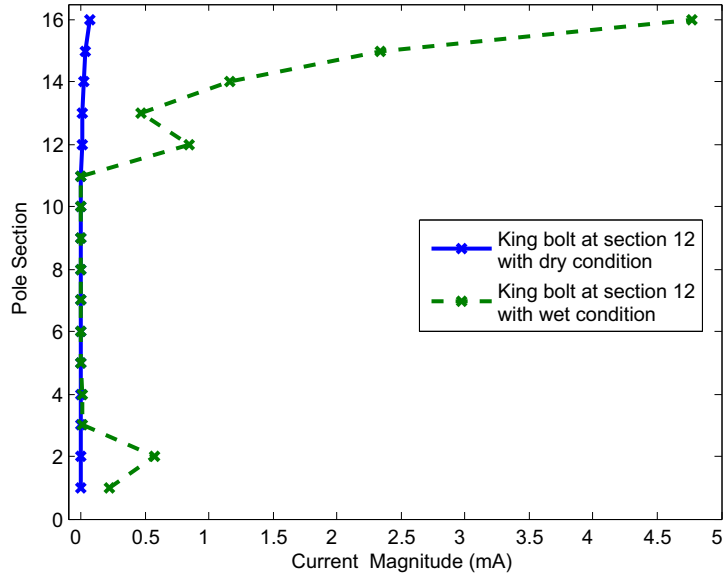
Figure 3.7: Current distribution for radial resistance

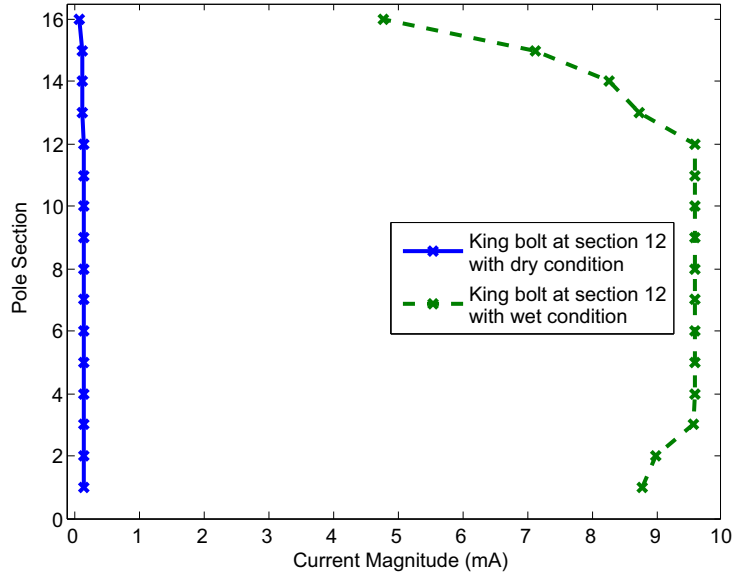
Figure 3.8: Current distribution for heartwood resistance

Leakage current with a value of 9.5 mA was recorded in the center section of the pole.

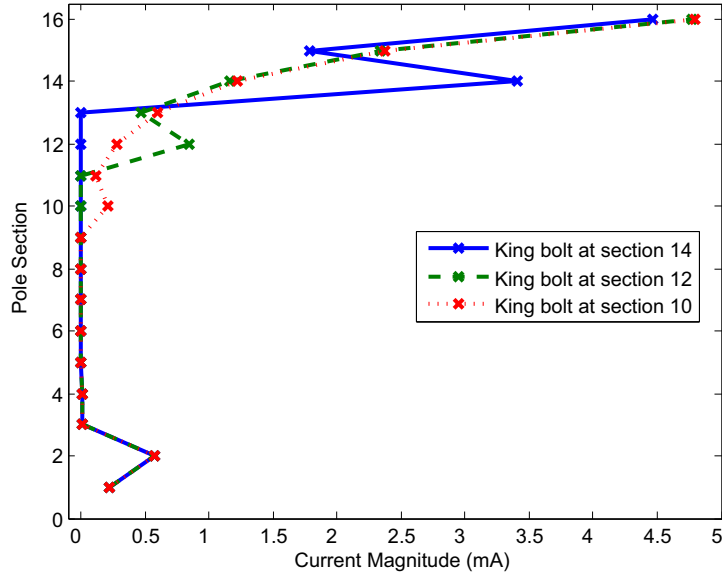
Figure 3.9: Current distribution of wet radial resistance with different locations of king bolt

The damage to wooden poles due to pole fires frequently takes place at the cross-arm junction where the attachment of the king bolt or the insulator's metal support is located. Figure 3.9 depicts a graph of how the metal insertion affects the current flow across the radial resistance. In this simulation, three different scenarios were created: king bolt at pole section 14, pole section 12 and pole section 10. In the first scenario, a current “spike” was created at section 14. The leakage current was increased from 1.7 mA to 3.4 mA at pole section 15. As the king bolt was shifted down to section 12 and 10, the effect became less apparent due to the fact that the leakage dropped to approximately 1 mA at pole section 14 for all three

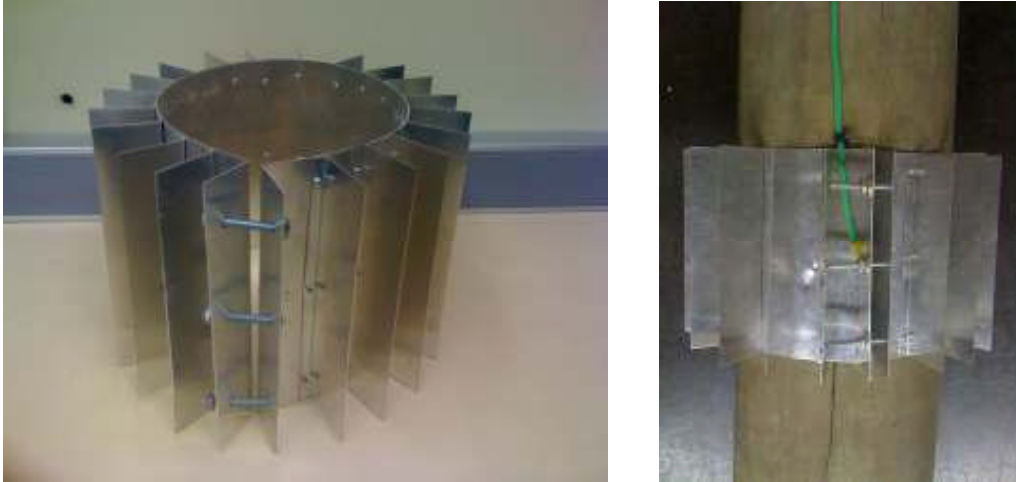
Figure 4.3: Metallic band

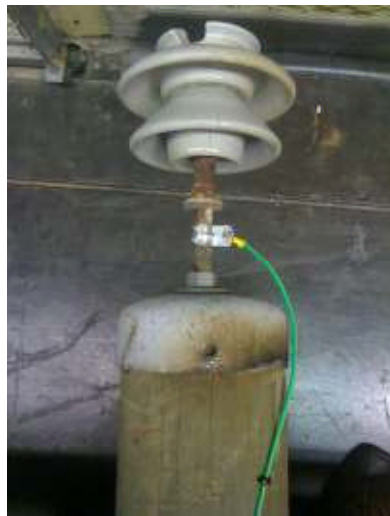
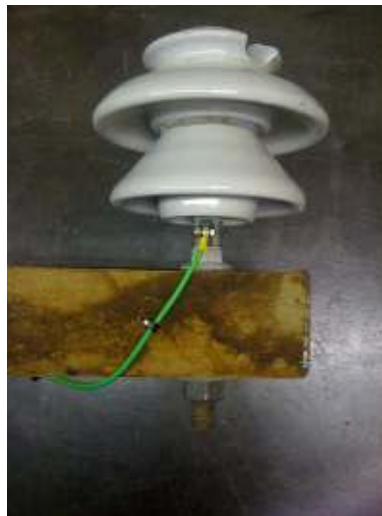
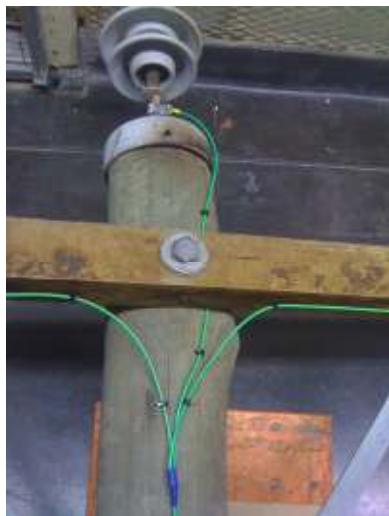
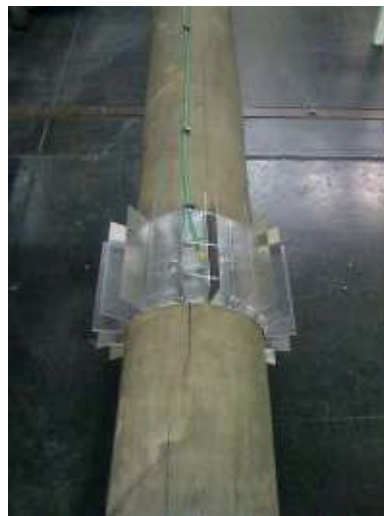
(a) Cable termination at pole-top insulator (b) Cable termination at cross-arm insulator

(c) Termination of 3 insulated cables (d) Cable termination at the metallic band

Physically, the source of leakage current was at the phase lines that are located at the top of the insulator. The polluted insulators allow leakage current flow through insulator pins to the wooden pole structures. Therefore, the leakage current must be immediately diverted away from the insulator pin to reduce the risk of current concentration at the metal wood insertion. As shown in Figure 4.4, the attachment of the shunting cables can be made at the insulator pin with cable clamps. Small screws, nuts and washers can attach the shunting cables firmly with cable clamps at the insulator pins and metallic band. Cable clips can be used with

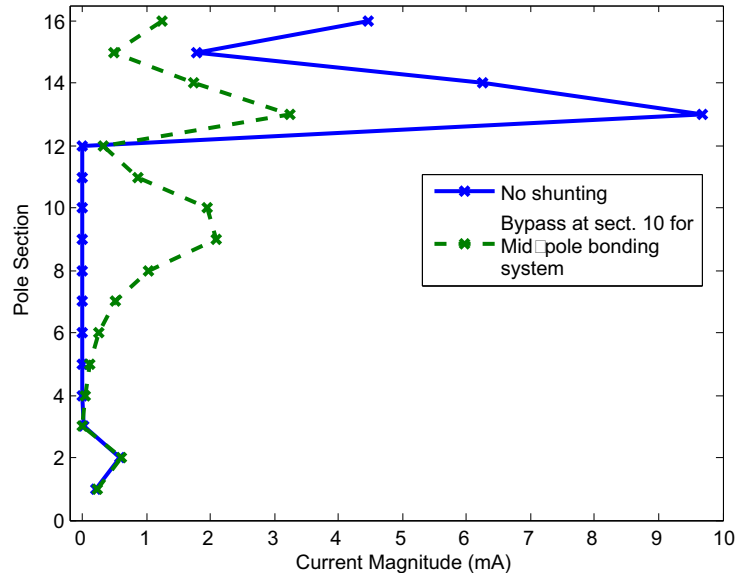
Figure 4.7: Comparison of radial current distribution in mid-pole bonding system and normal system

Figure 4.7 and 4.8 shows the radial current of wooden pole for conditions of

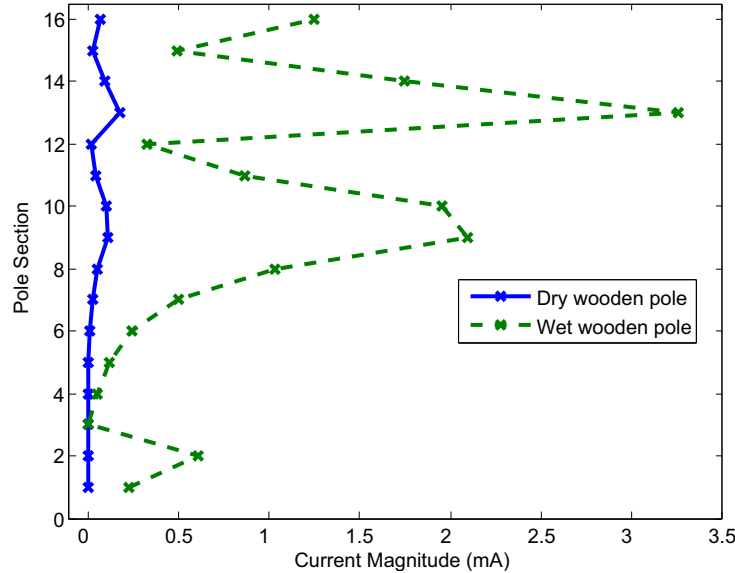
Figure 4.8: Radial current distribution of mid-pole bonding system

In addition, Figure 4.8 depicts the comparison of radial current distribution for the mid-pole bonding system under dry and wet conditions. For this simulation study, the leakage current was diverted from the insulator pin at Phase 2 to section 10 of wooden pole through a shunting cable. Under dry conditions, the radial current distribution, which is in the  $\mu\text{A}$  range, was very small compared to that under wet conditions. Based on both graphs, it is evident that the  $\mathbf{R}_{kb}$  and  $\mathbf{R}_b$

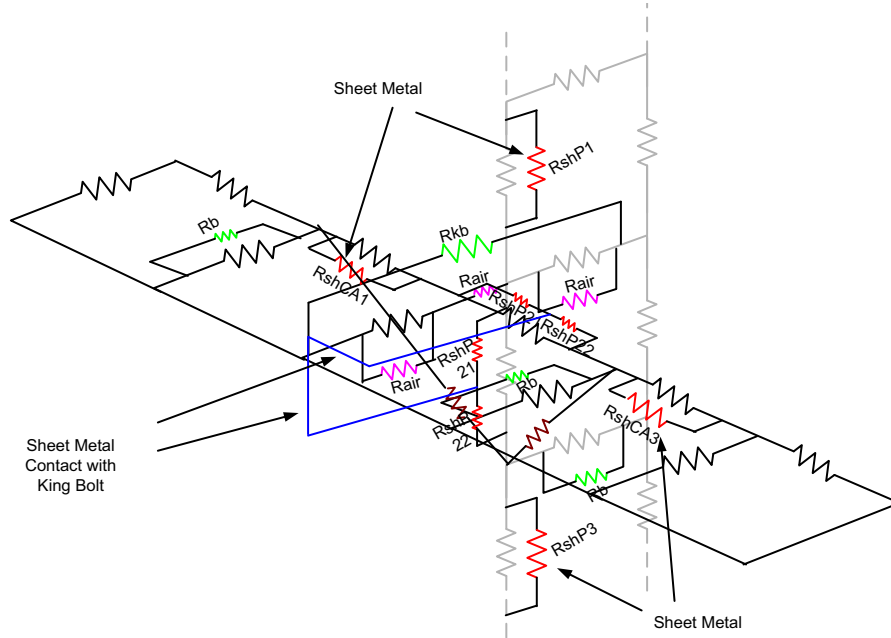
Figure 4.12: Electrical model for Ross shunting arrangement 2

wooden cross-arm and wooden pole. The developed electrical models of these shunting arrangements are shown in Figure 4.11 and 4.12. The shunting arrangement resistances for cross-arm and pole,  $R_{shCA}$  and  $R_{shP}$ , were connected to the

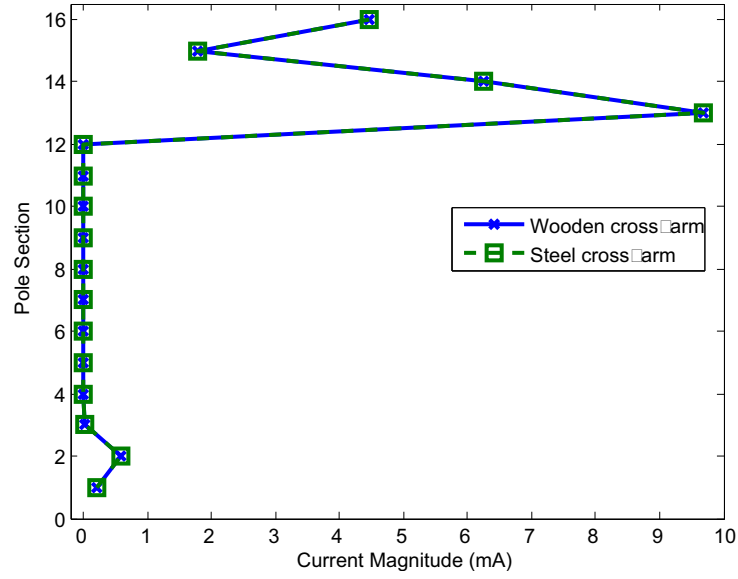
Figure 4.15: Comparison of radial current distribution between wooden and steel cross-arm under wet conditions

Similar to previous studies, the leakage current was assumed to flow from the polluted insulator located at the top section of the wooden pole i.e. at Phase 2 (refer to Figure 4.2) to the ground under wet conditions. Figure 4.15 depicts a comparative study of radial current distribution between wooden and steel cross-arm. The graph shows that the radial current distribution for wooden cross-arm is almost identical to the steel cross-arm simulation results; 6.3 mA and 9.7 mA radial current were recorded at sections 14 and 13. The effect of the king bolt insertion parallel to the radial resistance of the wooden pole and cross arm at section 12 caused the overall resistances at this section to be very small. Similar conditions for  $\mathbf{R}_b$  insertion also reduced the overall resistance at section 13. However  $\mathbf{R}_b$  resistance was small compared to  $\mathbf{R}_{kb}$  resistance. Therefore a rapid change in the radial current was plotted between section 14 and 13 for both cross-arms. Consequently, the radial current reduced significantly as it flowed toward the bottom section of the wooden pole.

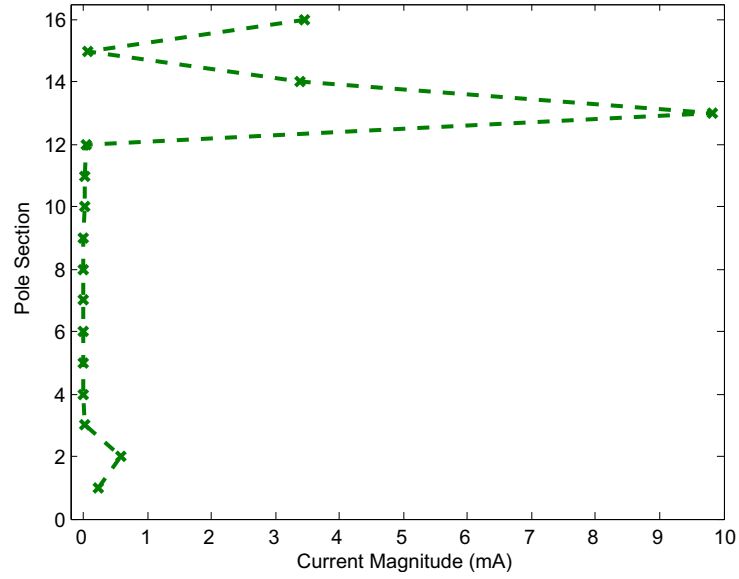
Figure 4.17: Radial current distribution of Ross's shunting arrangement 2

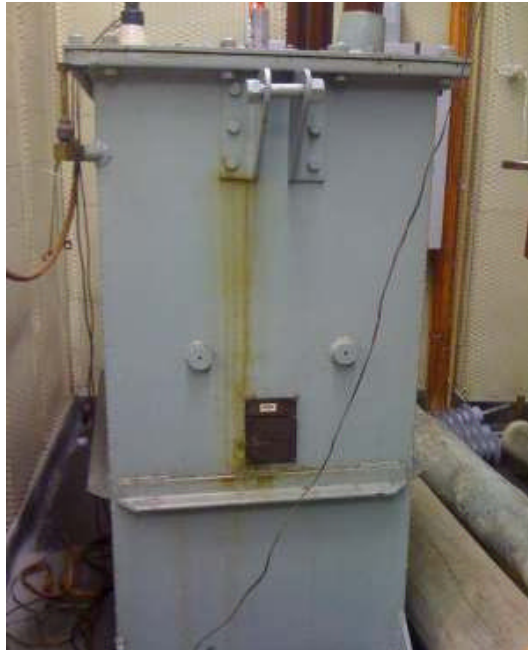
Figure 5.2: High voltage transformer

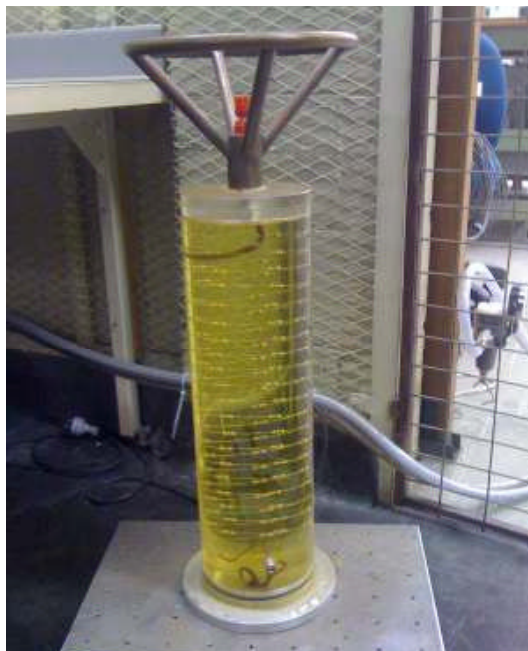
Figure 5.3: Voltage divider for high voltage measurement

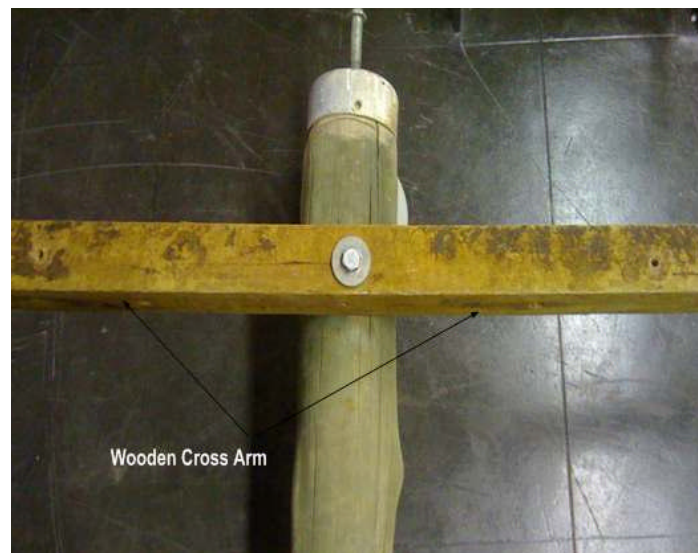
Figure 5.5: Wooden cross-arm

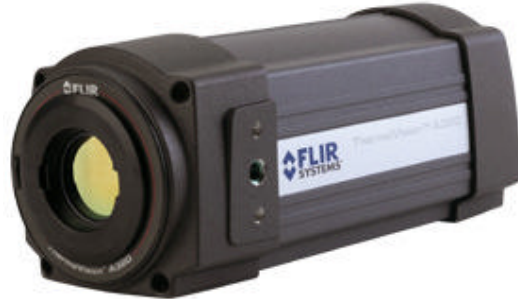
Figure 5.7: Thermovision A320 thermal camera

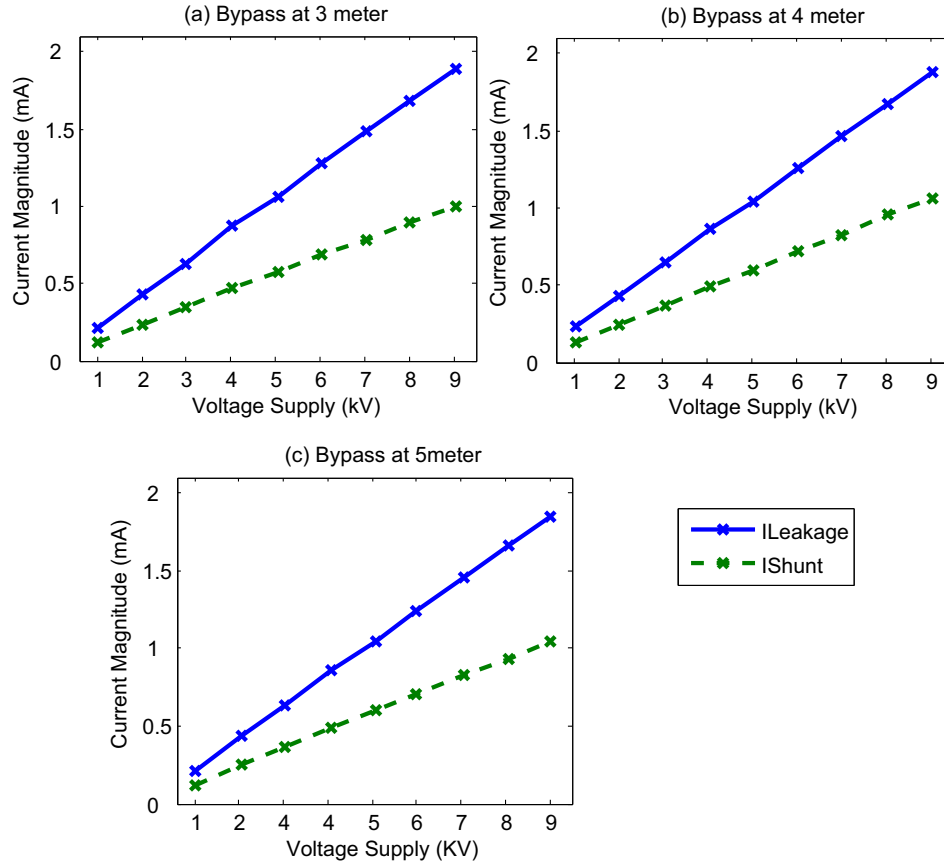
Figure 5.9: Mid-pole bonding system on wooden pole for leakage current from cross-arm to ground

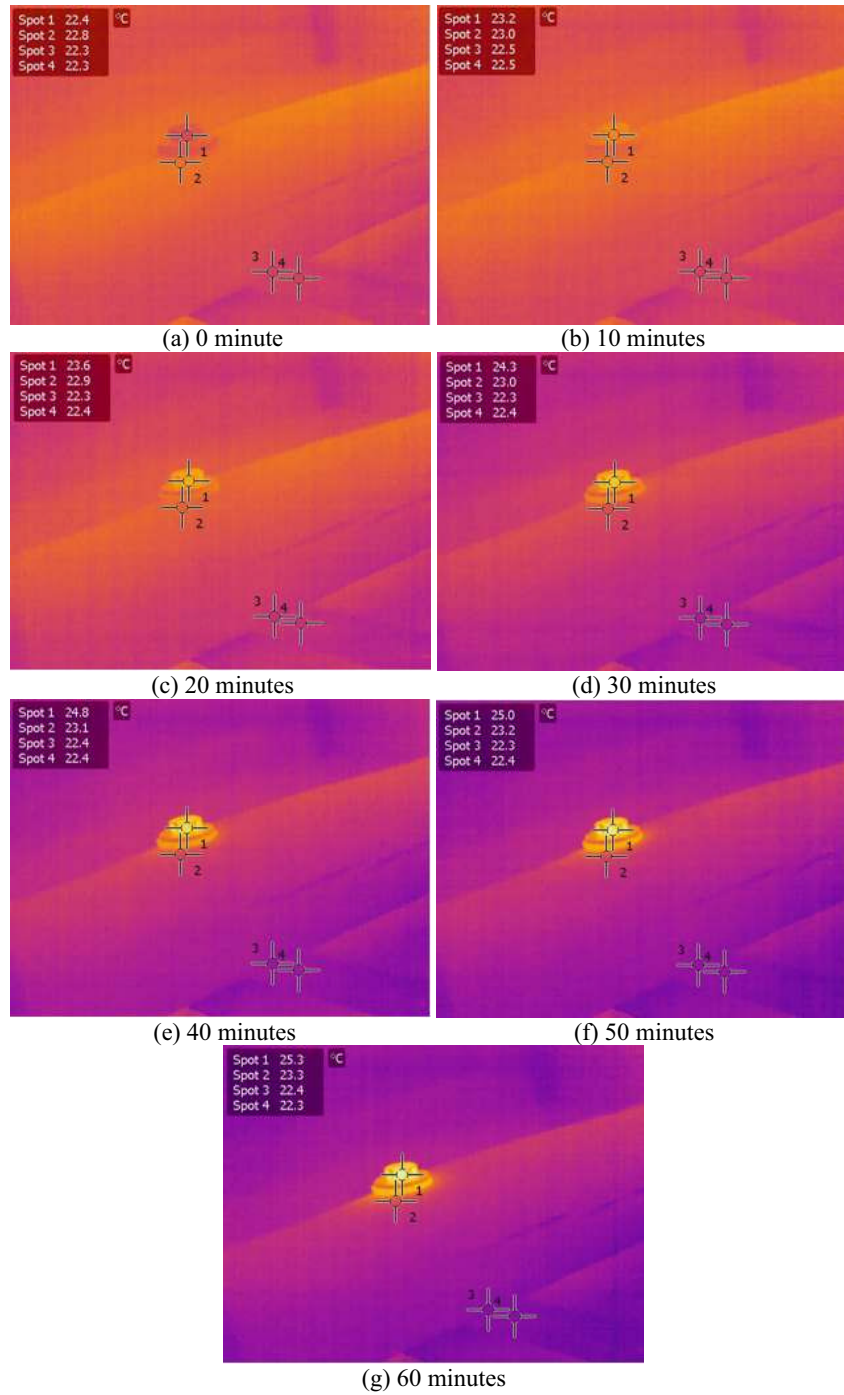
Figure 5.12: Thermographic images for steel cross-arm at 5 mA
