Chishti, M, Wang, C, Thomson, R and Orifici, A 2012, 'Experimental investigation of damage progression and strength of countersunk composite joints', *Composite Structures*, vol. 94, no. 3, pp. 865-873.

Experimental Investigation of Damage Progression and Strength of Countersunk Composite Joints

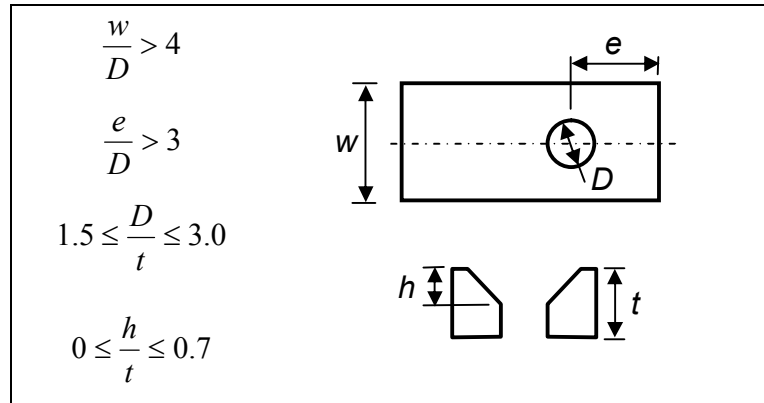
Figure 1: Specimen design guidelines to promote bearing failure (adapted from Ref. [10])

Research on the influence of bolted joint parameters on the joint strength and damage progression has also been dominated by investigations into straight-shank bolts. Bolt torque (BT) has been investigated by several authors for straight-shank bolts [5, 6] and found to increase bearing and failure loads, as well as limit delamination. Clearance (CL) in straight-shank bolt holes has been found to reduce the bolt contact area [7-9], affecting the load transfer, high stress regions and joint bearing loads. With regards to countersunk joints, recommendations for joint design to promote bearing failure are given in an ASTM standard [10], and summarised in Figure 1, though the effects of variation within these guidelines are not covered.

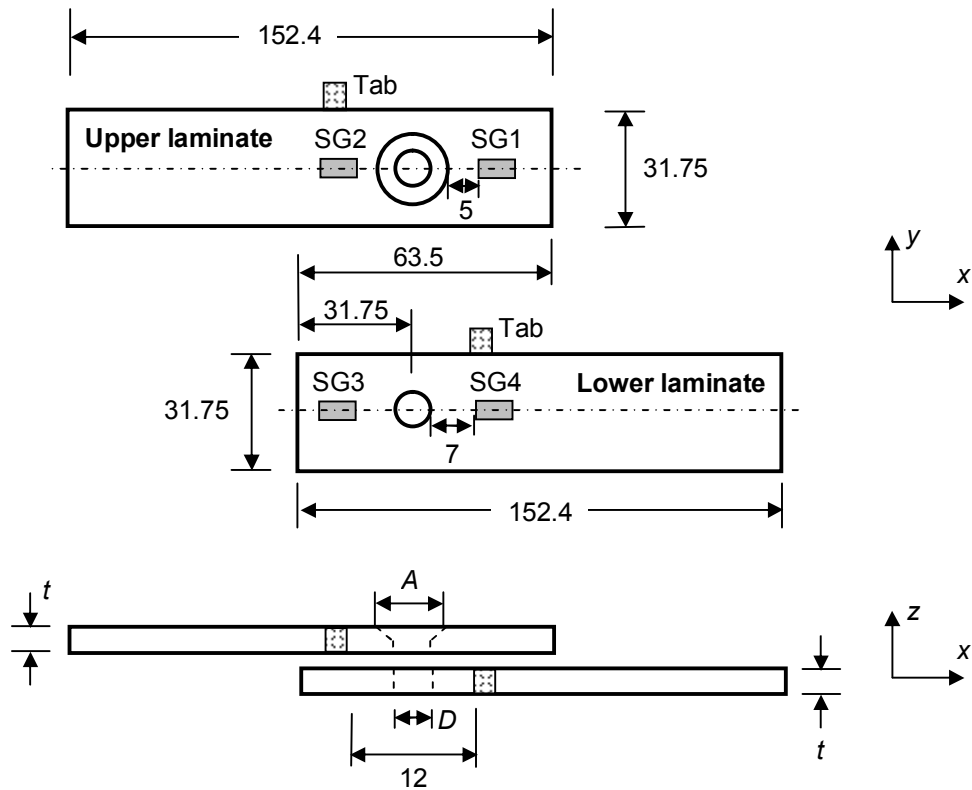
Figure 2: Countersunk joint geometry and dimensions (mm), strain gauge locations and extensometer tabs

Experimental tests were conducted in two configurations: a bearing test, and single-lap joints with countersunk bolts. Both specimens were designed according to the recommendations to promote bearing failure in the ASTM standard [10]. The details of the specimens are given in Figure 2 and Table 1, where the bearing test was equivalent to the lower laminate of the single-lap joint (with no extensometer tab). The bearing test used a straight-edge hole, whilst all other specimens were single-lap joints with countersunk holes. The specimens were all manufactured using plain weave carbon/epoxy T300/970 pre-preg (nominal ply thickness 0.22 mm). Specimens were tested in a 100 kN MTS hydraulic test machine. Strain gauges (SGs) were used as shown in Figure 2, though the bearing test used only one strain gauge at the SG4 location.

were gripped on the edge of each laminate and loaded in tension. An extensometer was placed between tabs as shown in Figure 2. Variations in the single-lap joints included different levels of bolt torque, bolt clearance, and countersink height to laminate thickness ratio h / t , each at three levels as summarised in Table 2. Bolt torque was introduced using a calibrated torque wrench, and clearance was introduced by increasing the diameter of the straight-edge portion of the bolt hole only. The specimens were loaded in displacement control at 0.5 mm/min until ultimate failure, though one bearing test specimen was only loaded until the onset of non-linearity.

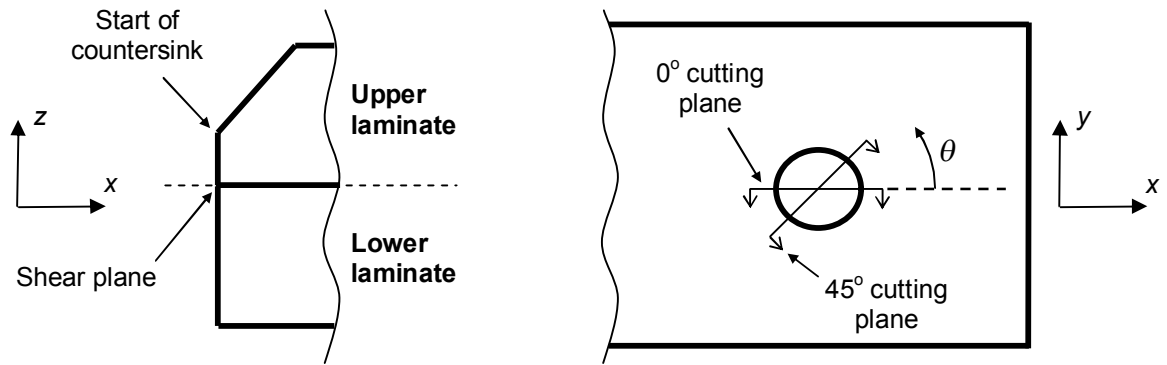
Figure 3: Cross-section labelling

In analysing the results, stresses in the radius (r) direction were considered, as shown in the cylindrical coordinate system in Figure 3. All models were taken to an applied load of 1.5 kN, and stresses were normalised using the maximum stress in the bearing test. This normalised radial stress is plotted as a function of the angular coordinate θ for a given ply

location. There were two 0° ply locations studied, as shown in Figure 3, which corresponded to the start of the countersink region and the shear plane.

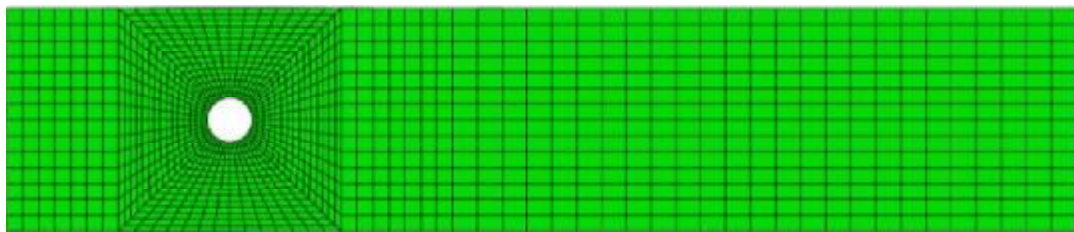
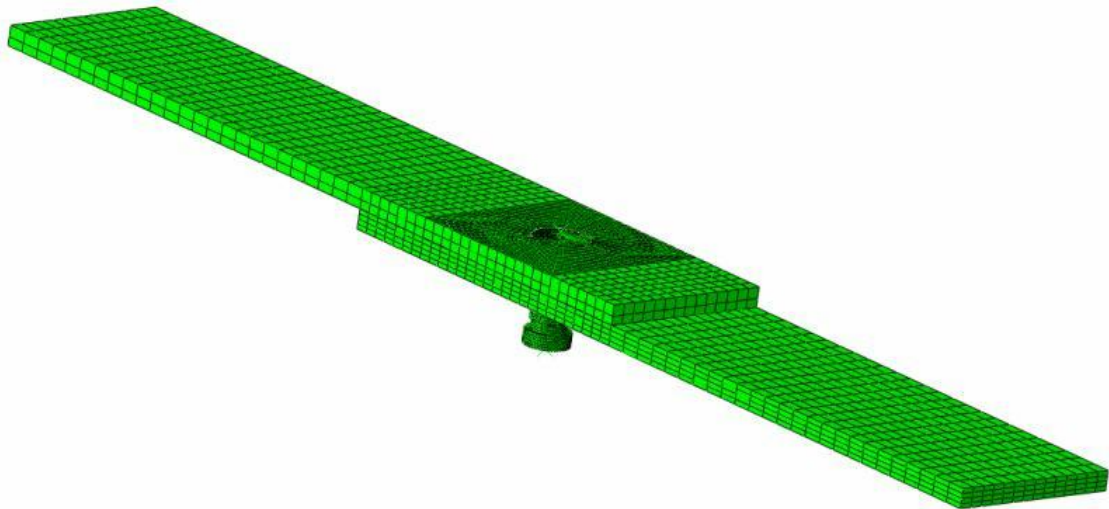
Figure 4: Numerical model. (a) In-plane mesh. (b) Single-lap joint.

Numerical analysis was conducted to study the stress distribution throughout the joints, as a means of providing further insight into the experimentally observed damage mechanisms. The analysis was conducted using Abaqus 6.9 [14], for both the bearing test and single-lap joints. The models used 3D continuum shells for the laminates and rigid elements for the bolt and nut, with friction-based contact implemented on all contactable surfaces. Bolt torque was introduced by applying an equivalent displacement of the bolt into the nut in a pre-loading analysis step, before the bolt-nut assembly was rigidly connected for the tensile loading. The in-plane and through-thickness mesh densities were determined using mesh sensitivity investigations, which are not included here for brevity. The in-plane mesh distribution is shown in Figure 4(a). In the through-thickness direction, the bearing test model used 32 elements, and the single-lap joint models (shown in Figure 4(b)) used 4 elements for the lower laminate and between 2 and 4 elements for the upper laminate depending on the hole geometry. Further detail on the model is provided in a previous publication [15], and the use of the model for detailed progressive failure analysis will be the subject of future publications.

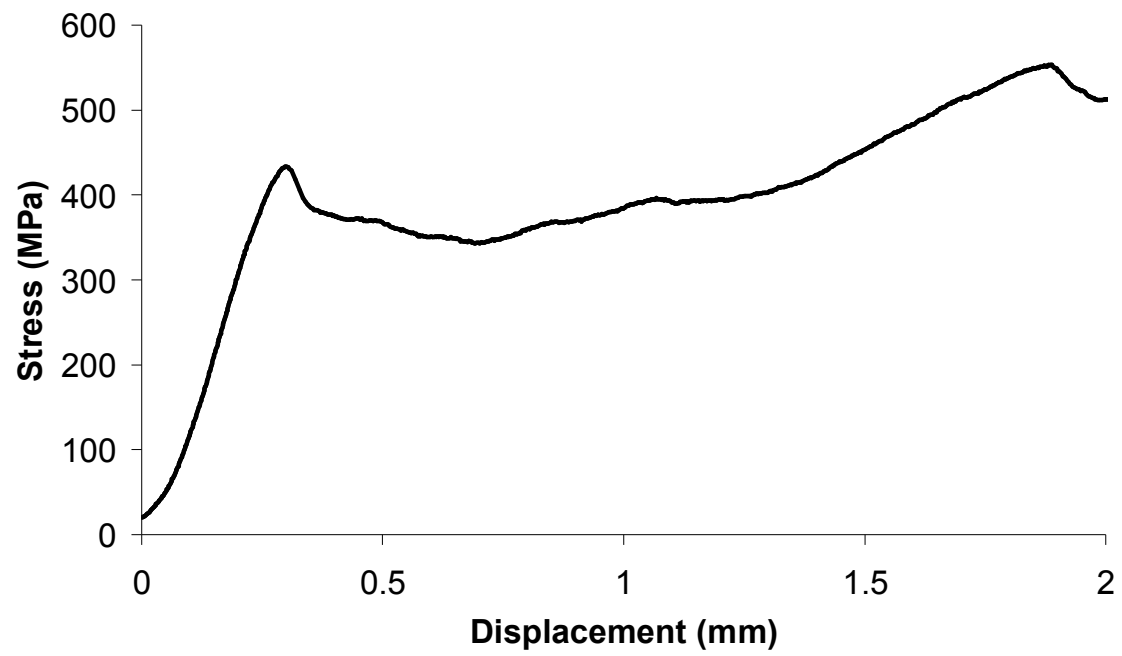
Figure 5: Bearing test, stress-displacement (test #2)

The results for the bearing test specimens are shown in Table 3, Figure 5 and Figure 6. The stress-displacement results in Figure 5 show a linear region and a drop in stress at the onset of non-linearity. The non-linear region is characterised by gradually increasing stress with increasing applied displacement, up to a maximum stress, which is higher than the stress for non-linearity onset.

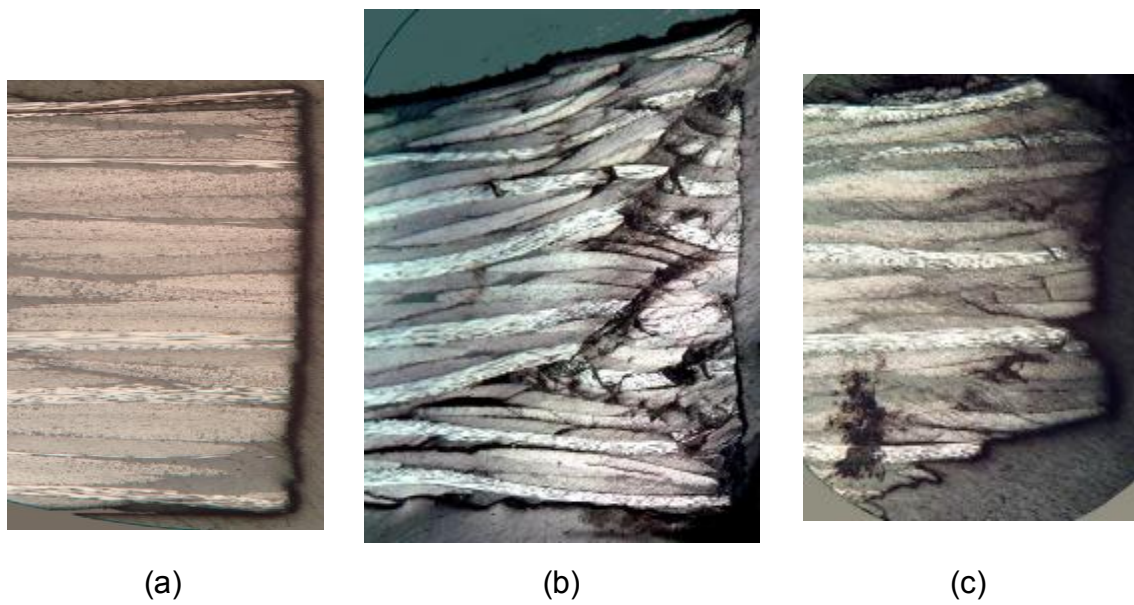
Figure 6: Bearing test 0° sections (a) Undamaged (b) Non-linearity onset (c) Ultimate stress

The results of the micrographs in Figure 6 show that the onset of non-linearity is associated with significant bearing damage. This damage is characterised by interlaminar and intralaminar shear cracks comprising of fibre kinking, matrix shear and matrix compression failure. Delamination was present at the onset non-linearity, but is not considered a major damage mode, and is not visible at ultimate stress due to the considerable edge loss and fraying of the section. Inspection of the 45° sections showed similar damage mechanisms but considerably less damage, as the extent of damage reduced around the circumference of the hole.

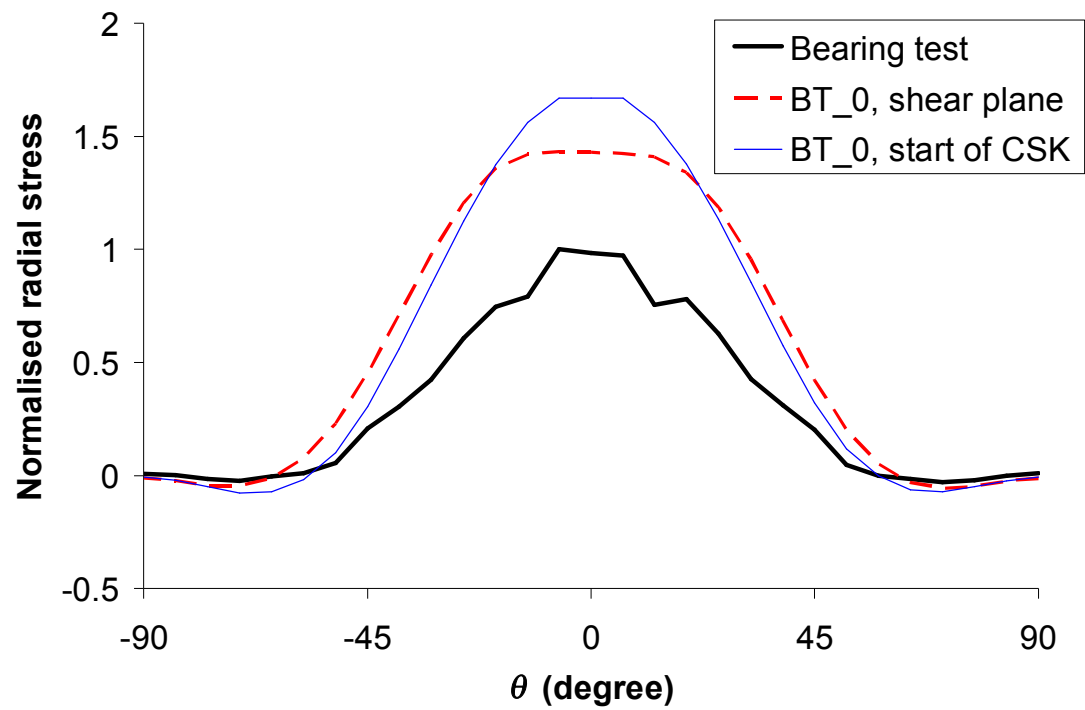
Figure 7: Normalised radial stress for the bearing test and countersunk joint with no bolt torque

The numerical results in Figure 7 and Table 4 compare the radial stress distribution of the bearing test with the countersunk joint with no bolt torque. From these results, the introduction of the countersunk geometry increased the radial stress at the shear plane and start of the countersink region by 43% and a 67% respectively, relative to the maximum stress in the bearing test. This agrees with the results from other researchers [11, 16], where the introduction of a countersunk hole has been found to increase the stress concentration factor, particularly at the start of the countersunk region.

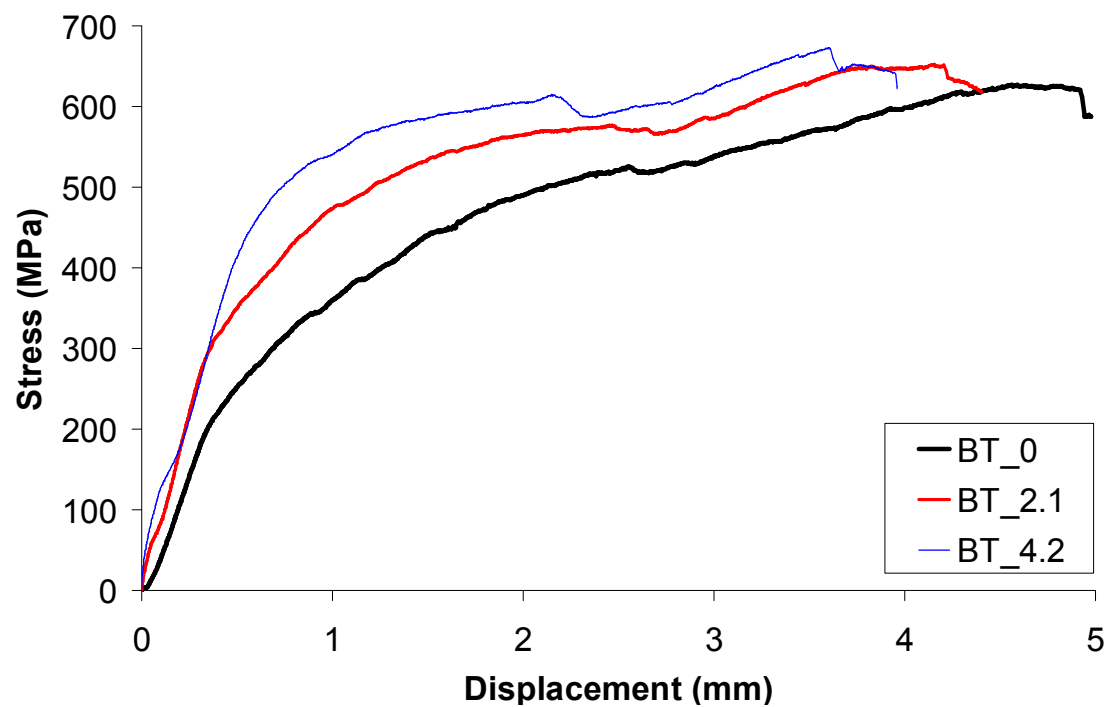
Figure 8: Countersunk joints, stress-displacement, bolt torque investigation

The results in Table 3 show that the introduction of the countersunk hole caused the bearing stress to be reduced to at least half of the bearing test value, whilst the ultimate stress increased by a small amount. This is also seen in Figure 8 from the stress-displacement history for the countersunk hole with no bolt torque (BT_0), which is characterised by a short linear region and extended non-linear region in comparison with the bearing test results in Figure 5. However, the exact effect of the countersunk hole is difficult to quantify from the results as different specimen configurations were used, and the single-lap joints also involve some degree of bending.

The results of the single-lap joints investigating the effect of bolt torque are shown in Table 3, Table 4 and Figure 8 to Figure 10. The results in Table 3 show that the application of 2.1 N m of bolt torque (BT_2.1) from the finger-tight case (BT_0) led to a significant increase in bearing stress (33%), whilst only a minor increase (3%) in the ultimate failure stress. Doubling the amount of bolt torque did not show any further improvement, with only marginal changes in bearing stress and ultimate stress. This is also evident from the stress-displacement history in Figure 8, where increasing bolt torque increased the length of the linear region. The insensitivity of ultimate failure load to bolt torque has also been reported by other authors [17-19], over similar bolt torque ranges.

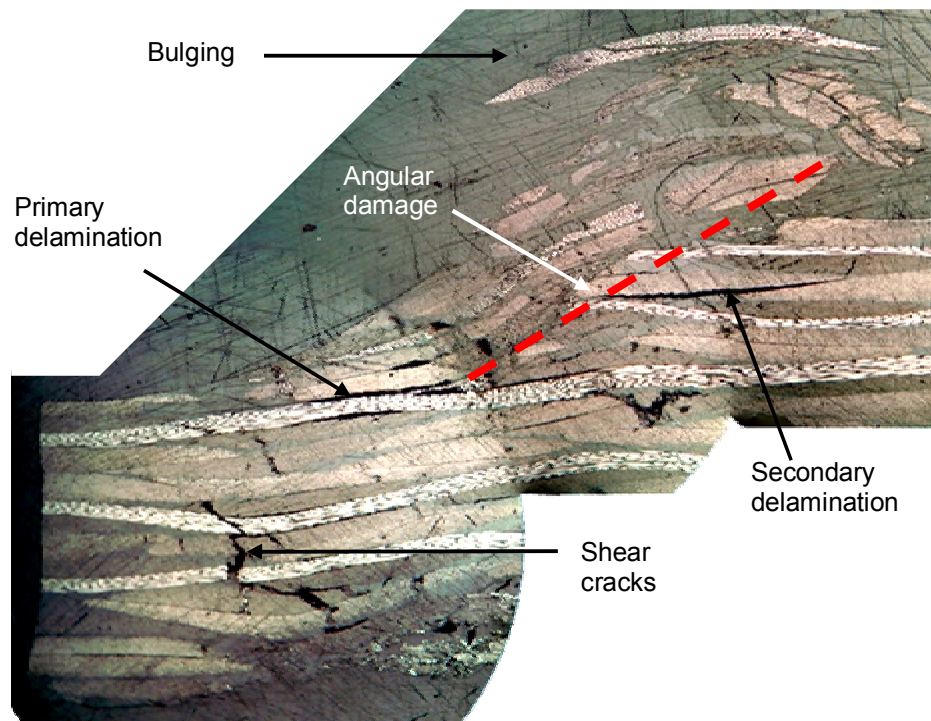
Figure 9: Countersunk joint 0° section, BT_2.1 upper laminate

The micrographs in Figure 9 and Figure 10 show 0° sections of the upper and lower laminate at BT_2.1. These show that the introduction of the countersunk hole led to an angular damage region in the upper laminate (Figure 9), as the bearing damage remained

parallel to the hole edge. Similar damage mechanisms to the bearing test were seen, and include intralaminar and interlaminar shear cracks within the bearing damage region and secondary delaminations outside of the bearing damage region and close to the free surfaces. Additionally, delamination was also evident at the start of the countersink within the bearing damage region (Figure 9), and is termed primary delamination as it is not a secondary effect of the shear cracks. The damage mechanisms in the lower laminate (Figure 10) were similar to the bearing test, though bolt rotation led to an angular damage region at the bottom of the laminate that was not seen for the bearing test. The 45° sections indicated that damage reduced around the hole circumference, where in particular the primary delamination was not seen at the 45° locations.

The micrographs in Figure 9 and Figure 10 show 0° sections of the upper and lower laminate at BT_2.1. From these, and the micrographs not shown at 45° and at other BT levels, a detailed study of the effect of bolt torque on through-thickness damage profile was conducted. The introduction of bolt torque reduced the length of the bearing damage region away from the hole, but increased the density of shear cracks through the thickness. Bolt torque also prevented fraying of the laminate as seen in the bearing test (Figure 6(b)) and BT_0. Instead, bulging was promoted at the outer surfaces of the laminate as shown in Figure 9 and Figure 10. Despite this, primary delamination was seen at all levels of bolt torque at the same location.

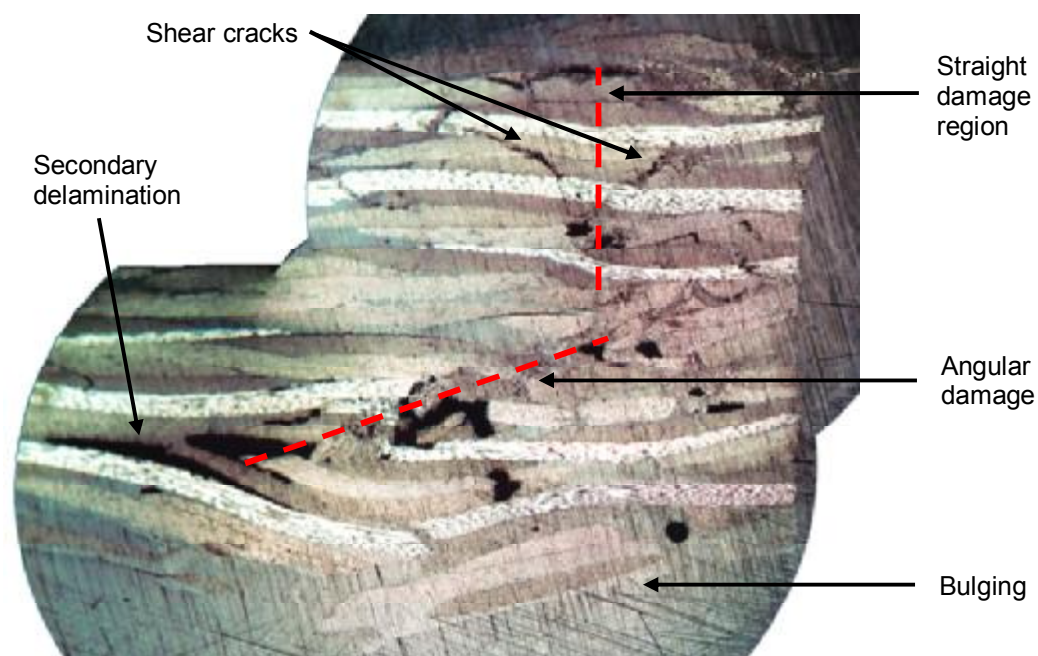
Figure 10: Countersunk joint 0° section, BT_2.1 lower laminate

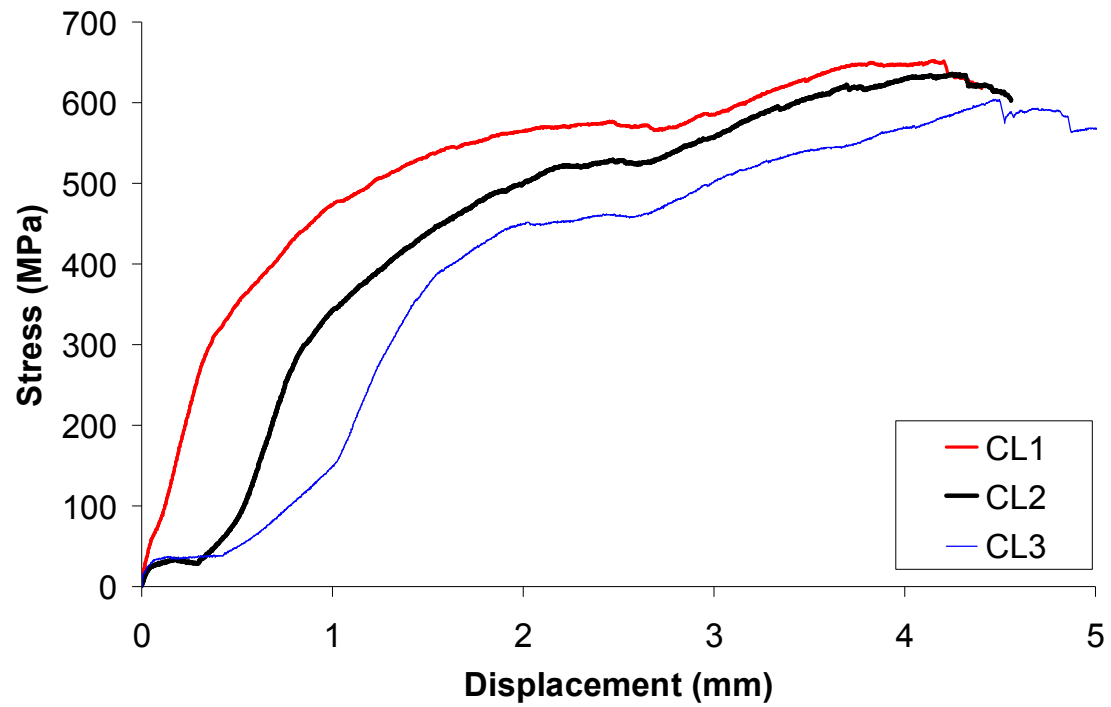
Figure 11: Countersunk joints, stress-displacement, bolt clearance investigation

stress by 7%, with a further slight reduction in ultimate stress. From the stress-displacement history in Figure 11, the introduction of clearance caused a shift towards larger displacements and introduced multiple stages in the linear region. Both of these effects are attributed to the sequence of loading of the joint with clearance, as shown in Figure 12, where the bolt first contacts one laminate, then rotates to contact the other laminate. The small reduction in ultimate stress as a result of introducing clearance agrees with results from other authors investigating countersunk joints [8, 9], though is in contrast to the large influence of clearance reported by other researchers studying straight-edge holes [7, 20].

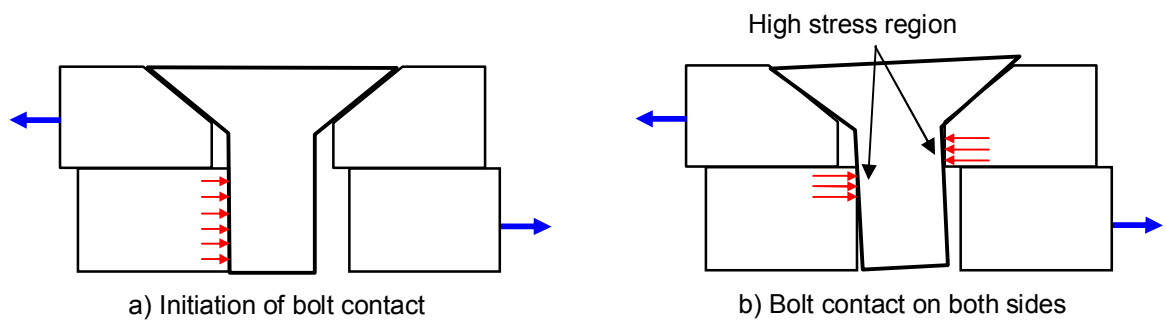
Figure 12: Countersunk joint, load sequence with clearance

The results of the single-lap joints investigating the effect of bolt clearance are shown in Table 3 and Figure 11 to Figure 13. The results in Table 3 show that the introduction of 220 µm of clearance led to a significant (17%) reduction in the bearing stress, though only a slight reduction in the ultimate stress. Doubling the clearance only reduced the bearing

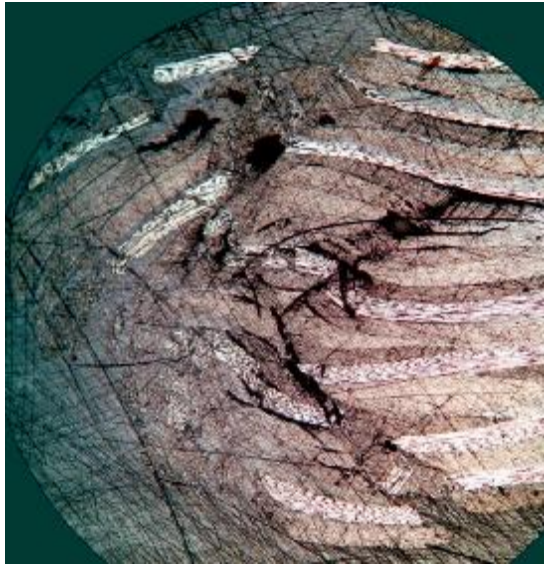
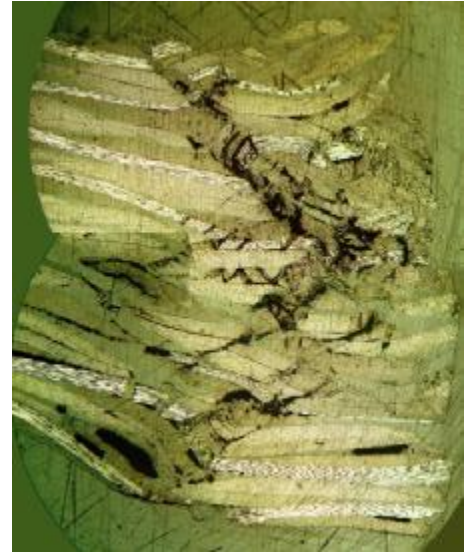
Figure 13: Countersunk joint 0° section, CL_240

The micrographs in Figure 13 and those not shown at 45° and other CL levels were used to study the through-thickness damage profile. For these images, the locations correspond to those indicated in Figure 3, and match those shown in Figure 9 and Figure 10, where the labelling in these latter two figures applies equally though has been omitted for clarity. The introduction of clearance increased the damage close to the shear plane, or interface between the upper and lower laminates. This is seen at the bottom of the upper laminate in Figure 13(a), and the top of the lower laminate in Figure 13(b), in comparison with the neat fit hole damage shown in Figure 9 and Figure 10. This changed the straight-edge damage regions to angular damage regions, so that both laminates contained two intersecting angular damage regions. This damage pattern also suppressed the occurrence of primary delamination, which was not seen in any joint with clearance. The increase in damage is explained schematically in Figure 12 by the sequence of loading in a clearance joint leading to high stress regions at the shear plane. These locations also had a higher

density of through-thickness cracks, though the length of damage away from the hole was reduced with increasing clearance.

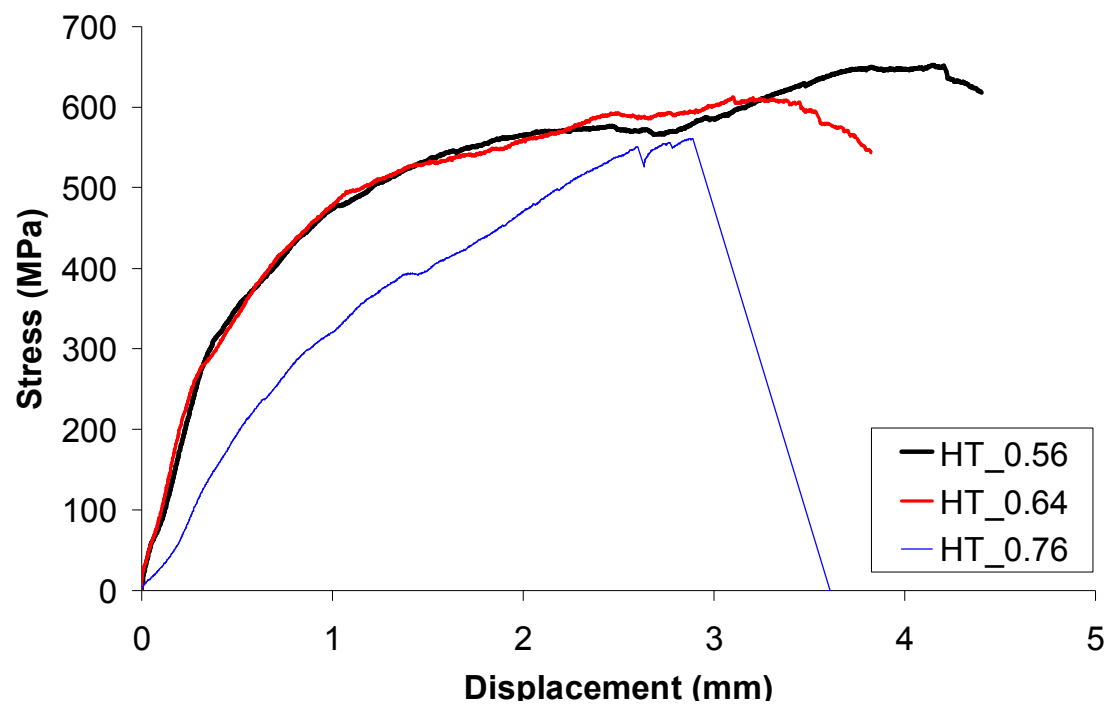
Figure 14: Countersunk joints, stress-displacement, height ratio investigation

For the specimens that failed in bearing, increasing the height ratio had a negligible effect on the bearing stress, and only a minor (5%) reduction in ultimate stress. The stress-displacement data shown in Figure 14 also illustrates the close comparison for these two levels of height ratio. Increasing the height ratio increased the bending displacement, or displacement in the through-thickness direction. This is associated with a smaller straight-edge region, which produces larger load eccentricity as it carries the majority of the load. Inspection of the micrographs at 0° and 45° at the two bearing failure HT levels also showed similar levels of damage. The micrographs did show that increasing the height ratio increased the extent of through-thickness damage close to the shear plane in both laminates, with the upper laminate showing an angular damage at the straight edge. Furthermore, no primary delamination occurred at increased height ratios, including HT_0.76 where bending failure was seen.

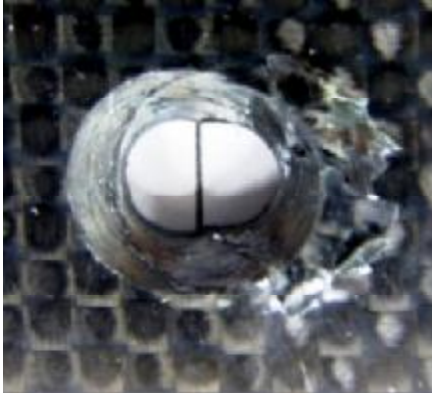
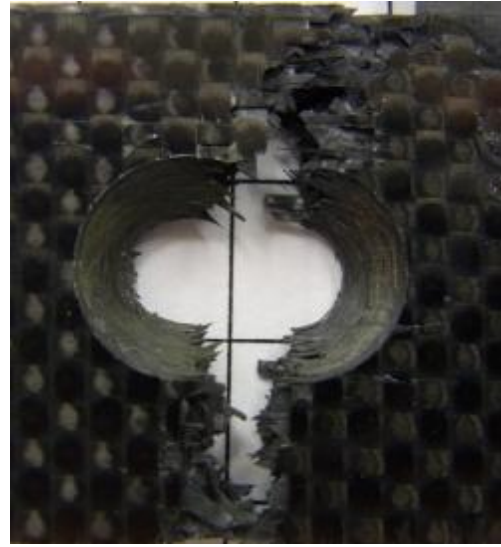
Figure 15: Countersunk joint upper laminate (countersink side) following ultimate failure

The results of the single-lap joints investigating the effect of height ratio are shown in Table 3, Figure 14 and Figure 15. The largest height ratio (HT_0.76) specimens failed in bending, with behaviour distinctly different from all other countersink joint configurations. This is illustrated in the stress-displacement history in Figure 14, and the net tension failure mode associated with bending shown in Figure 15(b). From Table 3, the bearing stress for the HT_0.76 specimen also shows a large coefficient of variation (33%), indicating the difficulties in applying this measure of bearing performance to joints failing in bending. Very limited work is available in literature on the effects of countersunk height ratio for single lap composite bolted joints, though similarly large reductions in ultimate strength at high height ratios have been reported [21].
