# Installation of a Pilot Experimental Trench at the Little Forest Legacy Site

Report No                            ANSTO / E-786

# **Installation of a Pilot Experimental Trench at the Little Forest Legacy Site**

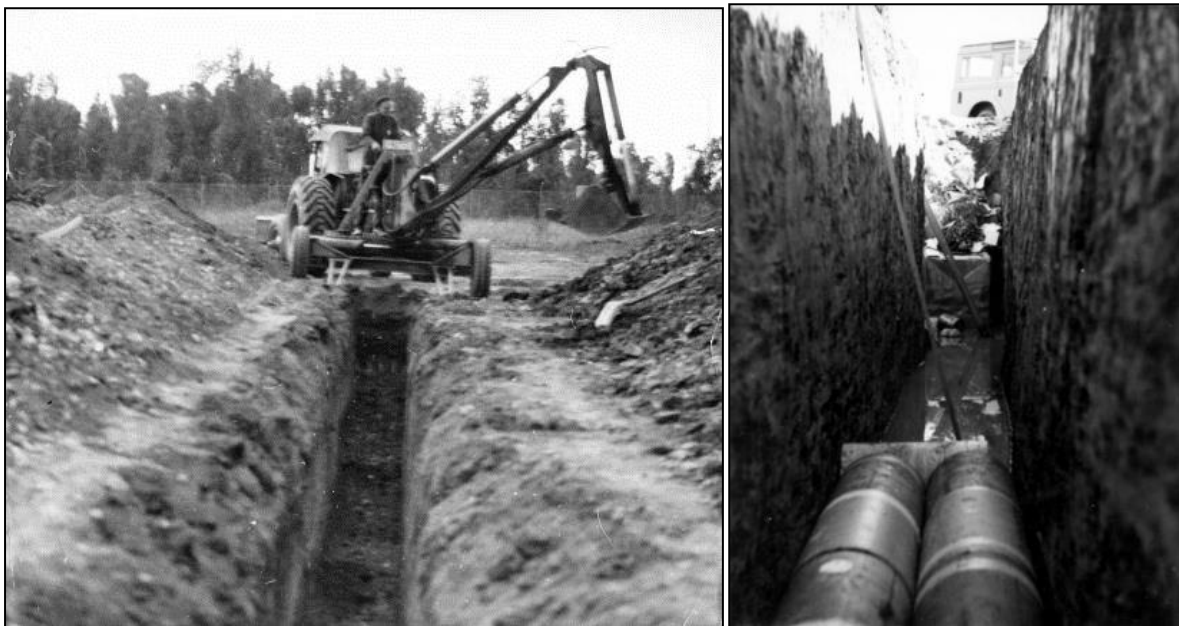
**Figure 3. Contemporary photographs of (a) trench excavation and (b) trench disposals. In (b) the presence of a significant amount of water is visible beyond the drums in the foreground [this is more obvious in the original print].**

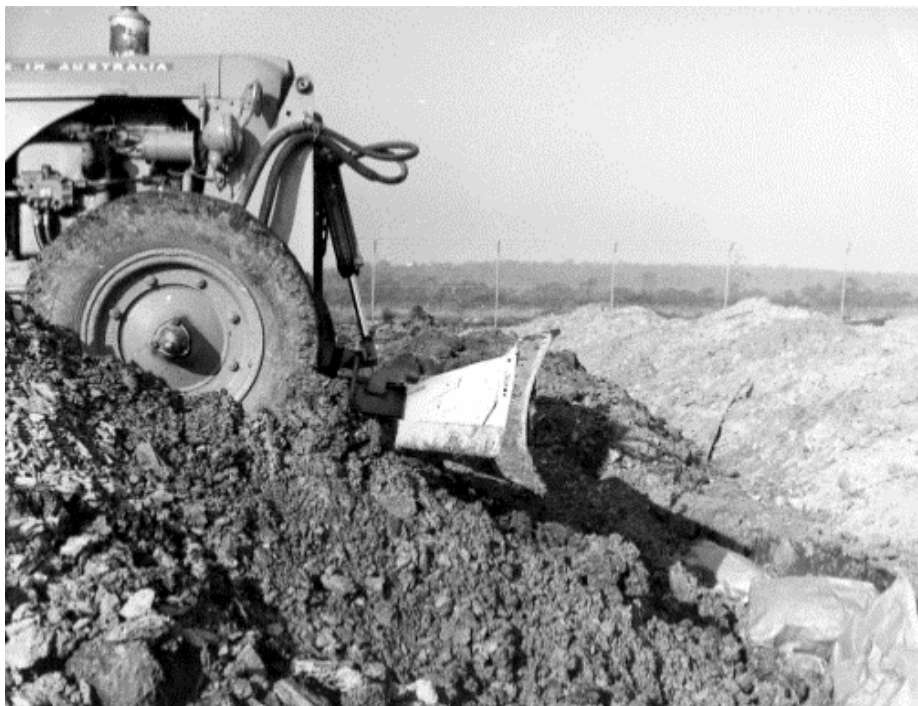
**Figure 4. Photograph of soil being pushed into filled trench.**

It appears that the close spacing of the trenches and the amount of material excavated resulted in considerable piles of soil accumulating near the trenches on the surface (Figure 4).

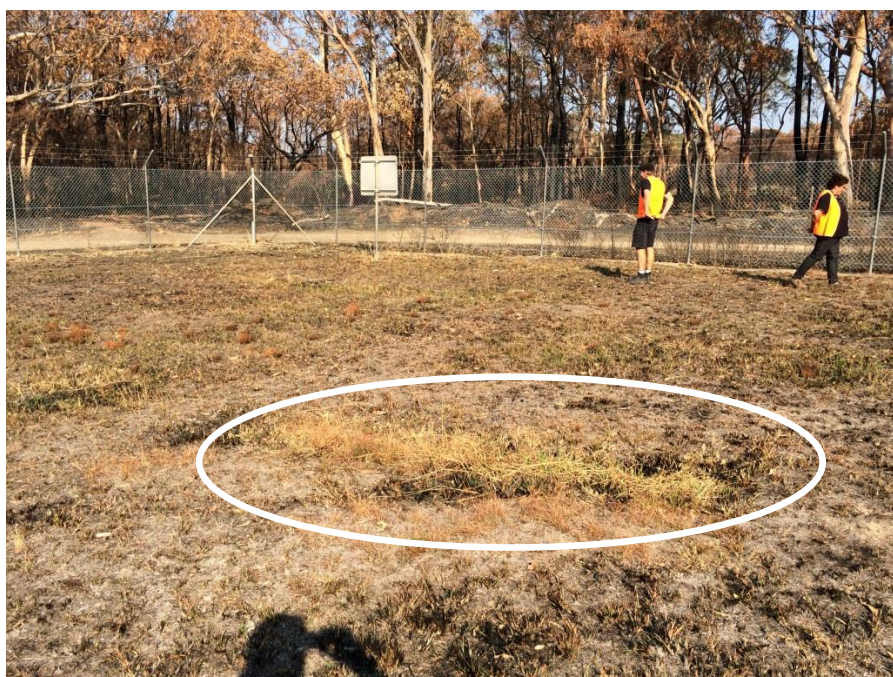
**Figure 6. Apparent position of a trench excavated in 1959. This photograph was taken in May 2018 following a bushfire near the site which partially burned the fenced area. This is likely to be the location of the trench at the bottom right of Figure 5.**

The trenching allowed some observations to be made on the hydrology of the site, including field measurements undertaken in 1959 (Figure 5). Based on these observations, one AAEC scientist concluded that “as the water level rises after rain it is obvious that the trenches will fill with water that will become contaminated with leached out activity from the waste”<sup>7</sup>. Thus, the field trenching experiments raised some concerns about the performance of the (as yet) unconstructed trenches. The locations of some of the experimental features installed in 1959 (trenches and “test-holes”) are still visible at the Little Forest site (Figure 6).

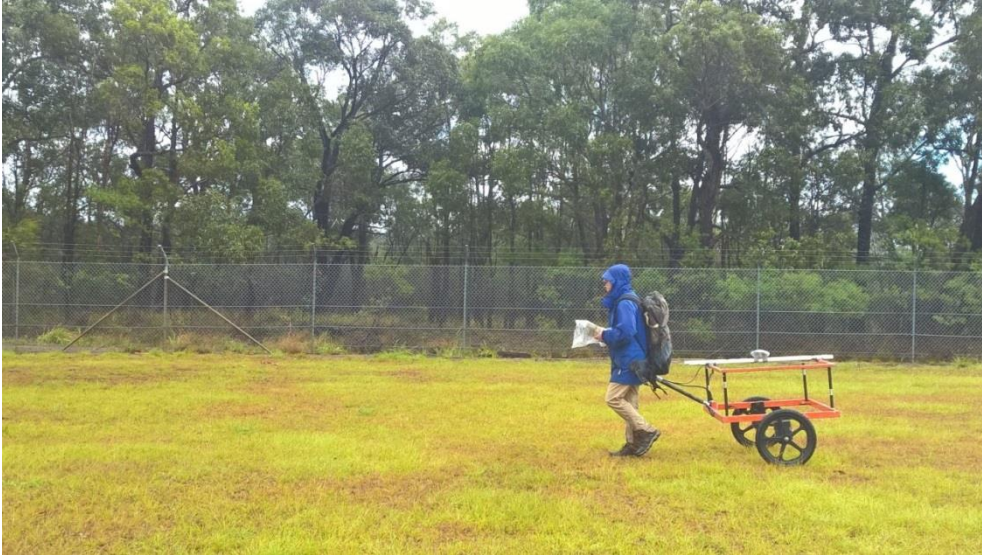
Figure 9. EM61 survey equipment over proposed test trench area.

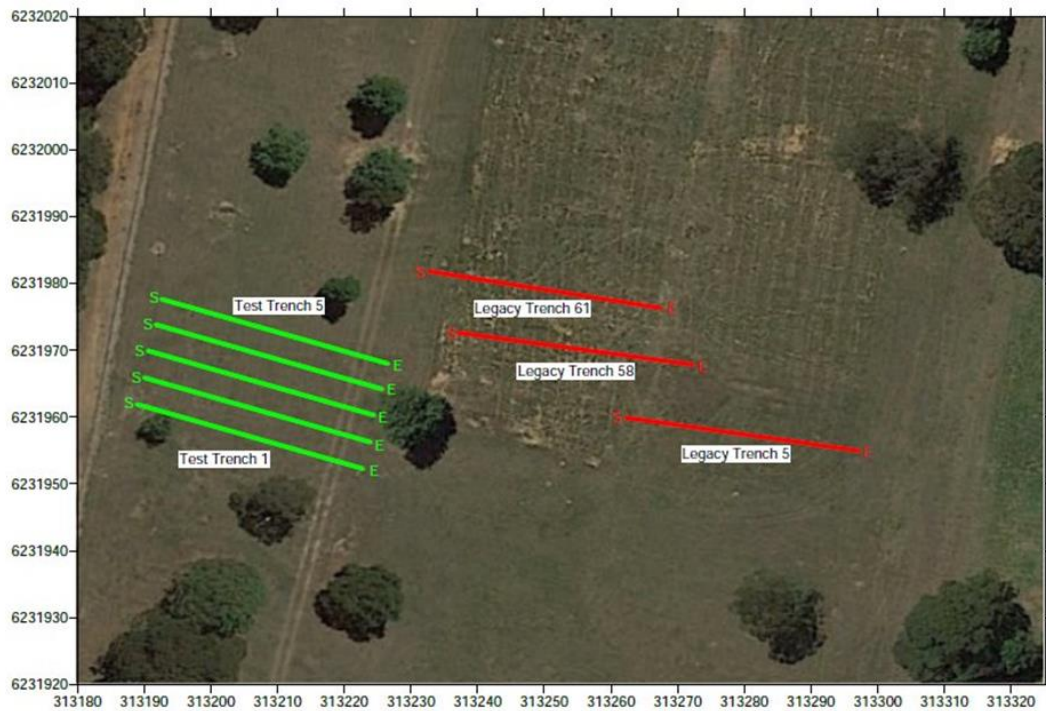
**Figure 12. Close-spaced resistivity survey lines showing the legacy trench area (red) and the proposed experimental test trench areas (green).**

As an additional objective, the resistivity equipment was also used to record pre-excavation conditions over the locations of the experimental trenches. The locations of the ERT survey lines chosen for the work are shown in Figure 12.

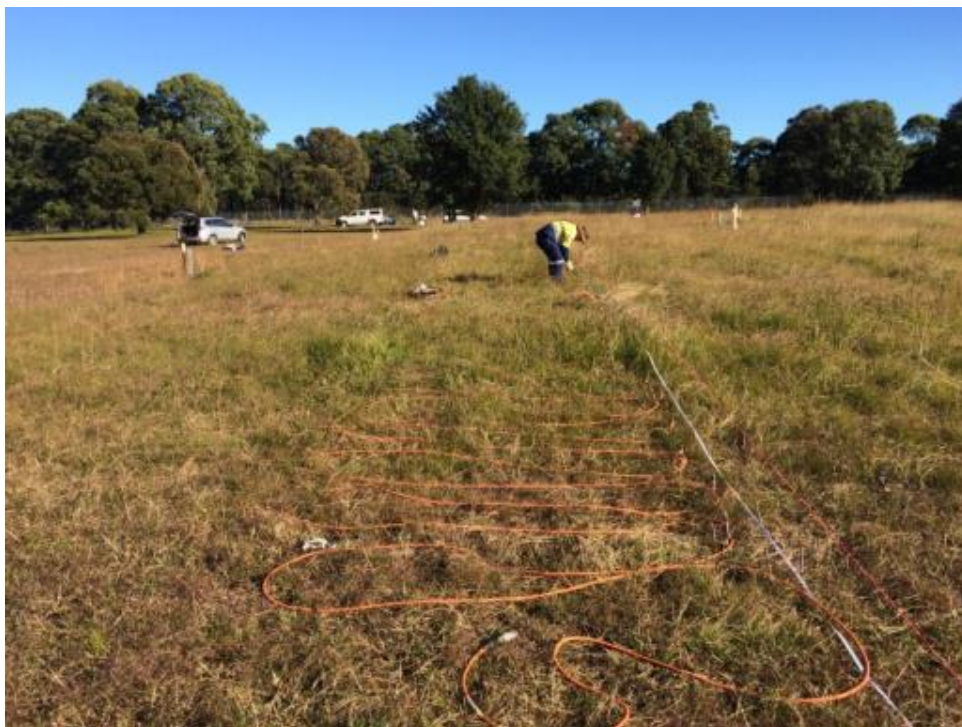
**Figure 13. Close spaced array used for resistivity measurements**

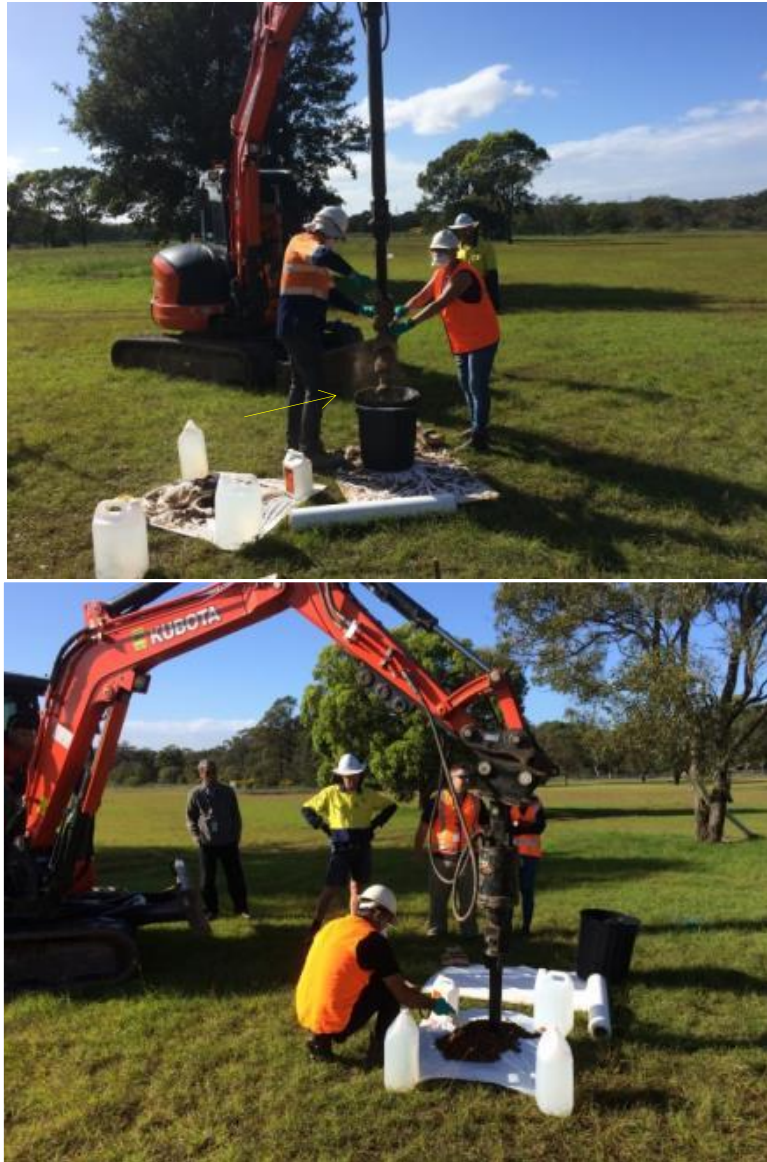
**Figure 18. (a) Preliminary augering to ascertain absence of local contamination. Note the puff of dust (LHS). This shows how dry the shaly-clay layer is, despite several weeks of prior rainy weather. (b) Sampling from auger. External gamma screening on all samples revealed no contamination above background**

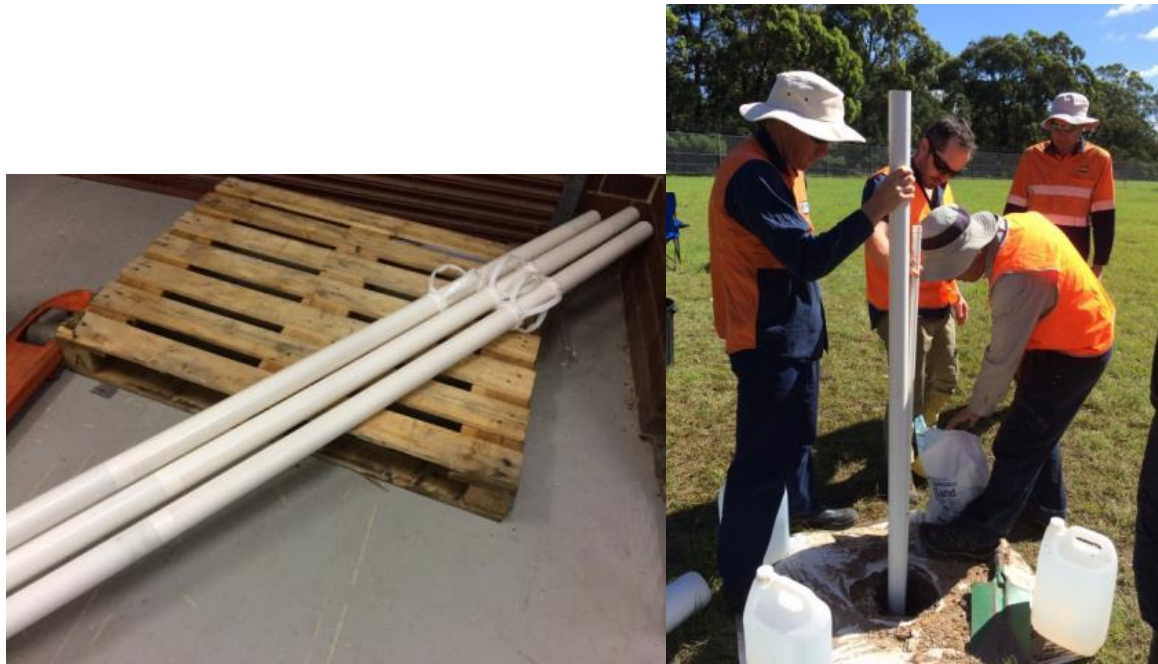
**Figure 19. (a) Pre-constructed piezometer, note the slotted section and spacers to keep it central in the hole. (b) Installation of sand-pack around slotted section. For more details, see Figure 25.**

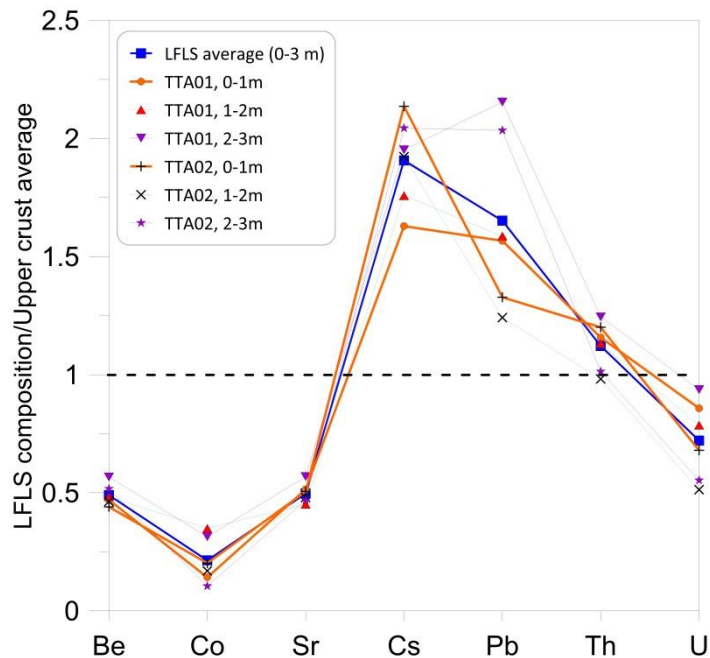
**Figure 20. Relative enrichment or depletion between concentrations in LFLS trench samples (0-3 m) and average upper crust compositions (McLennan, 2001) . The dashed horizontal line separates those elements that are enriched at LFLS, compared to Upper crust average compositions (Cs, Pb, Th) from those that are depleted (Be, Co, Sr, U).**

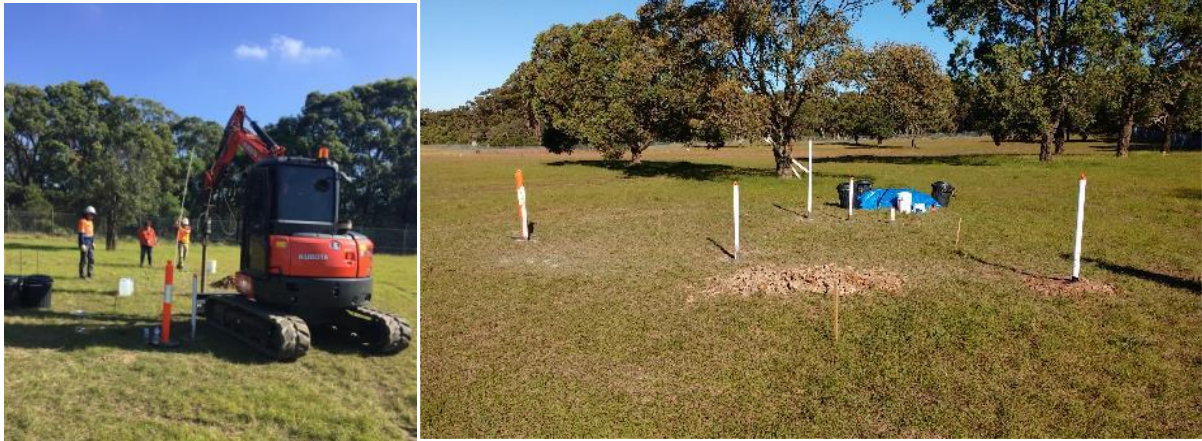
**Figure 22. (a). Augering for installation of piezometers 15 (b) Completed layout of new piezometers looking south-easterly (25/05/17).**

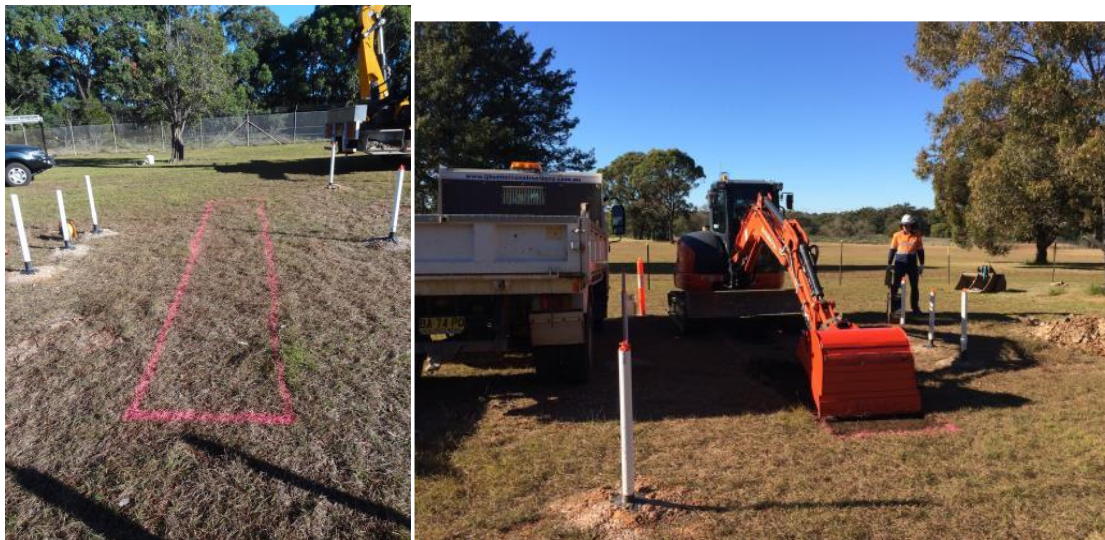
**Figure 26. (a) Marking out the area for the pilot trench. (b) commencement of excavation (Monday 26<sup>th</sup> June).**

The progress of trench construction is documented in Figure 26 to Figure 31. Please refer to these figures and captions for brief explanations. Note that the shoring boxes seen in many of the figures were part of the safety requirements for this operation (as discussed in Section 8 of this report). After installation of in-trench sampling ports and piezometers, the trench was filled with river gravel to provide a uniform composition and maintain structural stability (Figure 32 to Figure 34). The properties of this material are summarised in Table 6.

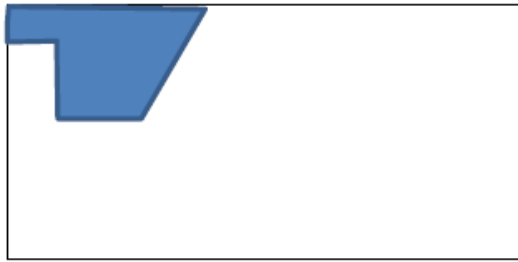
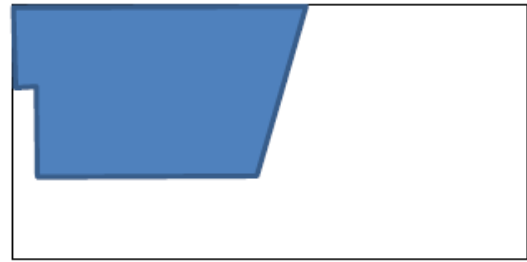
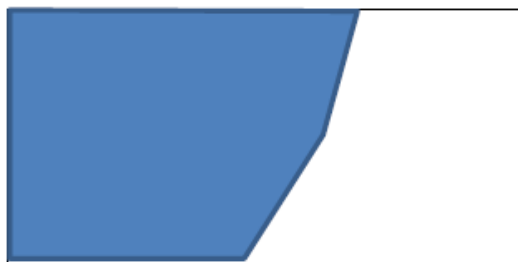
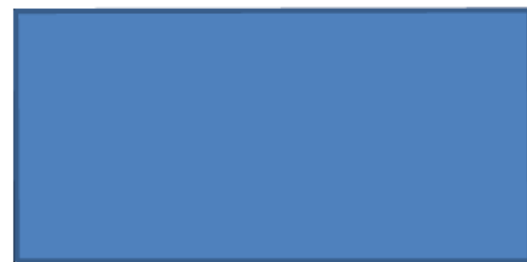
Day 1. Monday 26 June

Day 2. Tuesday 27 June

Day 3. Wednesday 28 June

Day 4. Thursday 29 June

**Figure 27. Schematic of daily progress on trench installation (section from west to east). Sections in blue correspond to excavated material and blue hatching to gravel infill (added on Friday 30<sup>th</sup> June and Tuesday 4<sup>th</sup> July). The last two panels show installed piezometers.**

The approximate progress of the trench excavation depth after each day is shown schematically in Figure 27. On day 1, the process commenced, progressively exposing horizontal and vertical faces, and obtaining intact cores from these depths using pre-manufactured metal tubes (see also Figure 37).

of the pilot trench. Thus, the comparison with Figure 27 is particularly instructive. The preceding discussion is based on a qualitative interpretation of the raw data presented in Figure 56.

2. Groundwater levels at TT06 began to decline rapidly at midday 27<sup>th</sup> June 2017, when the depth of excavation reached approximately 2 m (Figure 27). It is possible that the excavator broke through competent layers at approximately 131.2m to 132.4m AHD (1.6m to 1.8m depth) around midday resulting in a loss of confinement at TT06 and drainage of water from the vicinity of TT06 into the trench. A loss of confinement at TT06 would be consistent with the field observations that the lower layers of weathered shale appeared saturated from below.

4. On the 28<sup>th</sup> June 2017 at 10:00 groundwater levels in TT06 declined again when the excavation depth reached ~3 m (Figure 27) in the western end, followed approximately 1 hour later by TT03, TT04 and TT05.

5. On 29<sup>th</sup> June 2017 at 14:45, after the excavation depth reached ~3 m in the eastern half of the test trench (Figure 27), there was a small sudden drop in groundwater pressure at TT02 followed immediately by an increase in the rate of pressure decline in all monitoring piezometers. This suggests connectivity between the eastern end of the trench and TT02. Quantitative analysis of the lag times for this pressure effect to be observed at other nearby piezometers could provide further estimates of the relationships between key aquifer properties (e.g. hydraulic conductivity and storage).

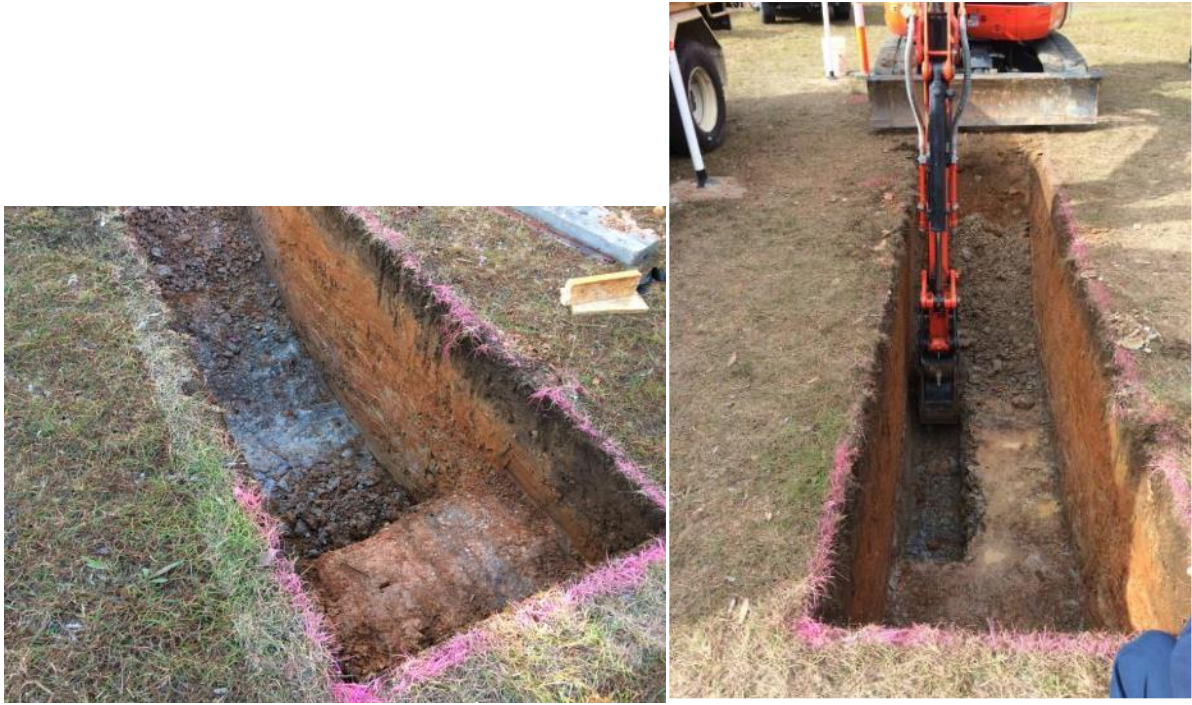
**Figure 28. Progress of the trench early on Tuesday 27<sup>th</sup> June.**

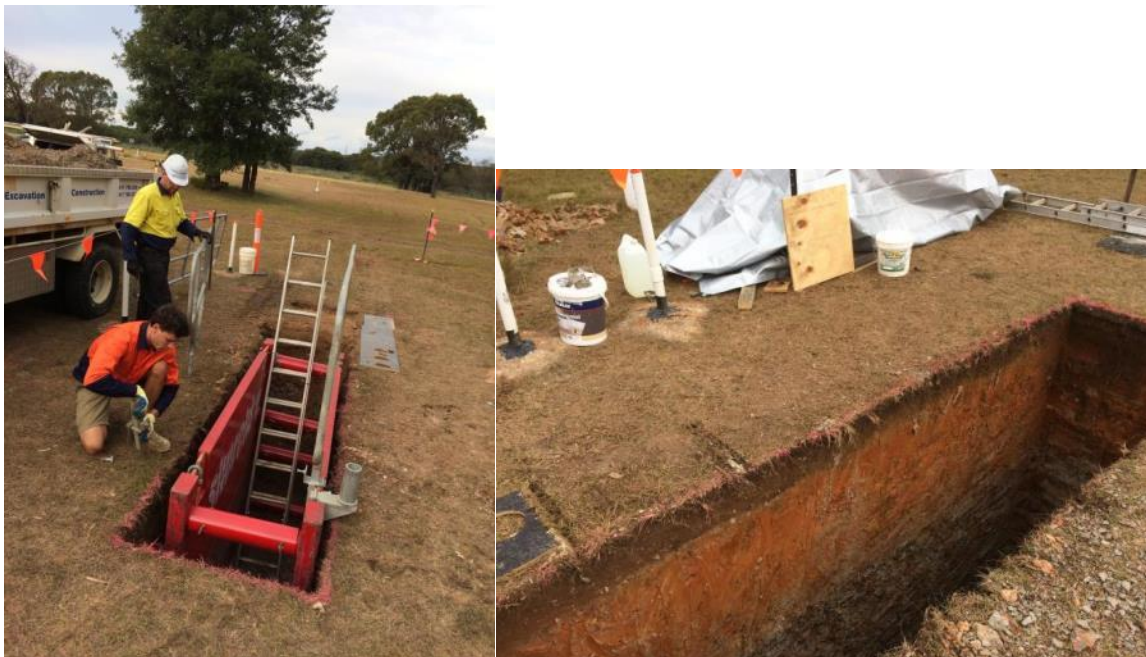
**Figure 29. (a) First installation of a trench shoring box in the partially excavated trench (Tuesday 27<sup>th</sup> June, 3 pm). (b) Photograph of trench with shoring box removed (Wed 28<sup>th</sup> June, 1 pm).**

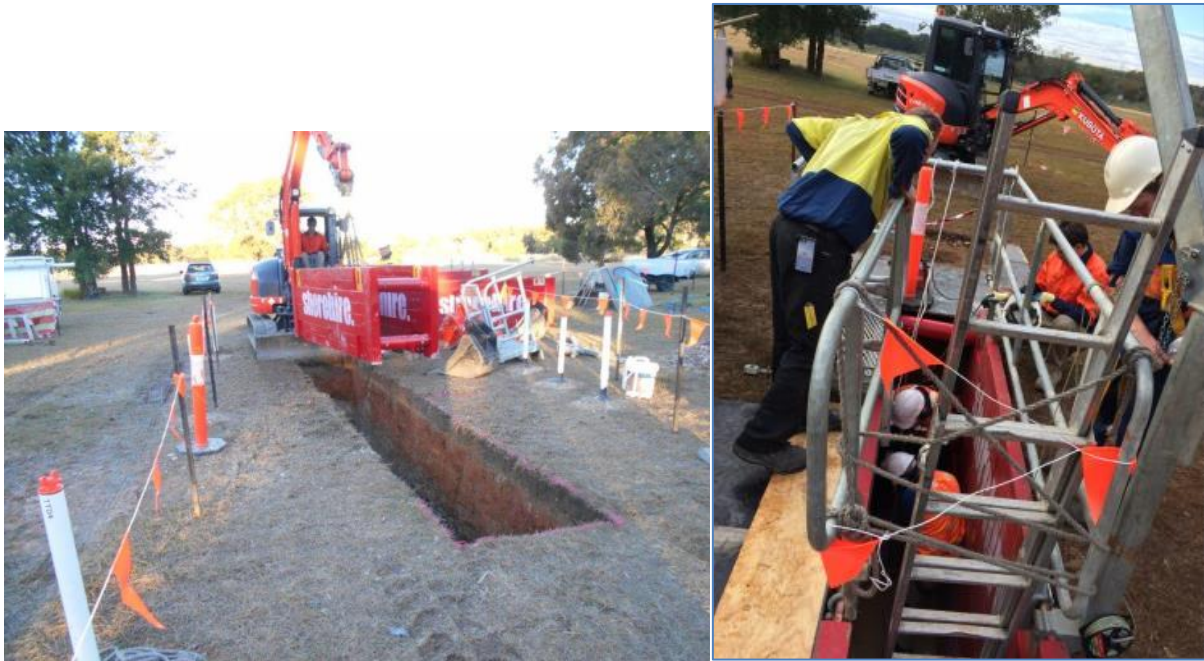
**Figure 30. (a) Installation of a shoring box in the completed trench (Thursday afternoon, 29<sup>th</sup> June). (b) In-situ inspections of completed trench within shoring box (Friday 30<sup>th</sup> June, 10 a.m.).**

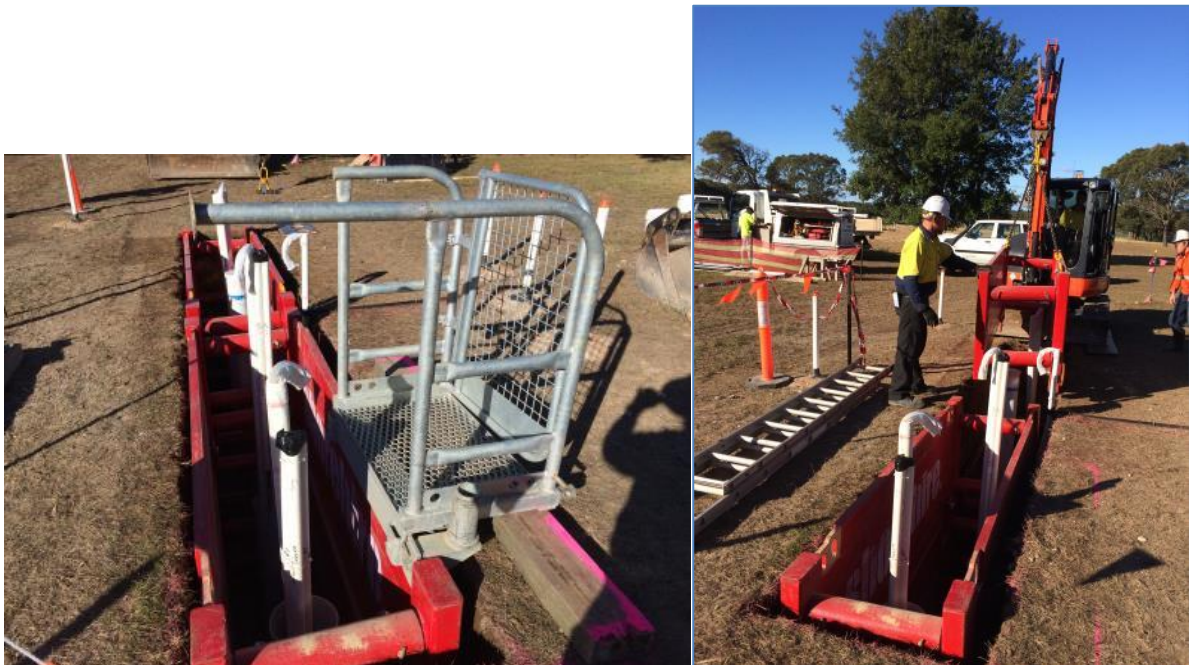
**Figure 31. (a) Installation of the sampling tubes and in-trench piezometers (Friday, 30<sup>th</sup> June, 2 pm). (b) Removal of shoring boxes (Friday 30<sup>th</sup> June, 3 pm). The removal of the shoring boxes was a delicate operation, with special care being taken to avoid disturbing installed piezometers.**

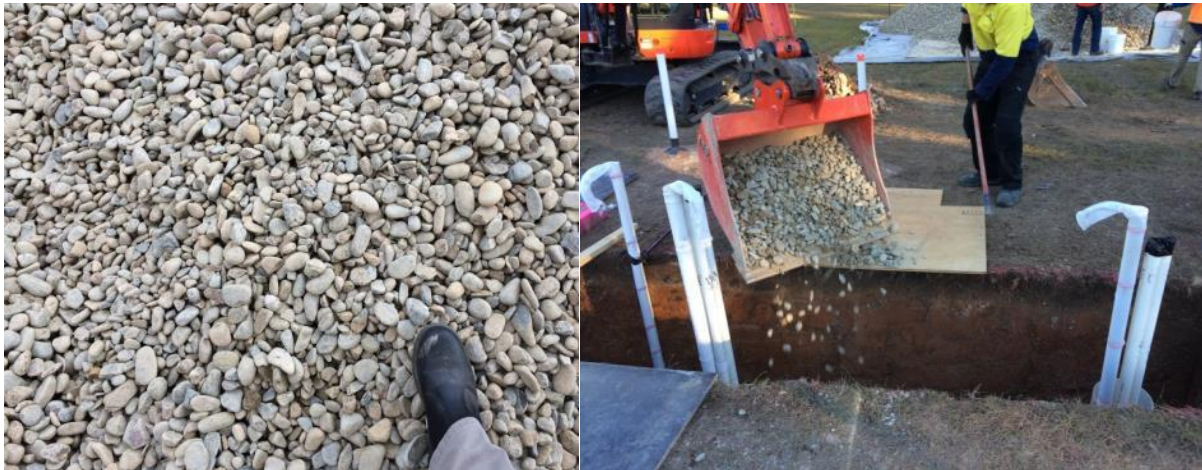
**Figure 32. (a) River gravel used to fill the pilot trench. The pebbles were nominally in the range 2 cm to 4 cm in size. (b) Commencement of filling of the trench (Friday 30<sup>th</sup> June, 3:30 pm). On Friday the trench was filled to within 1.5 m of the ground surface, at which point it no longer met the definition of a confined space.**

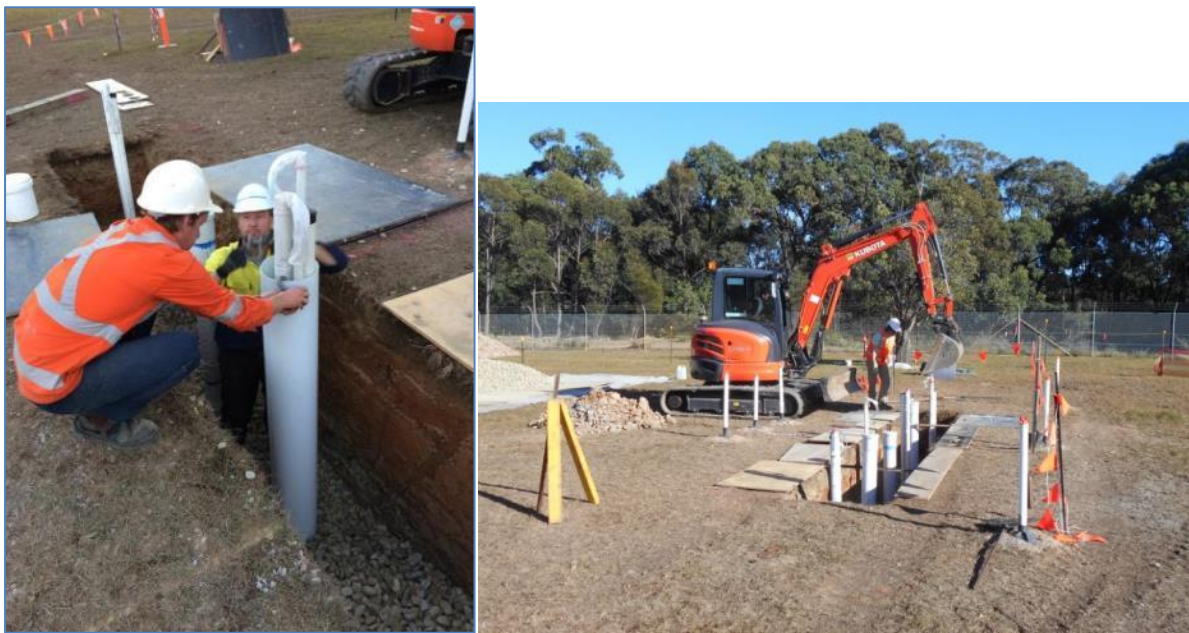
**Figure 33. (a) The removal of some PVC pipes which had protected the piezometers when the stones were being emplaced. (b) Final filling of the trench on Tuesday 4<sup>th</sup> July. Prior to this time, two additional large diameter sampling experimental tubes (XP1 and XP3) were installed to a depth of ~2 m. See also Figure 50.**

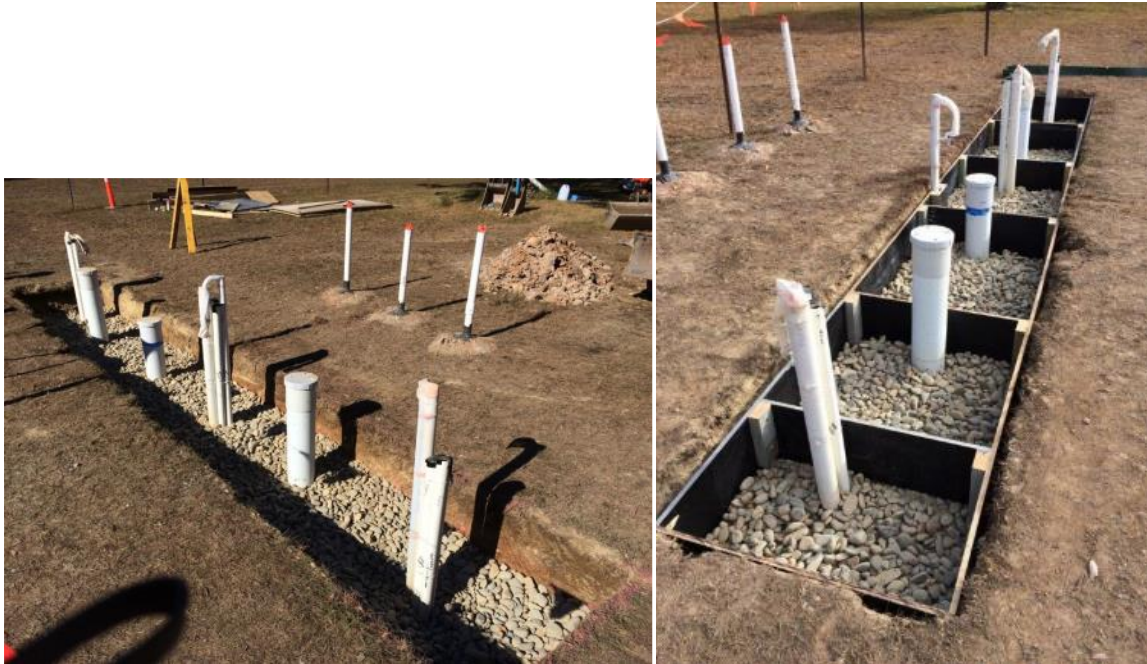
**Figure 34. (a) Final state of the trench after filling with pebbles to within approximately 300 mm of ground surface (b) After installation of plywood to protect the side walls of the trench. Following extensive discussion it was decided not to cover the pebbles with a soil layer as this would have introduced a flux of particles into the pebbles which would have progressively affected hydraulic properties. The option remains to install a soil cover at a later date if desired.**

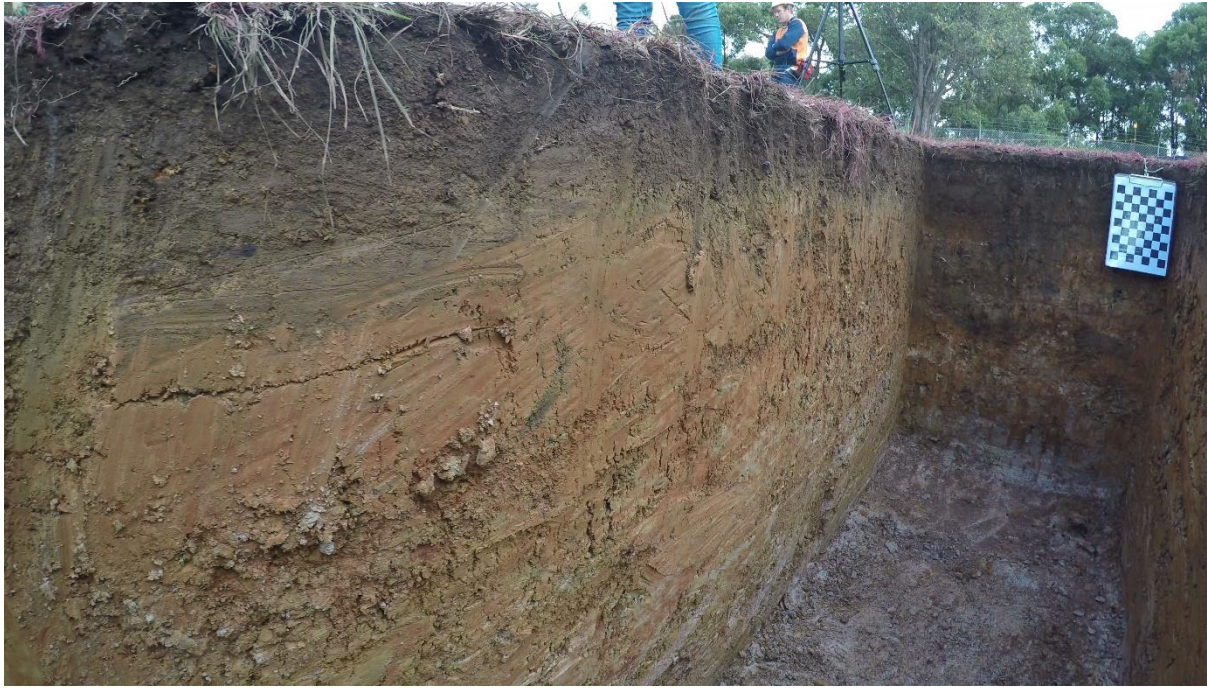
**Figure 36. Southern Wall of Pilot Trench.**

The top 1.25 m of a soil profile from the trench is shown in Figure 35. Qualitatively the profile is similar to that previously observed in nearby locations (Figure 17). This photograph also shows some metal tubes inserted for the purpose of obtaining intact samples. A view of the excavation of the trench is shown in Figure 36. Some of the obtained samples are shown in more detail in Figure 37 and Figure 38.

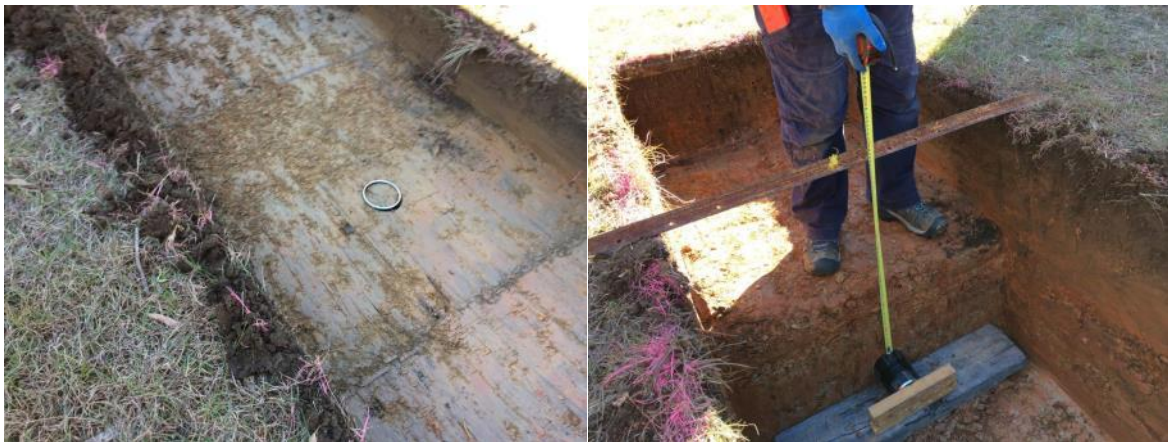
**Figure 37. Photograph of sampler for intact materials for both (a) vertical cores (b) horizontal cores. Intact cores could only be obtained by this method for depths to ~1.1 m below ground level. Beyond this depth, the less-weathered shale materials fractured when trying to insert the steel corers.**

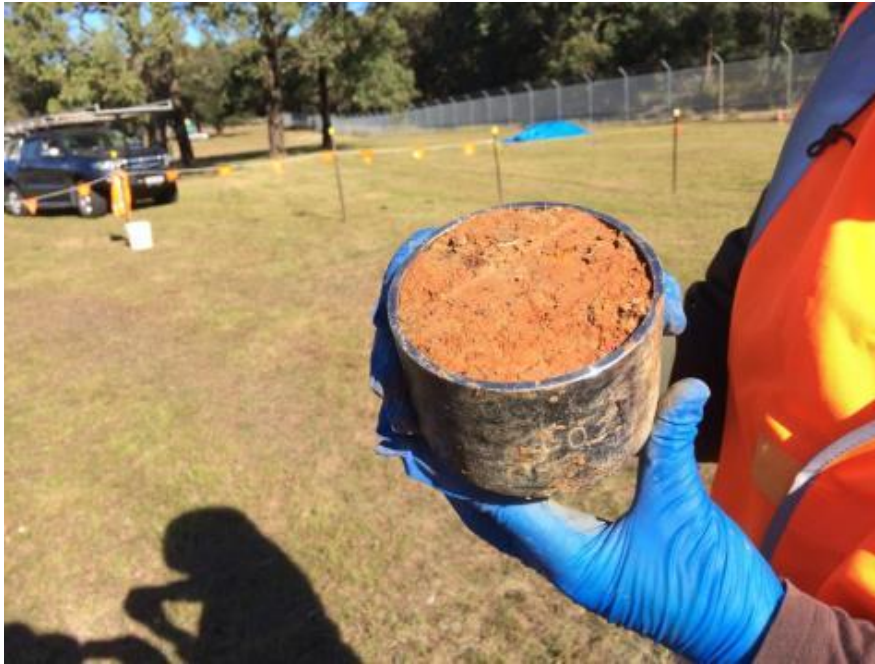
Figure 38. Example of intact core obtained from the red clay layer.

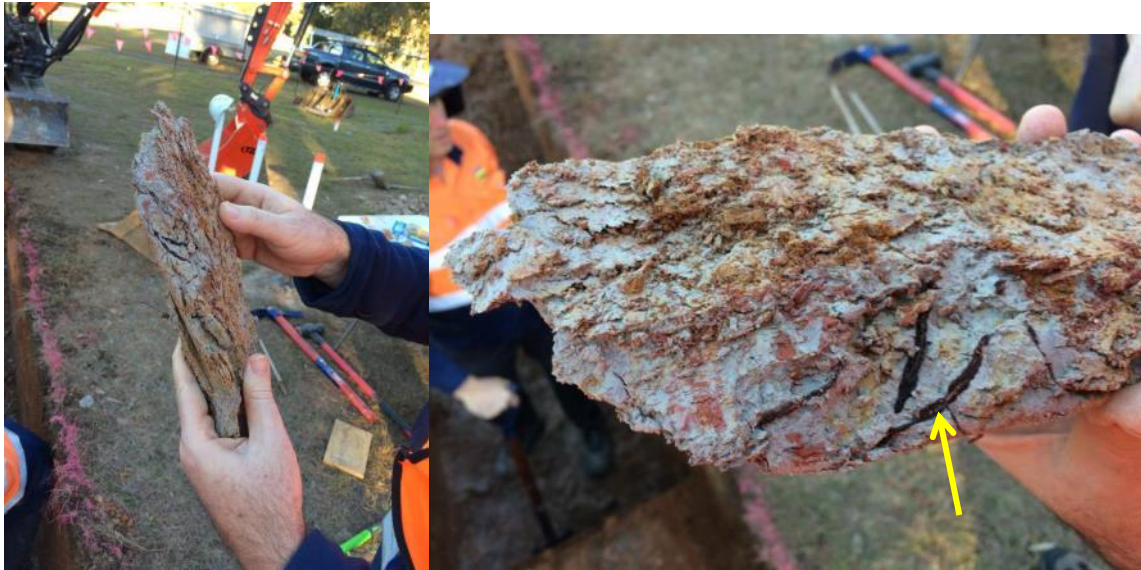
**Figure 40. Photographs of a sample from the partially weathered shale layer (~ 1.1 m below ground level) which contained tree roots.**

Examples of geological samples obtained are shown in Figure 39 to Figure 43. Of particular importance to note is the presence of tree roots in many samples from 2.5 m or greater depth (Figure 42). This is considered to be of significance because of the potential for tree roots to penetrate the waste trenches (at comparable depth) as well as the possibility of forming preferential pathways through some of the less permeable layers. Tree roots were encountered alive, dead and decomposed, and also burnt (i.e. charcoal). This results in enhanced macro-porosity and permeability around the tree roots. In one case the channels formed by a former-tree root were simply tested by pouring water through them, thereby demonstrating significant possibility to act as water conduits.

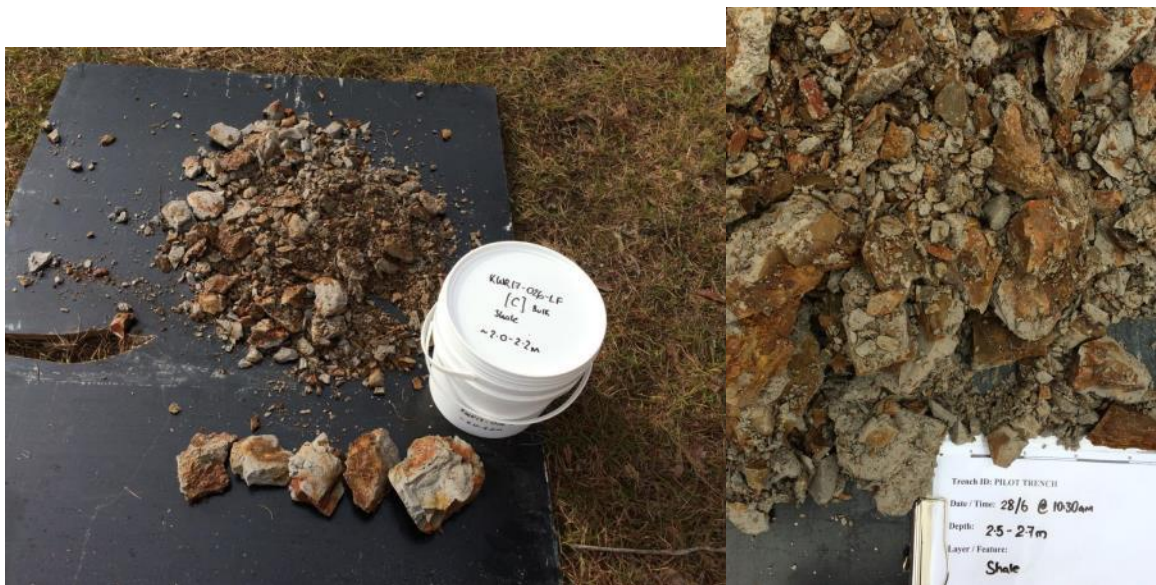
**Figure 41. Examples of less weathered samples (a) from 2.0 – 2.2.m and (b) from 2.5 to 2.7 m.**

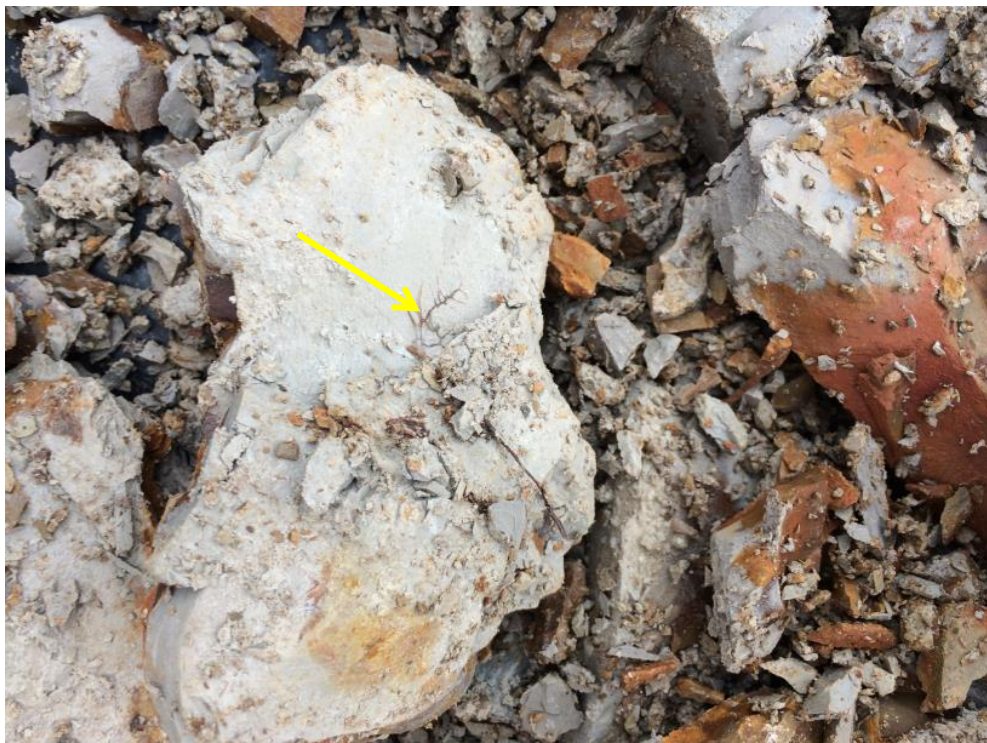
**Figure 43. Another example of a relatively unweathered sample containing a root. Towards the right of the image, iron staining along fracture planes indicates a potential water flow path.**

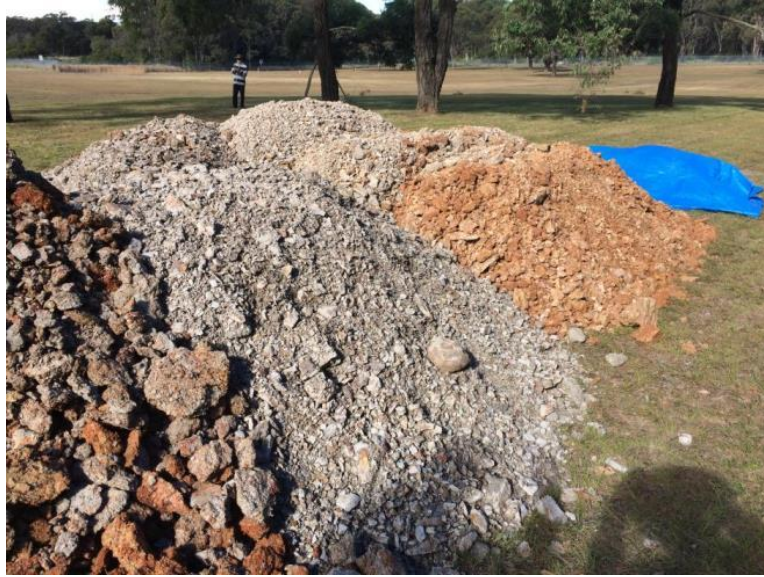
**Figure 44.** The piles containing material removed from the trench during the excavation, showing differences in coloration of materials from various depths.

The material from the trench was put aside for later use (Figure 44) with the topsoil stored separately. Note that more detailed geological and soil-profile information has been presented in previous reports (e.g. Hankin (2012)) and these profiles will be discussed in upcoming reports and papers.

The resistance of the deeper, more intact shale layers to our trenching equipment was considerable and it is arguable whether the 1960's operations would have penetrated deep into the shale if it was encountered. Furthermore, the amount of spoil generated (Figure 44), should be compared with Figure 62(a) and photographs in Figure 63. It should be taken into account that we constructed a single trench 6 m long, whereas the legacy trenches comprised over 70 trenches of nominal lengths of 25 m. This consideration (together with the photographic evidence) verifies the presence of large amounts of unconsolidated materials around the disposal

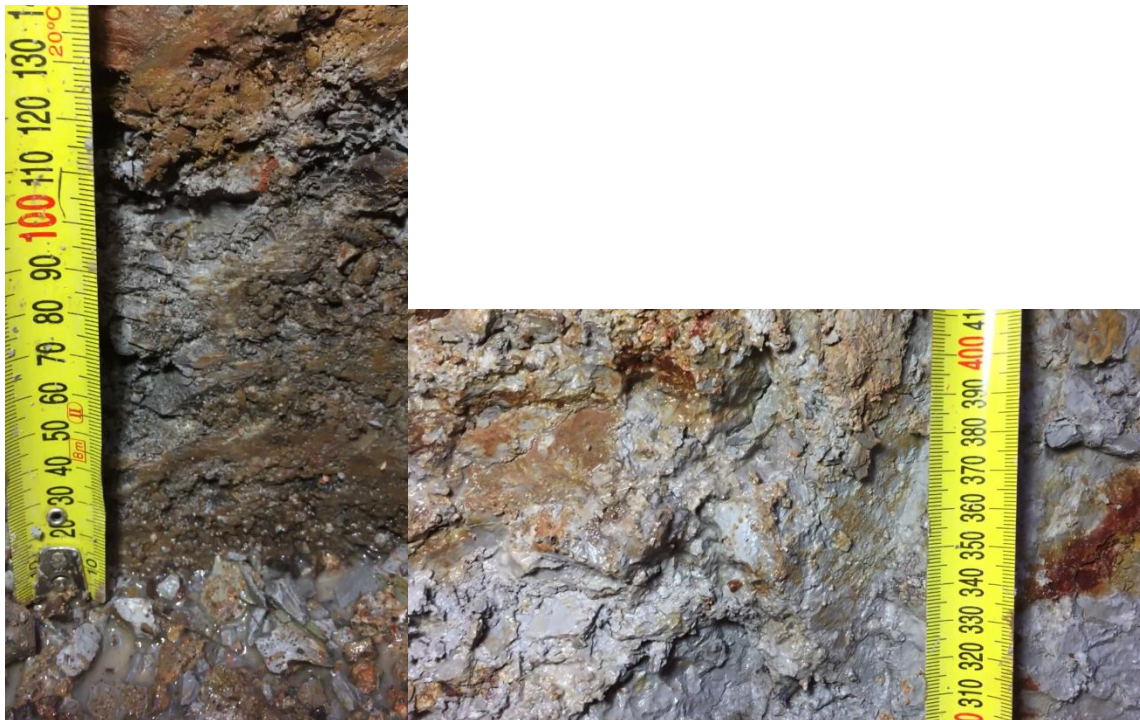
**Figure 45.** (a) Water accumulated in the base of the completed trench, southern side, western end (video still). Note the position of the measuring tape, with its end resting on the trench base. (b) Clear evidence of water entering the trench approximately 35 cm above the base at the western end (video still, depth ~2.65 m).

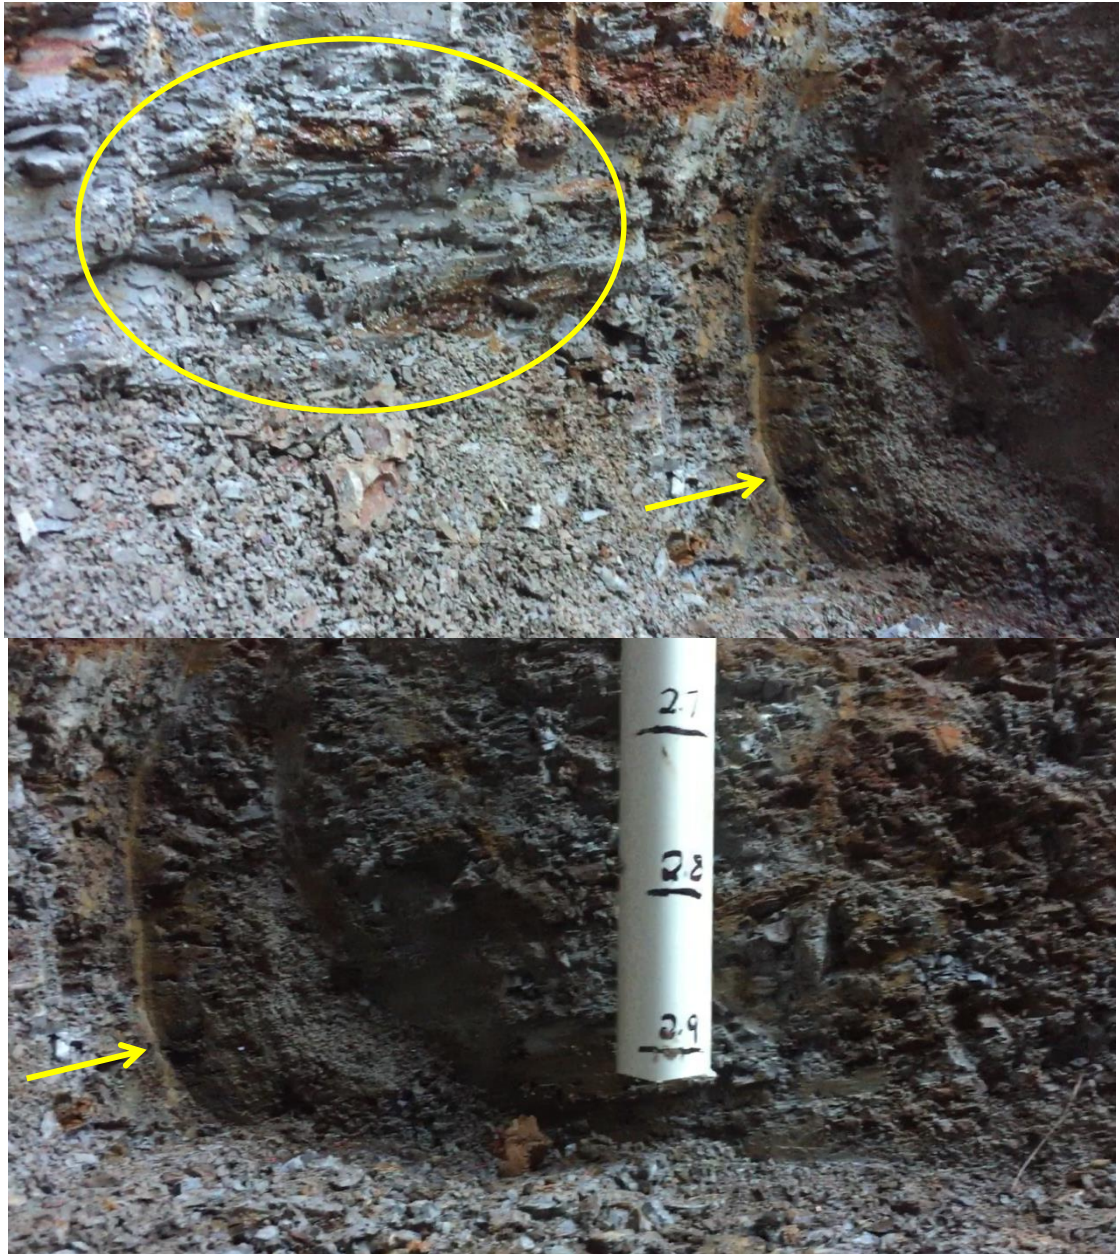
**Figure 46. Video stills from southern face of the trench, near the eastern end. Note that the upper image overlaps the lower image (the arrows show a common feature in the two photographs, which is possibly a scrape from the excavator). Both images were taken at approximately the same depth (2.8 m). There is clear evidence of water ingress at this depth (for example, in the circled area in the upper image).**
