# Installation of a Pilot Experimental Trench at the Little Forest Legacy Site

Report No                            ANSTO / E-786

# **Installation of a Pilot Experimental Trench at the Little Forest Legacy Site**

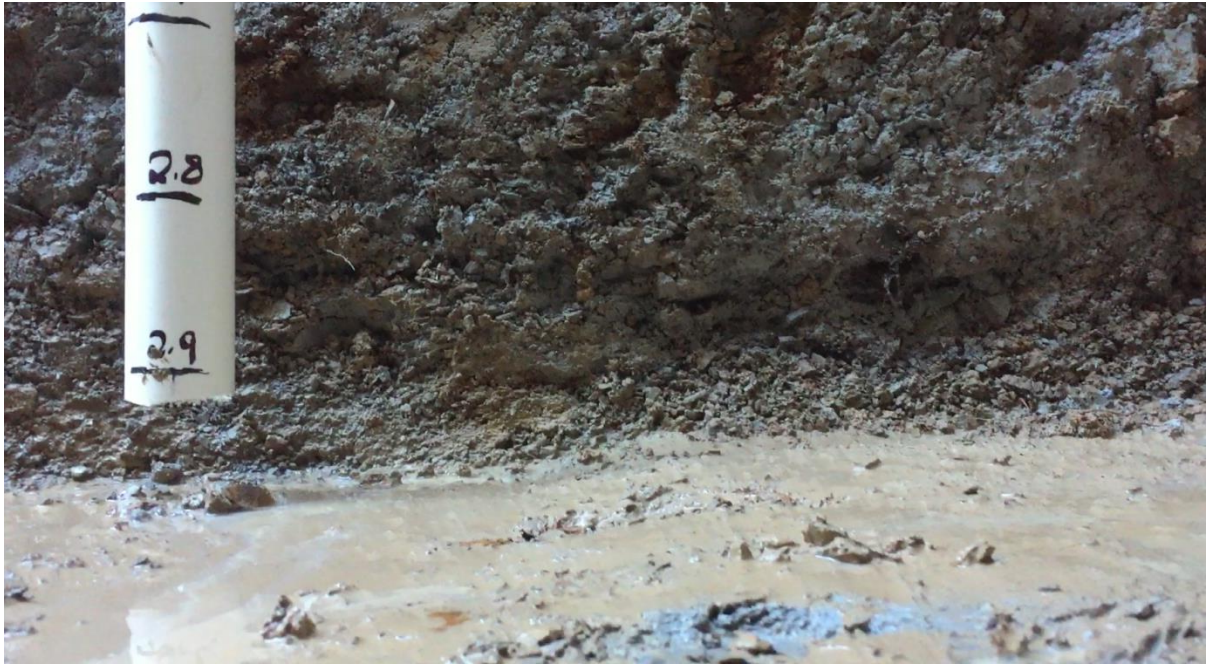
**Figure 47. Video still of the base of the trench (southern trench face, western end). Note that the trench sides appear to be more weathered but less fractured at the western end and the nature of the connectivity appears different from that shown in Figure 46.**

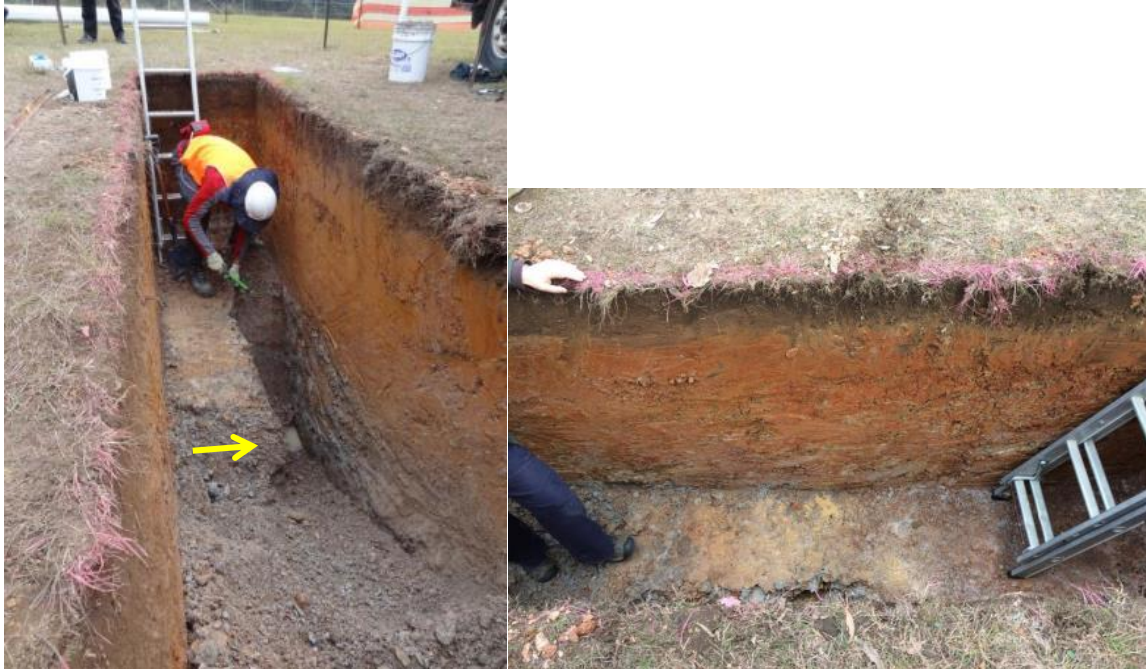
**Figure 51 (a) Photographs of a small amount of seepage observed from shallow layers (b) View of southern edge of trench after initial excavation (to ~1.2 m).**

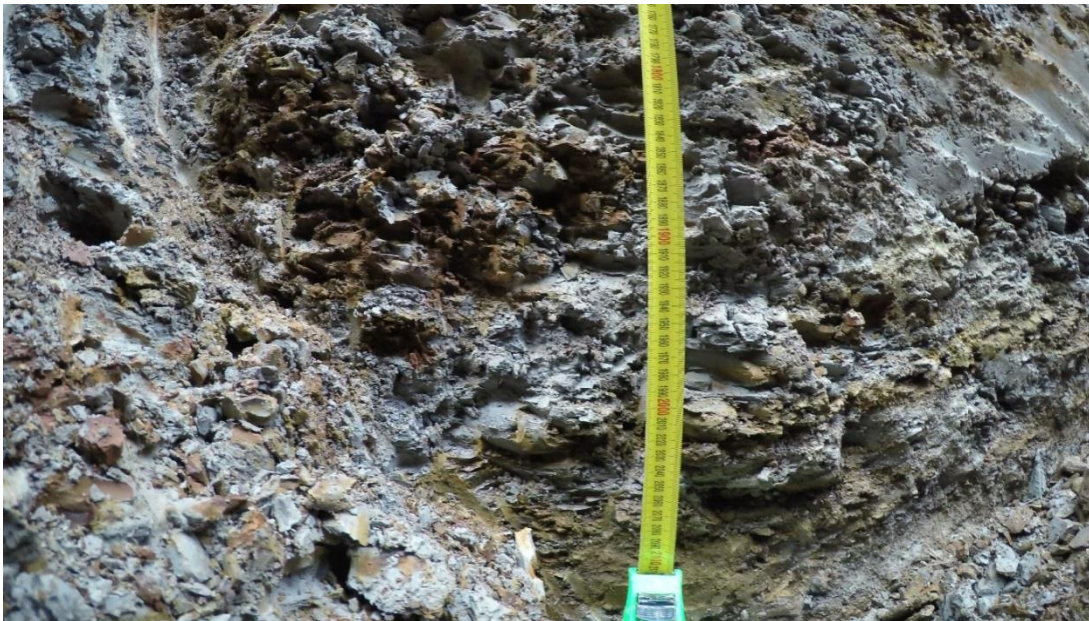
**Figure 52. Weathered shale layer (~1.7-2.0 m) immediately above a seepage accumulation zone (northern face of trench).**

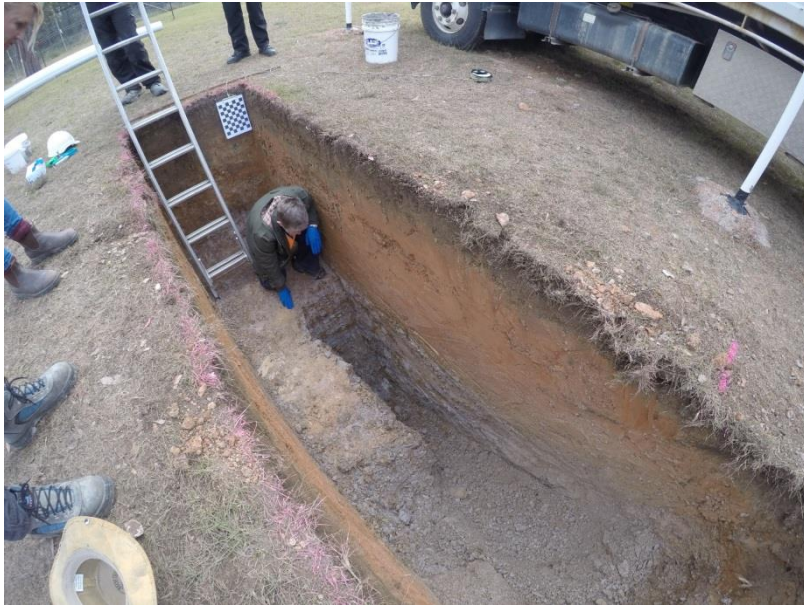
**Figure 53. Dr Cath Hughes inspecting seepage into Pilot Trench below the hard shale / siltstone layer at 2.15m depth**

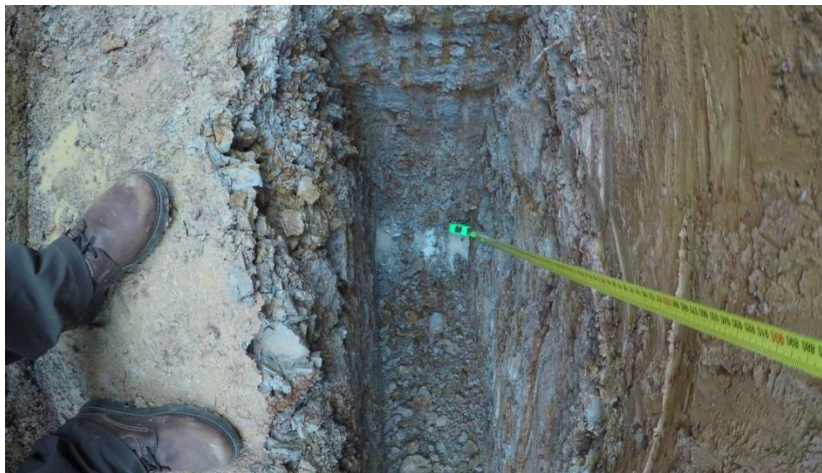
**Figure 54. Seepage into Pilot Trench below the hard shale/siltstone layer at ~2.15m depth**

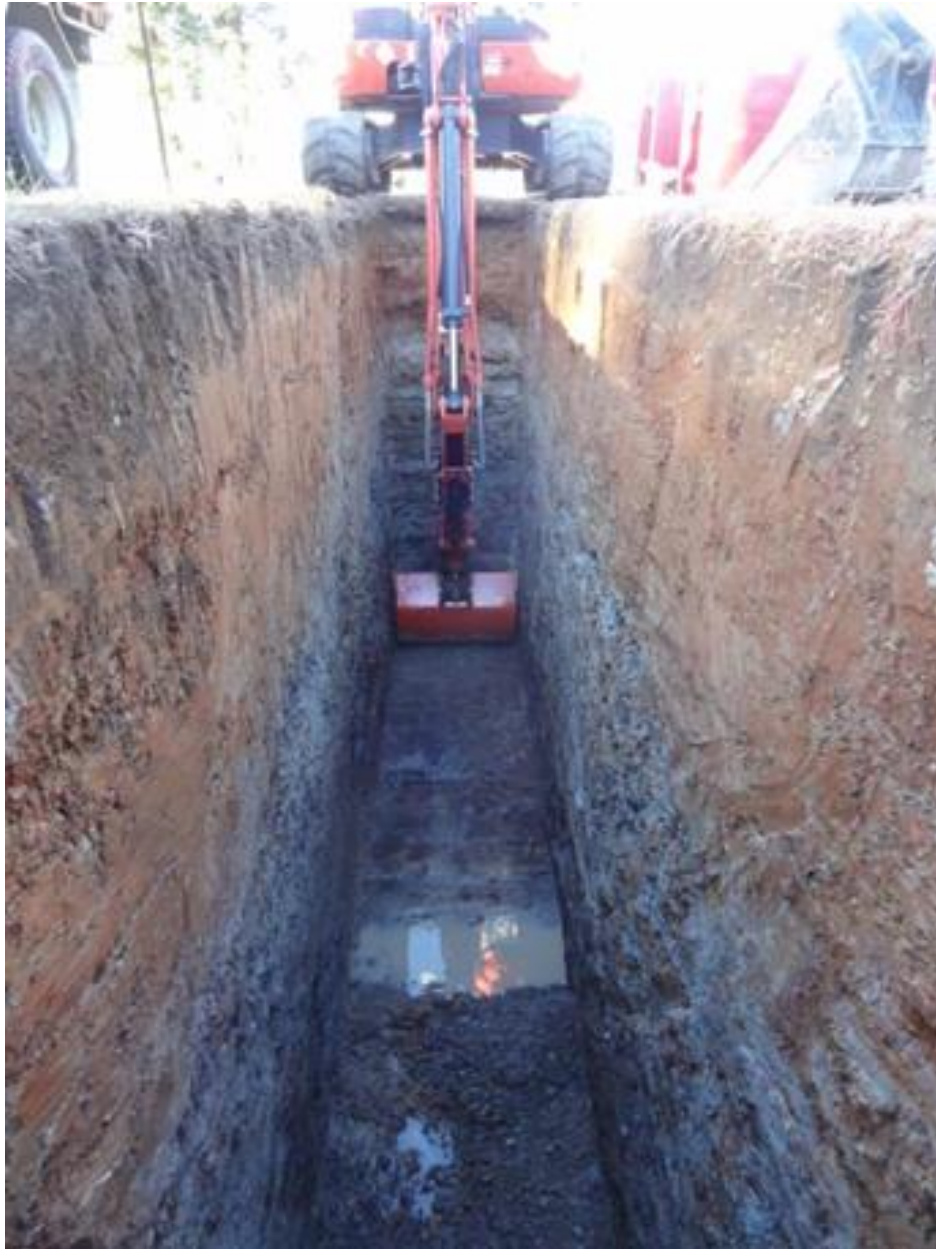
**Figure 55. Water accumulating in the trench from the wetter layers observed at depth. The colour gradation in the layers shows a transition from (red) clay to (grey) weathered shale. The boundary occurs between ~0.9 and ~1.1 m.**

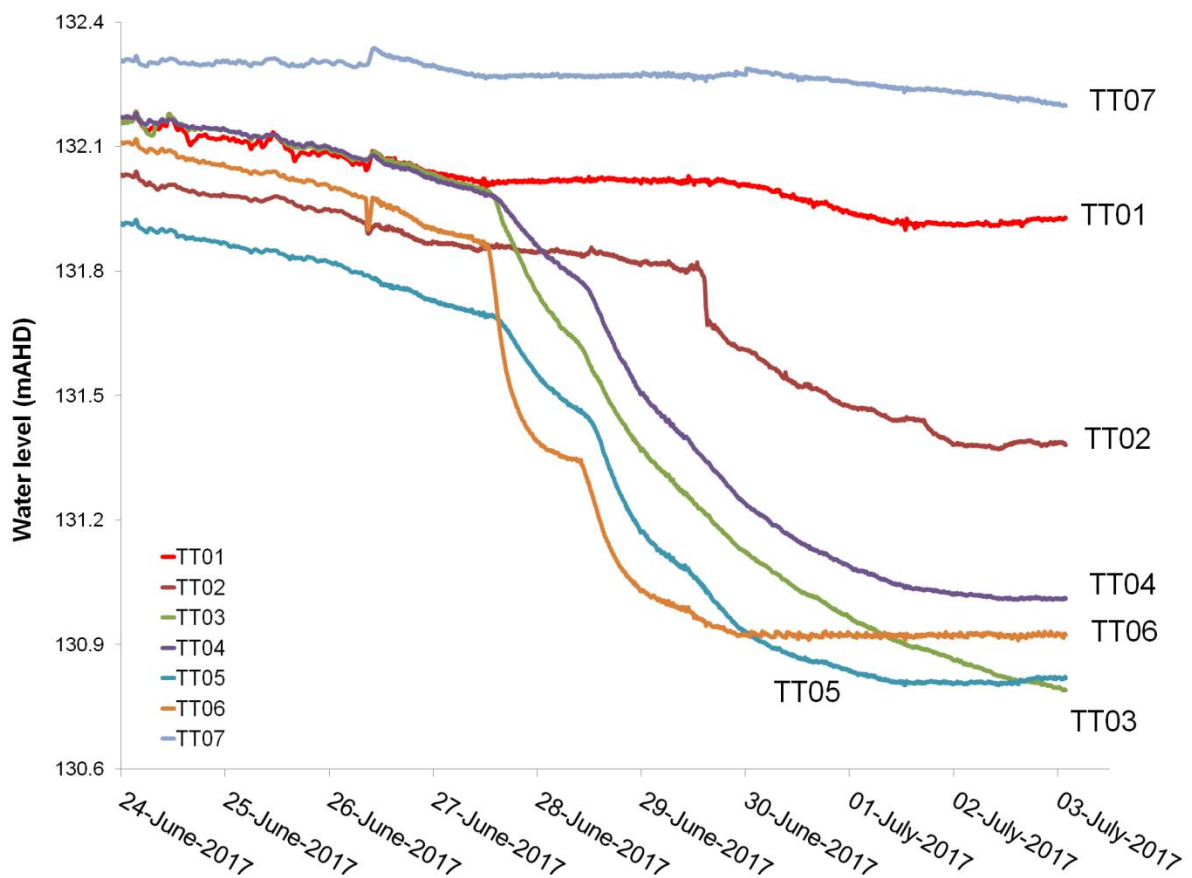
**Figure 56. Hydrographic response to excavation. The daily progress of the trench is shown on Figure 27, with clear hydrographic responses to each additional excavation step. The four up-gradient piezometers are TT01 (some distance away), TT02, TT03, and TT04 (all ~3m depth arranged E to W). The other measurement points (TT05, TT06, and TT07) are the nested set on the down-gradient side (4.4, 3.4 and 1.9 m depth respectively, as depicted in Figure 24). TTT02 responds later to the excavation of the eastern end of trench on 29<sup>th</sup> June (Figure 27). The lack of hydrologic response of the down-gradient shallow piezometer (TT07) is noticeable. Note that the high water level in this borehole is due to the addition of water during Lugeon testing (see Figure 58).**

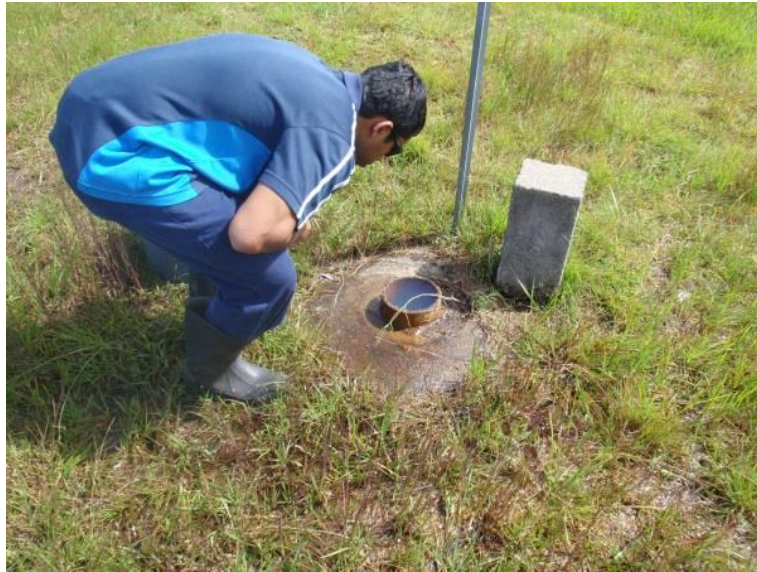
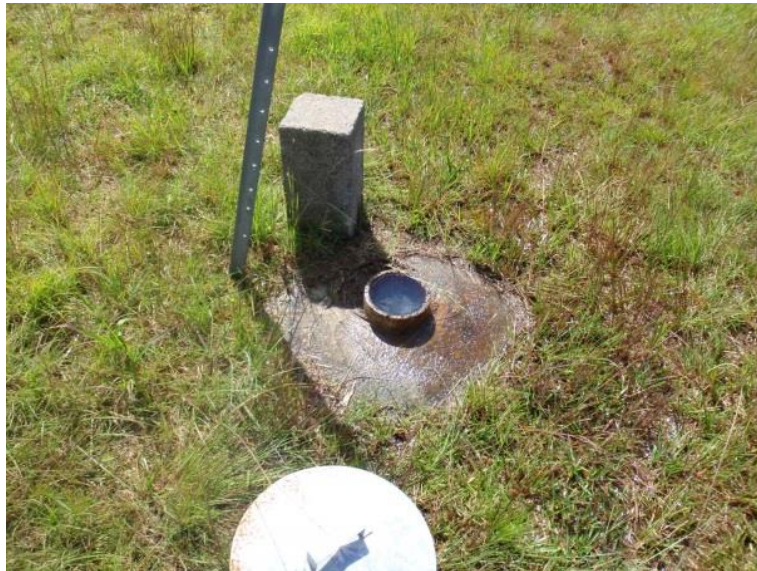
**Figure 57. Borehole OS3 after extreme rainfall event showing artesian behaviour (9 March, 2012).**

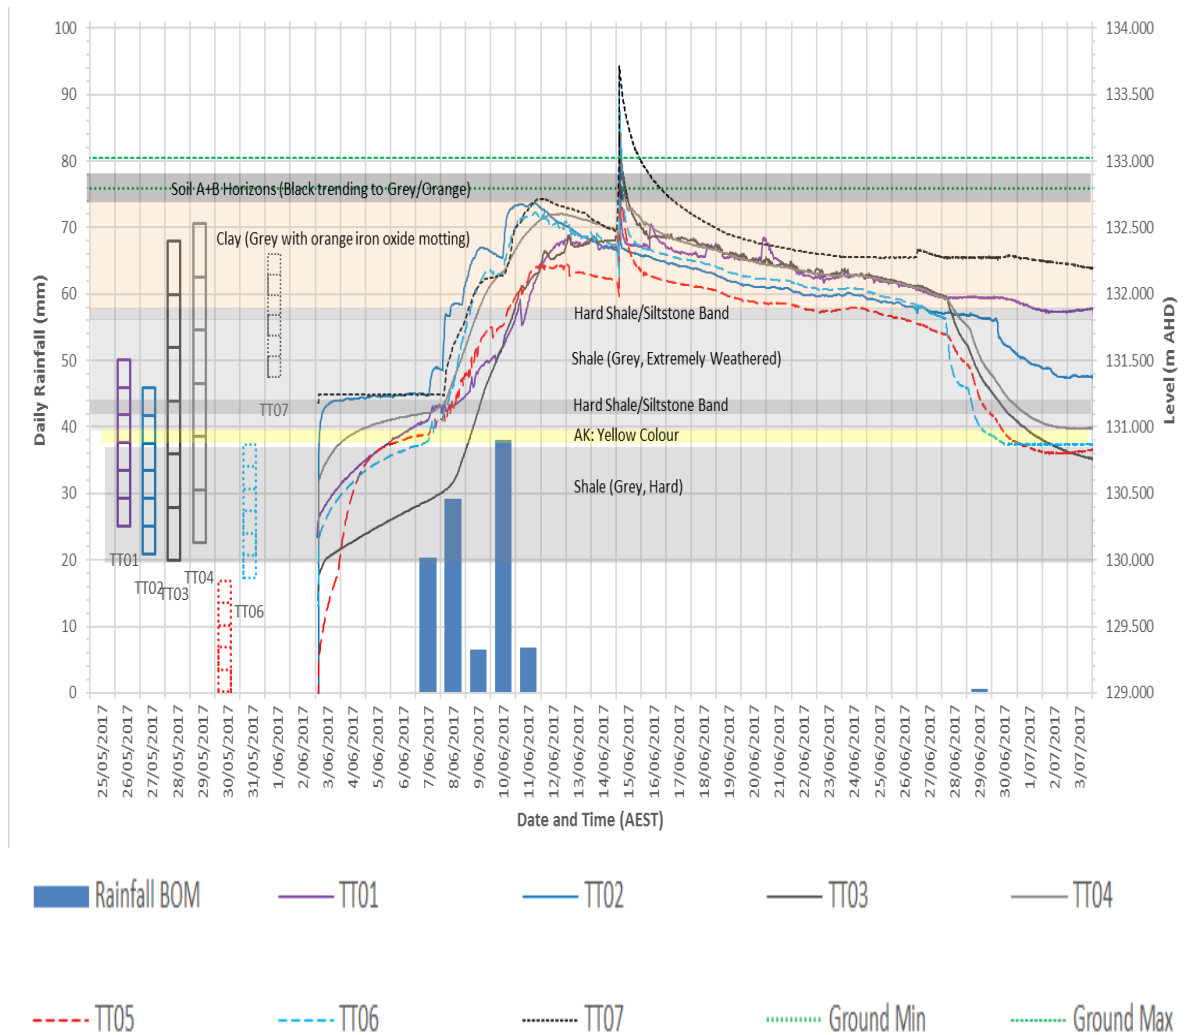
**Figure 58. Piezometer Water Level Responses (from Piezometer Construction, during Lugeon Testing and Pilot-Trench Construction). The screen depths for each borehole are shown at the left side of the figure. Note the effect of rainfall from 7<sup>th</sup> to 11<sup>th</sup> June.**

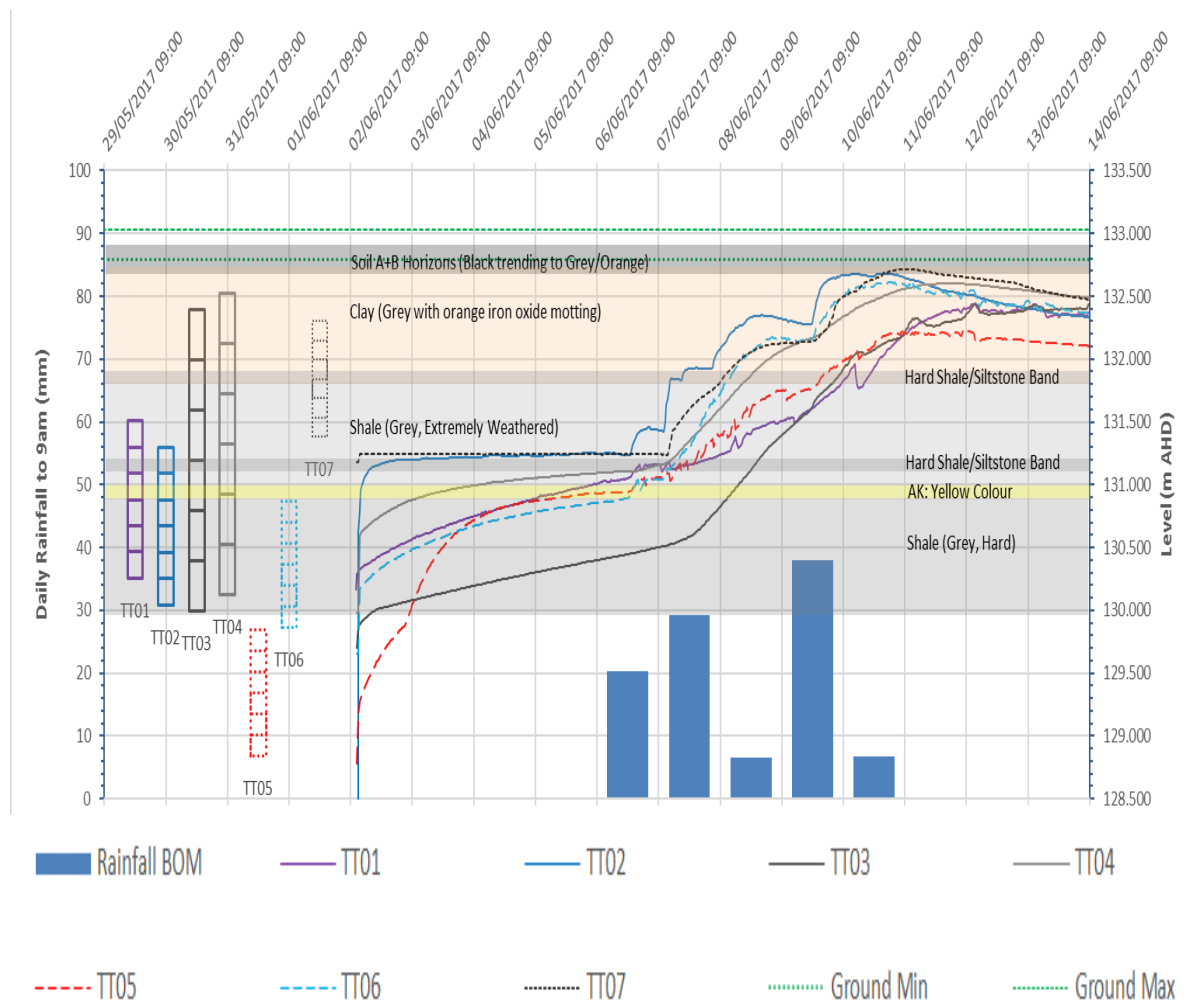
**Figure 59. Piezometer responses following augering and well construction (2<sup>nd</sup> June 2017 to 14<sup>th</sup> June 2017). The screen depths for each borehole are shown at the left side of the figure.**

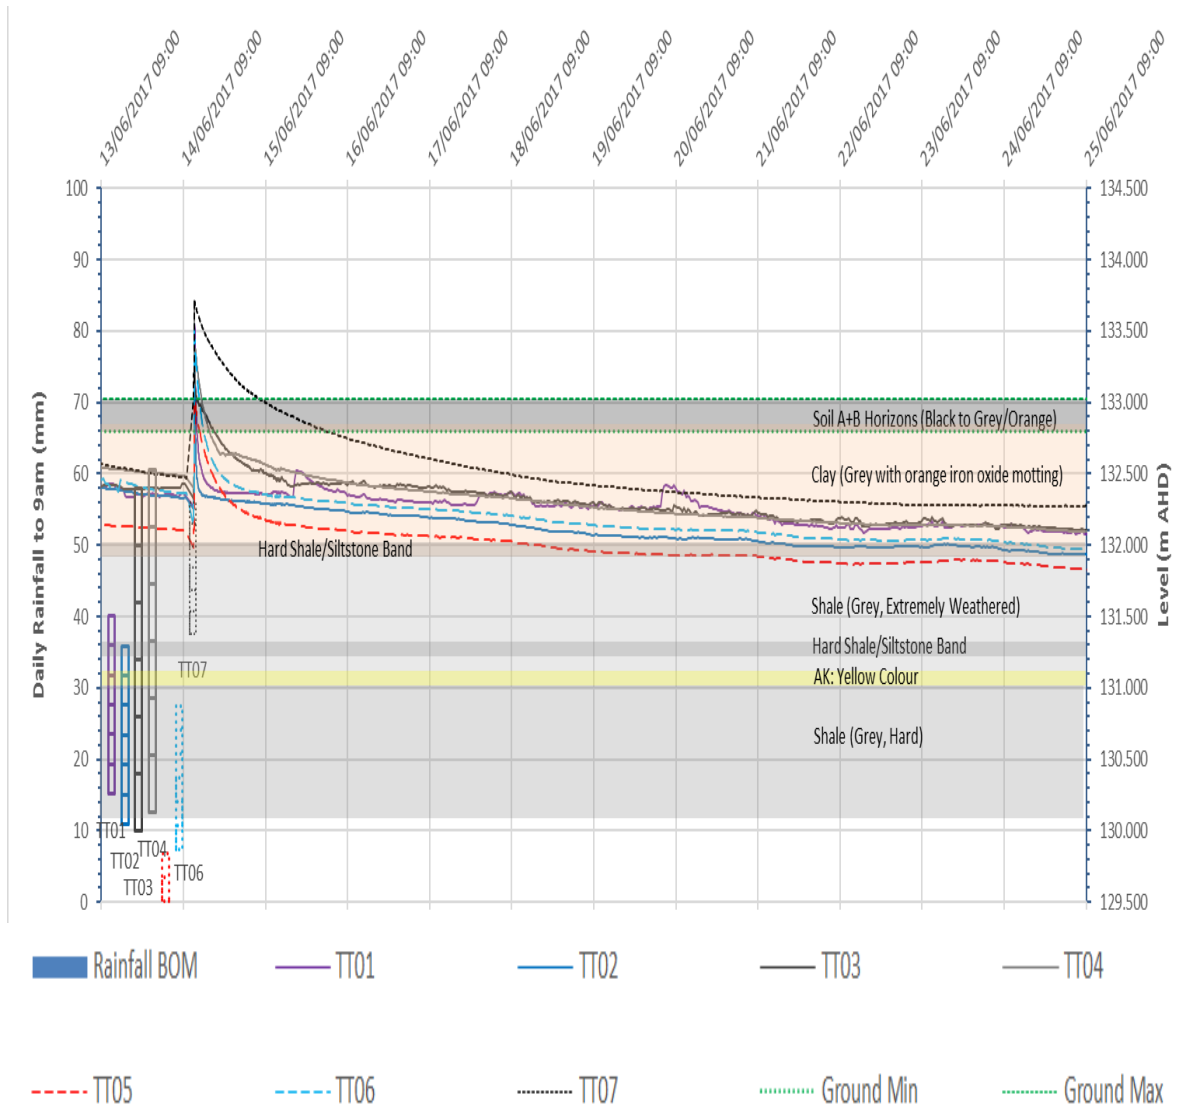
**Figure 60. Piezometer responses to Lugeon testing prior to Pilot Trench construction (14<sup>th</sup> June 2017 to 25<sup>th</sup> June 2017).**

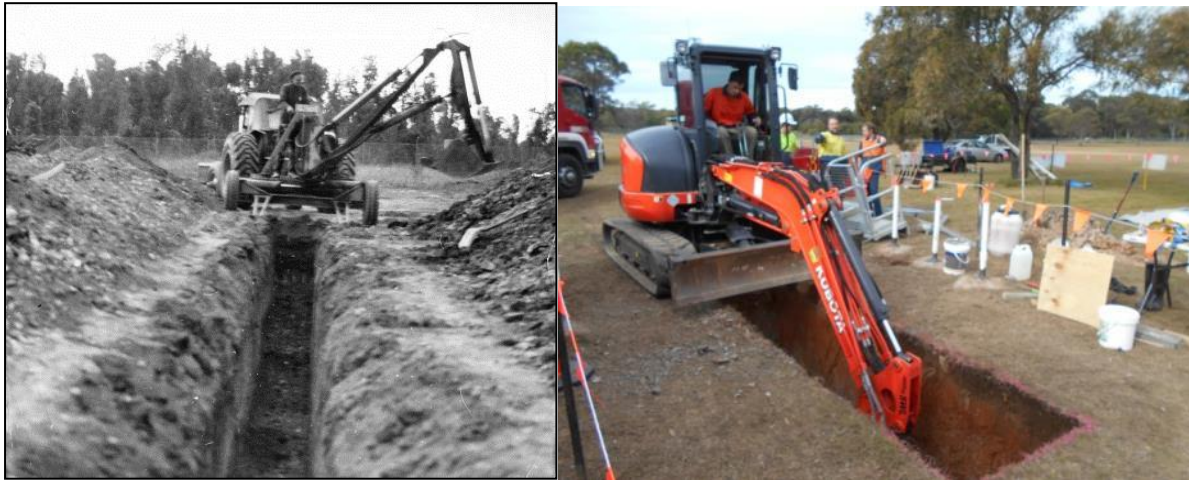
**Figure 62. Comparison of photographs of (a) excavation of historic trenches and (b) of the pilot trench.**

Although our equipment was somewhat different from what was used during the disposal operations, we were able to make some comparisons, which were assisted by considering contemporary and historic photographs (Figure 62). The accuracy with which the modern equipment could excavate the pilot trench, and the storage of spoil in a separate location resulted in a very neatly defined trench (Figure 62b). As noted above, very exact dimensions were obtained which were very similar to the nominal dimensions described in the various available historical reports. However, the experience suggested that the legacy trenches may well have not conformed closely to the nominal specifications in all cases.

It is also possible that the stepped appearance of the trench base shown in Figure 62(a) may have resulted in a trench which differed somewhat from the pilot trench which conformed almost exactly to a rectangular prism. Unfortunately it is not possible to know whether the photograph in Figure 62(a) represents the final trench, or whether additional excavations occurred to make it more in conformance with a rectangular prism (similar to the pilot trench construction). It is noted that the steps (if present) would have affected the amount of materials emplaced and possibly the mode of emplacement.

The resistance of the deeper, more intact shale layers to our trenching equipment was considerable and it is arguable whether the 1960's operations would have penetrated deep into the shale if it was encountered. Furthermore, the amount of spoil generated (Figure 44), should be compared with Figure 62(a) and photographs in Figure 63. It should be taken into account that we constructed a single trench 6 m long, whereas the legacy trenches comprised over 70 trenches of nominal lengths of 25 m. This consideration (together with the photographic evidence) verifies the presence of large amounts of unconsolidated materials around the disposal

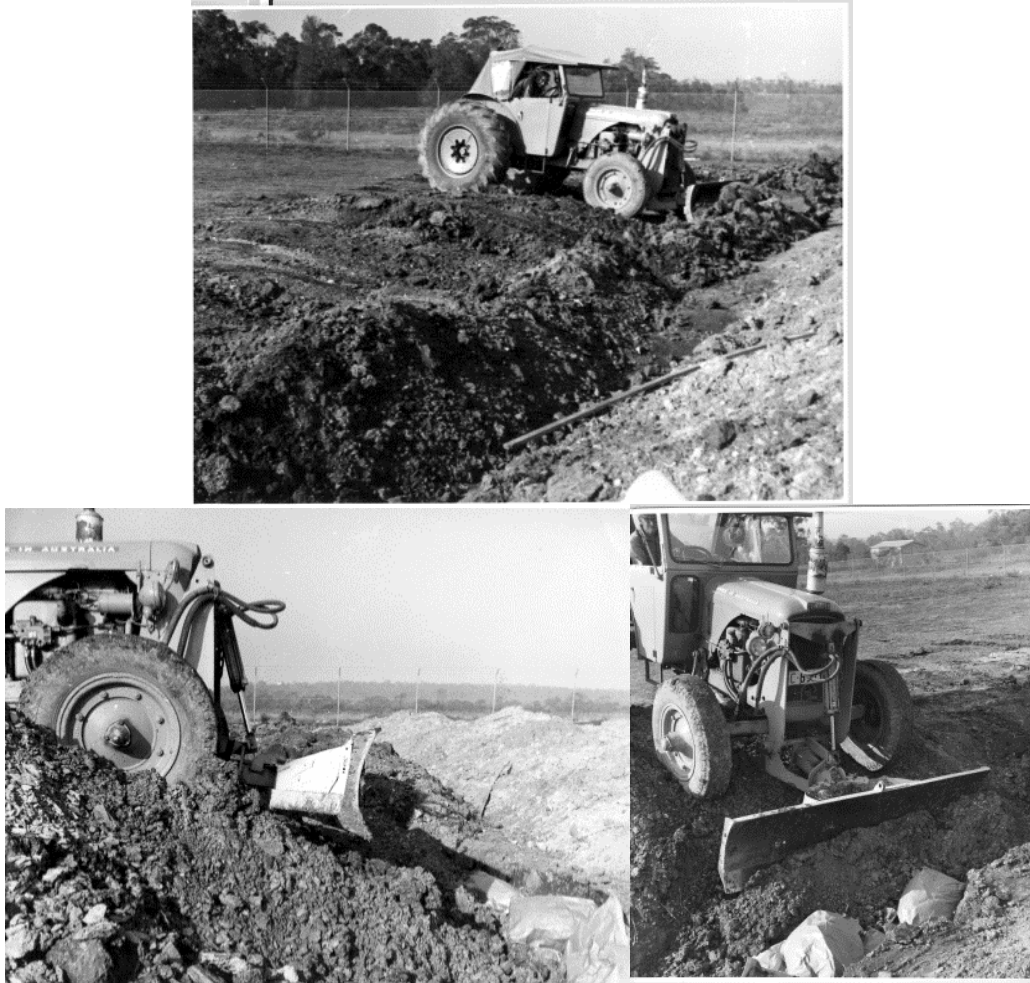
**Figure 63. Contemporary photographs covering of disposal trenches. Note the amount of fill materials on the ground surface**

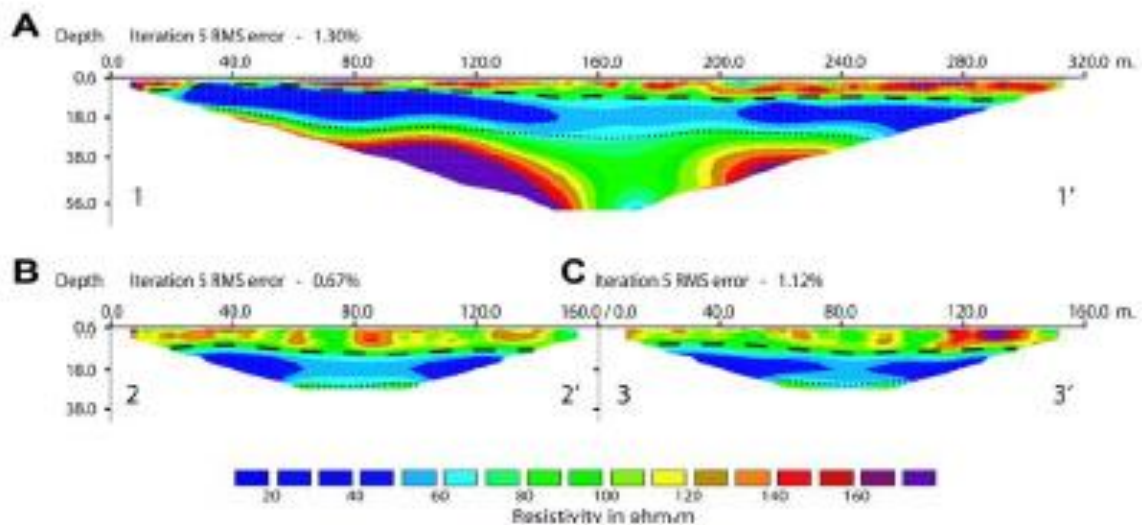
**Figure 65. Electrical resistivity profiles oriented following the numeric legend in the transects (See Figure 64). High resistivity materials close to the surface (green to purple in colour) represent the soil and top weathered shale. The low resistivity colours (blues) represent the shale lens. Higher resistivity materials below the shale represent the sandstone (from (Hankin, 2012)).**
