McCombie, PF, Mundell, C, Heath, A & Walker, P 2012, 'Drystone retaining walls: ductile engineering structures with tensile strength', *Engineering Structures*, vol. 45, JEST4017, pp. 238-243.
<https://doi.org/10.1016/j.engstruct.2012.06.046>

Drystone retaining walls: ductile engineering structures with tensile strength

Abstract

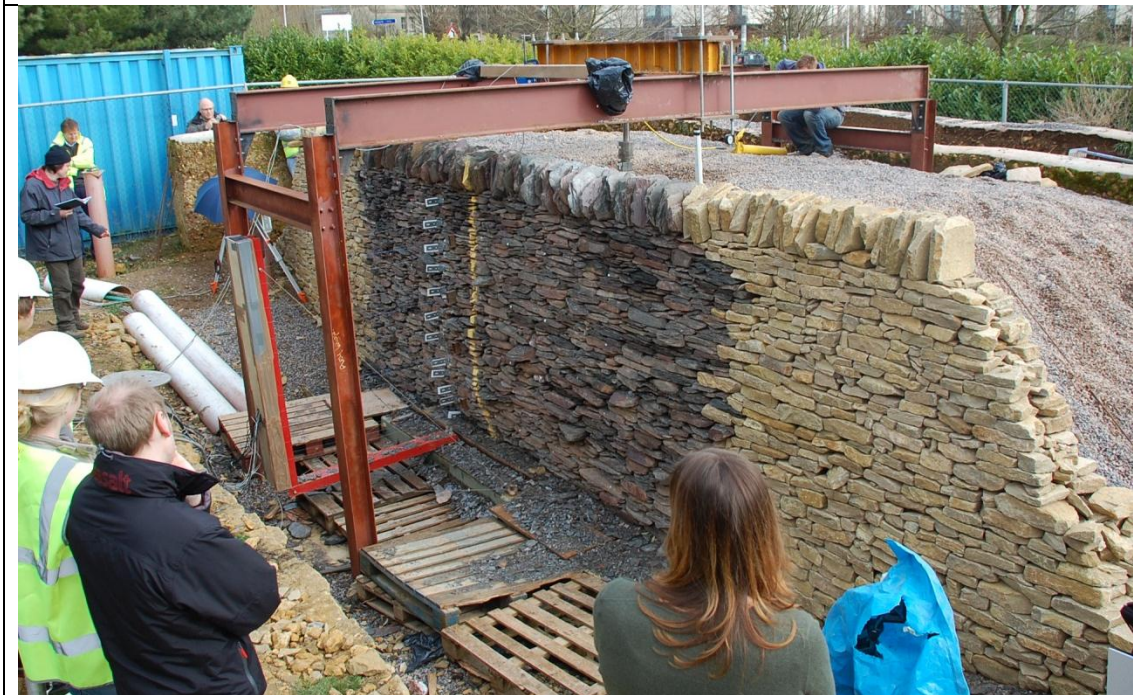
Figure 1 Test arrangement

a) Schematic cross-section through a test wall, and (b) overview of Wall 5 during testing.

Following the raising of the platform, a load was applied to the surface of the gravel behind the top of each wall via a 600mm square plate, as seen in Figure 1. The walls began to yield when loads of between 6 and 11 tonne (60 and 110 kN) were applied to this plate, with final collapse occurring only after considerable deformation, as indicated in Table 1. Prior to the final collapse, the load could be removed and all movement of the structures would cease. The walls are shown at their maximum deformations prior to collapse in Figure 2. The targets attached to the wall face were horizontal prior to the application of load to the top of the backfill, and hence indicate the rotation

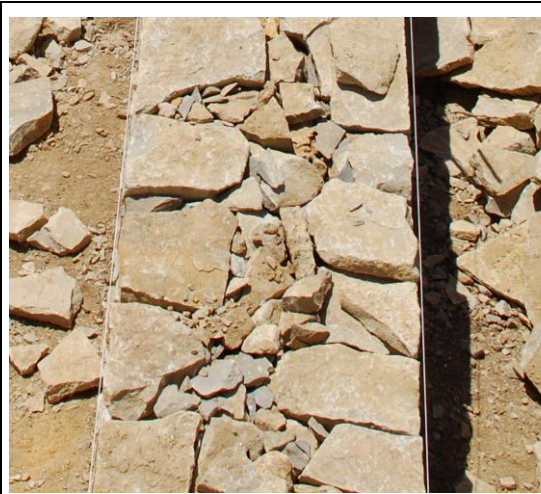
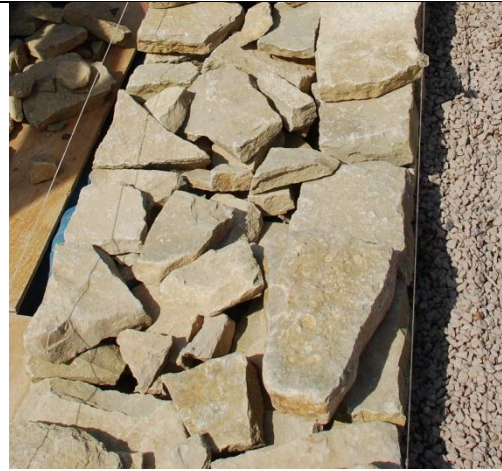
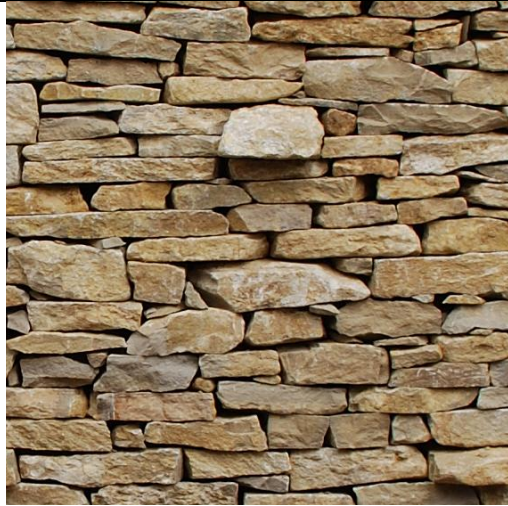
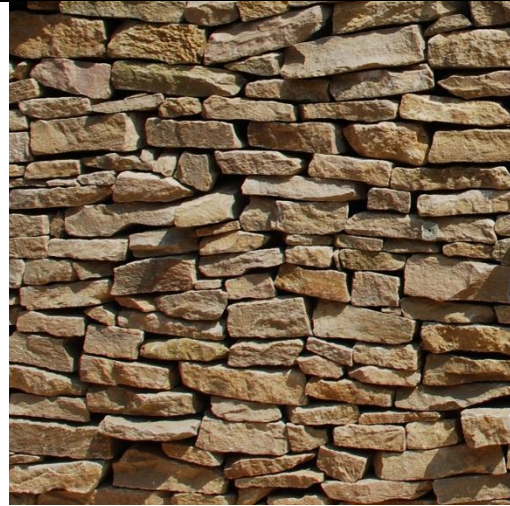
Figure 3 Variations in test wall construction

a) Wall 1 Construction

b) Wall 3 Construction

c) Wall 1 Elevation

d) Wall 3 Elevation

Wall 3 was deliberately built much more quickly with a lower density, and a quality of construction which better reflected common historic practice in the field. Modern professional drystone wallers work to very high standards, producing densely built walls with very few running joints and sufficient through-stones, which span from the front to the back of the wall and hold it together. The packing

of the stone in Walls 1 and 3 is compared in Figure 3. Wall 3 included running joints, as in wall 2. The lower density permitted noticeable rotation of individual stones as load was applied. For the most part, such rotations were through relatively small angles from a position which was stable during construction to a position which was stable under the applied loading. The consequent small local movement would result in a small local reduction in the applied load, which might result in a transfer of load to adjacent sections of the wall through friction in the fill, or may result in an overall reduction in the load applied to the wall if the upper part of the wall rotates back slightly against the fill (Figure 4). The accumulation of such small changes in geometry resulted in a configuration which increased the favourable loads while reducing the unfavourable loads, and could better resist those loads.
