# **Refurbishment of NASA's Johnson Space Center Liquid Nitrogen Bulk Storage Tanks in preparation for Thermal Vacuum Optical Testing of the James Webb Space Telescope (JWST)**

30<sup>th</sup> Space simulation Conference  
November 5-8, 2018  
Annapolis, Maryland

## Refurbishment of Liquid Nitrogen Bulk Storage Tanks

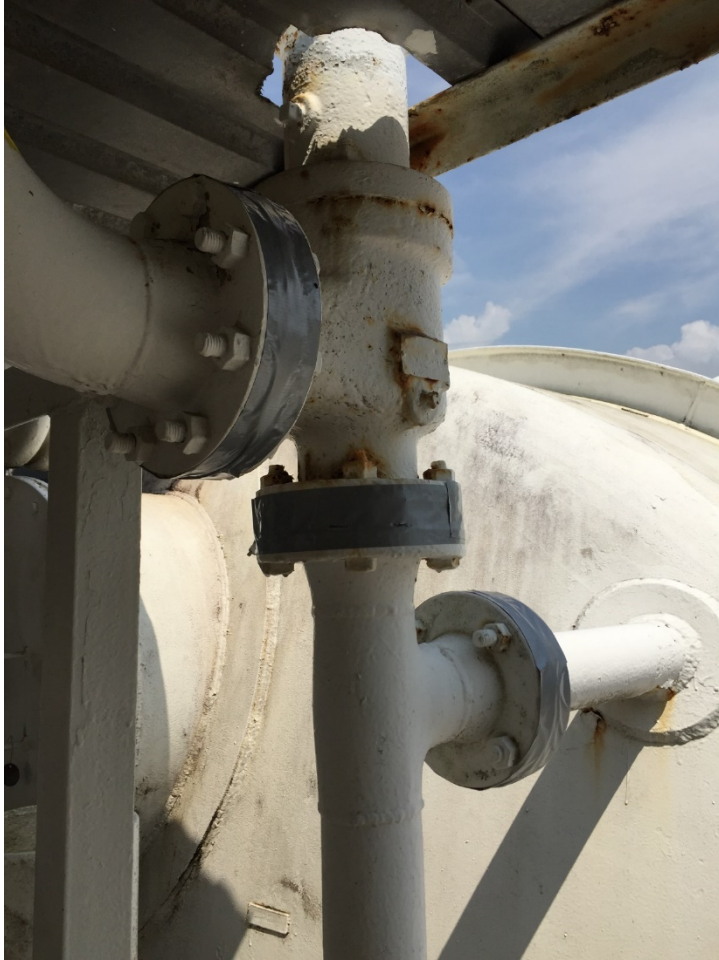
SAFETY DEVICE TK-201

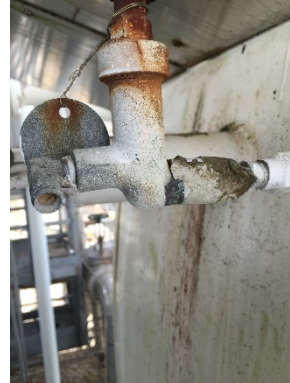
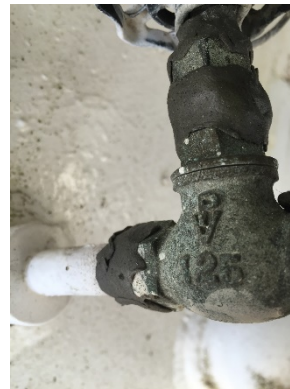
VACUUM GAUGE ISOLATION  
VALVES

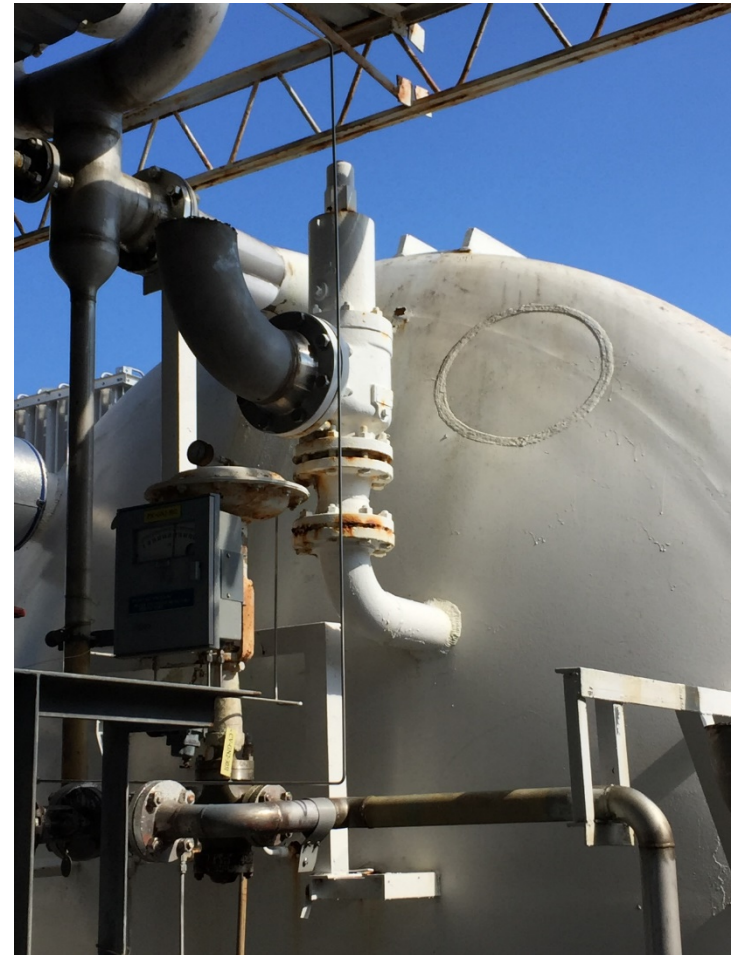
SAFETY DEVICE TK-202

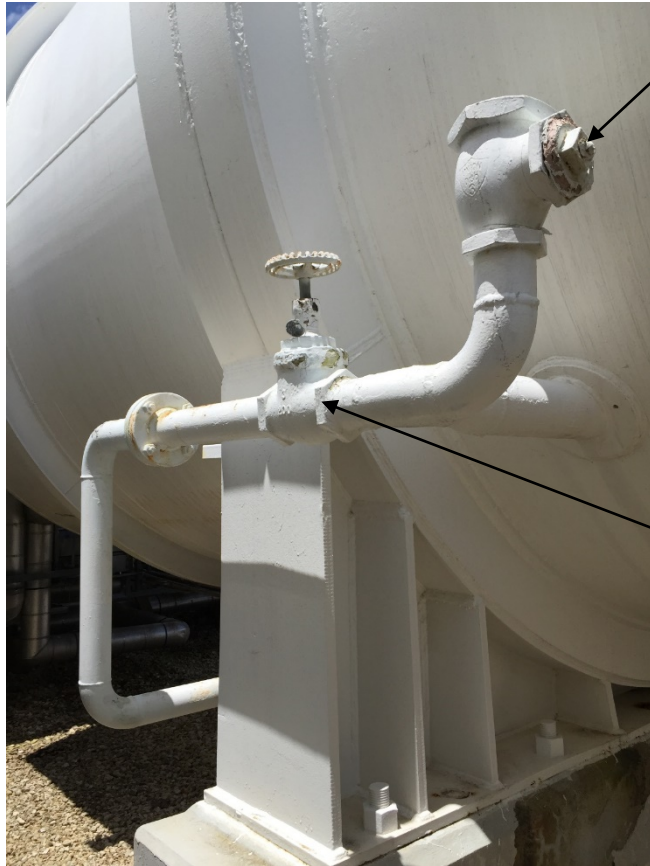
CAPPED  
ANNULUS  
SAFETY  
DEVICES  
-LEAKING-

VACUUM  
ISOLATION  
VALVES  
-LEAKING-

VACUUM  
ISOLATION  
SOLENOID  
VALVES  
-NOT WORKING-

VACUUM PIPING WITH VALVE AND  
SAFETY DEVICE

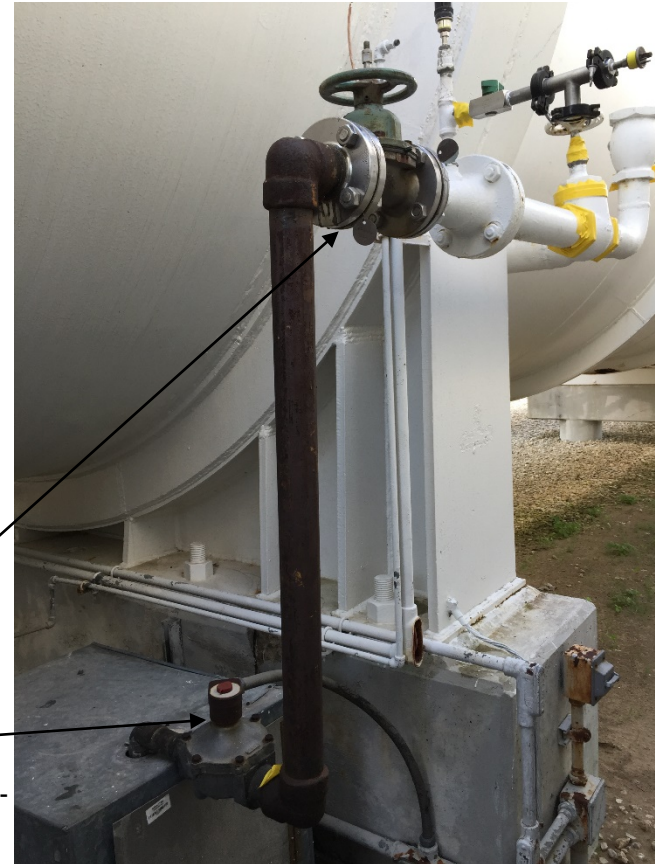
VACUUM PIPING WITH VALVE

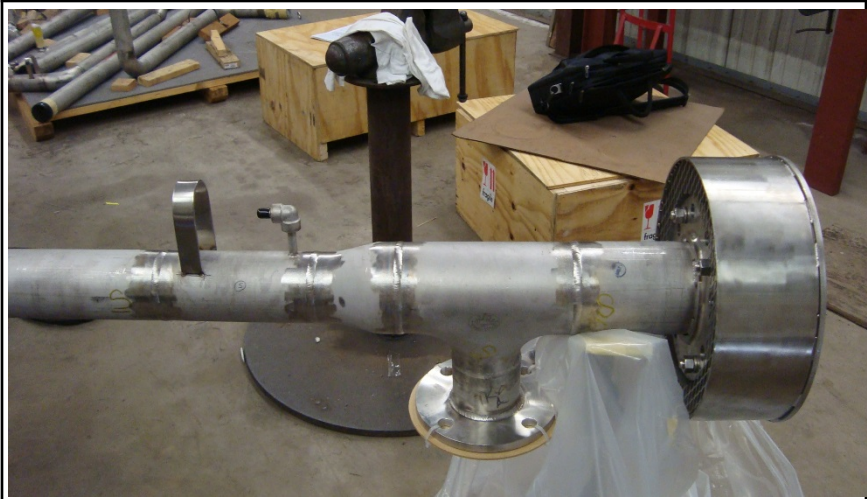
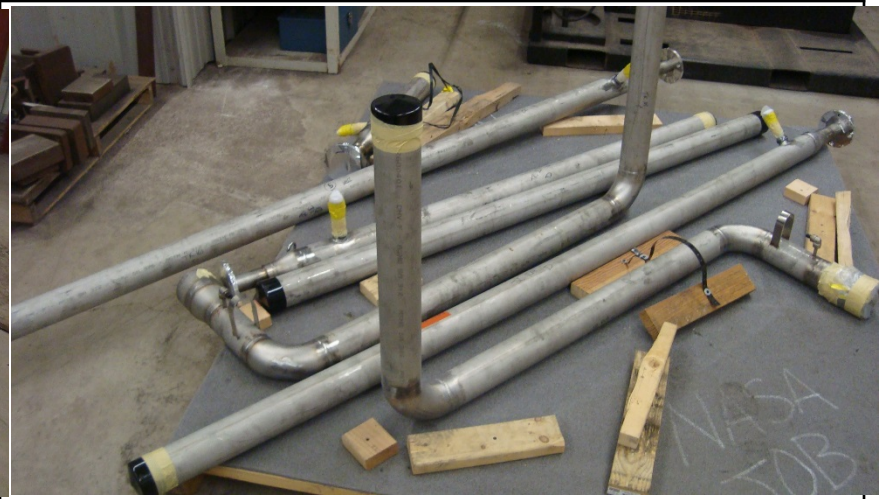
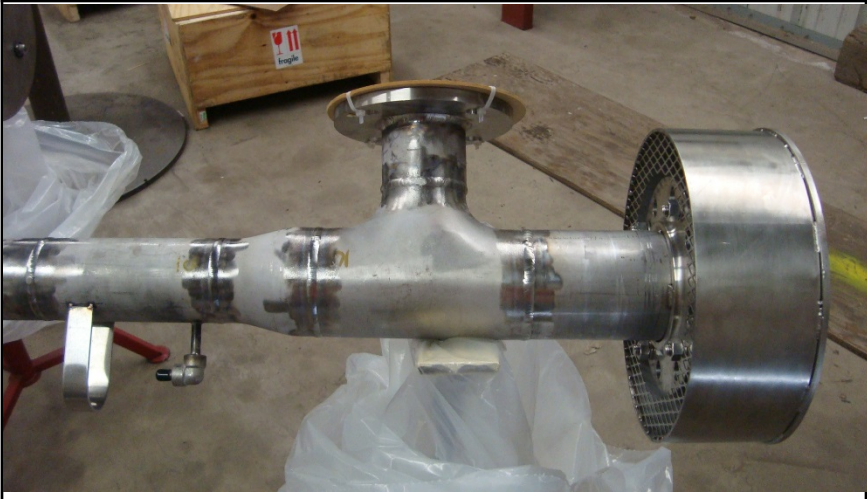
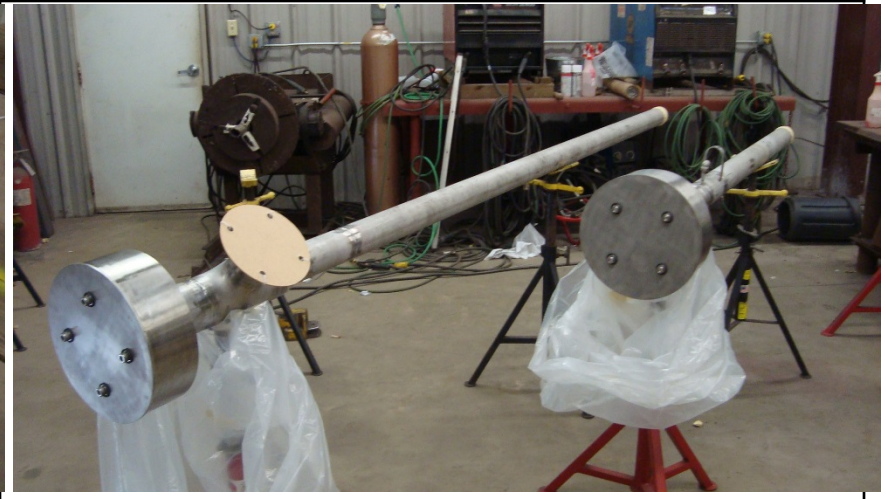
SHOP FABRICATION OF VACUUM PIPE SPOOLS WITH ANNULUS SAFETY DEVICES

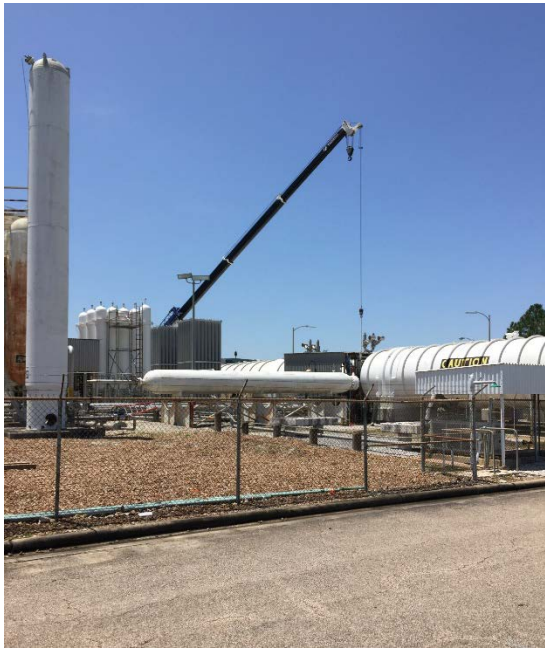
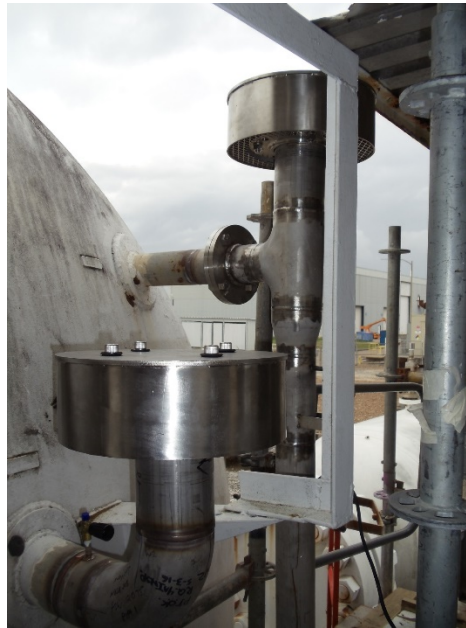
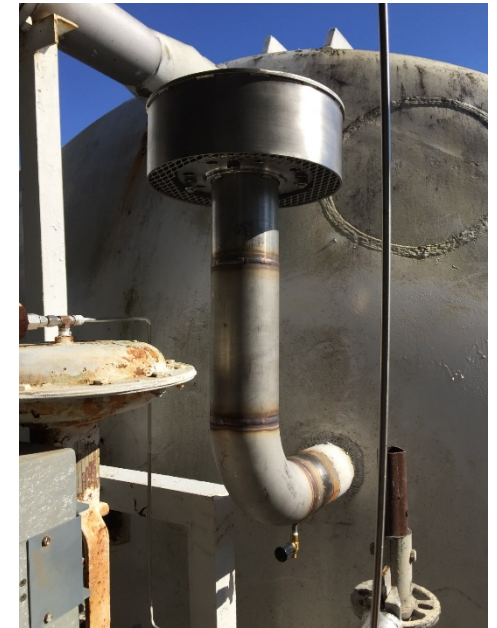
### INSTALLATION OF VACUUM ANNULUS SAFETY DEVICES

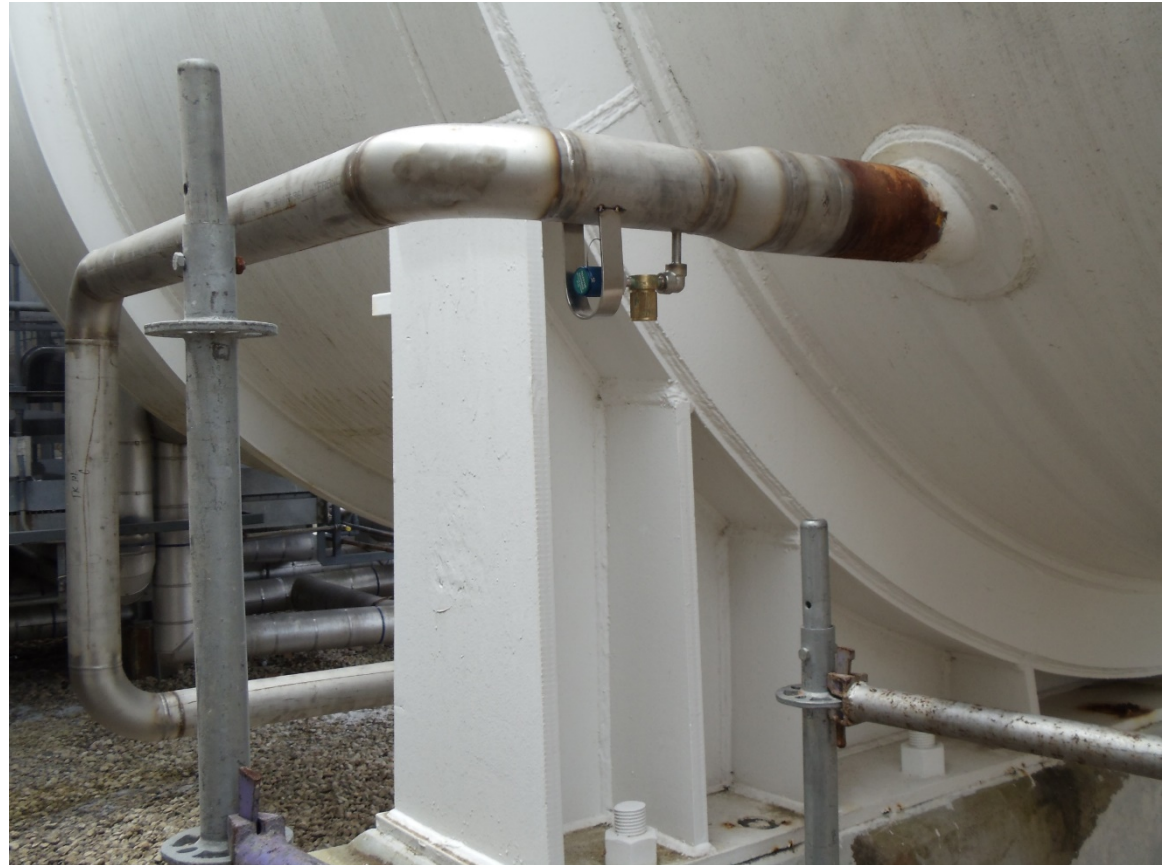
NEW INSTALLED VACUUM PIPING

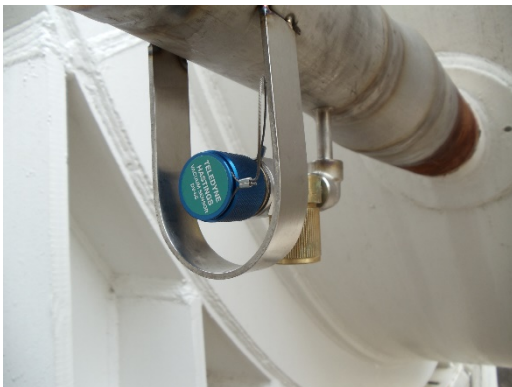
THERMOCOUPLE VACUUM TUBE

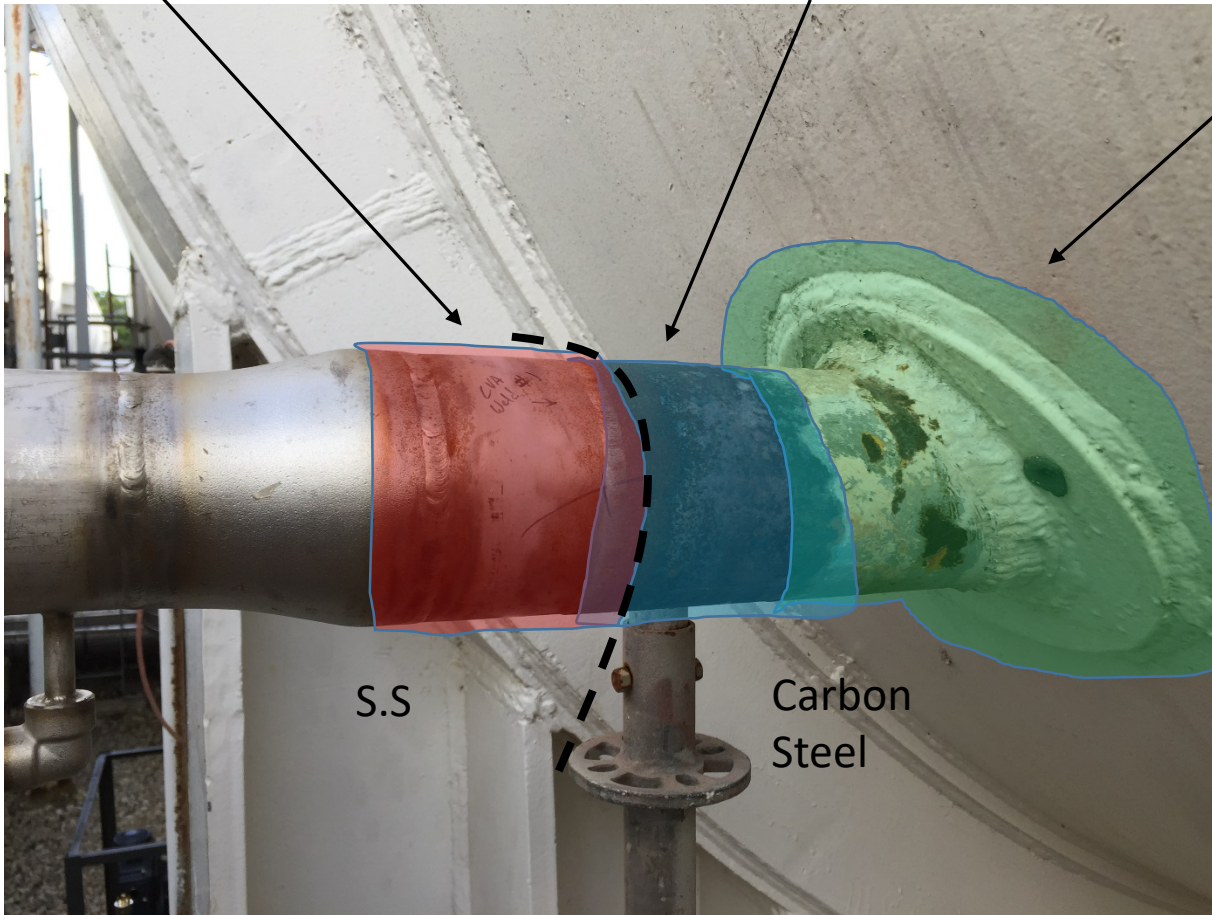
Typical Process on all tanks  
Surface Preparations (Emphasis on the S.S. to Carbon Steel)

Passivate (Step 3)

Rust Knockout (Step 2)

Remove paint (Step 1)

CORROSION CONTROL

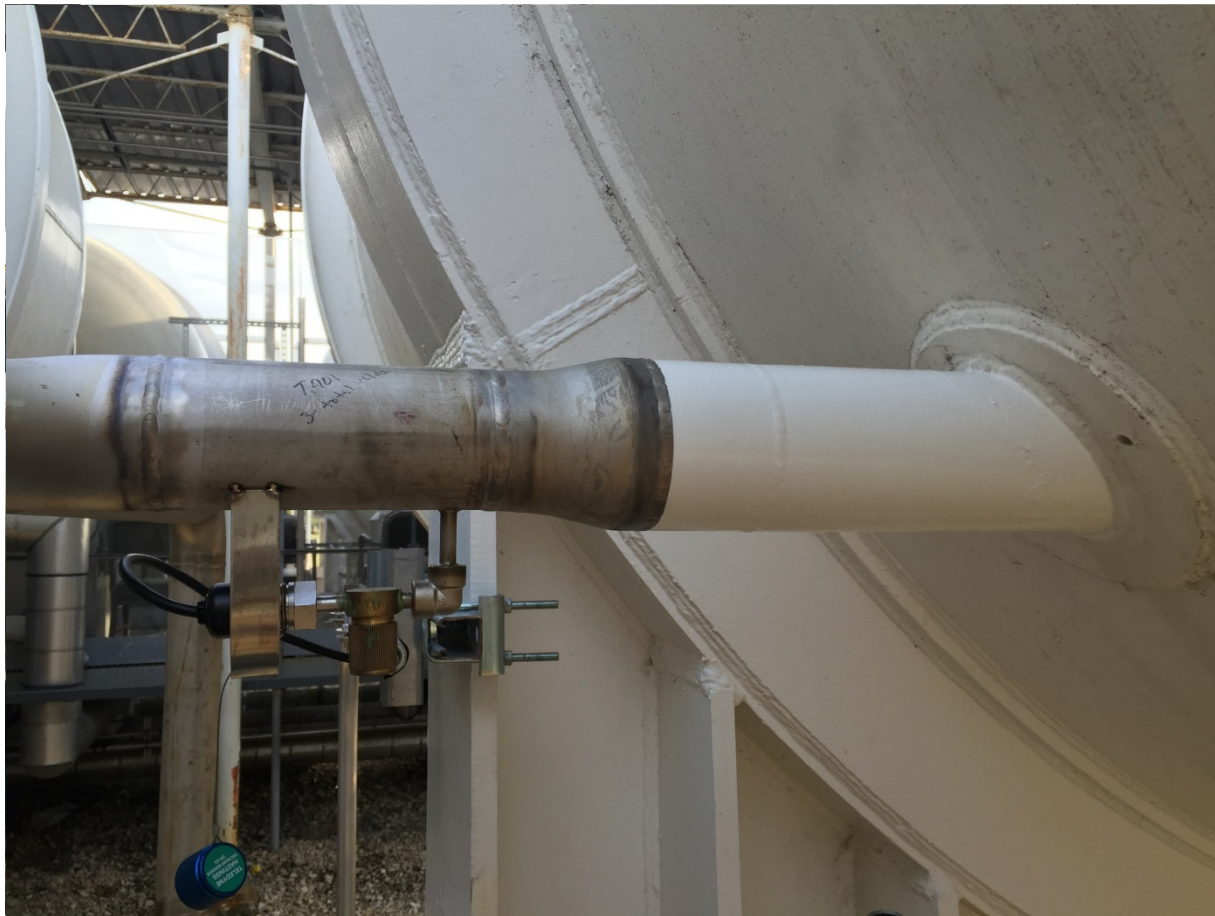
Top Coat Process -Typical on all Tanks Paint 4” beyond the S.S side weld seam

NEW INSTALLED PIPING WITH COATING

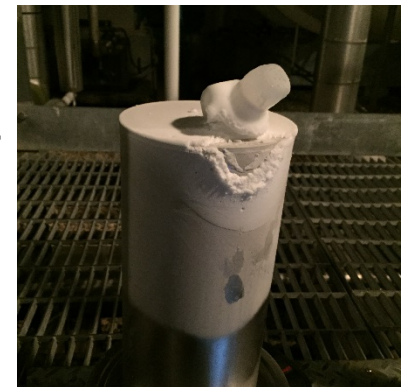
- Helium leak check on vessels revealed annulus safety devices were all leaking on the -100 Type I tanks. 4 total tanks.
- Tank -201 after replacement of both annulus safety devices could not be successfully pumped down.
  - Two mechanical pumps were fouled in the process of vacuum pumping.
  - Culprit-Previous annulus safety device had allowed water to intrude through the corrosion.
- Tank -202 successfully reached  $< 35$  microns and success full three day rate of rise.
- Performed exploratory engineering evaluation on one Type I Tank flange to aid in the design to remove and replace the leaking safety devices.
- Tank -201 coldtrap water vapor collection. Trap was Changed every 4-6 hours for +50 days during JWST Thermal pathfinder test.

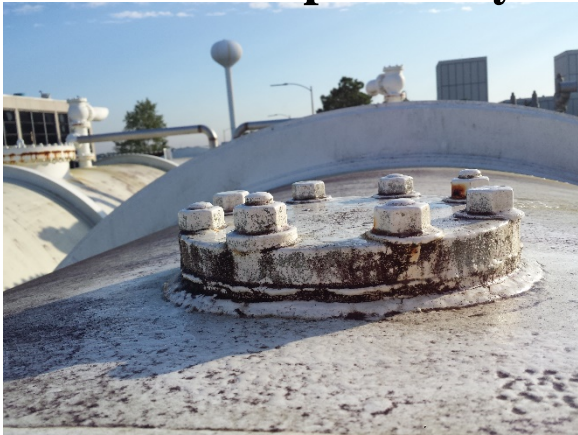
Pearlite Fill Flange, Carbon Steel

During helium leak checks all Type 1 tank annulus safety devices failed helium leak checks. An effort was made to identify if the pearlite fill Flanges could be used to accommodate new safety device.

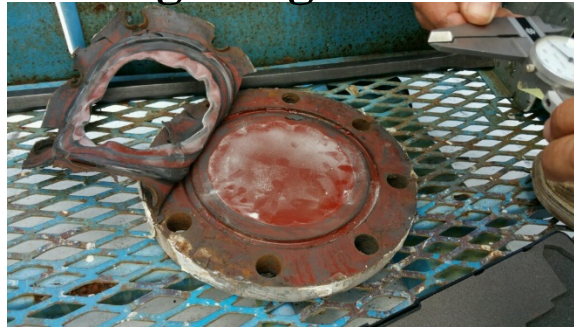
O-ring groove on blank flange.  
Note: A gasket was used with an unknown sealant.

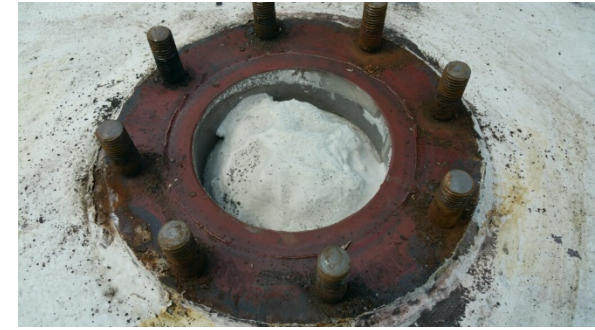
Pearlite flange with carbon steel flange.

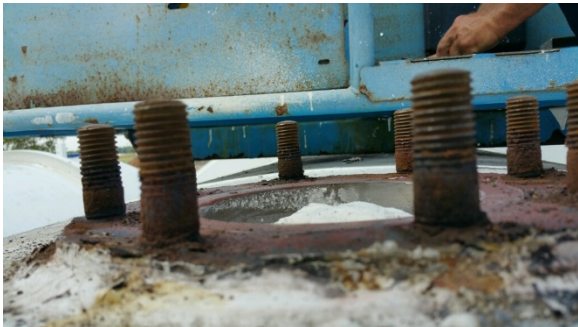
Major corrosion on studs

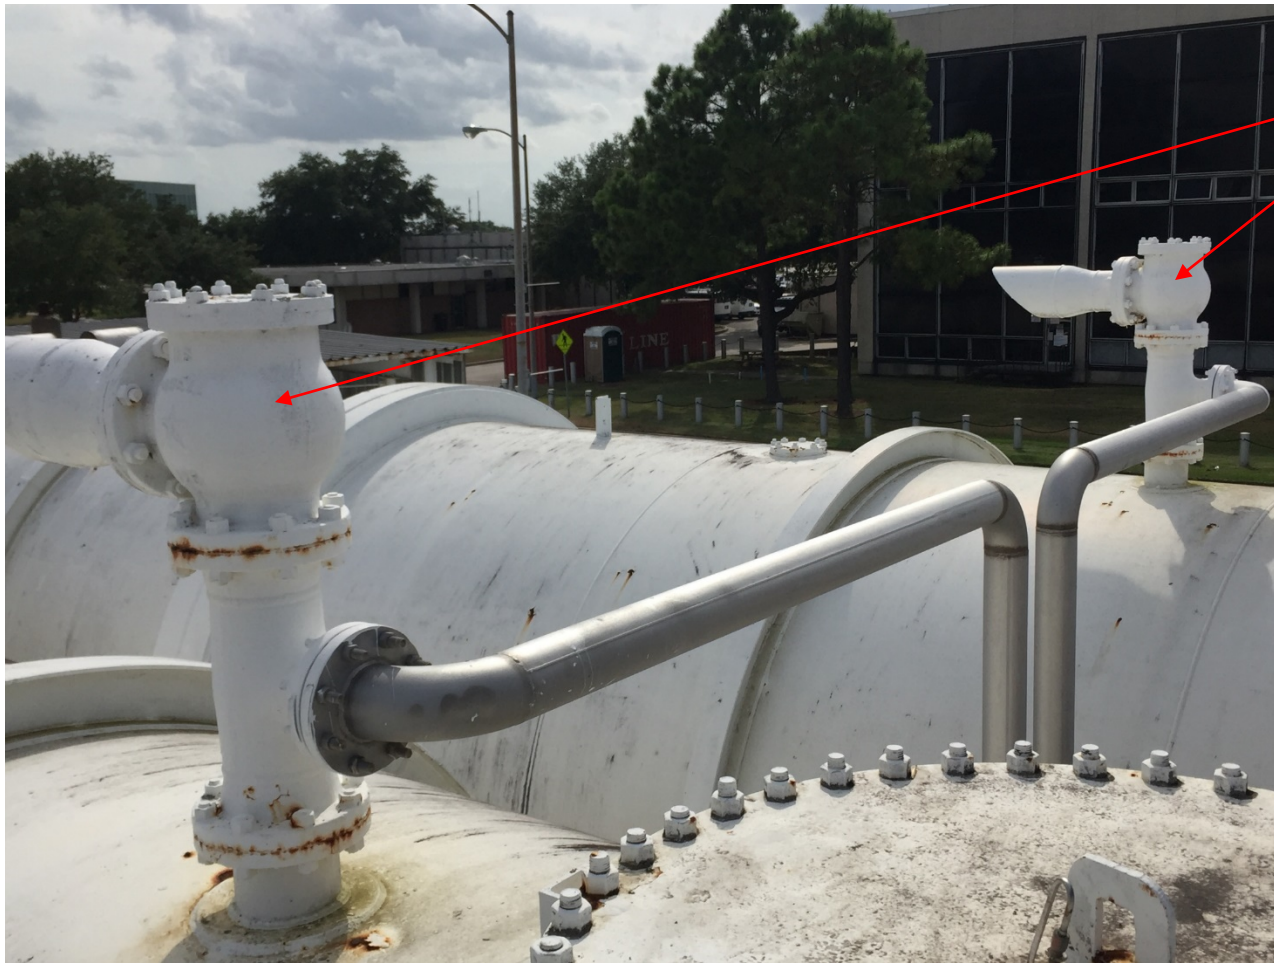
ANNULUS  
SAFETY  
DEVICES  
-LEAKING-

SIZED NEW REQUIRED  
DISCHARGE AREA FOR  
EACH TANK PER  
CGA 341-6.4.2

56 in<sup>2</sup> WAS REQUIRED  
PER TANK

THE EXISTING PORT  
PLUS TWO PEARLITE  
FILL PORT FLANGE  
WOULD HAVE TO  
ACCOMMODATE THE  
NEW SAFETY DEVICES.

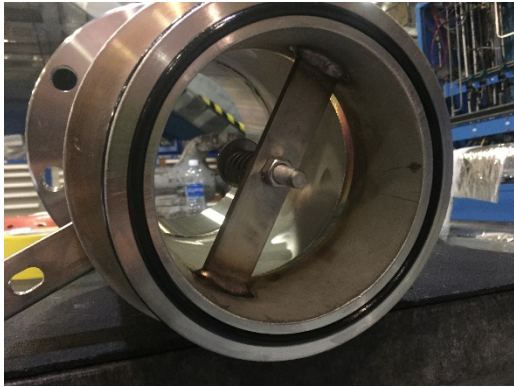
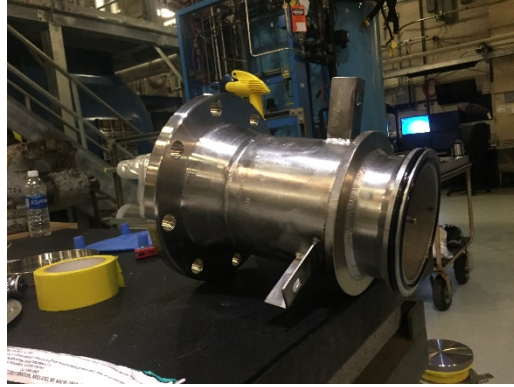
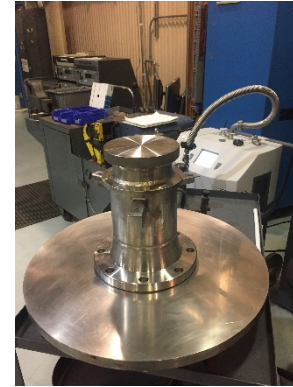
Vacuum Annulus Safety Devices Bench Checking

Helium Leak Checking by JACOBS Techs.

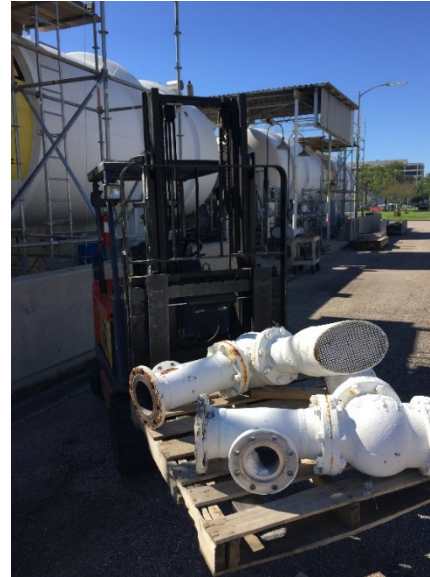
End of Service Life

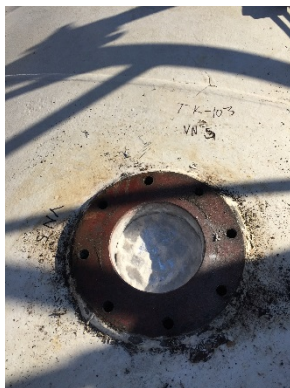
Existing Flange Condition
