NASA/TM—2018-219961

Prepared for the  
54th Joint Propulsion Conference  
cosponsored by AIAA, SAE, and ASEE  
Cincinnati, Ohio, July 9–11, 2018

# **In-situ Diagnostic for Assessing Hall Thruster Wear**

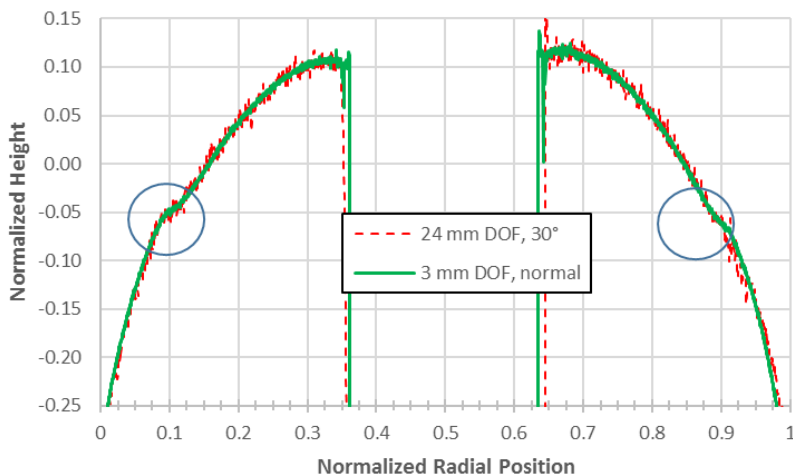
Figure 8.—Tabletop scans of the keeper with both 3 and 24 mm DOF pens. Domed aspect of keeper is exaggerated here from scaling.

Figure 8 compares profiles of the keeper downstream surface taken with each pen. Note that the large curvature shown in Figure 8 resulted from manufacturing or polishing of the keeper and not from erosion during operation. Each profile captures the 15  $\mu\text{m}$  steps (circled) between the eroded and previous masked regions of the keeper despite the lower resolution of the 24 mm DOF pen. Slight differences in the keeper orifice diameter reflect the need to anchor the measurement to a known radial location (i.e., the profile scans of the diameters were not over the exact same location but differed by a very small amount resulting in variations in measured diameter—anchoring the scans to a known location would eliminate this issue). Figure 9 shows the geometry of the cathode-to-keeper gap as measured by the 24 mm DOF pen. Note that the keeper orifice wall is shown as an angled line corresponding to the angle of the pen. Horizontal surfaces are shown without distortion and gaps must be calculated by correcting for the pen angle (as indicated by the dotted line showing the cathode-to-keeper gap relative to the keeper thickness).

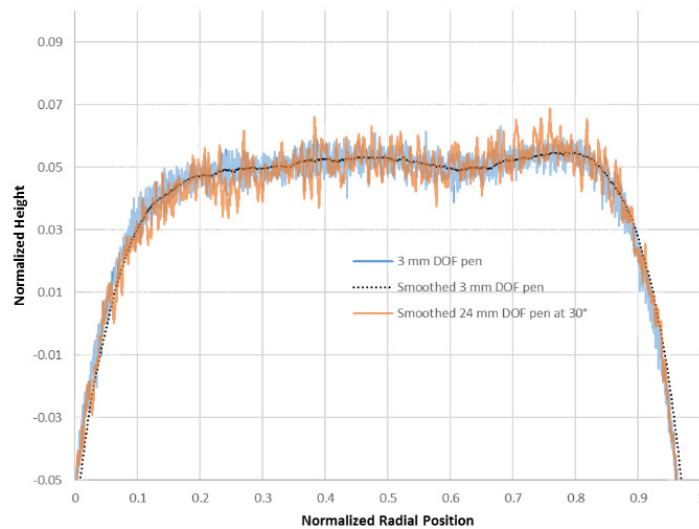
Figure 10.—Comparison of profiles of the inner front pole cover taken with the two optical pens.

One objective of these tests was to determine the correlation between the two pens. Specifically, the 3 mm DOF pen has a higher resolution than the 24 mm DOF pen. By performing a scan of the same area with both pens, the two sets of results were compared, resulting in a correction for the 24 mm DOF pen. This correction can then be applied to measurements such as IFPC wall thicknesses, which are measured in the perpendicular direction to the exit plane of the thruster. Figure 10 compares radial profiles of the IFPC taken with each of the pens. The dark line through the center of the data represents a moving average fit to the 3 mm DOF data. The 24 mm DOF raw data is not shown here, as it requires significantly more smoothing to recover the same shape. That said, both pens appear to capture the same fabrication-induced features of the pole cover including the large curvatures at the inner and outer edges and the wavy surface. This facilitates the correlation of the two pens referred to in Table 2. Because of the higher resolution and correspondingly higher scan speeds of the 3 mm DOF pen, its use in the in-situ characterization of the surface is preferred.
