**42nd Annual Conference on Composites,
Materials, and Structures**
(Cocoa Beach, Florida)

**High Temperature Ceramic Microstructure and Interface Evolution during
Exposure to Particulate Laden Combustion Flows in Gas Turbine Engines**

**Andy Nieto, Michael Walock, Anindya Ghoshal, Muthuvel Murugan, Luis Bravo, Blake Barnett, Marc Pepi, Jeff Swab,
William Gamble, Mark Graybeal**
U.S. Army Research Laboratory – APG, MD

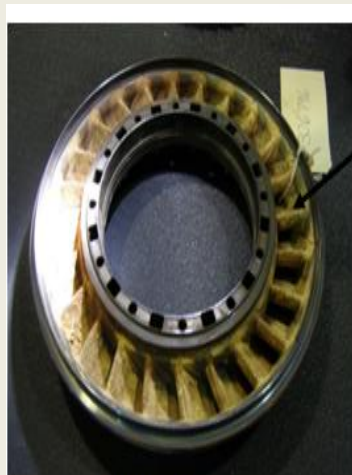
Field returned engine hardware from SWA

- Sand build up (glazing)
- Plugged cooling holes
- Nozzle oxidation
- CMAS attack

Typical rotorcraft gas turbine engine nozzle and rotor blades with sand-induced damages

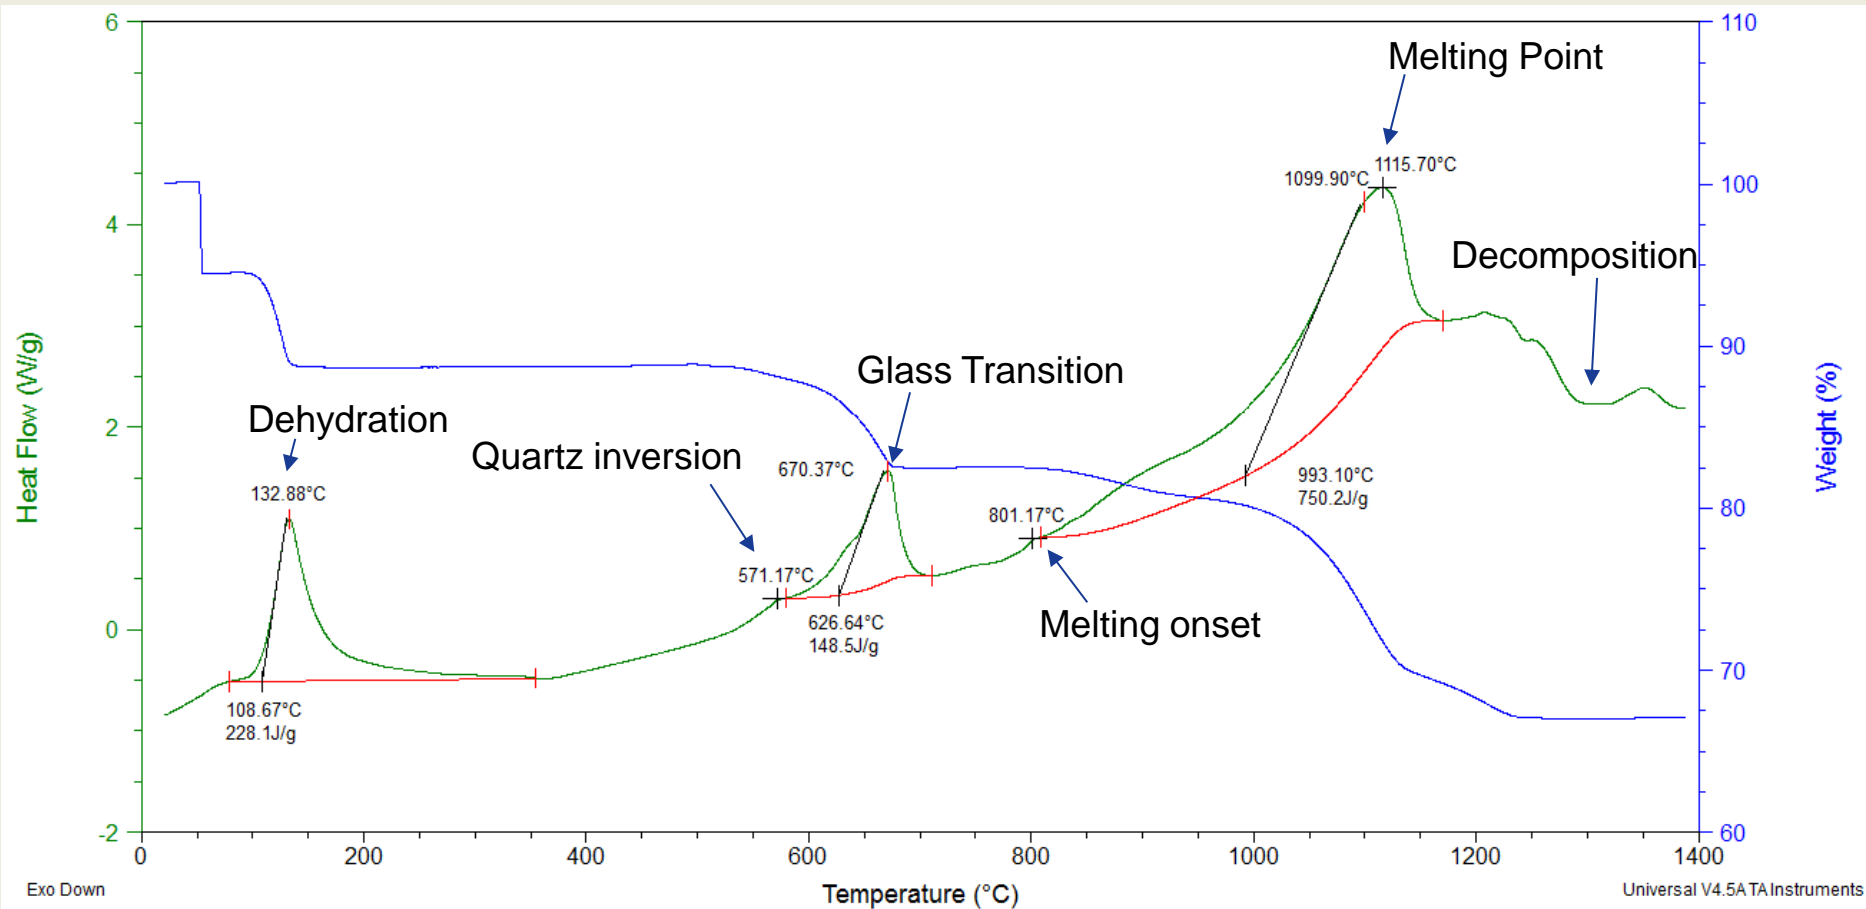
Differential Scanning Calorimetry AFRL-02

under Ar gas flow

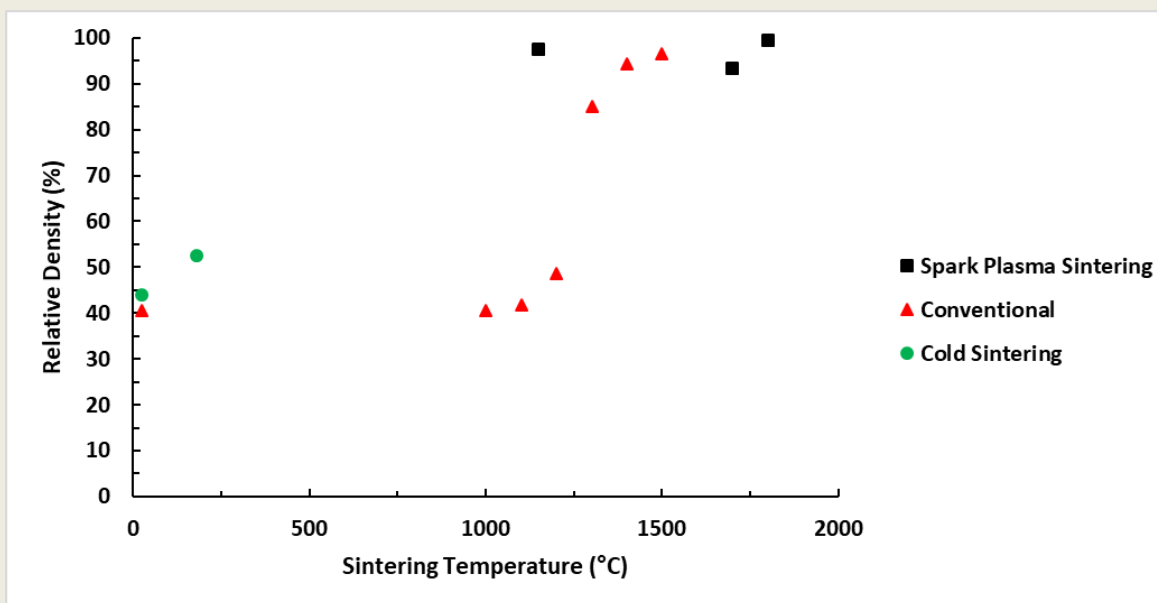
Comparison of relative densities achieved through varying sintering methods

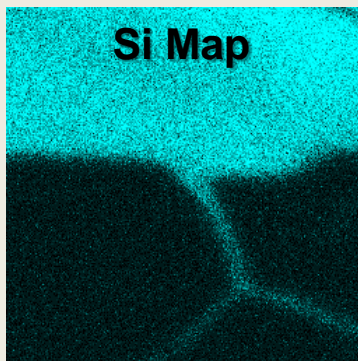
- Highly dense pellets were expected to mitigate CMAS attack by preventing infiltration
 - Lack of pores eliminates facile pathway for infiltration
- CMAS infiltration is observed on near surface, adjacent to surface deposits
 - Infiltration depth over 50 μm into bulk

- TEM studies underway to elucidate CMAS infiltration mechanism in the absence of porosity
- Nanometric YSZ particles at triple junction exhibit severe twinning
 - Not seen in YSZ grains away from CMAS
 - Deformation twinning suggests CMAS induced strains play a role in infiltration/dissolution/reaction mechanisms
- STEM/EDS/EELS analysis will attempt to determine atomic scale diffusion mechanisms at CMAS/YSZ interface

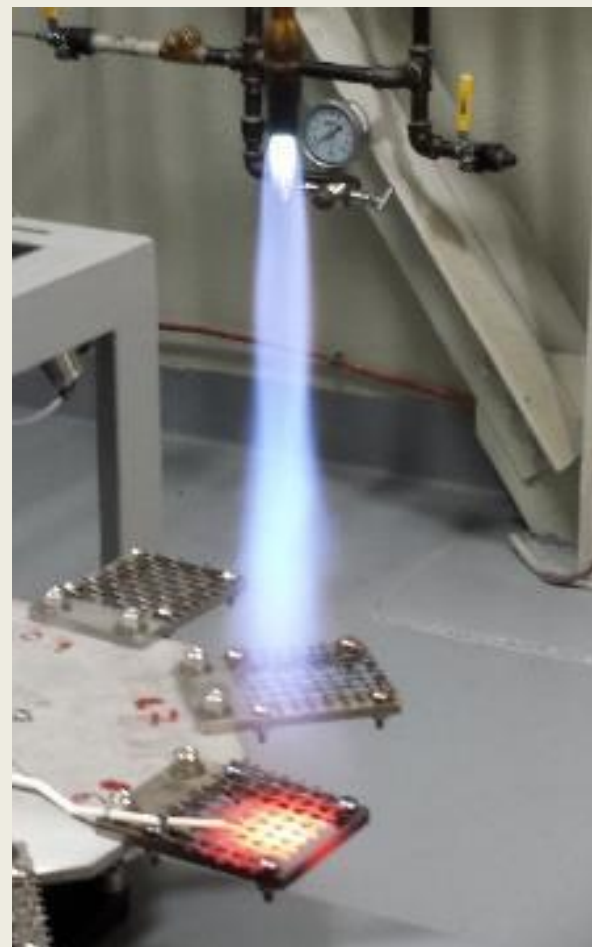
Button cell Flame Test Rig

- Oxy-propane torch
- Motorized rotary stage
- Temperature measurement → Optical pyrometer
- Test parameters
 - Surface temperature ~ 1300 °C
 - 3 cycles – IN/OUT: 3 min/3 min
 - AFRL-02 sand → slurry deposited on surface, and allowed to dry before test

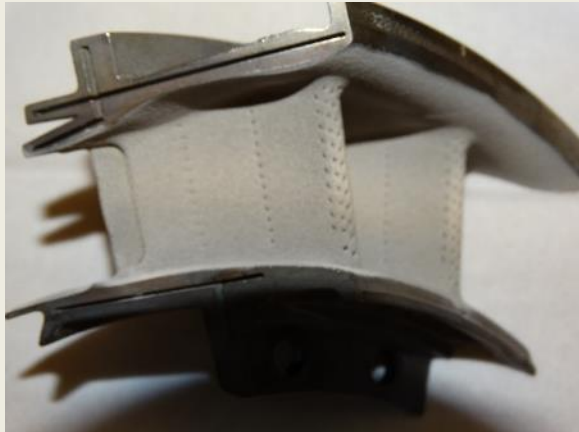
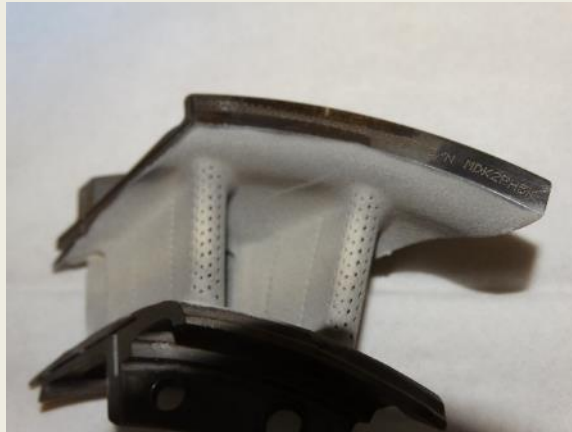
Nozzle 1 – 7YSZ via APS

- Leading Edge Holes are largely clear
- Clogging increases as you approach the vane's trailing edge

NOTE: Samples were grit-blasted for coating adhesion

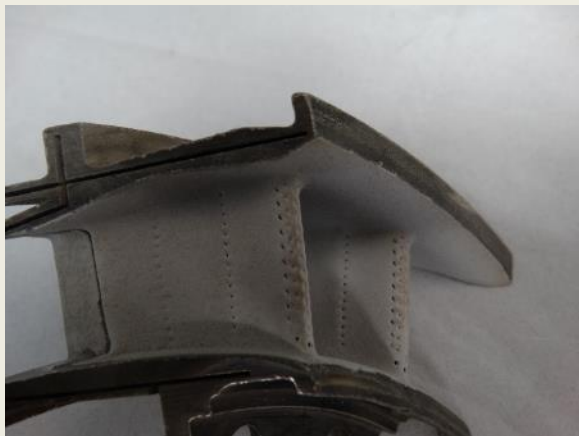
Nozzle 2 – 8YSZ via SPSS

- Cooling hole row at the peak of the leading edge is clogged
- Trailing edge shows less clogging than Nozzle 1, despite identical spray path
- Finer Coating Droplets (Solution Plasma Topcoat) appear to bridge cooling holes more easily/thoroughly, despite increased bleed air inlet pressure/flow.

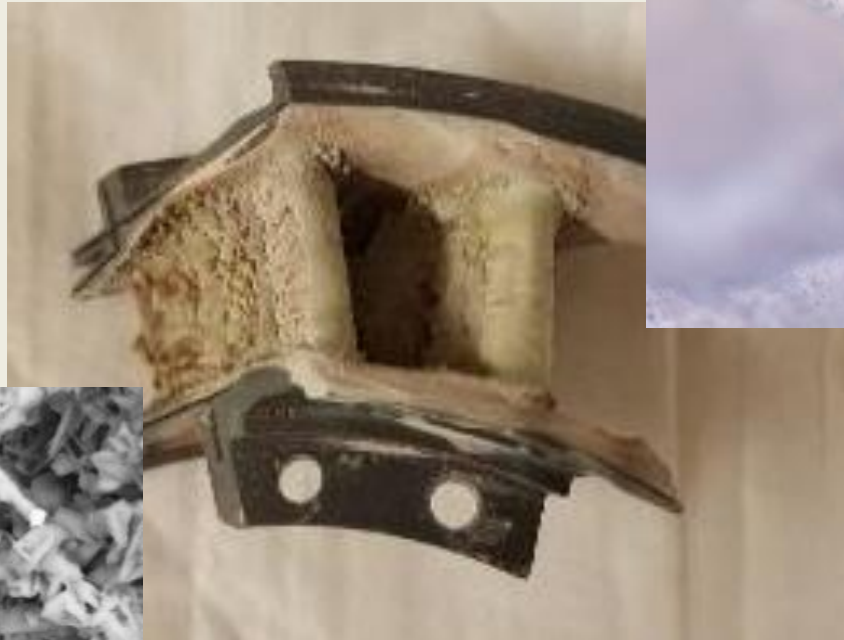
- Most CMAS deposits are very rough and porous
- CMAS deposits can be white, red, or both.

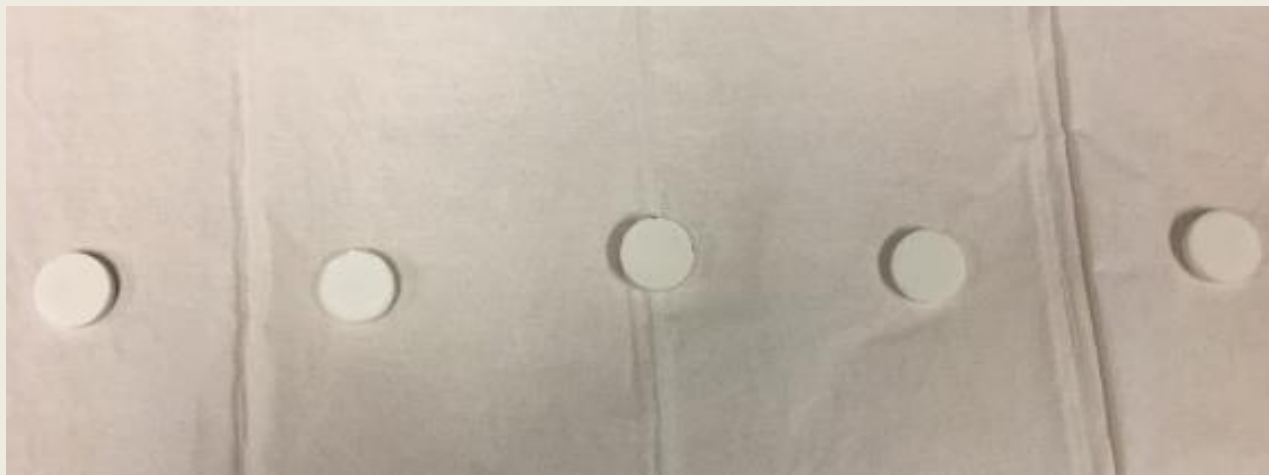
**Pellets Post
CMAS Attack
Testing**

**Adhesion,
morphology, and
size of CMAS
deposits can be
seen to vary
significantly**
