NASA/TP—2018-219787

Preload Loss in a Spacecraft Fastener via Vibration-Induced Unwinding

*Christopher DellaCorte and S. Adam Howard
Glenn Research Center, Cleveland, Ohio*

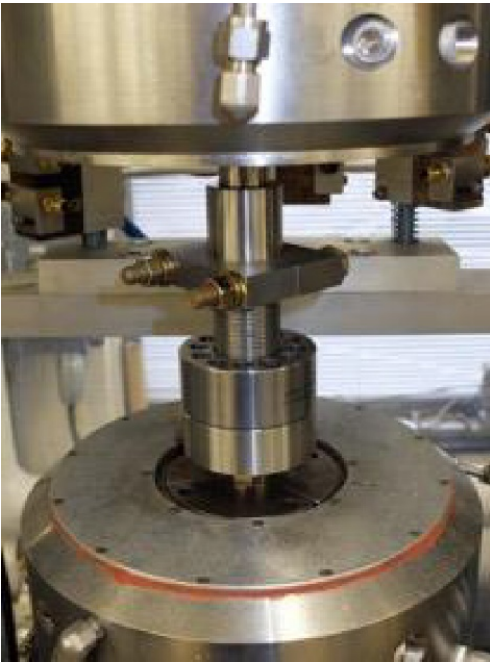
Figure 8.—Supernut-separation bolt loaded in load frame to measure prevailing (thread friction) torque.

With this setup, axial loads between 2,267.96 to 20,411.66 kg (5,000 to 45,000 lb) are applied to the threaded joint while a rotary actuator is used to turn the bolts and record breakaway and running torque. Rotation was at constant speed and data were acquired until a steady-state torque at each of the three

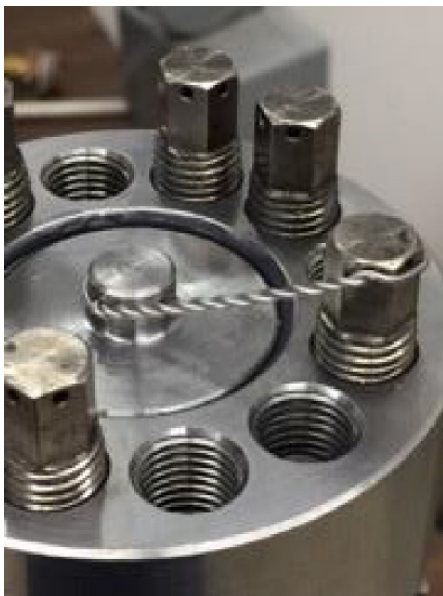
Figure 9.—Supernut-separation bolt safety wire configuration used during structural test article vibration test. Note the relatively small diameter center post and incorrect (backward) winding direction around the center post.

The second test that has been conducted is to ascertain the torque resistance of the safety locking wire. In this series of tests, surrogate separation bolts were manufactured to replicate the separation bolt end features and threads, but were long enough to allow installation in a torsion load frame. With this setup, various lock wire configurations could be readily installed and tested without any bolt preload that could mask the torque results. Figure 9 shows the safety lock wire test setup that mimics the STA vibration test condition.

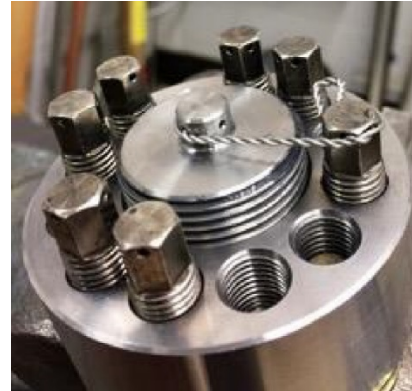
Figure 10.—Supernut-separation bolt safety wire configuration using proper horizontal alignment and correct winding direction around center post.

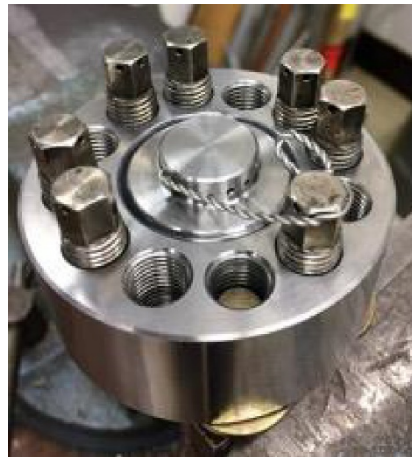
Figure 11.—Supernut-separation bolt safety wire configuration using improper angled alignment with correct winding direction around a large diameter center post.

Also tested was a single wire using a separation bolt with a large-diameter raised-wire connection intended to increase the rotational diameter of the wire to enhance restraining torque (Figure 11).

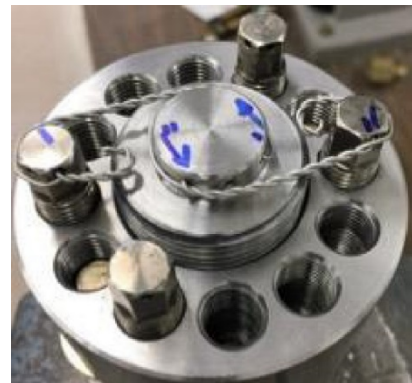
Figure 12.—Supernut-separation bolt safety multiple-wire configuration using proper horizontal alignment with correct winding direction around a large-diameter center post.

Lastly, multiple wires were tested in all configurations. Figure 12 shows a double lock wire arrangement with a coincident axial wire attachment.

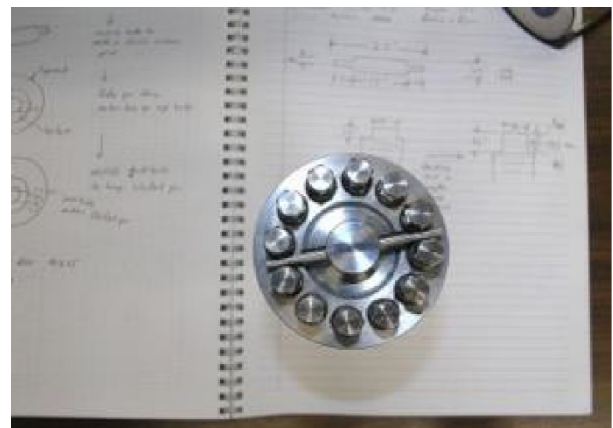
Figure 18.—Bladed cotter pin used for positive locking of supernut-separation bolt.

A sensible recovery plan is to provide positive locking features, such as cotter pins, that are capable of restraining levels of unwind torque that represent a significant percentage of the prevailing torque. Going forward, it is recommended to continue experimental and analytical investigations to quantify unwind forces with respect to environmental (loads, vibrations, etc.) and other factors. The results of such investigations could lead to valuable design guidance for the proper engineering of bolted joints.
