#### NASA/TM-2015-218812

# Full-Scale Prop-Rotor Stability Tests on the XV3 at High Advance Ratios

David G. Koenig Ames Research Center Moffett Field, California

Joseph P. Morelli U.S. Army Aeronautical Research Laboratory Ames Research Center Moffett Field, California

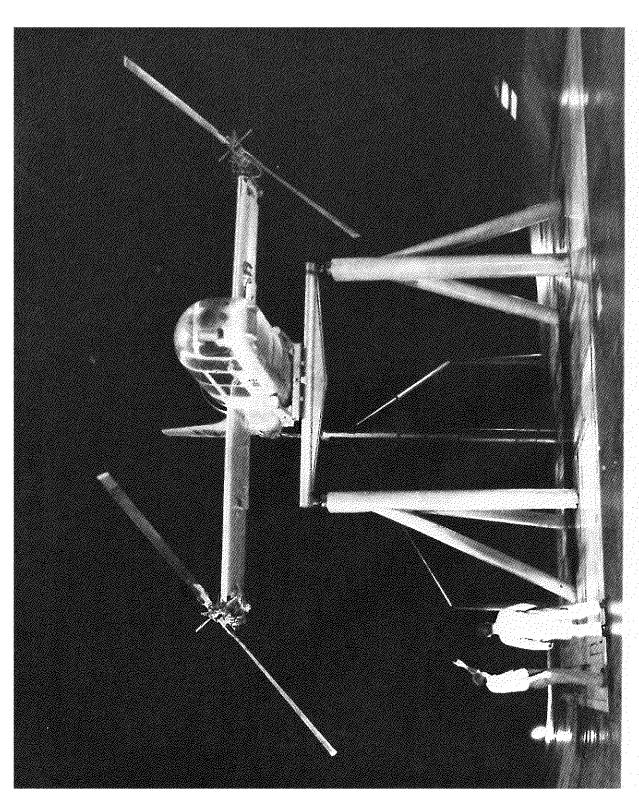
Figure 1.- The XV-3 mounted in the Ames 40- by 80-Foot Wind Tunnel. (a) Wing mount.

The XV-3 is shown in figures 1(a) and (b) mounted in the 40- by 80foot wind tunnel with the wing mount and the roll free installations
respectively. Sketches of the XV-3 and roll free mount arrangements are
presented in figure 2. A summary of geometric data for the aircraft is
presented in Table I. A list of the configurations tested is shown in
Table II. The pylons were fixed in the horizontal or airplane position
for all the tests.

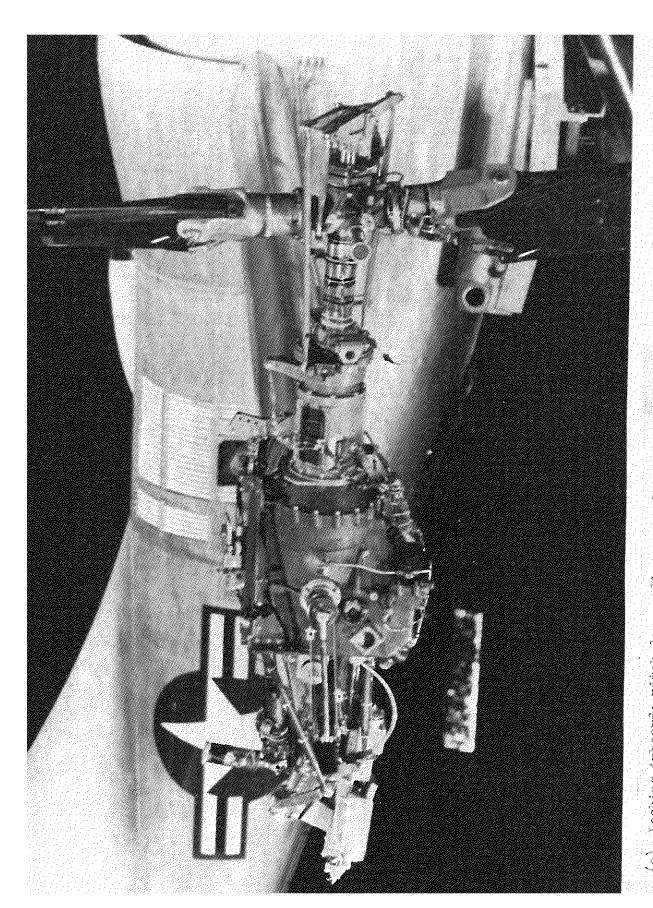
(a) Looking inboard; pitch damper disconnected. Pigure 3.- Detail views of the right pylon-rotor assembly.

The primary changes made to the original XV-3 rotor-pylon support system are described in the following paragraphs. Detail photographs of the right pylon-hub assembly and diagrams of the swashplate stabilization or coupling linkage and pylon restraint arrangements are shown in figures 3(a) through 3(g).

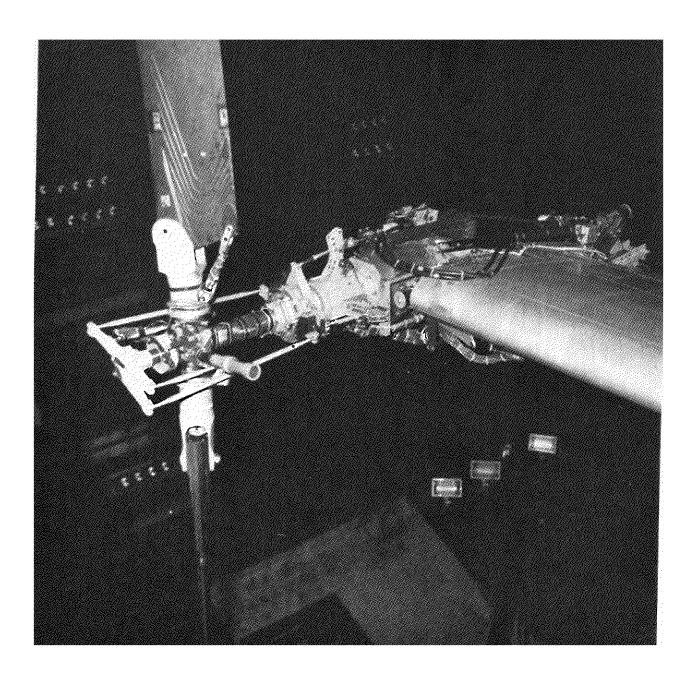
(b) Looking outboard; pitch damper connected.
Figure 3.- Continued.

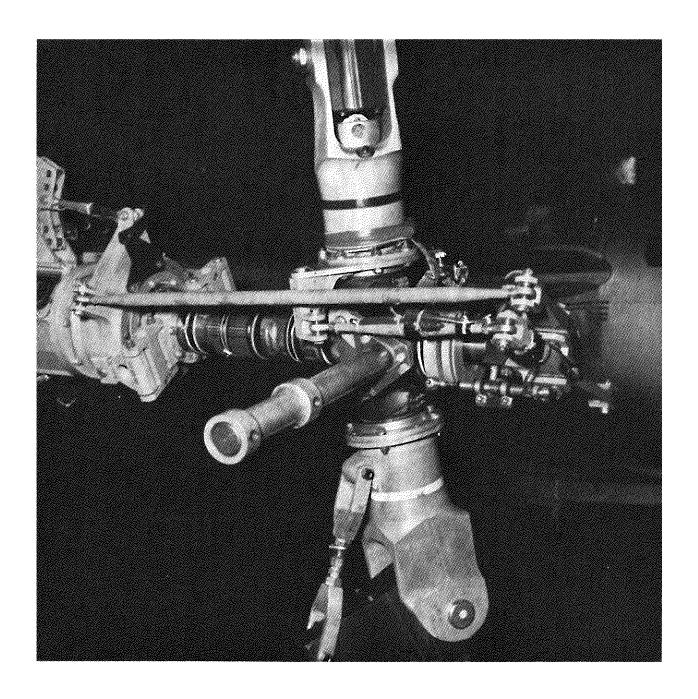
(c) Hub-swashplate assembly.
Figure 3.- Continued.

Swashplate Modifications. The swashplate was modified for the present tests by moving it from a position forward of the hub to the present position near the transmission. The cyclic pitch control was disconnected and the swashplate was connected to the blades through arms mounted on the end of the collective pitch tube. (See figure 3c.) Provisions were made to obtain nominal values of 20 and 35° of  $\delta_3$  and swashplate retardation,  $\epsilon$ . Retardation was obtained by re-indexing the rotating part of the swashplate with respect to the hub in a direction opposite to rotor rotation.

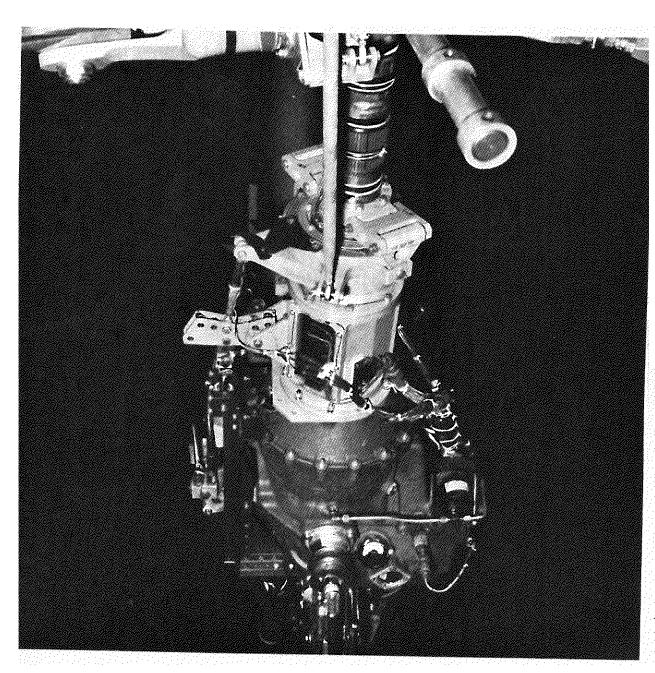
(G) Iylon transmission assembly.

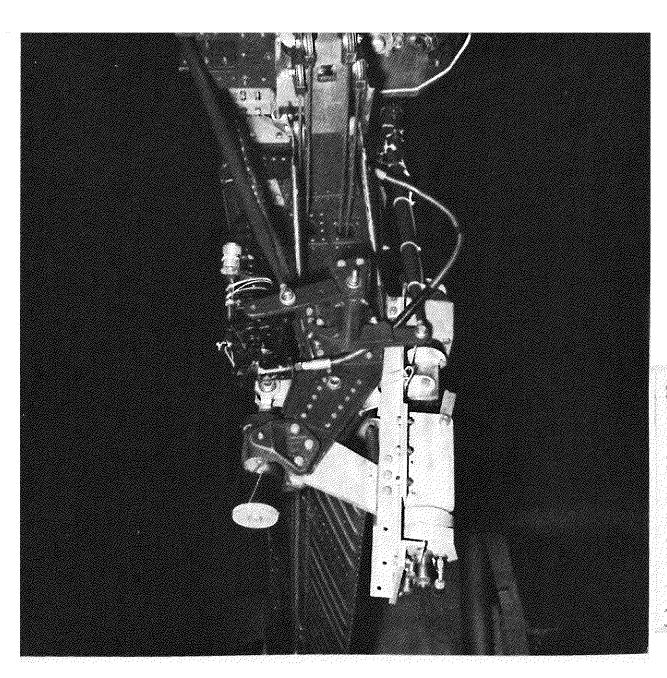
(e) Aft pylon wing tip assembly.

Pylon Actuators. An hydrualic actuator was installed in the right pylon restraint linkage as shown in figures 3(e) and (g). Statically the hydraulic actuator could pulse the pylon up  $1-1/2^{\circ}$  and back again

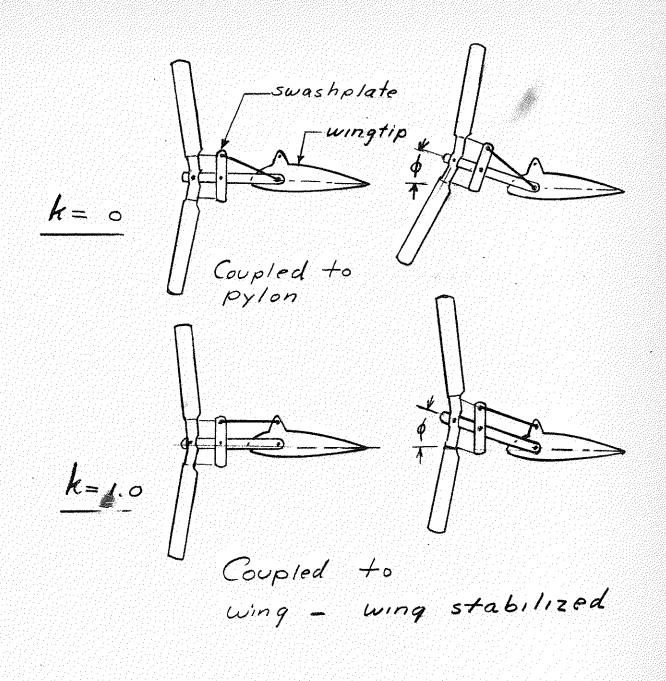
(f) Swashplate stabilization. Figure 3- Continued.

Swashplate Stabilization. The swashplate was stabilized by coupling the swashplate to the wing or fuselage as illustrated in the sketches of figure 3(f) (for wing coupling).

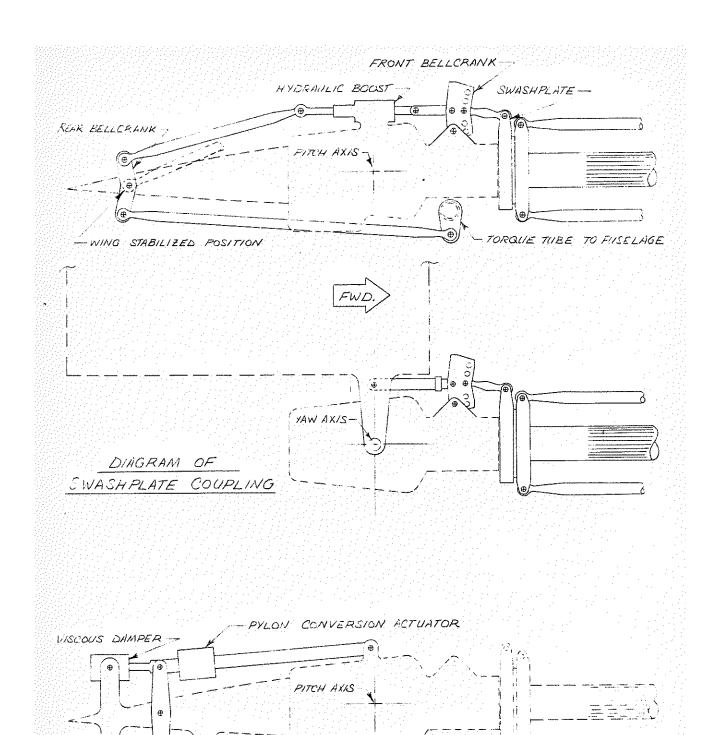
(9) Swashplate Coupling and Pylon Restraint
Figure 3. - Concluded.

LORD MOUNT

ACTUATOR

PYLON RESTRAINT IN PITCH

(YAW RESTRAINT IS SIMILAR)

As shown in figure 3(g), the swashplate was moved in the pitch direction through a fast-response hydraulic boost. Swashplate stabilization,  $k_{\rm X}$  (or  $k_{\rm y}$ ), could be set by choosing proper combinations of connecting rod positions on the bell cranks. A torque tube running through the wing to the fuselage enabled the coupling of the swashplate to the fuselage. The swashplate was coupled to the wing tip rather than the fuselage after it was found that relative wing-tip-fuselage motion in torsion was negligible. With wing stabilization, the rear connecting rod was attached at the pivot point of the rear bell crank. The swashplate was coupled to the wing without hydraulic boost in the yaw direction.

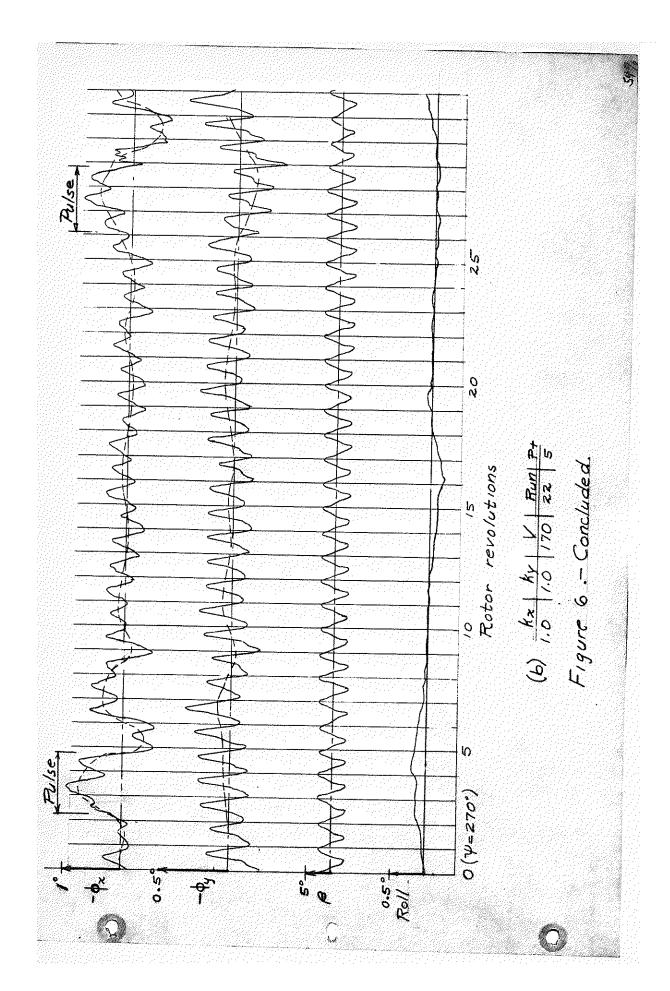
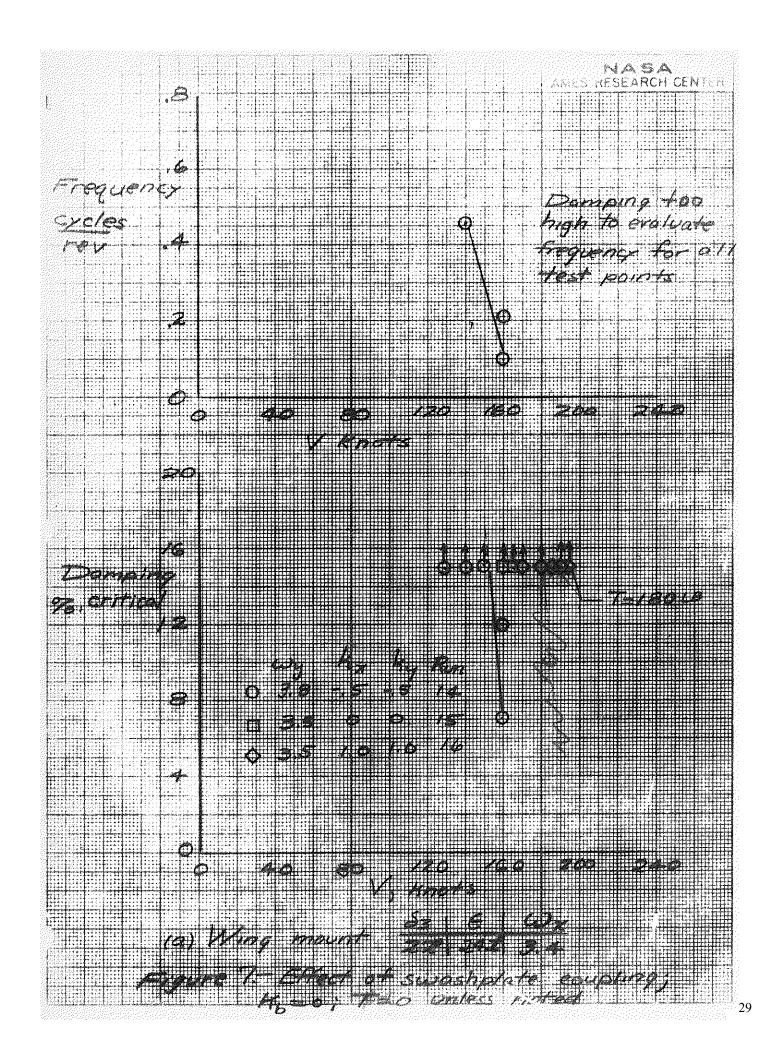
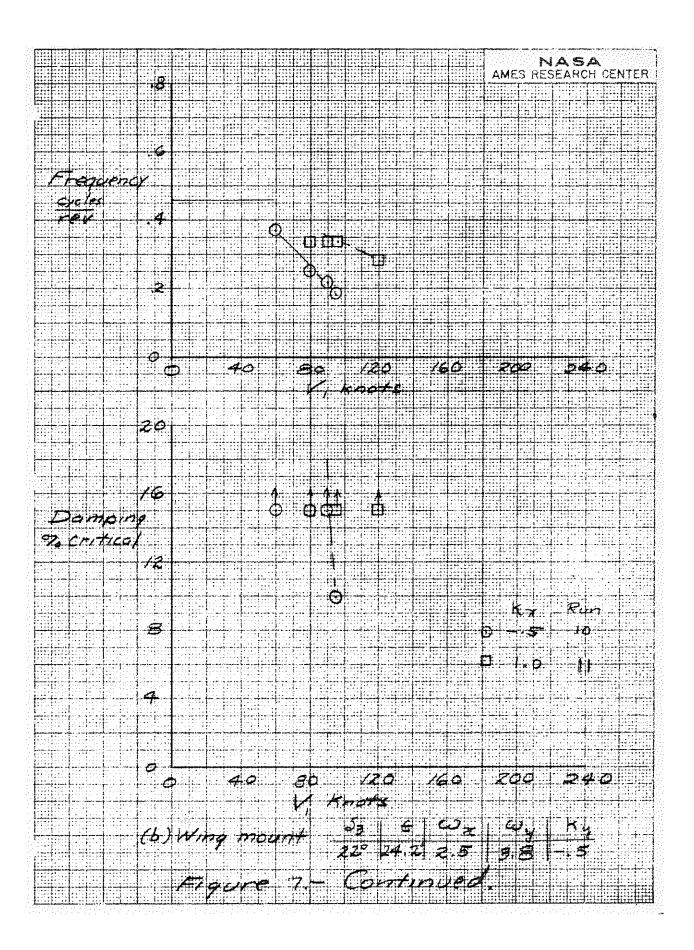
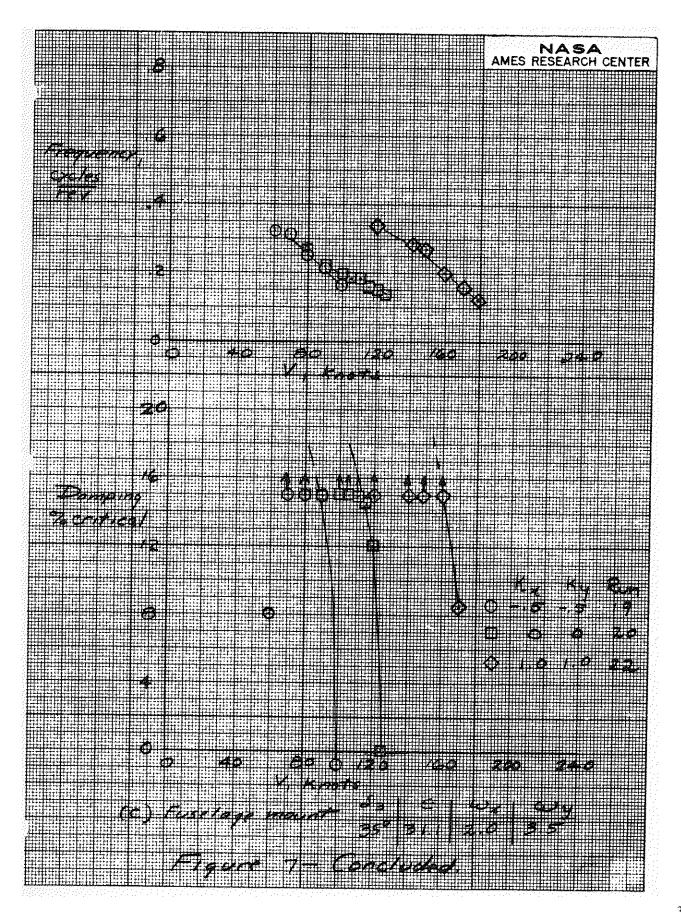
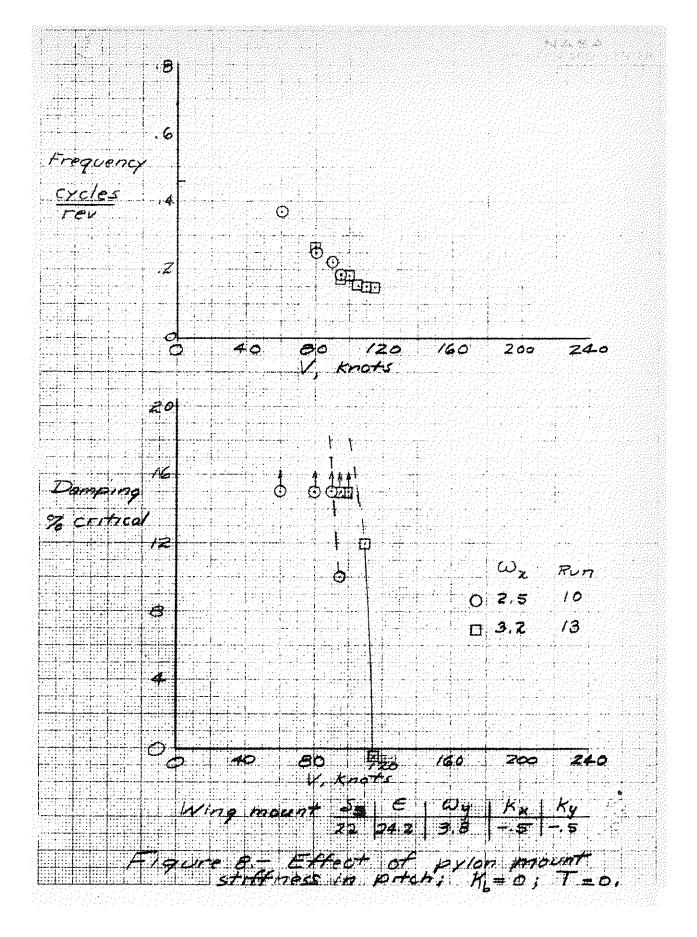
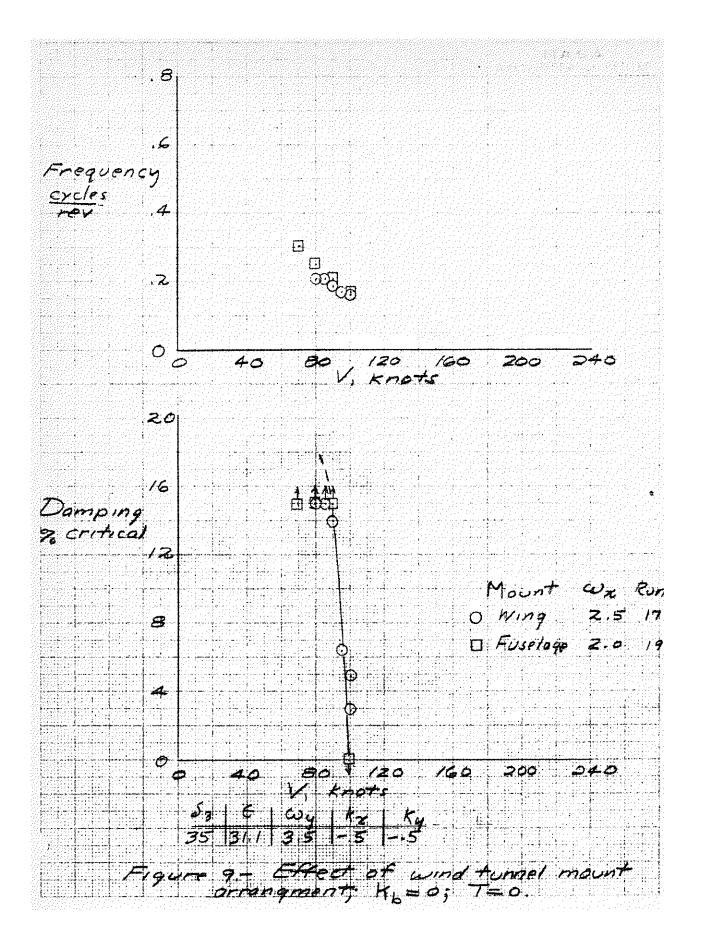
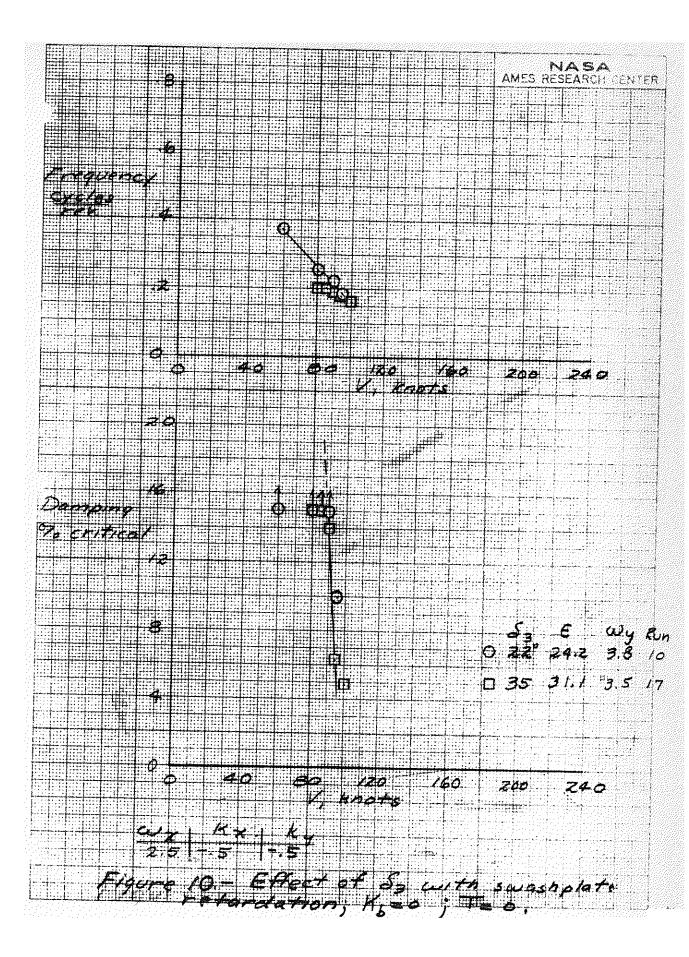
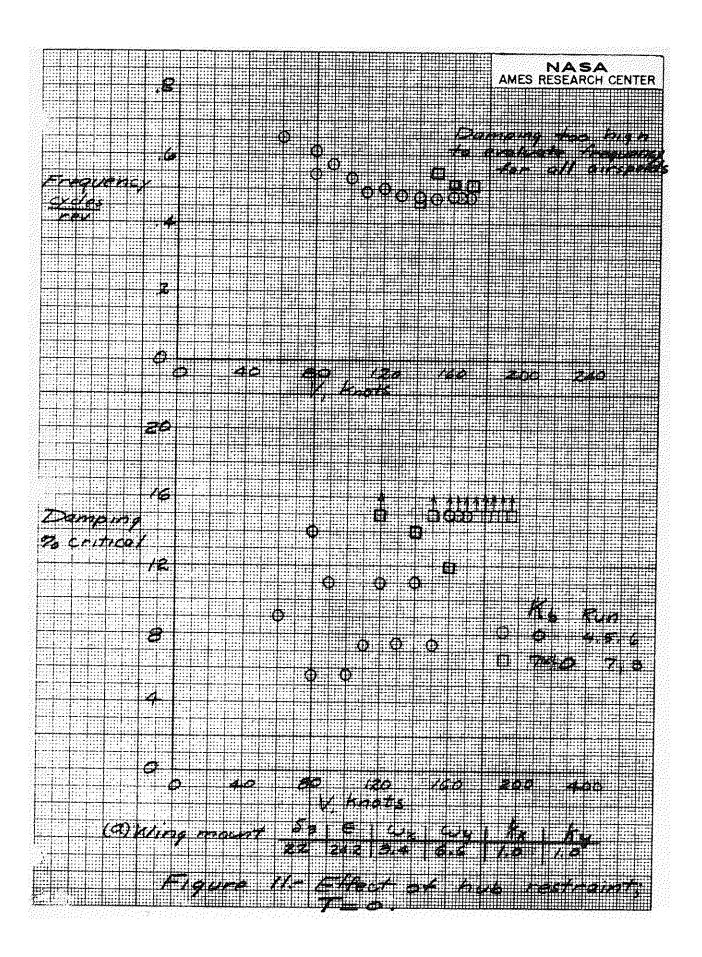
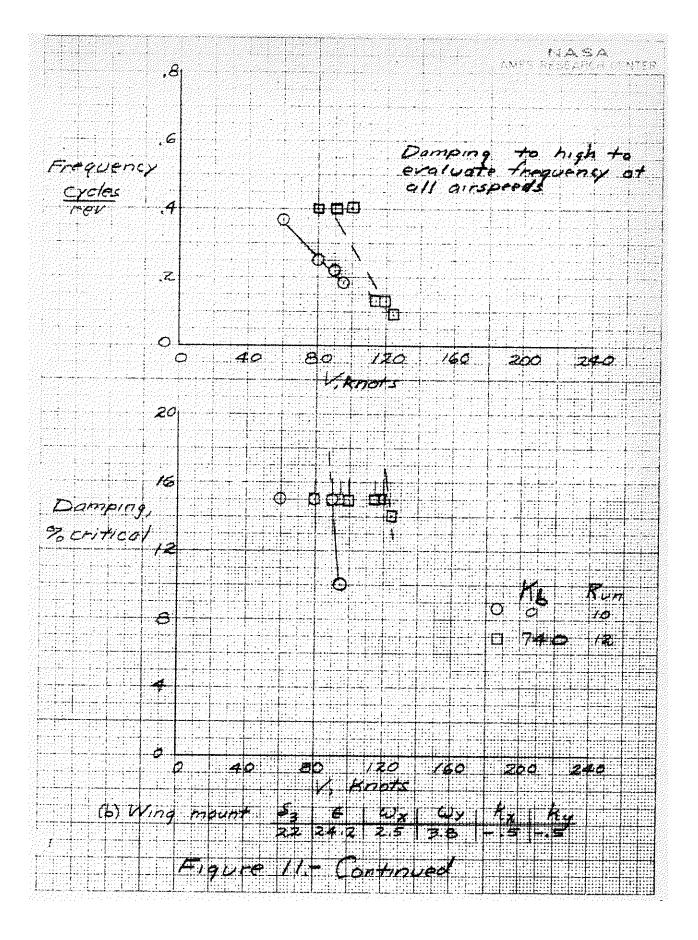
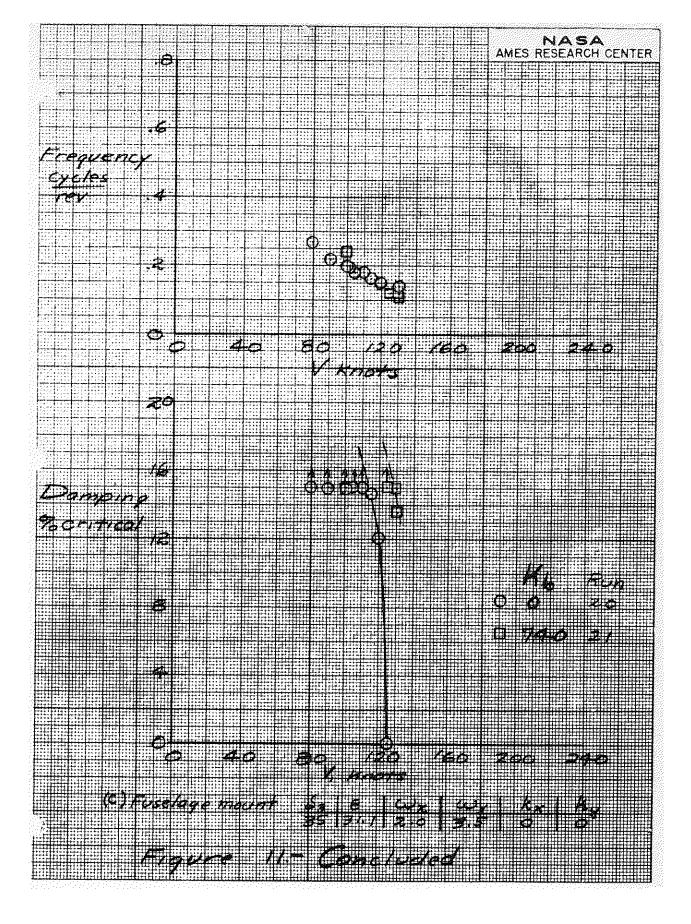
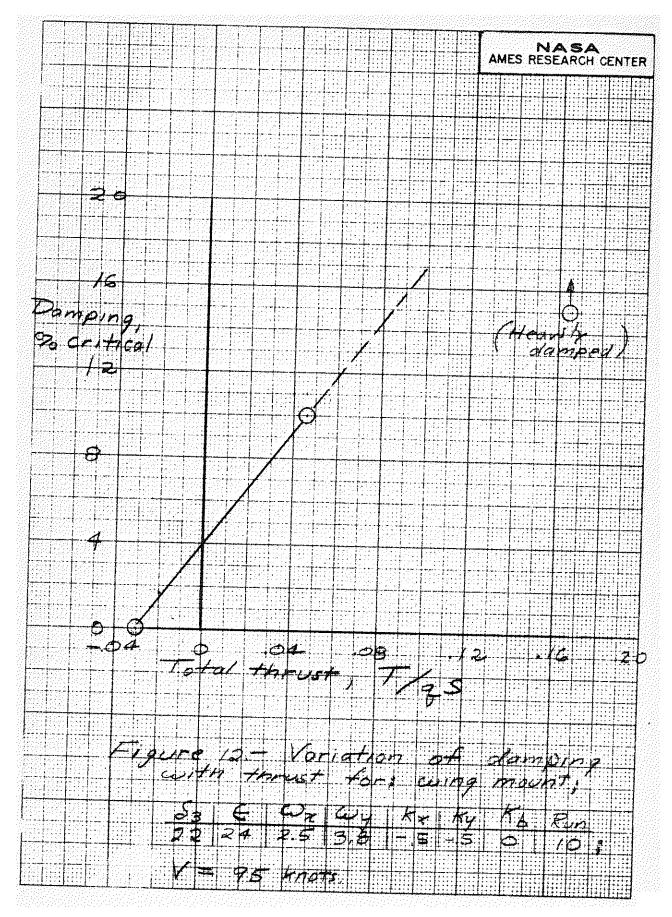
The damping ratios (in terms of % critical damping, see Figure 4) of the backward whirl mode are presented as functions of airspeed in figures 7 to 11. Damping as a function of thrust is presented in figure 12. As may be seen from the figures, crossover speeds or airspeeds for neutral stability were not obtained for some of the configurations. Since the damping deteriorated abruptly before reaching a crossover speed, several of the test runs were terminated as soon as any reduction in damping was noticed. The data points corresponding to damping above 15% critical were noted on the plots by the symbols at 15% critical damping with arrows attached. Frequencies shown for high damping are based on estimations for the time to complete one-half cycle.

Time histories of pylon displacement and rotor flapping are shown in figures 5 and 6 for several test conditions. The conditions chosen indicate the effect of changes in swashplate coupling on the rate of decay of the right pylon oscillation after the pylon was pulsed. The dashed lines on the displacement traces represent the backward whirl or
