## Experimental investigations into SGP laminated glass under low velocity impact

Wang, Xing-er; Yang, Jian; Liu, Qiang; Zhao, Chenjun

- Drop weight tests were conducted to investigate the impact damage of SGP laminated glass.
- The high speed camera was adopted to capture the crack initiation and propagation.
- 27 SGP laminated glass panels in eight groups were tested using a mean minimum breakage velocity test approach.
- The effects of panel sizes, interlayer thickness, support conditions and glass make-ups on the impact behaviour were investigated.
- The impact energy and peak impact force that trigger the glass breakage were determined.
- The dynamic stiffness, energy dissipation and delamination behaviour are reported.

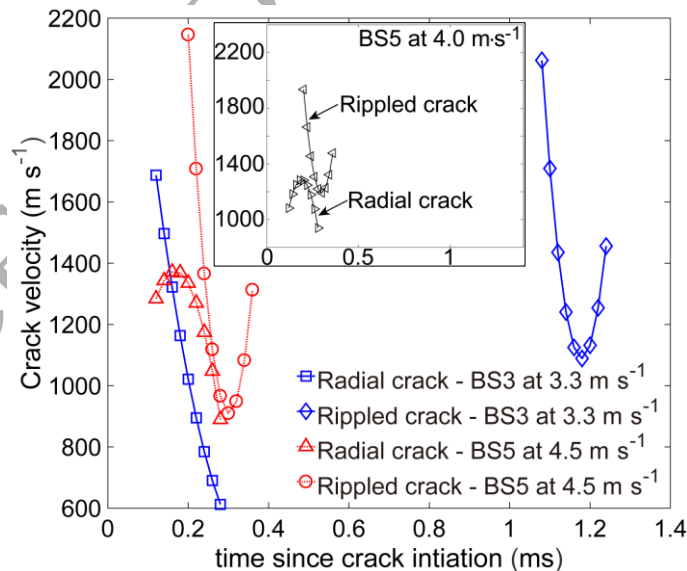
**Fig. 4.** Crack propagation speed of specimens No. 1 (BS3) and No. 5 (BS5)

The crack propagation speed obtained for the specimens in **Fig. 3** is summarised and shown in **Fig. 4**. It can be seen that the propagation speed of rippled cracks in both cases show the same

trend, i.e. deceleration first and then acceleration. The peak speed of rippled cracks in the BS5 case (around  $2146 \text{ m}\cdot\text{s}^{-1}$ ) is slightly greater than that in the BS3 case (around  $2063 \text{ m}\cdot\text{s}^{-1}$ ). **Figure 4** also shows that the propagation speed of the radial cracks is evidently lower than that of the rippled cracks, with a peak speed of approximately  $1688 \text{ m}\cdot\text{s}^{-1}$  in BS3 and  $1335 \text{ m}\cdot\text{s}^{-1}$  in BS5. The propagation speed of radial cracks in BS3 experiences a monotonic decline, the crack tip propagation decelerates to nearly  $600 \text{ m}\cdot\text{s}^{-1}$  when it reaches the edge. In comparison to the monotonic trend in BS3, the radial crack tip in BS5 first accelerates to  $1335 \text{ m}\cdot\text{s}^{-1}$  and then decelerates to  $890 \text{ m}\cdot\text{s}^{-1}$  afterwards. A similar observation on the propagation of the radial cracks can be found [28], where its trend and peak can be traced within  $0.04 \text{ ms}$  after the crack initiation. Therefore, one can anticipate that the propagation speed of radial cracks up to  $0.08 \text{ ms}$  in BS3 may also show the same trend but there is no evidence to support this argument due to an absence of high speed photos.

In addition, **Figure 4** shows an inset figure that presents the crack propagation speed in BS5 when impact velocity decreases to  $4.0 \text{ m}\cdot\text{s}^{-1}$ . It should be noted that the case in BS3 with a

different breakage velocity from  $3.3 \text{ m}\cdot\text{s}^{-1}$  cannot be found in the same glass make-up and is hence not included in **Fig. 4**. Compared with the results at the impact velocity of  $4.5 \text{ m}\cdot\text{s}^{-1}$ , the peak propagation speeds of both radial (around  $1933 \text{ m}\cdot\text{s}^{-1}$ ) and rippled cracks (around  $1280 \text{ m}\cdot\text{s}^{-1}$ ) at the impact velocity of  $4.0 \text{ m}\cdot\text{s}^{-1}$  have an evident decrease. However, both cases show a similar variation pattern. Such observation supports the conclusion that the peak propagation speed is expected to decline when impact velocity decreases. As the crack propagation is driven by the stress component normal to the crack front [32], which can be significantly reduced by decreasing impact velocity.

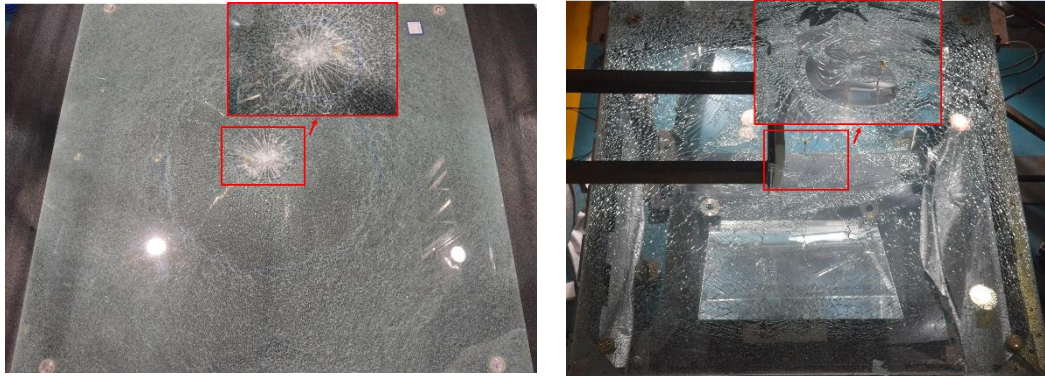
**Fig. 11.** Crack patterns of specimen No. 2 at first breakage.

(a) Two glass crack patterns in BS3 at 1<sup>st</sup> breakage      (b) Outer glass crack pattern in BS1 at 1<sup>st</sup> breakage

The behaviour of specimen No. 2 in BS1, as shown in **Fig. 10 (b1)**, indicates that the energy dissipation of No. 2 experiences a non-monotonic trend with an inflexion point near the impact velocity of  $2.5 \text{ m}\cdot\text{s}^{-1}$ . Such a trend consists of a peak in the pre-breakage stage and a trough in the post-breakage stage. Only one specimen presents this particular trend and it may be caused by an unusually strong adhesion between the glass and the interlayer. Strong adhesion tends to lead to the outer glass layer and the SGP interlayer having greater local strain and a higher strain rate, and thus the breakage of the outer glass layer is more likely to be triggered [36]. This assumption can be validated by comparing the crack patterns of the two No. 2 specimens broken in different sequences as shown in **Fig. 11**. It can be seen that the outer glass layer of the specimen in BS3 shatters into ‘dice’ of similar size, while the area near the impact point cracks into large fragments in a ‘starburst’ pattern (**Fig. 11 (a)**). In contrast, the outer glass layer of the specimen in BS1 shatters into large glass fragments of irregular shape (**Fig. 11 (b)**). Such irregular shapes are probably due to the stronger adhesion between the glass and interlayer. Once one of the FT glass layers breaks, the intact glass holds the broken counterpart through adhesive shear action so that the locked-in stress can be released slowly. In contrast, weak adhesion does not provide such interaction, and thus the glass breaks into a typical fragmentation pattern, namely small ‘dice’.
