Investigation of Laser Deposited Wear Resistant Coatings on Railway Axle Steels

A Thesis Submitted in Fulfilment of the Requirements for the Degree of
Master of Engineering

School of Aerospace, Mechanical and
Manufacturing Engineering
RMIT University
July 2013

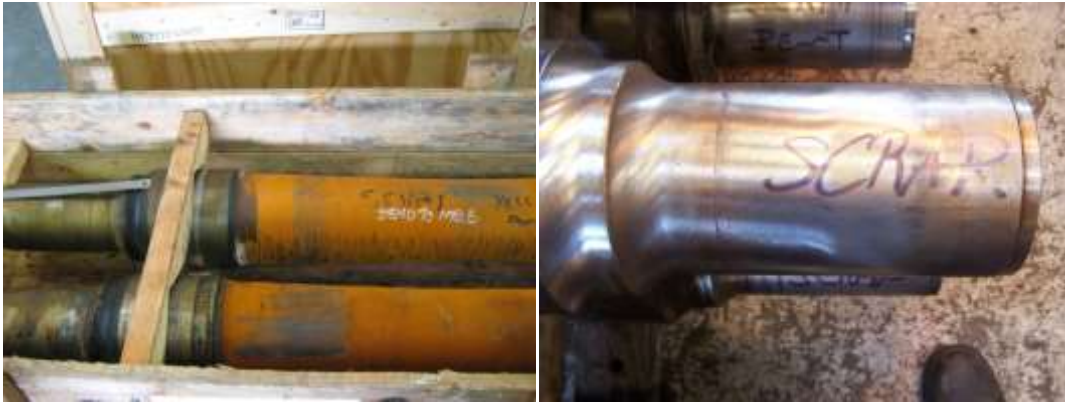
Figure 1.1: Scrapped railway axles with worn journals

Every year, the rail operators across the world scrap thousands of rail axles due to the size of the two bearing journals being under tolerances and size defined for them or deep scratches on the journals which occur while changing the wheels (Figure 1.1).

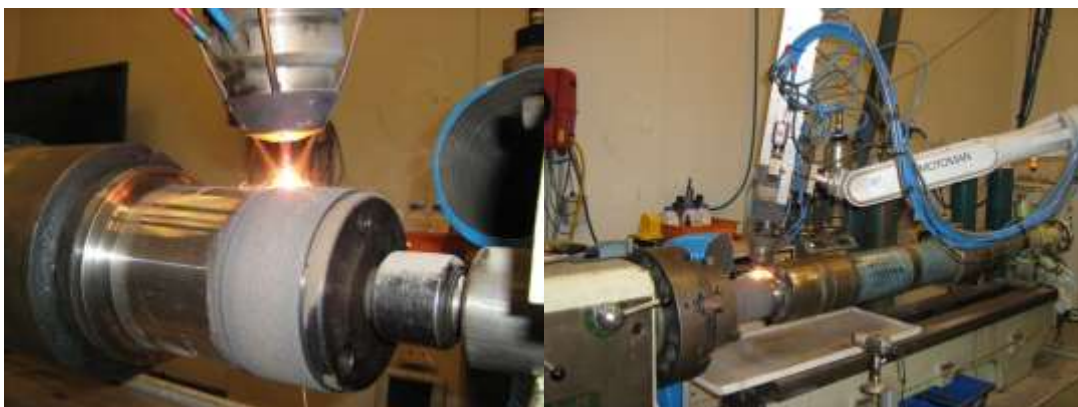
Figure 1.3: Laser Cladding of a worn railway axle in Hardchrome Engineering Pty Ltd

Figure 1.3 shows the trial laser cladding of a railway axle in Hardchrome Engineering Pty Ltd in Melbourne Australia.

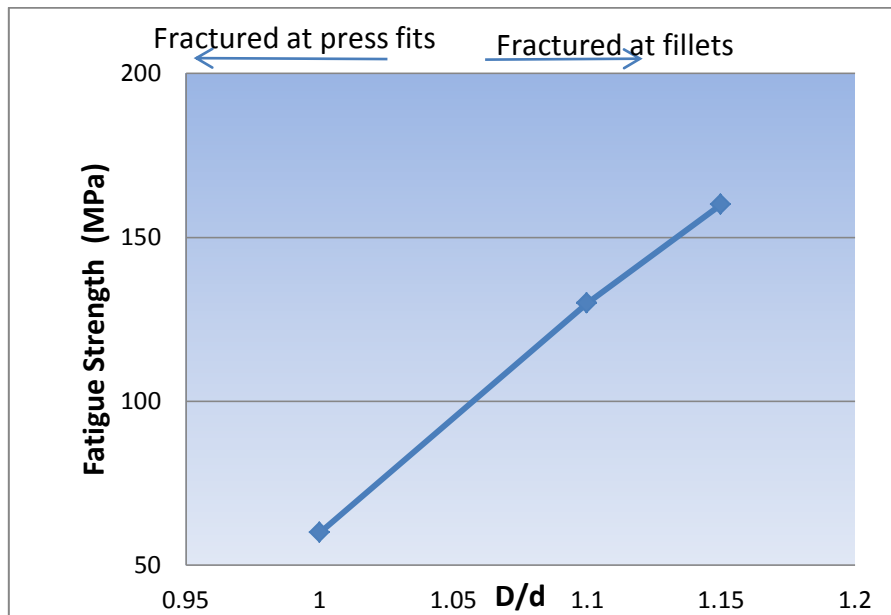
Figure 2.7: Diameter ratio between the press fitted parts and the plain section versus the fatigue strength [14]

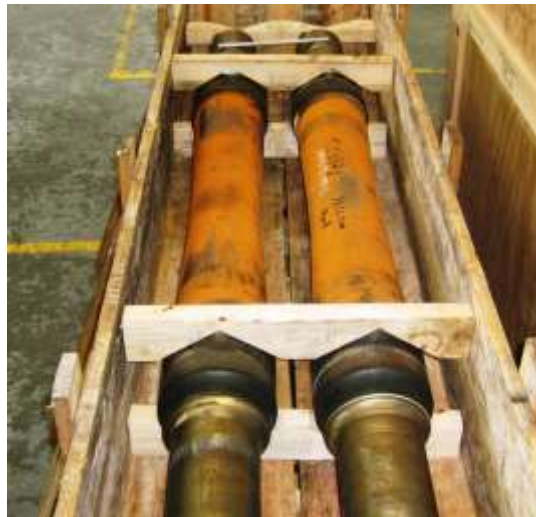
Figure 2.8: Two retired axles with corroded surface

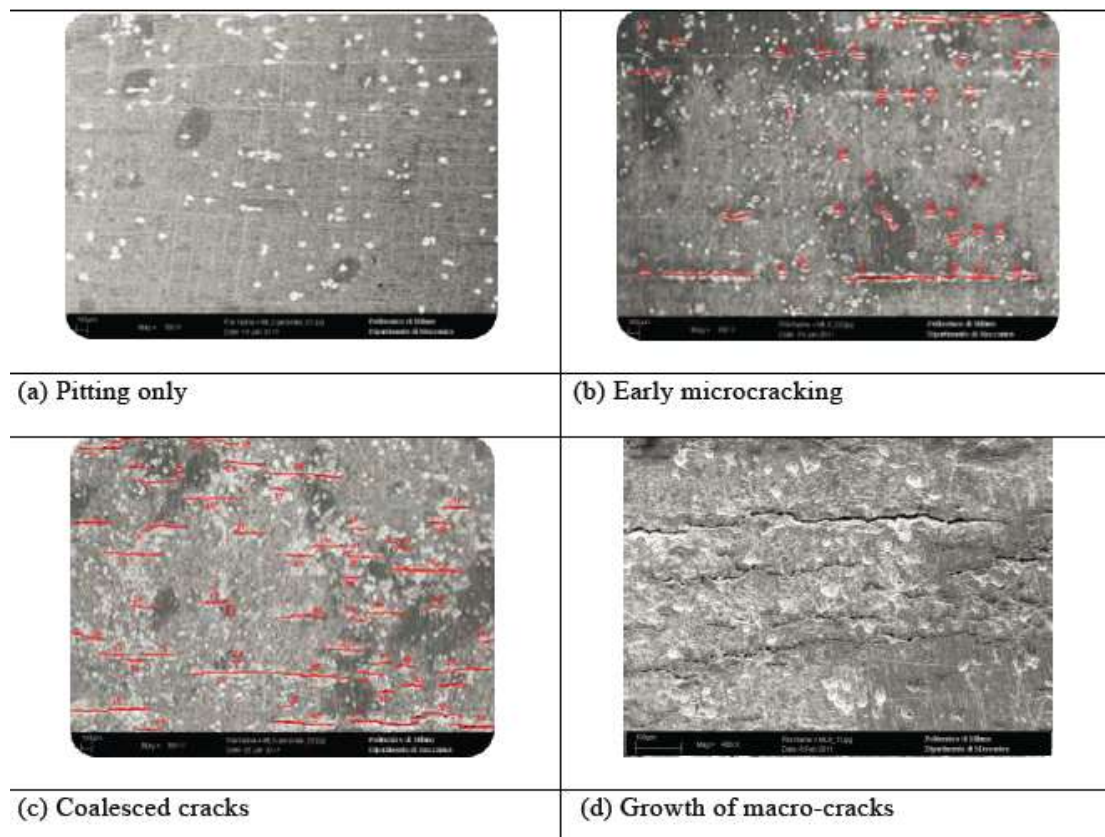
- Stage 1: Pitting, similar to the pitting without fatigue. The pits act as crack initiation sites.
- Stage 2: Formation of micro cracks.
- Stage 3: Coalescence of micro cracks.
- Stage 4: Crack propagation.

Figure 2.10: The four stages in the "pit-to-crack" transition [40]

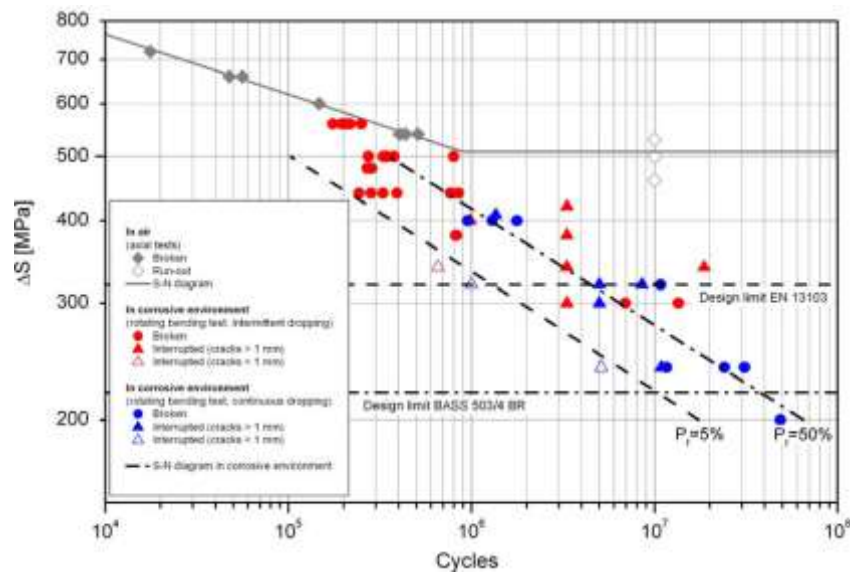
Figure 2.12: The S-N curves in air and in corrosive environment of EA1N alloy [23]

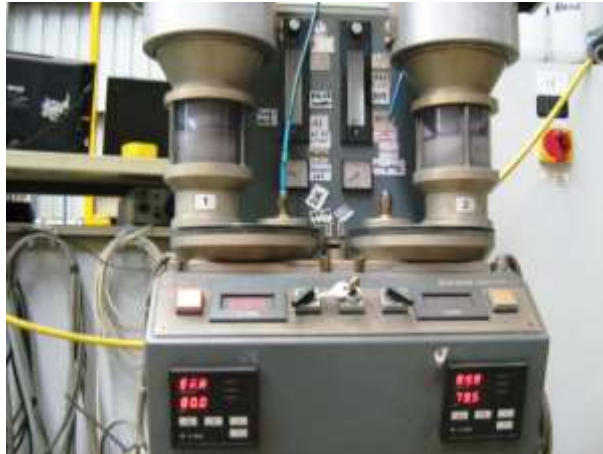
Figure 3.8: Sultzer-Metco twin-10 powder feeder

The powder feeder used was a Sultzer-Metco twin-10 (Figure 3.8). The powder flow rate was set by the powder feeder. Due to the wearing of powder nozzle by the powder itself, the flow rate of powder was not constant and therefore before each cladding the powder flow rate was examined to see if there were any changes in the nozzle. To examine the powder flow rate, the powder feeder would start running for one minute and the powder which came out of it would get collected in a container. Then the powder would be weighed and the flow rate was therefore determined.

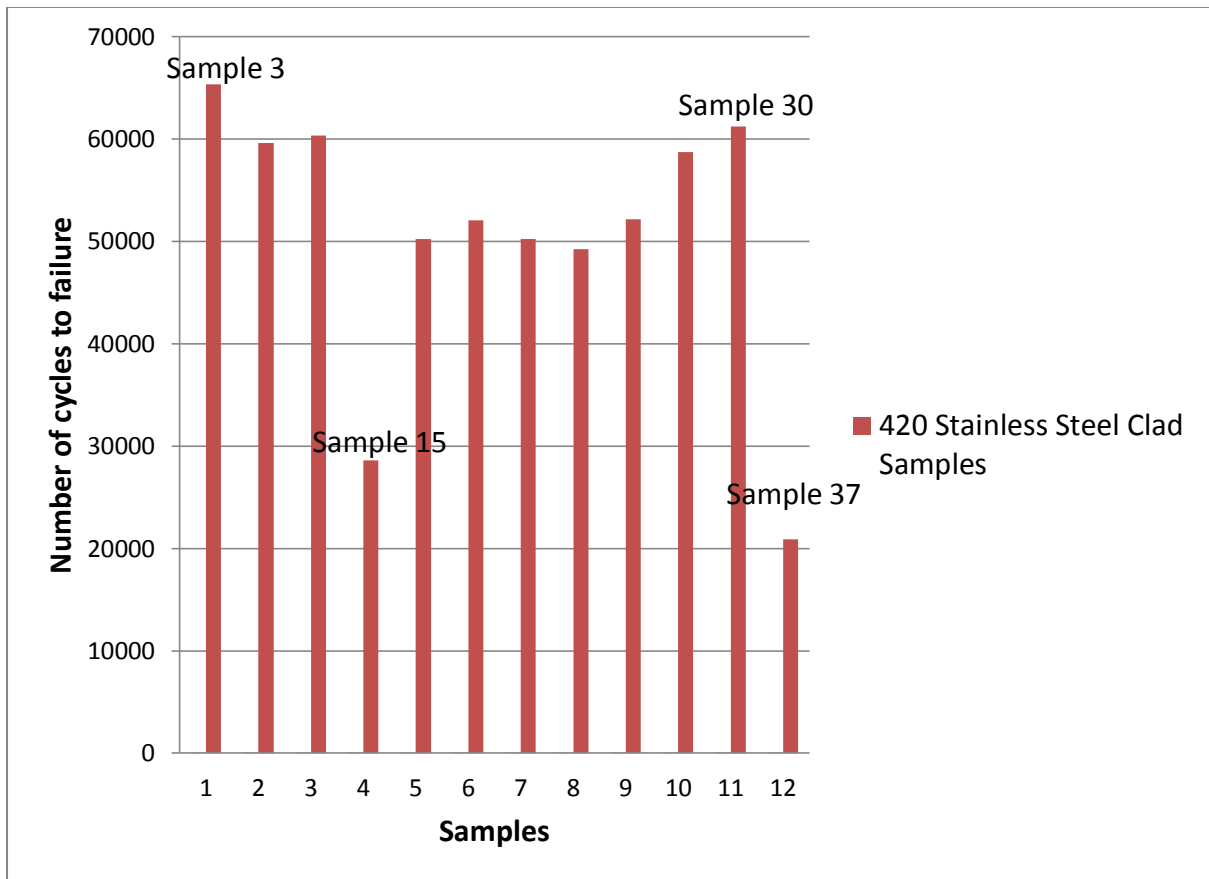
Figure 4.2: Rotary bending fatigue test results for 420 stainless steel clad samples heat treated at 580° C for 1 hour

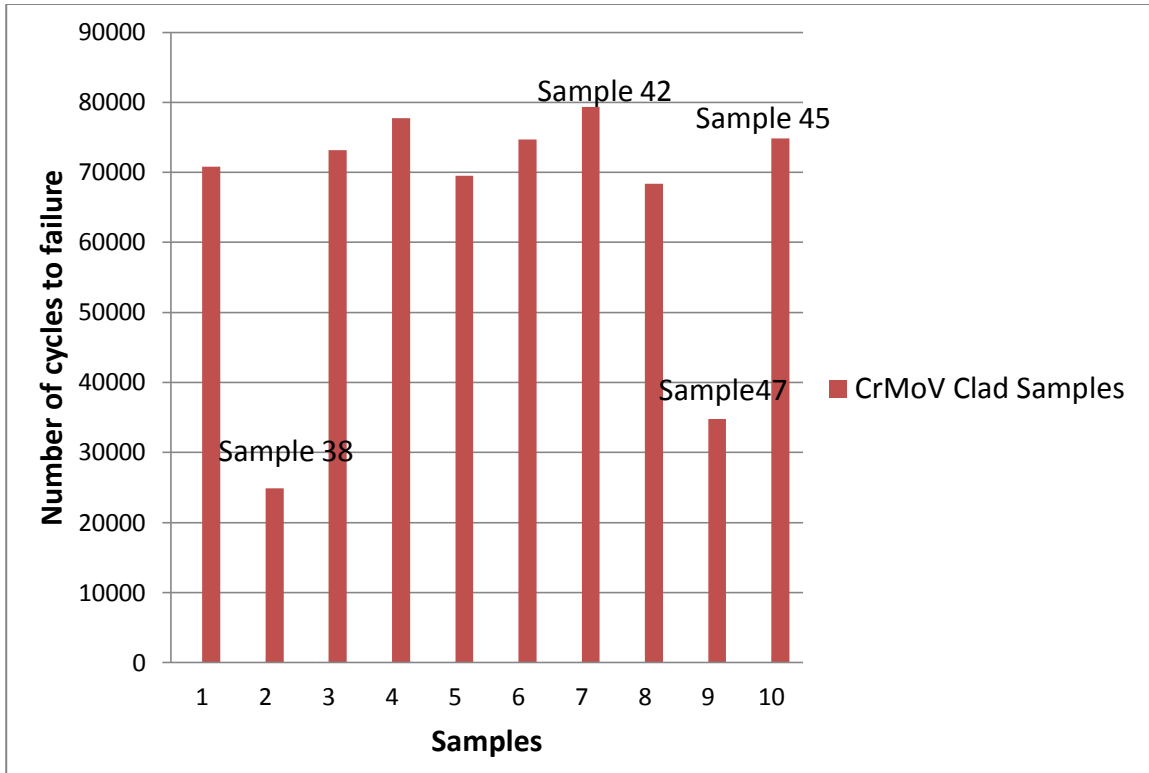
Figure 4.18: Number of cycles to failure for CrMoV clad samples heat treated at 580° C for 1 hour

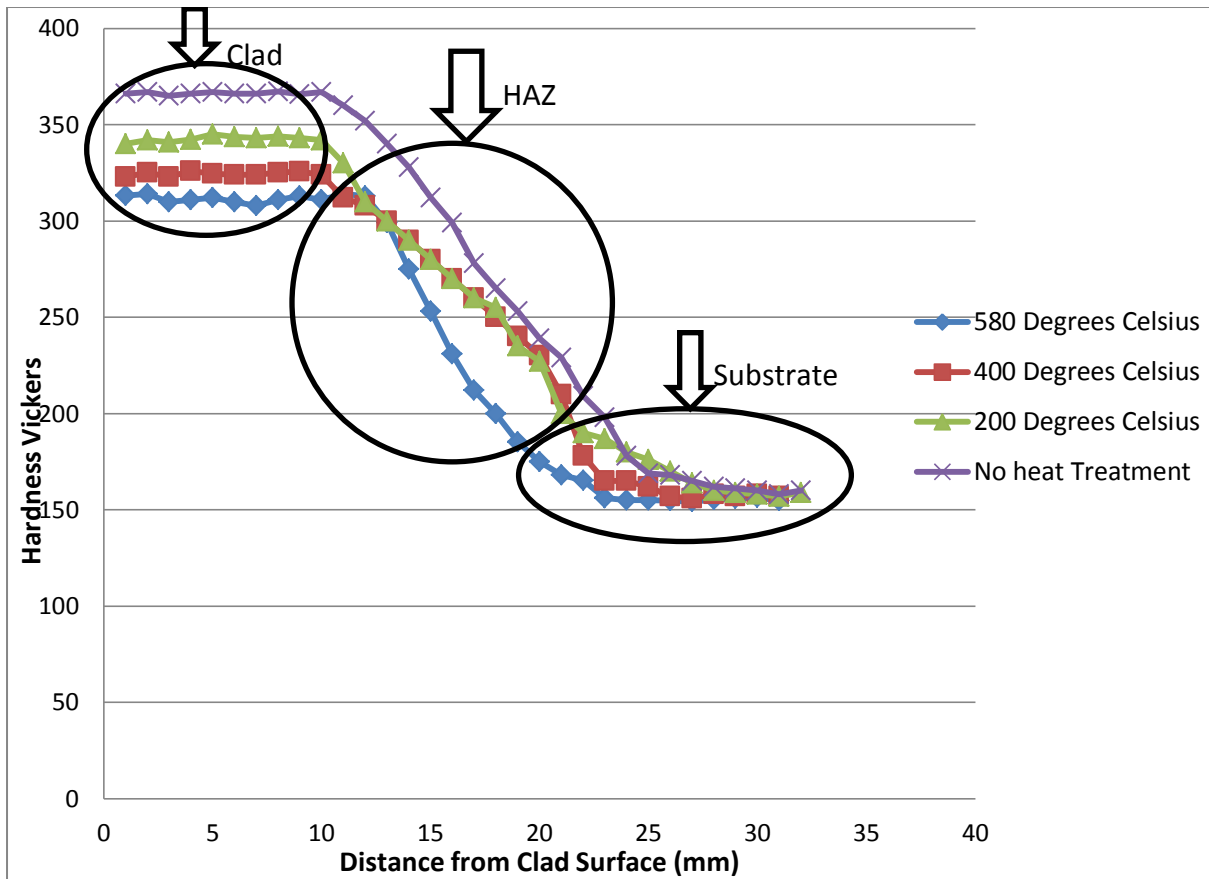
Figure 4.25: Hardness profiles for CrMoV clad samples with different heat treatment conditions

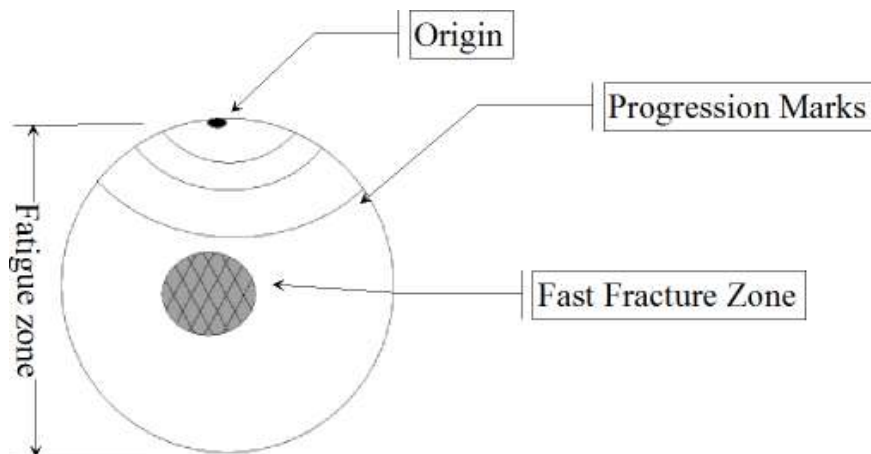
Figure 4.4: The macroscopic features of the fracture surface of a failed fatigue sample

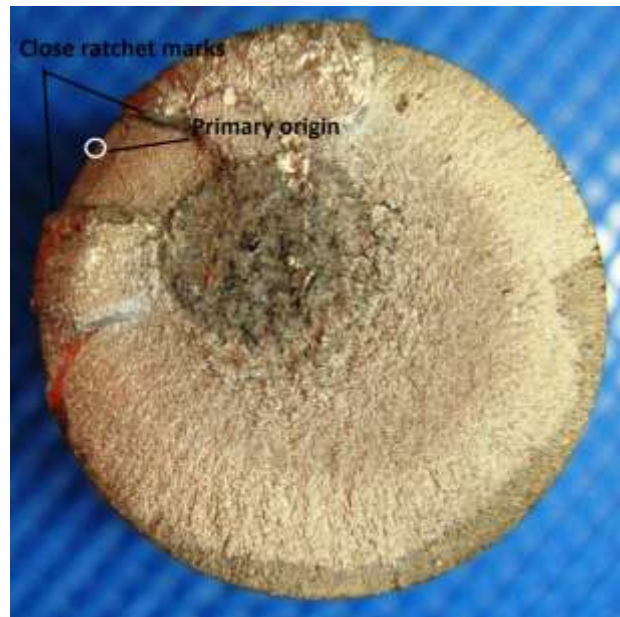
Figure 4.47: Locating of the primary origin using the angles of the ratchet marks
