Composite Technology for Exploration (CTE)

Briefing to SLS USA Team Dec 13, 2018

Longitudinal Joint (L-Joint)

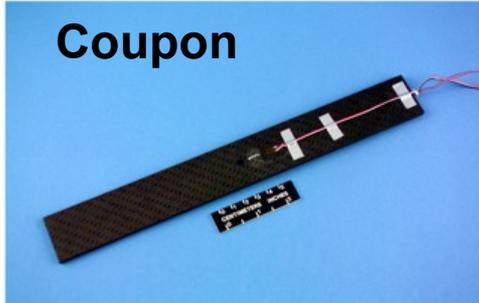
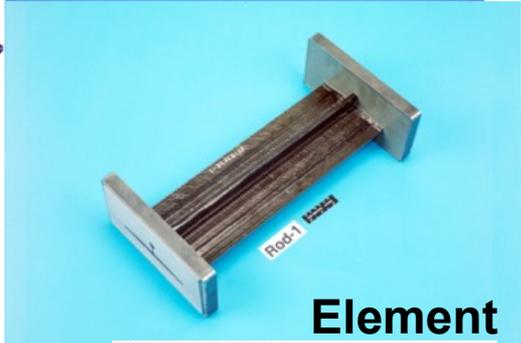
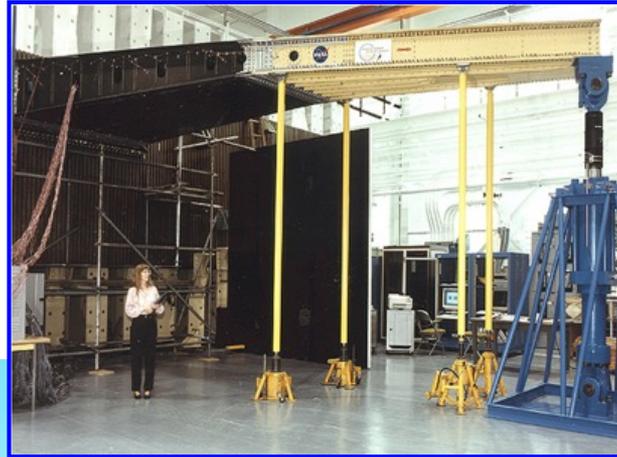
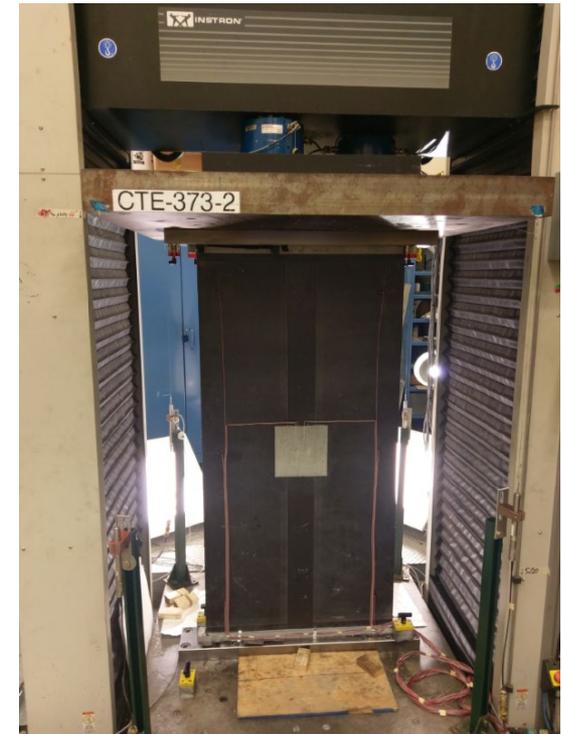
Damage Tolerance

CTE Joint design development includes damage tolerance testing at the joint element and component levels

For CTE purposes a jointed sandwich panel is considered a conic or cylindrical section subcomponent.

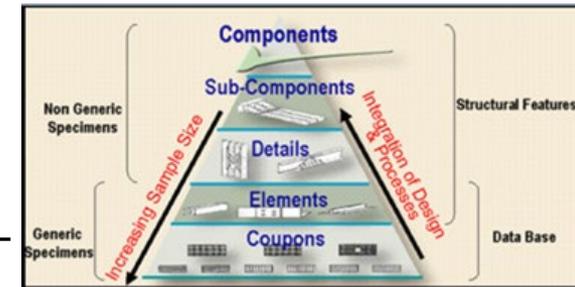
1. Designed, built, and tested L-Joint and sub-elements. Showing 87% mass reduction and 98% part count reduction over state of the art joint designs.
2. Designed and tested L-joint element and buckling panels for sub-component / scale up testing.
3. Validated pre-test predictions are within 9% based on non-linear analyses approaches

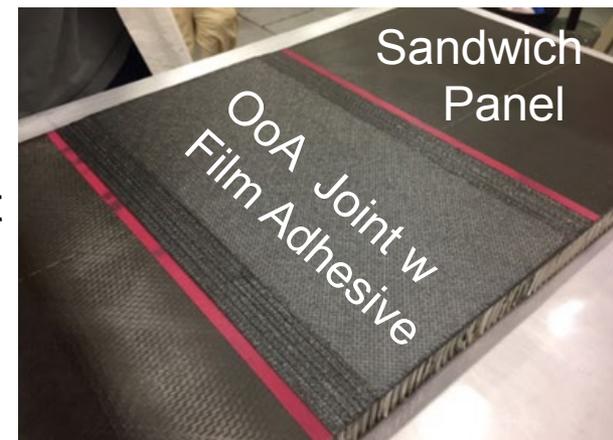
Design

- Get correct bending stiffnesses for Double Cantilever Beam coupon, and get correct interface
- CTE mismatch between fabric and tape materials and/or co-bond process had caused panel warping

- Got a flat panel with equivalent DCB arm stiffnesses using a hybrid fabric / uni tape design

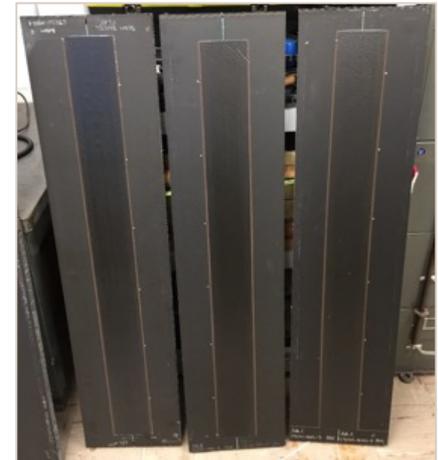
CTE Longitudinal Joint Mass and Part Count	Total Mass (lb-f)	# Fasteners	Part Count
Metallic Splice / Bolted with 1 Row of Bolts – Core Densification	330	2100	2116
Metallic Splice / Bolted with 1 Row of Bolts – Bushings	207	2100	4216
Composite Bolted with 1 Row of Bolts- Core Densified	290	2100	2116
Composite Bolted with 1 Row of Bolts- Bushings	167	2100	4216
Composite Bolted FailSafe – Core Densified	234	530	546
Composite Bolted FailSafe – Bushings	144	530	1076
All Bonded	42	N/A	40
CTE Final Design, As Built Data	27	0	40

**Proven: 2.0 FoS Bonded longitudinal joint
87 - 92% mass reduction and 98% part reduction.**

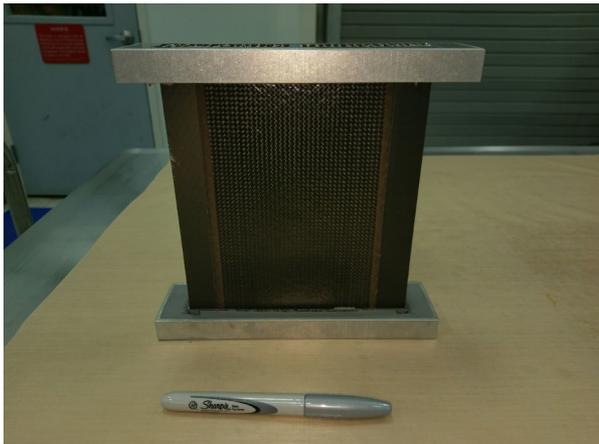
Bonded panels prior to sub-element manufacturing

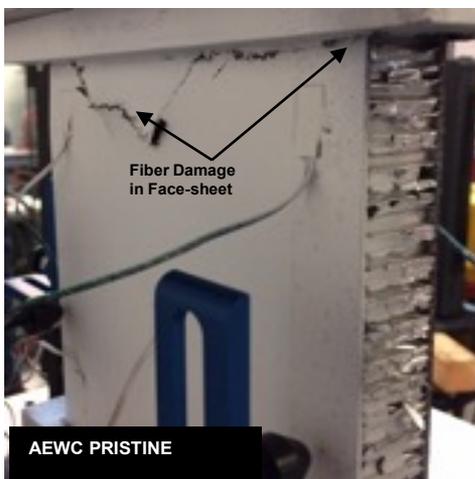
AEWC – PRISTINE COUPONS

- All Pristine AEWK coupons failed above CTE Point Design Limit Load (LL or DLL) with 2.0 FS
- Progressive damage analysis (PDA) using cohesive zone and COSTR damage model used to predict joint failure
- *Pre-test and post-test correlation achieved within 5% and 3%, respectively, of average test data for all tests*

Failed AEWK Coupon

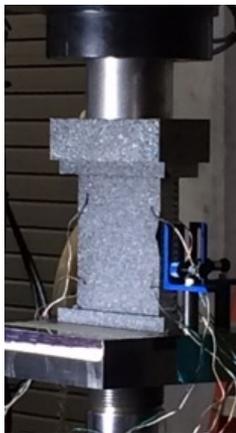
Test Setup of AEWC & HEWC Coupons

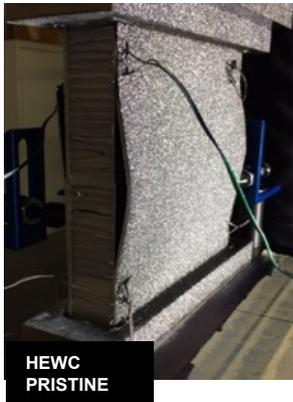
HEWC – PRISTINE COUPONS

- All pristine HEWC coupons failed above CTE Point Design Limit Load with 2.0 FS
- Progressive damage analysis (PDA) using cohesive zone and COSTR damage model used to predict joint failure
- Failure mode captured in analyses
- Pre-test and post-test correlation achieved within 3% of average test data for all tests

Failed HEWC Coupon

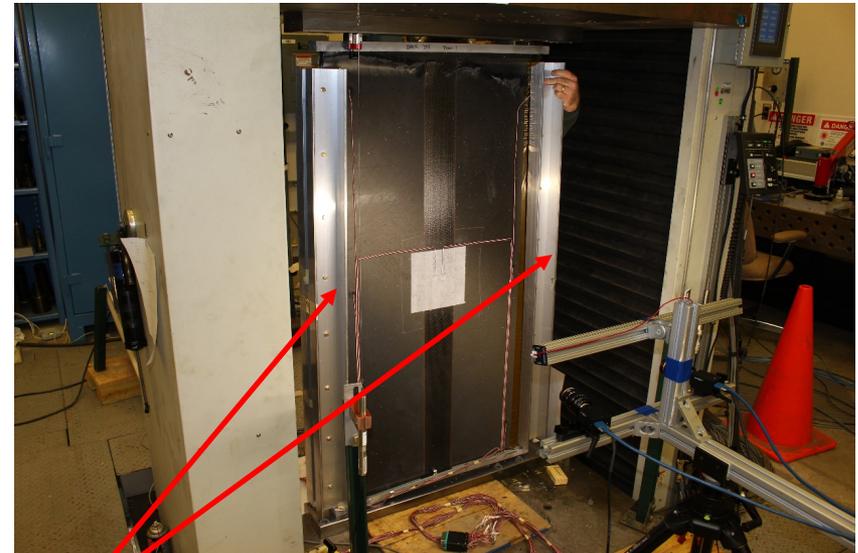
Panel Buckling Test Set-up

Side rails added to prevent buckling

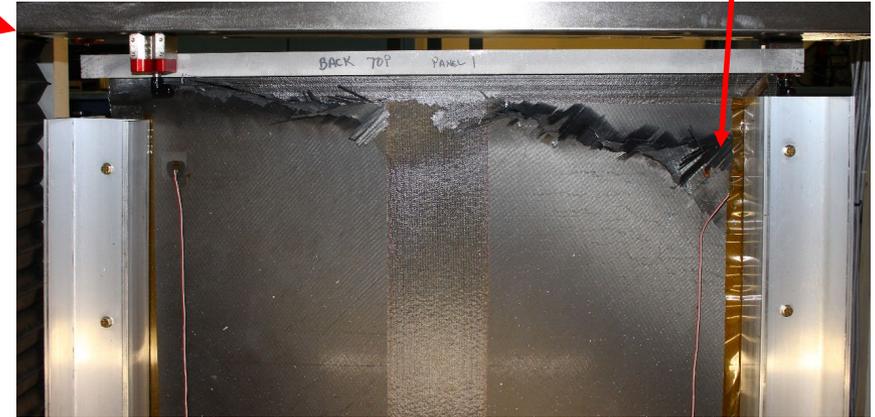
Local Region Showing Facesheet Failure

Failure in the end indicates joint strength was 'at least' 5893 lb-f/in
 (For reference AEWC coupon achieved 6966 lb-f/in)
 indicates a MS of 0.47 demonstrated in the scale-up joint

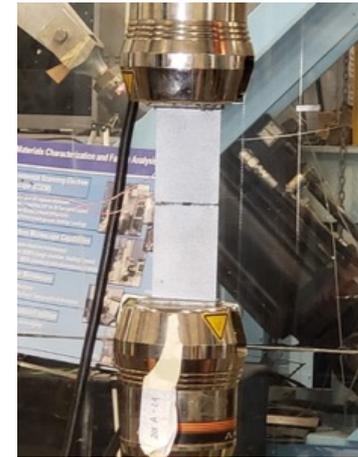
LaRC Testing

- Material model implemented in finite element for failure prediction
 Abaqus ▪ Failure Criteria ▪ Stress Degradation ▪ Plane-Stress ▪ Orthotropic Analysis for notched coupons using various failure criteria: Failure Criteria: Tsai-Wu, Hashin, Maximum Stress
- Post-damage added and assessed using response surface

Ongoing test and modeling to enhance COSTR
