# POINT CLOUD ANALYSIS FOR CONSERVATION AND ENHANCEMENT OF MODERNIST ARCHITECTURE

**KEY WORDS:** 3D survey, Conservation, Modernist Architecture, Point cloud analysis, Intensity values, State of conservation

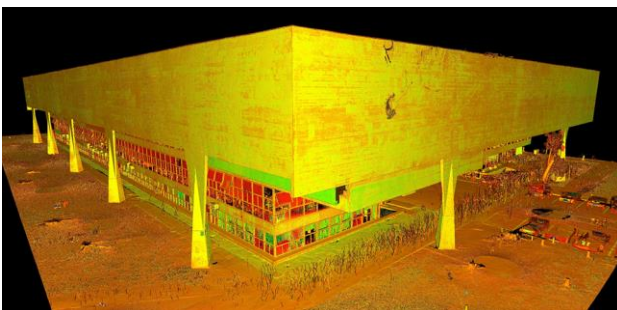
Figure 2. The 3D model of the building in point cloud visualization

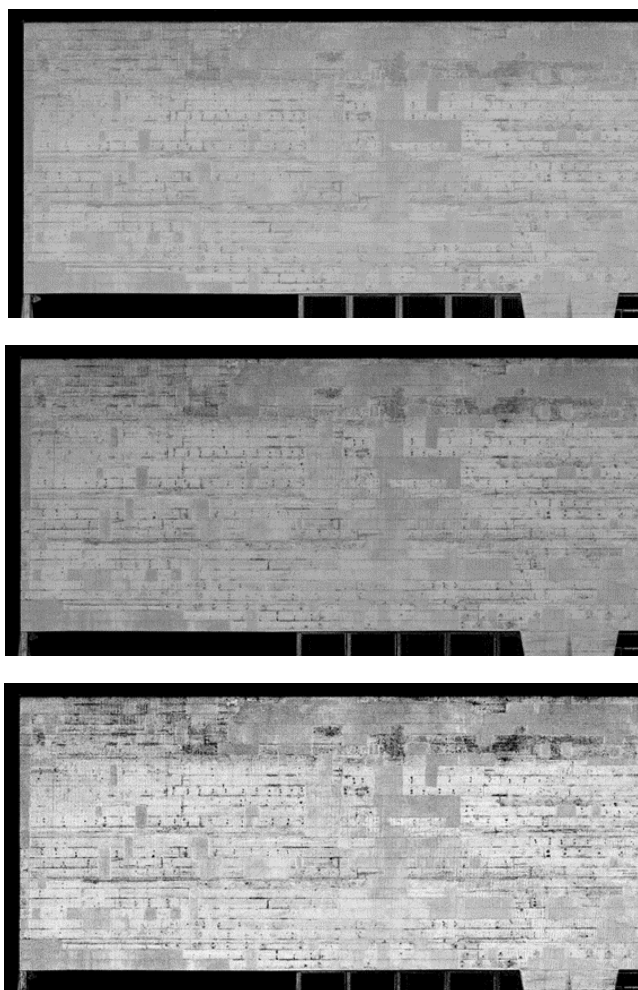
Figure 4. Greyscale visualization of a sample are of the point cloud

INTENSITY VALUES			
BW_P1	min	max	gamma
1	0,1	0,99	0,6
2	0,18	0,99	0,6
3	0,2	0,99	0,6
4	0,22	0,99	0,6
5	0,24	0,99	0,6
6	0,24	0,99	0,6
7	0,24	0,99	0,6
8	0,24	0,9	0,6
9	0,24	0,8	0,6
10	0,24	0,6	0,6
11	0,24	0,5	0,6
12	0,24	0,5	0,6

Table 2. Intensity values data tested during the post-processing in greyscale visualization (sample 1)

INTENSITY VALUES			
BW_P2	min	max	gamma
1	0,0761	0,99	0,6
2	0,1	0,99	0,6
3	0,15	0,99	0,6
4	0,2	0,99	0,6
5	0,15	0,99	0,55
6	0,15	0,99	0,5

Table 3. Intensity values data tested during the post-processing in greyscale visualization (sample 2)

According to instrument' specifications (pulsed scanner Leica ScanStation C10), different visualizations of the point cloud have been displayed in order to help accentuate variations of surfaces' characteristics, starting from the full range of colors mapped in the software by default.

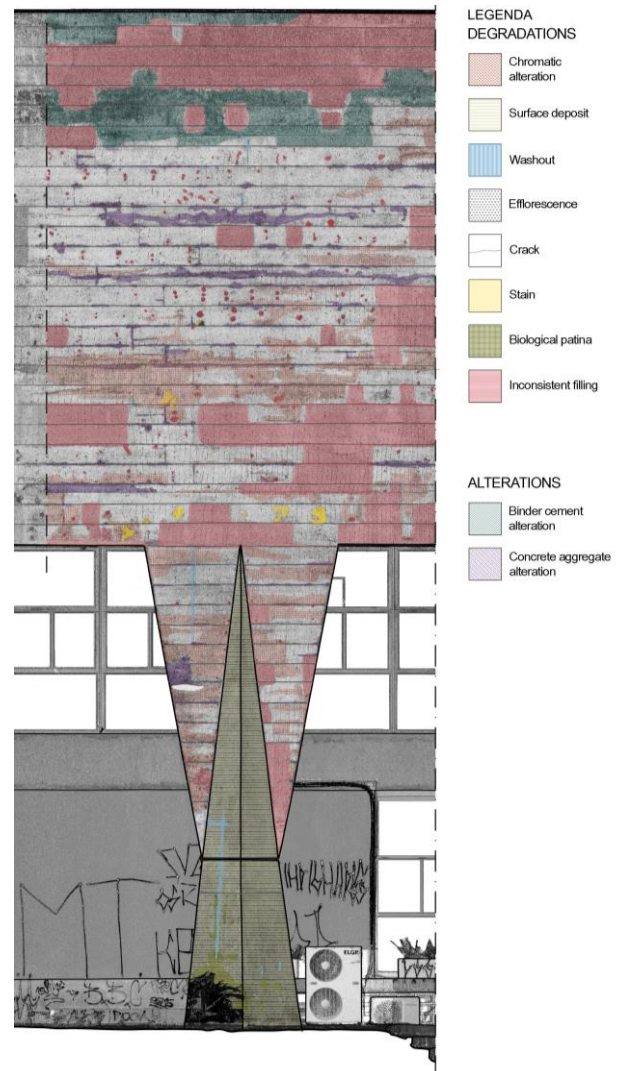
Figure 7. Detail of degradation mapping
