## LANDSLIDE MANAGEMENT IN THE UK, – THE PROBLEM OF MANAGING HAZARDS IN A ‘LOW RISK’ ENVIRONMENT

A D Gibson<sup>1</sup>, M G Culshaw<sup>2</sup>, C Foster<sup>3</sup>, C V L Pennington<sup>3</sup>

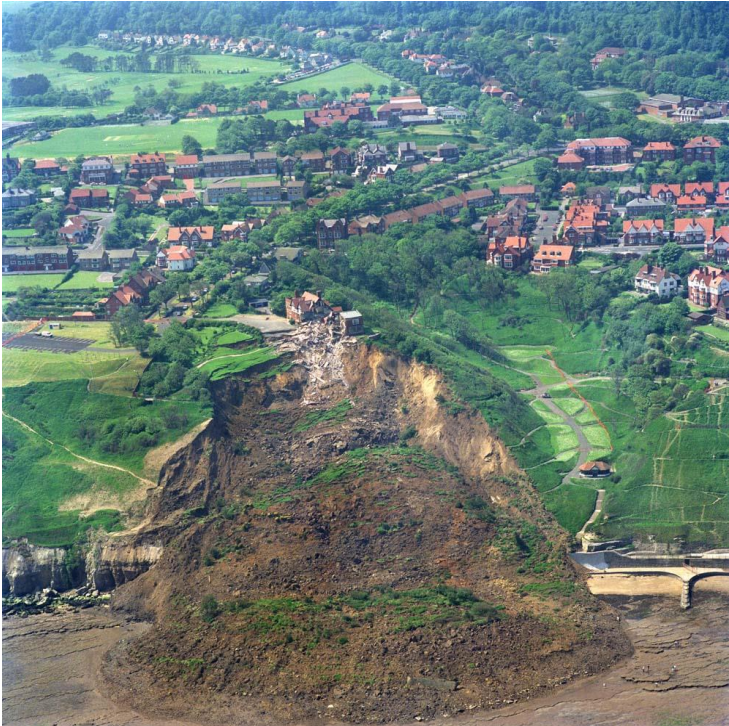
**Fig. 3** The Holbeck Hall Hotel landslide, Scarborough, North Yorkshire

The Holbeck Hall Hotel in Scarborough, North Yorkshire, England (Fig. 2), was destroyed as a result of a landslide that took place over a period between the night of the 3<sup>rd</sup> and 5<sup>th</sup> of June 1993 (West 1994; Lee *et al.* 1998; Lee 1999; BGS 2008a). The hotel had been built in 1880 close to the coastal cliff top; the coast was known to have been susceptible to movement and slipping (though not recognised as landsliding at that time). Following an unusually wet period in May (West 1994), a pre-existing relict landslide reactivated and began to move downslope, the bulk of the movement taking place overnight. The foundation of the hotel was partially undermined and most of the structure of the hotel subsequently collapsed (Fig. 3). The remains of the hotel were demolished. The subsequent movement of the slide and collapse of the hotel was sufficiently slow to allow repeat visits to the site to monitor progress. The slow movement of the hotel also meant that all residents could be evacuated and that electricity and gas supplies could be switched off before they caused fire.

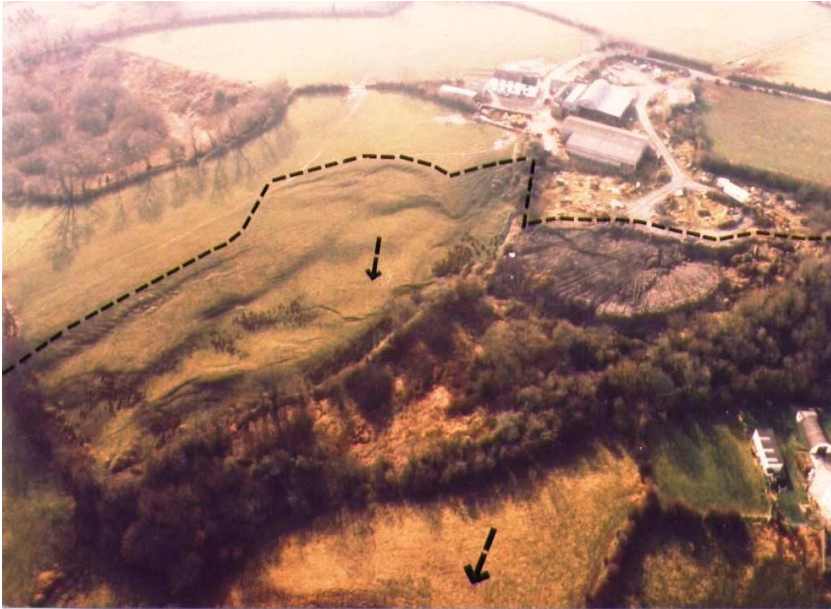
**Fig. 5** Landsliding at St Dogmaels. Image courtesy of Dyfed Police

Subsequent investigations showed that the landslide was a reactivation of part of an ancient (12 000 years ago), complex, multiple retrogressive failure. The landslide was a moderately deep-seated non-circular failure and took place in glacio-lacustrine deposits which were up to 60m thick infilling a deeply-incised valley (Fletcher & Siddle 1998). Ground movements of up to 1m began at the head of the landslide and gradually progressed downhill. Movements continued for almost eight months. The ground movement affected the upper part of the ancient landslide, which, itself, extended down to the edge of the main part of the village of St Dogmaels.

The landslide appeared to be caused by the presence of artesian and sub-artesian groundwater levels in the glacio-lacustrine deposits and periods of higher-than-average rainfall in the months and weeks leading up to the failure (Maddison 2000). Other factors, such as the presence of a waste tip at the head of the landslide, poorly-maintained land-drains on the landslide and poorly-controlled drainage of water from springs upslope from the landslide, may have contributed to the failure.

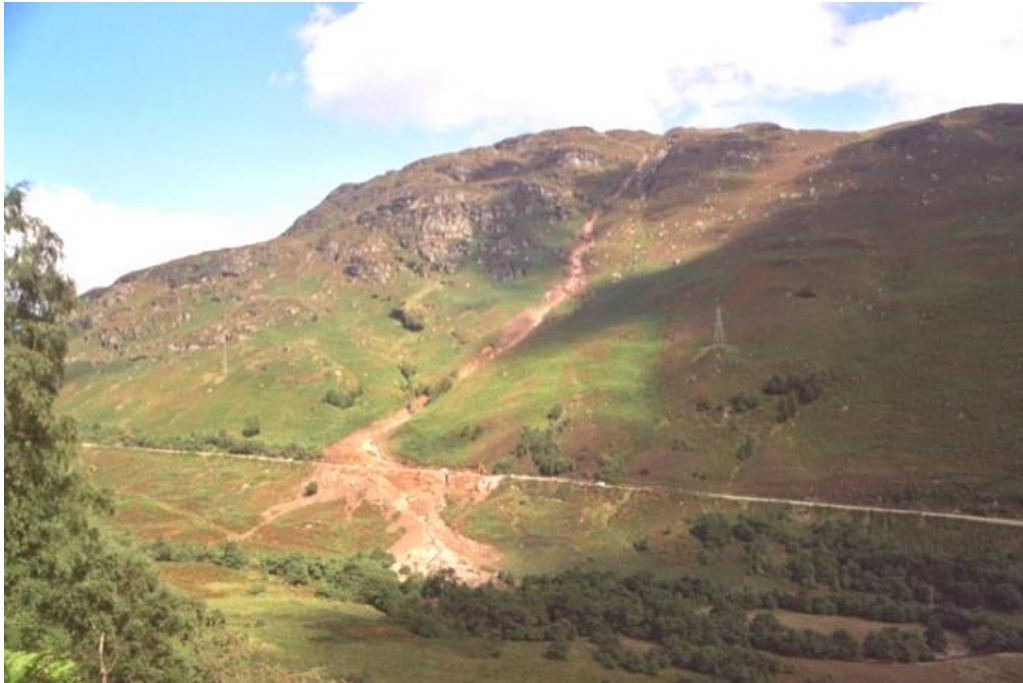
**Fig. 7** Debris flow deposit at Glen Ogle.

On 18<sup>th</sup> August, a debris flow was triggered by an intense rainfall event that displaced a small peat slide into one of the streams that would normally drain through one of the road culverts (Fig. 7). This peat slide set off a cascade within the stream channel, first ripping up weathered bedrock, then mobilising a relict deposit of granular head/landslide material. This dense flow moved rapidly down slope, scouring superficial materials on the way and eventually overwhelming the drainage culvert designed to protect the road. The flows entirely blocked the highway, trapping 57 people in 20 vehicles, with potential for further failures. All 57 people were airlifted to safety by military

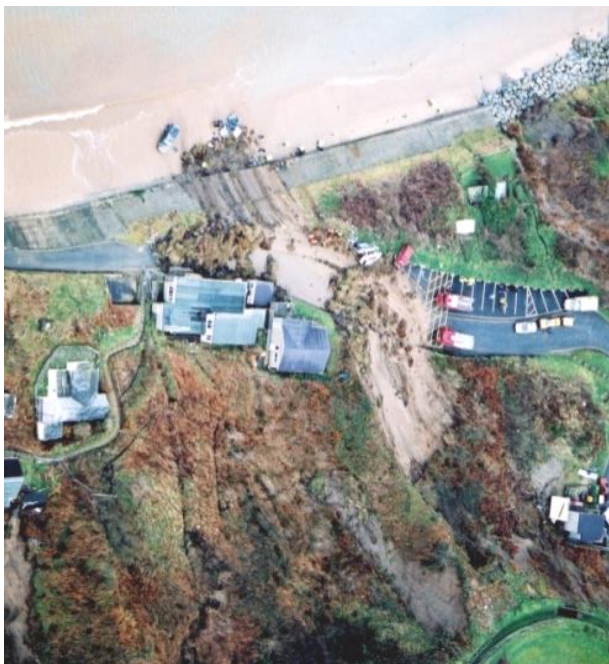
**Fig. 10** Landslide at Nefyn. Note the dark mudslide at the top of the slope (right hand side of the image) that could have triggered a similar debris flow above a residential property. Image courtesy of North Wales Police
