NASA/TM—2019-220035

Bend-Test Results of the MISSE 7 Flexural Stress Effects Experiment After 1.5 Years of Space Exposure

Prepared for the
2017 International Space Station Research and Development Conference
cosponsored by NASA, American Astronautical Society, and CASIS
Washington, D.C., July 17–20, 2017

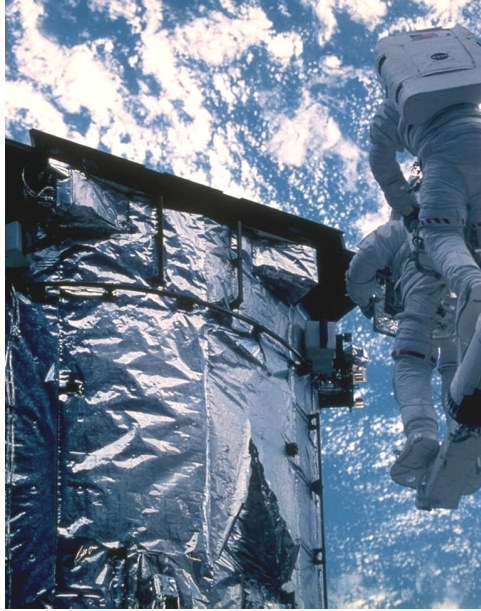
Figure 1. Example of cracking of the aluminized-Teflon FEP insulation on the HST after 5.8 years of space exposure (Ref. 2).

Materials on the exterior of spacecraft are exposed to many environmental threats that can be harmful to spacecraft and their operations. These threats include solar radiation (ultraviolet (UV), x-rays), charged particle radiation (electrons, protons), thermal cycling (hot and cold cycles), micrometeoroid impacts, debris impacts (space particles), and atomic oxygen (AO). Many of these environmental exposures can weaken polymers and affect their mechanical and structural properties (Ref. 1). An example of space induced materials degradation can be seen on the Hubble Space Telescope (HST) (Ref. 1). When sent up into space, the HST was covered with multilayer insulation blankets comprised of a normally stretchy outer layer of aluminized Teflon® fluorinated ethylene propylene (FEP). However after being exposed to solar radiation, charged particle radiation, and thermal cycling the FEP on the HST became brittle causing it to crack after being exposed to the space environment for only 5.8 years as shown in Figure 1. To prevent this

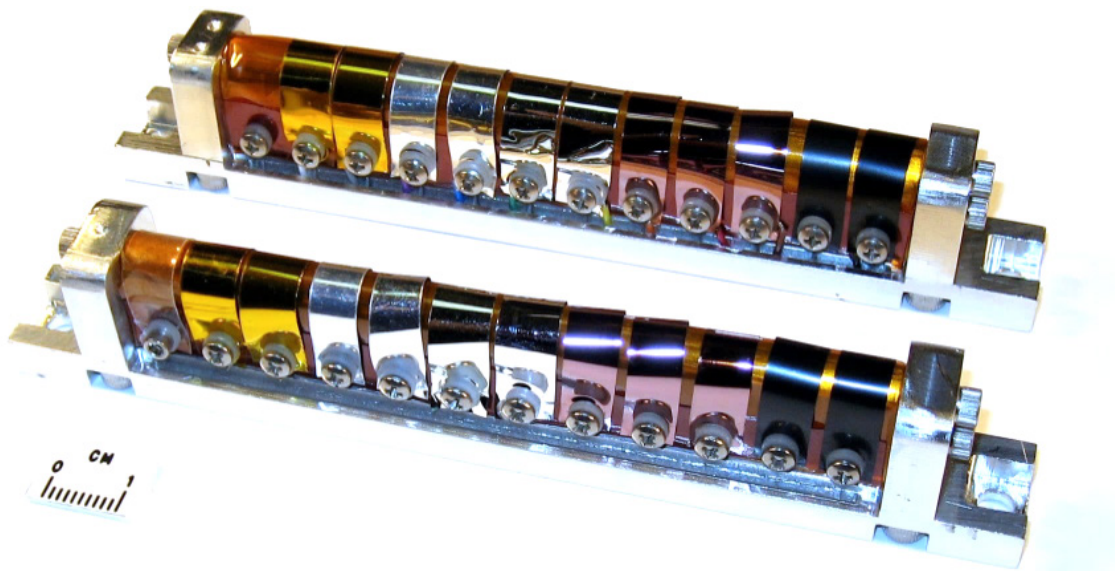
Figure 5. Pre-flight photograph of the two FSEE holders with the flight samples.

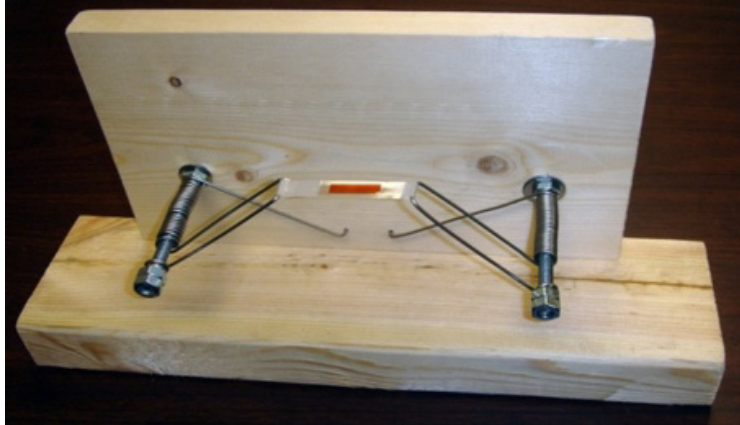
Figure 7. The bend-test mechanism in its idle state; the polymer being tested rests atop the Kapton stretched across the center, with the space exposed surface face down.

Testing was conducted on a semi-suspended pliable surface held up with two supports, as shown in Figure 7. Successively smaller mandrels (cylindrical steel pieces) were used to apply surface strain to samples. The materials were rested, with the space-exposed surface facing down, upon the semi-suspended surface and the mandrels were used to press the samples down, causing the bend-test pliable surface and the flight sample to wrap around the mandrel, as shown in Figure 8 and as illustrated in Figure 9. This put the space exposed surface of the polymer in tension and induced cracking in the embrittled samples without applying a net tensile load to the sample. A total of 23 mandrels were used and ranged in size from 1.253 cm (0.493 in) to 0.052 cm (0.020 in). A decrease in diameter resulted in an increase in strain as indicated in Equation (1). The strain values ranged from 0.202% to 4.678% in 1 mil samples, 0.404% to 8.939% in 2 mil samples and 1.003% to 19.704% in 5 mil samples.

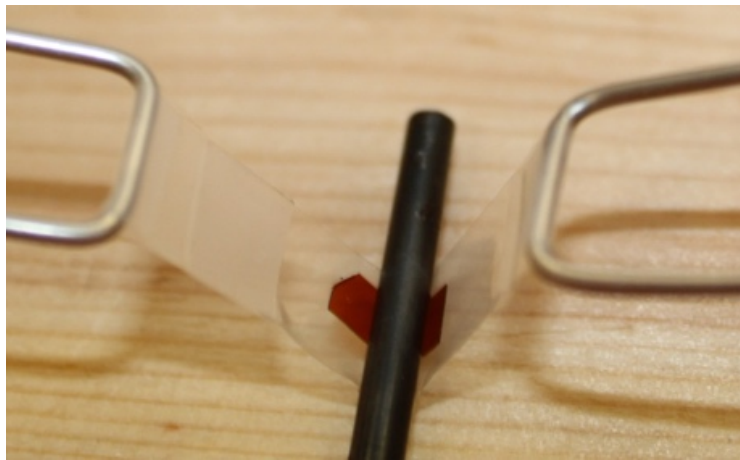
Figure 8. The bend-test mechanism in its testing state; the polymer being tested wraps around the circumference of the mandrel with the space exposed surface in tension.

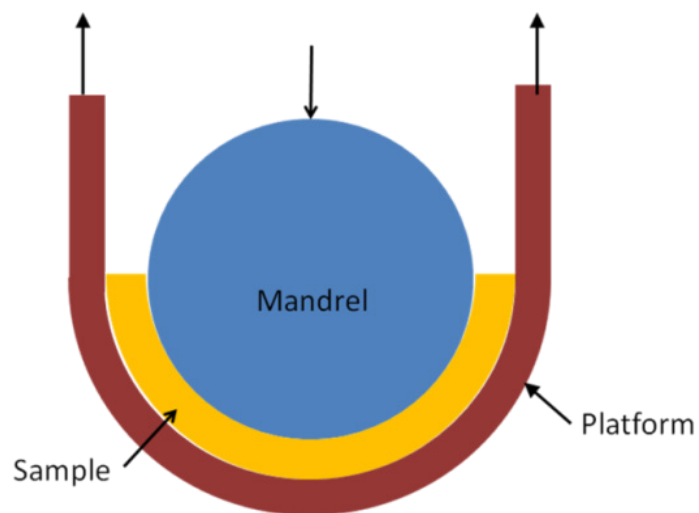
Figure 9. Illustration of the bend-test configuration showing a cradle platform used to bend the sample around the mandrel (Ref. 5).

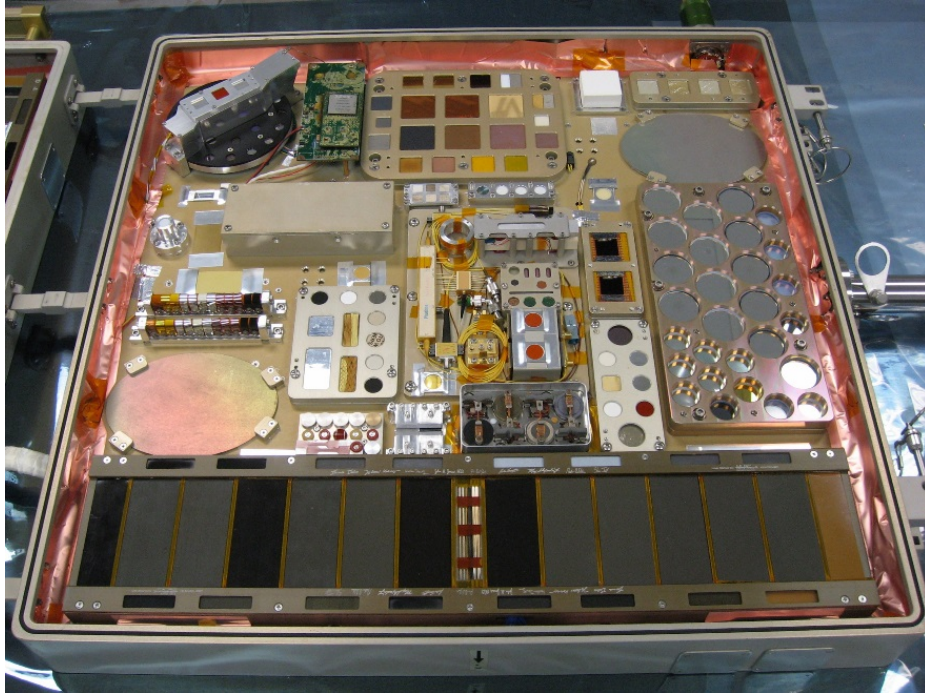
Figure 10. Post-flight photo of the MISSE 7B wake tray.

Figure 10 is a post-flight photo of the MISSE 7B wake tray. Figure 11 shows a post-flight photo of the FSEE sample holders. Figure 12 shows a top view of the FSEE samples on their flight holders before (left) and after (right) space exposure along with a material legend. In Figure 12, the right side of the samples was zenith facing, while the left side was nadir facing. As mentioned previously, the samples were separated into two groups for post-flight testing, one which would be bend-tested and another which would be tensile tested. This way as much data as possible could be collected. Additionally, the SLA/DC 93-500 sample, shown in Figure 13, will be undergoing a different kind of testing, as the sample appeared cracked post-flight, and cannot be bend-tested as it is already cracked. Figure 14 shows the cracks in the SLA/DC-93-500 sample. In addition, DC-93-500, the substrate, is a silicone which when exposed to the space environment converts to a silicate and shrinks and cracks. Mud tile-like cracking of AO exposed DC-93-500 silicone has been previously reported (Ref. 7).
