MARIKA MÄKINEN
OPERATION OF VACUUM SEWER SYSTEM
– CASE ONDANGWA, NAMIBIA
Master of Science Thesis

MARIKA MÄKINEN: Operation of Vacuum Sewer System – Case Ondangwa, Namibia

Keywords: vacuum sewer system, Namibia, Ondangwa, sanitation

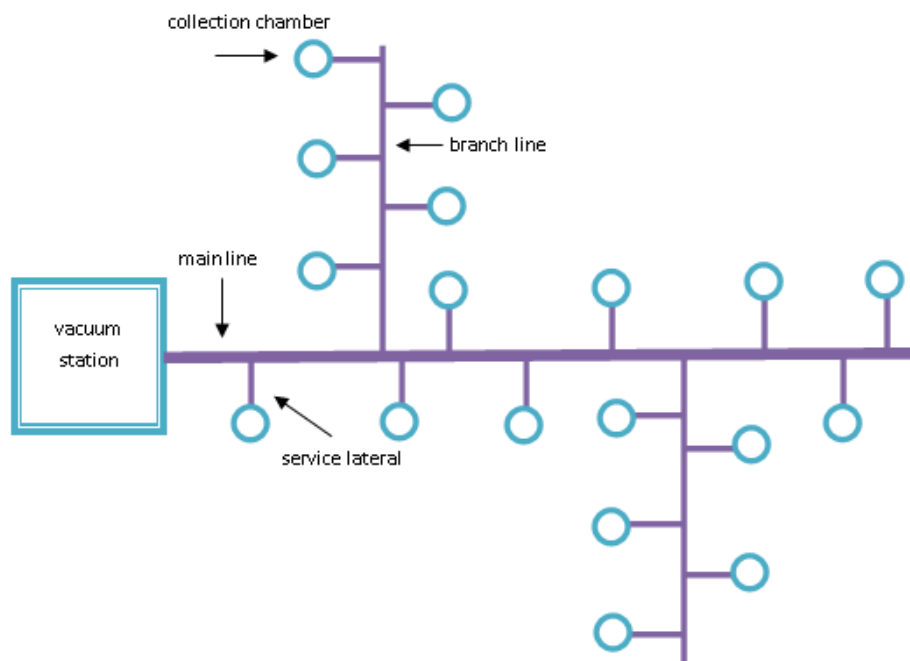
The main operating principle of vacuum sewer system (Figure 1) is to transport sewage by differential air pressure from the formation place (houses) to the vacuum station. The main components of the vacuum sewer system are vacuum station, vacuum sewer line and vacuum station (Water Environment Federation, 2008).

Figure 1. Main components of the vacuum sewer system (modified from Water Environment Federation, 2008).

First the sewage is drained by gravity from houses to the collection chambers. From collection chambers the sewage is transported by the differential air pressure through vacuum sewerlines to the vacuum station. Finally, from the vacuum station the sewage is pumped to a conventional system or to treatment facilities (Li et al., 2010; Werner et al., 2005).

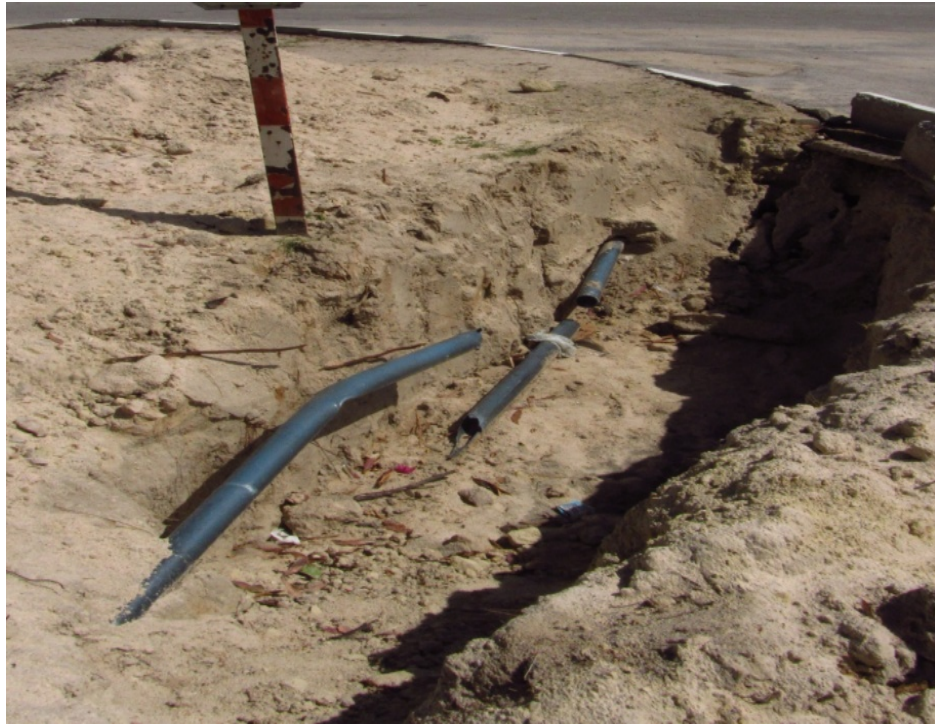
The vacuum sewer network has been damaged several times accidentally when excavating for some other services in the same trench (Figure 9). All the cases are not reported to the Town Council. It is suspected that there is a leakage somewhere in the main line caused during a construction of a road and therefore the vacuum sewer system is not functioning properly in Oluno. The vacuum sewer network is not marked and therefore not protected from these accidents.

Figure 9. A damaged vacuum sewer in a trench in Old Ondangwa.
