# Flood-Plain and Channel Aggradation at Selected Bridge Sites in the Iowa and Skunk River Basins, Iowa

U.S. GEOLOGICAL SURVEY  
Water-Resources Investigations Report 95-4290

Prepared in cooperation with the  
Iowa Highway Research Board and the  
Highway Division of the  
Iowa Department of Transportation  
(Iowa DOT Research Project HR-350)

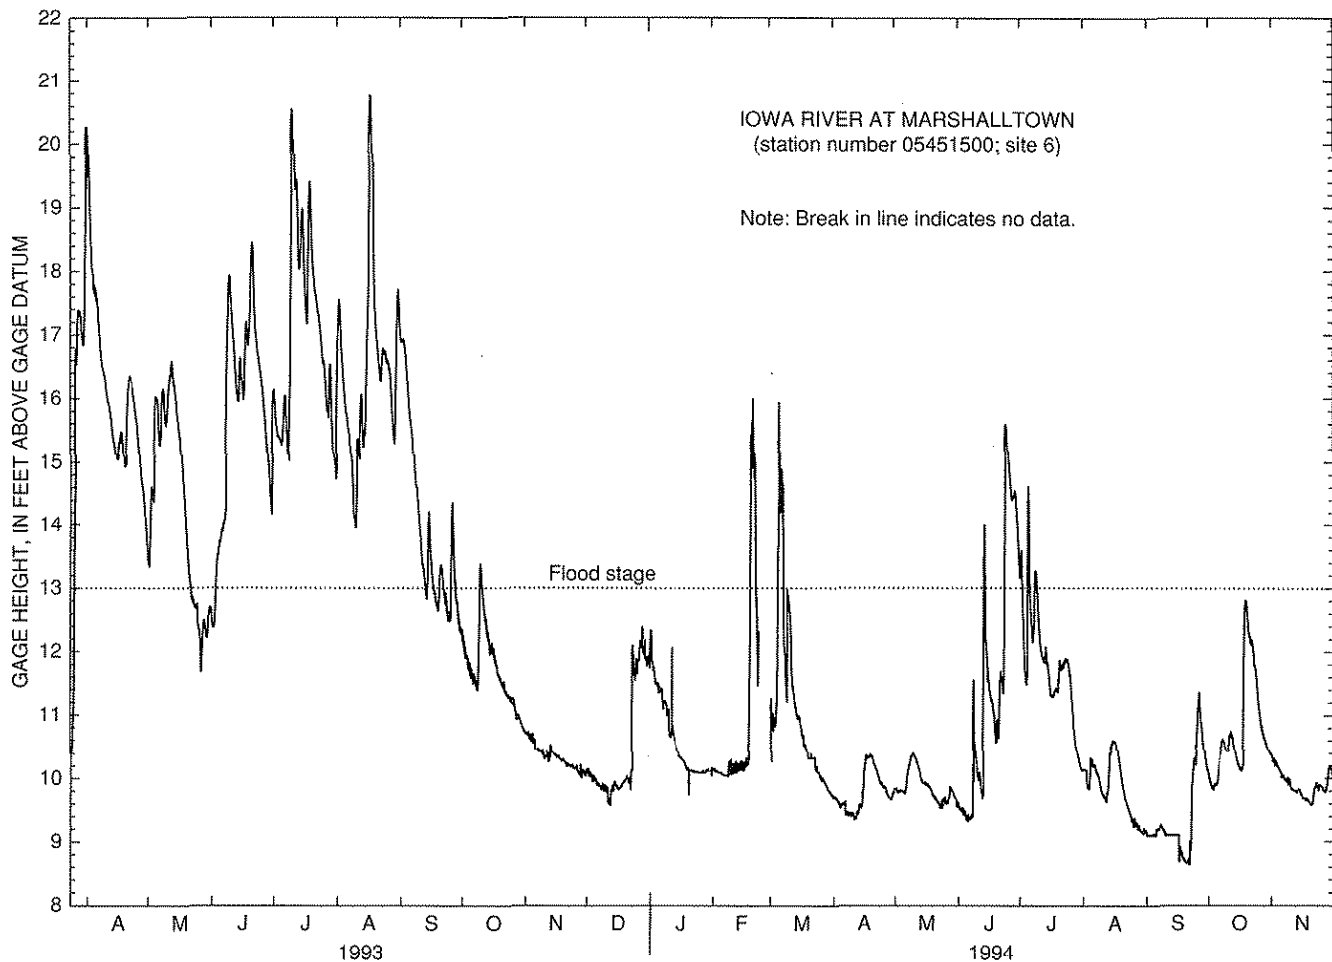
**Figure 3.** Instantaneous gage heights for the Iowa River at Marshalltown, Iowa, for the period March 24, 1993, to November 30, 1994.

The State Highway 14 bridge crossing the Iowa River at Marshalltown is the site of the Iowa River at Marshalltown streamflow-gaging station (station number 05451500; fig. 1, site 6). Thirteen feet is the flood stage and bankfull stage established by the National Weather Service for this gaging station (information provided by Mike Longnecker, National Weather Service, written commun., February 1995). Streamflow records for this gaging station indicate overflow of the north bank at a stage of 13 ft. Figure 3 shows instantaneous gage heights for the Iowa River at Marshalltown for the period March 24, 1993, to November 30, 1994. During the period March 25 to September 27, 1993, gage heights for the Iowa River at Marshalltown exceeded the 13-ft flood stage during 171 days of this 187-day period, indicating the length of time the sediment pads might have been inundated. Due to differences in channel and flood-plain conditions at each of the three bridge sites where the pads were installed, overbank flooding of the Iowa River at Marshalltown at a 13-ft stage might not indicate similar overbank flooding at another location. The 13-ft stage shown on figure 3 provides only an indication of the possible beginning of overbank flooding at the sediment pad locations. During October 1993, after the floodwaters receded, 9 of the 10 sediment pads were recovered and sediment-deposition depths over the pads were measured. The pad installed near the southeast corner of the State Highway 14 bridge was scoured away during the flood.

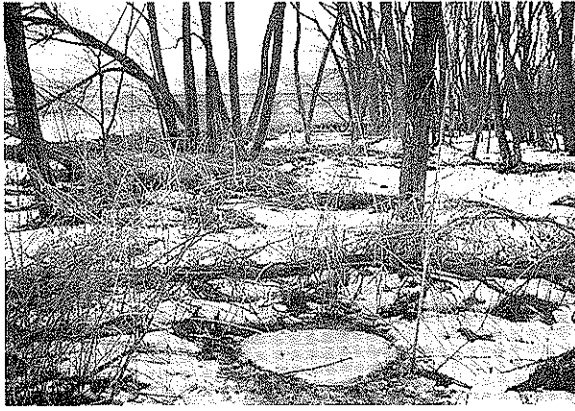
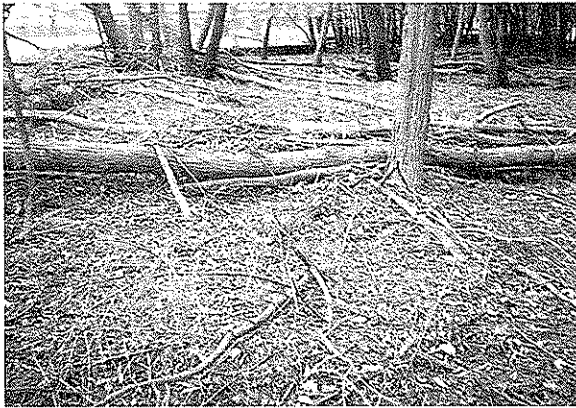
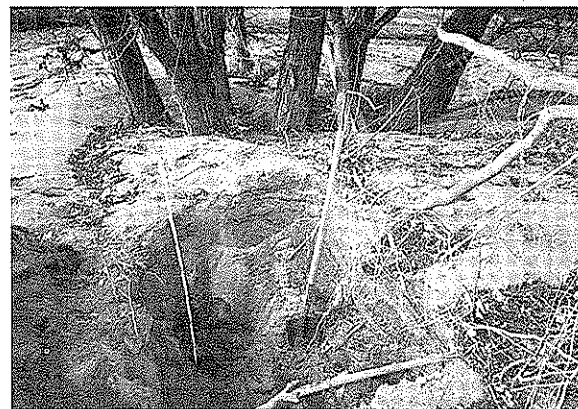
A. State Highway 14 bridge at Marshalltown (site 6)

B. U.S. Highway 30 bridge near Montour (site 7)

Installation of sediment pads on left downstream side of bridges on March 25, 1993

C. State Highway 14 bridge at Marshalltown (site 6)

D. U.S. Highway 30 bridge near Montour (site 7)

Recovery of sediment pads following the flood during October, 1993

E. State Highway 14 bridge at Marshalltown (site 6)

F. U.S. Highway 30 bridge near Montour (site 7)

Depth of sediments deposited on pads during the 1993 flood

Figure 4 shows sequences of photographs taken at two of the sediment-pad sites on the Iowa River; figures 4A, 4C, and 4E show the pad installed near the northeast corner of the State Highway 14 bridge at Marshalltown (site 6) and figures 4B, 4D, and 4F show the pad installed near the southeast corner of the U.S. Highway 30 bridge near Montour (site 7). Figures 4A and 4B show the sediment pads following installation on March 25, 1993, prior to overbank flooding on March 26; figures 4C and 4D show recovery of the sediment pads during October 1993, following recession of floodwaters; and figures 4E and 4F show depth of sediment deposited on the pads as a result of the 1993 flood.

The State Highway 14 bridge crosses the Iowa River at the north edge of Marshalltown in Marshall County. This is the site of the Iowa River at Marshalltown streamflow-gaging station (station number 05451500; fig. 1, site 6). Streamflow records for the periods from October 1902 to September 1903, from October 1914 to September 1927, and from October 1932 to September 1993 were available for use in this study. The datum of the gage is 853.10 ft above sea level. The dendrogeomorphic analyses listed below indicate that upstream rates of flood-plain aggradation are not greater than downstream rates and suggest that backwater effects from the State Highway 14 bridge and causeway have not contributed to increased aggradation on the upstream side of the bridge. Figure 4E shows the depth of sediments deposited as a result of

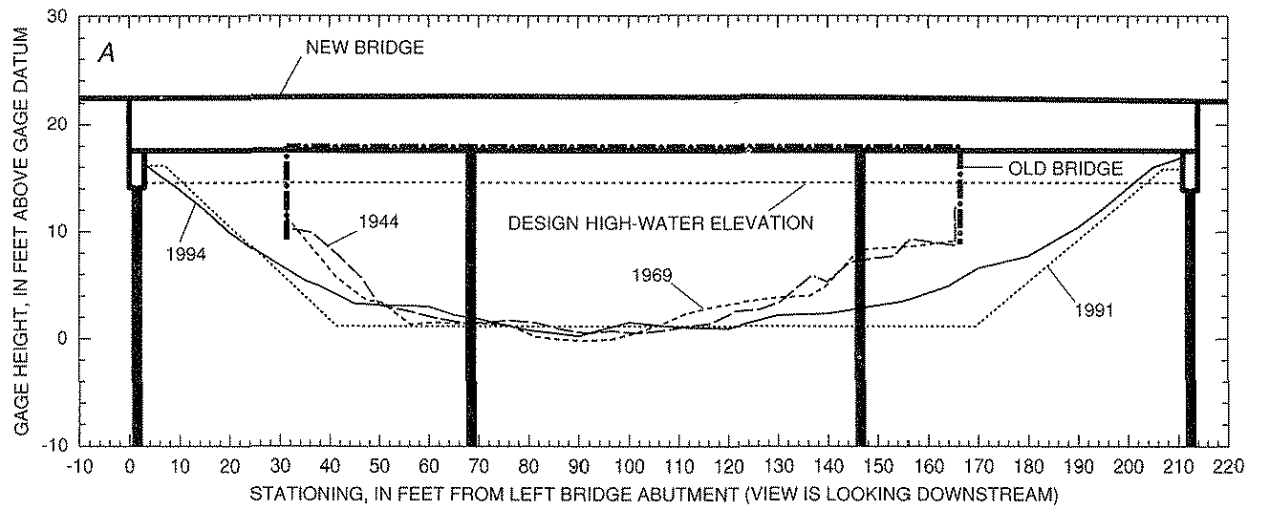
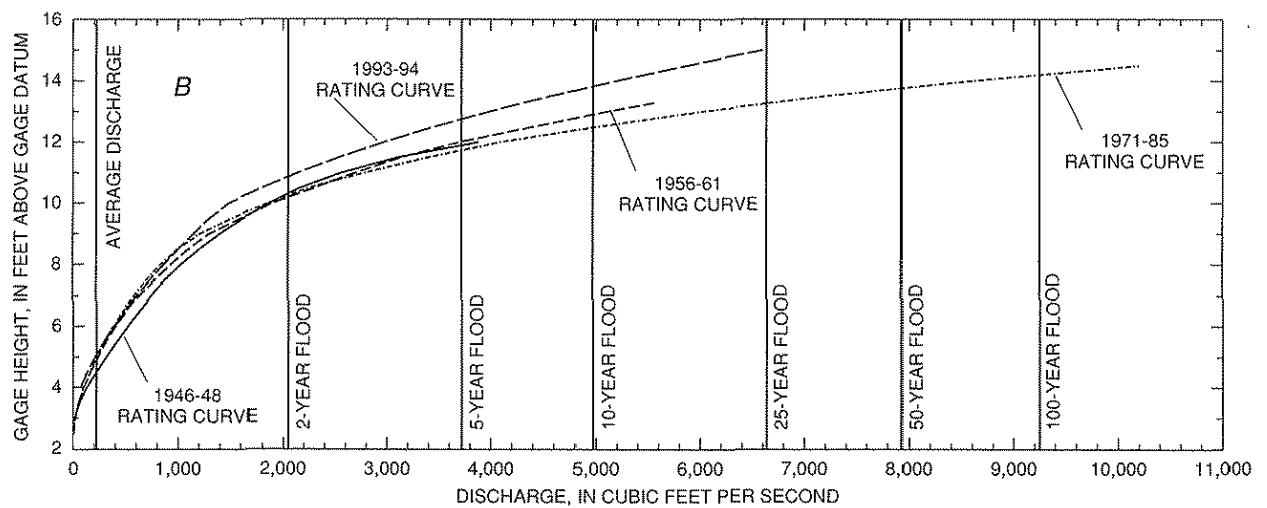
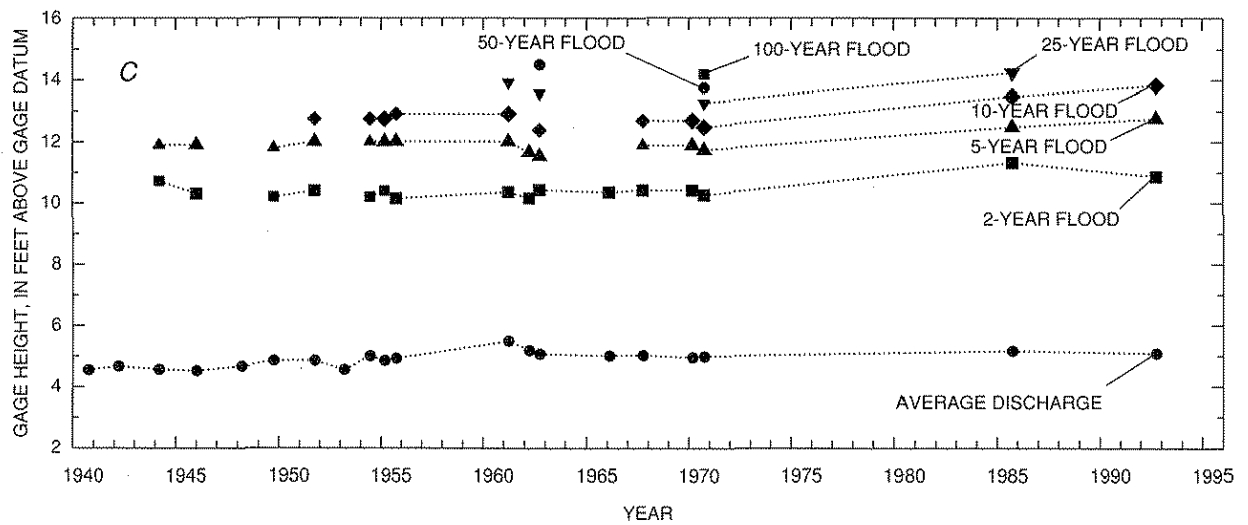
**Figure 5.** Selected (A) bridge-opening cross sections, (B) stage-discharge rating curves, and (C) time series of rating-curve stages for selected discharges for County Road C38 bridge crossing the Iowa River near Rowan, bridge site number 1 (streamflow-gaging station number 05449500).

The County Road C38 bridge (fig. 5A) was built in 1991 to replace an old bridge built in 1905. The design high-water elevation for the bridge was 1,157.9 ft (gage height 14.55 ft). Differences in elevation between bridge-opening cross-sections obtained from the IDOT bridge-situation plan and from the 1994 transit survey indicate a decrease in cross-sectional area of 12.9 percent below the design high-water elevation. Figure 5A shows that for the period 1991–94, deposition occurred on both channel banks of the bridge opening, with the greater amount occurring on the right bank. A comparison between cross sections obtained from discharge measurements made in 1944 and 1969 indicates minor change in the bridge-opening. The stage-discharge relation of four selected rating curves (fig. 5B) shows a general trend of increasing gage height for specific discharges and a time series of the 20 rating curves developed for the period of record (fig. 5C) also shows this general trend.

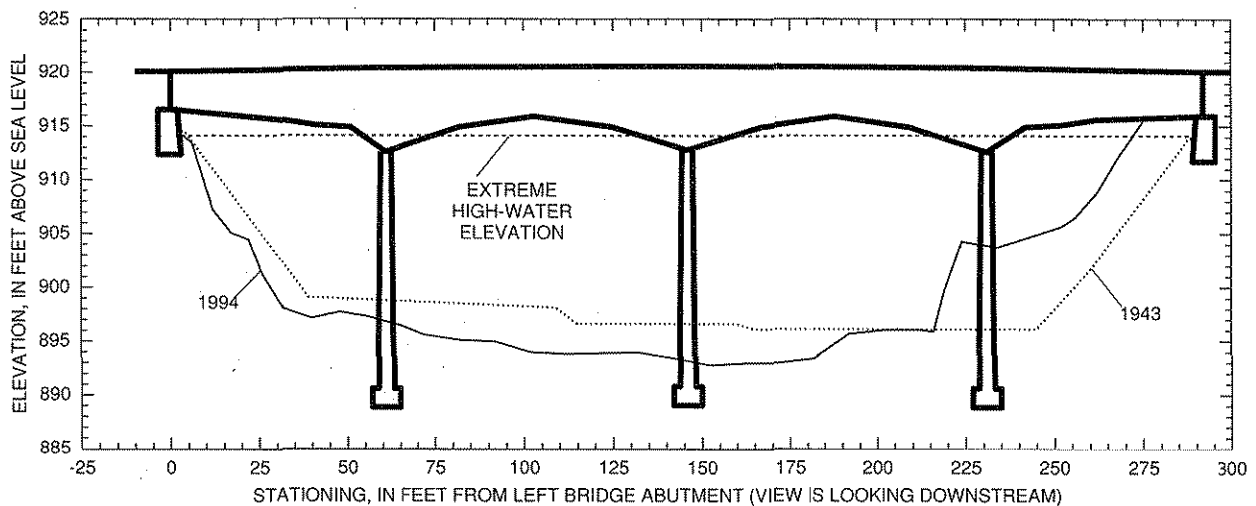
**Figure 8.** Selected bridge-opening cross sections for County Road E18 bridge crossing the Iowa River near Liscomb, bridge site number 4.

The County Road E18 bridge crosses the Iowa River about 1.5 mi west of Liscomb in Marshall County (fig. 1, site 4). The County Road E18 bridge (fig. 8) was built in 1943. The extreme high-water elevation for the bridge was 914.1 ft above sea level. Differences in elevation between bridge-opening cross-sections obtained from the IDOT bridge-situation plan

and from the 1994 transit survey indicate an increase in cross-sectional area of 2.3 percent below the extreme high-water elevation. Figure 8 shows that for the period 1943–94, scour occurred across the channel bed and on the left bank, and deposition occurred on the right bank. Bridge cross-section and geometry elevations obtained from the bridge-situation plan were adjusted by -4.90 ft to rectify them with high-water-mark elevation information obtained for the 1969 flood at this bridge by the USGS and the Marshall County Highway Department (information supplied by Ed Kasper, Marshall County Engineer, written commun., May 1994).

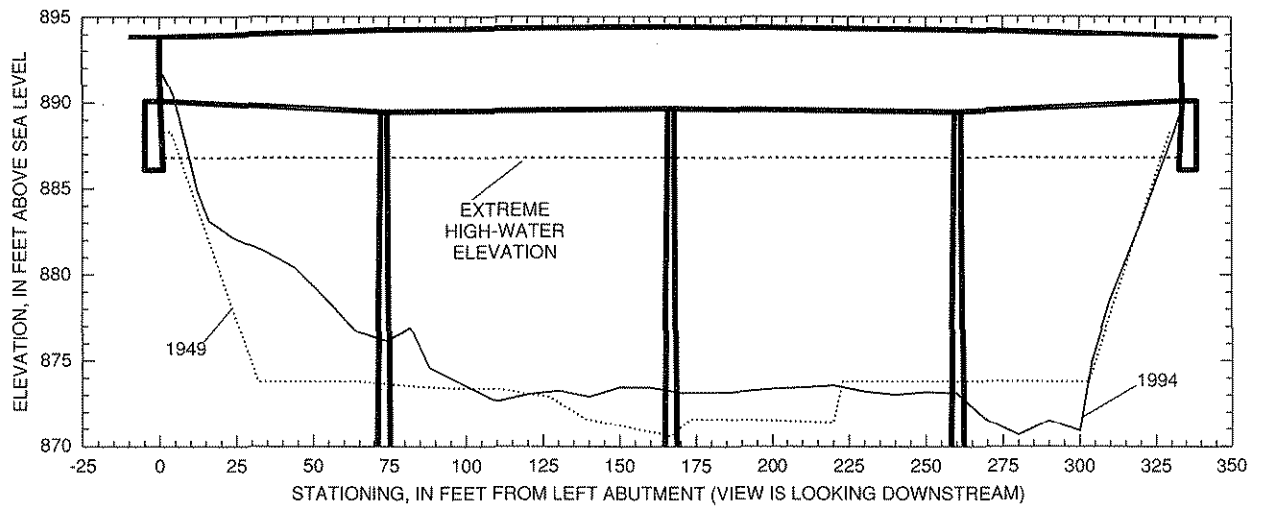
**Figure 9.** Selected bridge-opening cross sections for State Highway 330 bridge crossing the Iowa River near Albion, bridge site number 5.

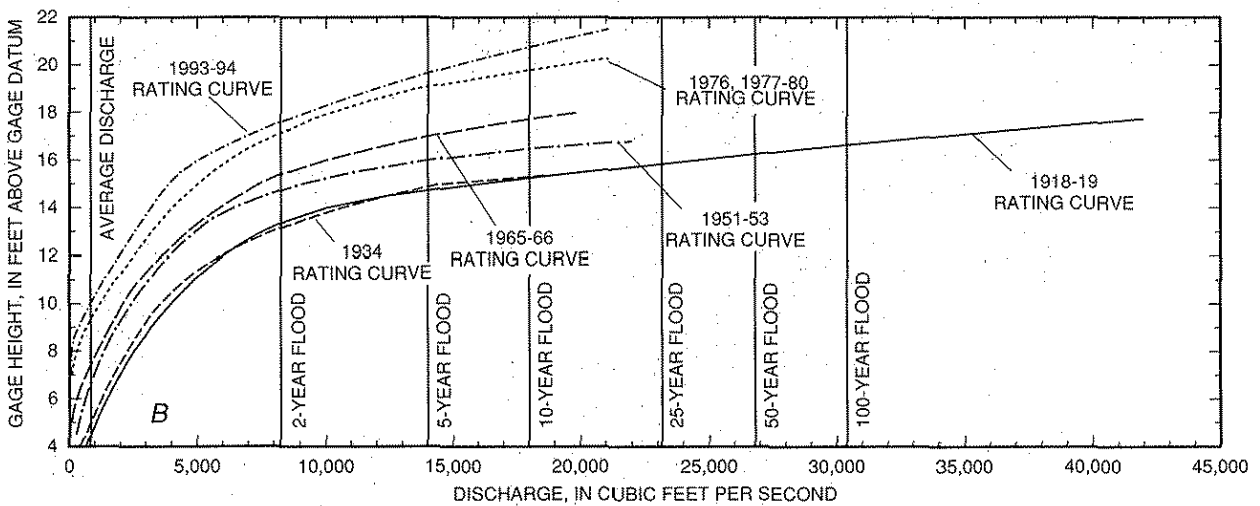
**Figure 10.** Selected (A) bridge-opening cross sections and (B) stage-discharge rating curves for State Highway 14 bridge crossing the Iowa River at Marshalltown, bridge site number 6 (streamflow-gaging station number 05451500).

The bridge shown in figure 10A carries the two northbound lanes of State Highway 14 and was built in 1968 just downstream of an older bridge built in 1934, which after 1968, carried the two southbound lanes of State Highway 14. In 1987, the old upstream bridge was replaced with a new bridge. The extreme high-water elevation for the bridge, shown in figure 10A, was 870.72 ft (gage height 17.62 ft). Differences in elevation between bridge-opening cross-sections obtained from the IDOT bridge-situation plan and from the 1994 transit survey indicate a decrease in cross-sectional area of 17.5 percent below the extreme high-water elevation. Figure 10A shows that for the

discharges show a greater increase in stage after about 1942. Rating-curve analyses provide specific information on selected time periods of increased stages. For instance, stages for the average discharge increased by 0.7 ft during 1920–33, by 4.4 ft during 1937–57, by 2.2 ft during 1965–75, and by 0.9 ft during 1980–92. Likewise, stages for the 5-year flood-frequency discharge increased by 1.5 ft during 1942–54, by 2.6 ft during 1960–73, and by 0.6 ft during 1980–92.

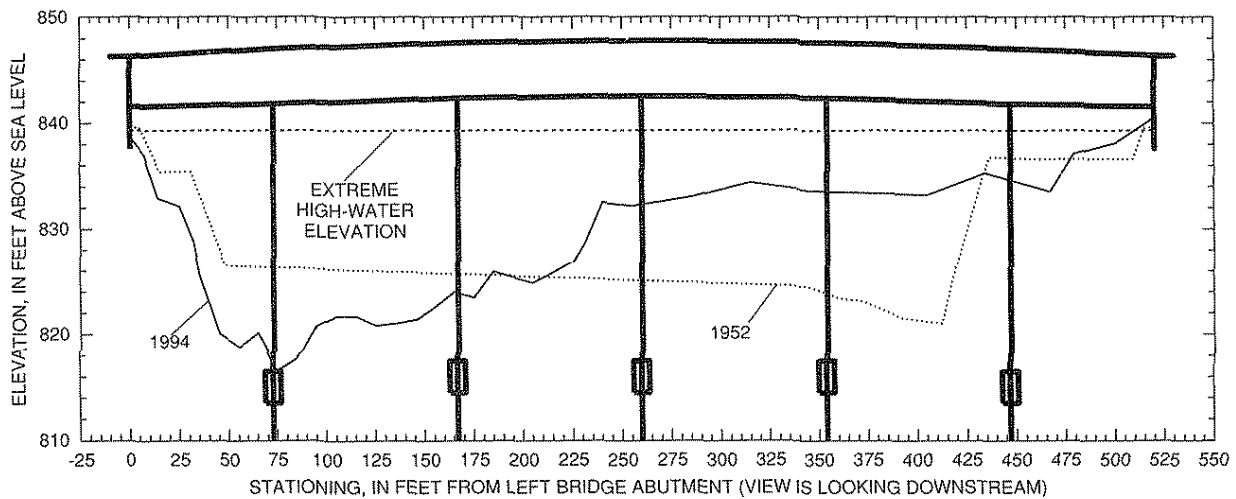
Figure 12. Selected bridge-opening cross sections for U.S. Highway 30 bridge crossing the Iowa River near Montour, bridge site number 7.

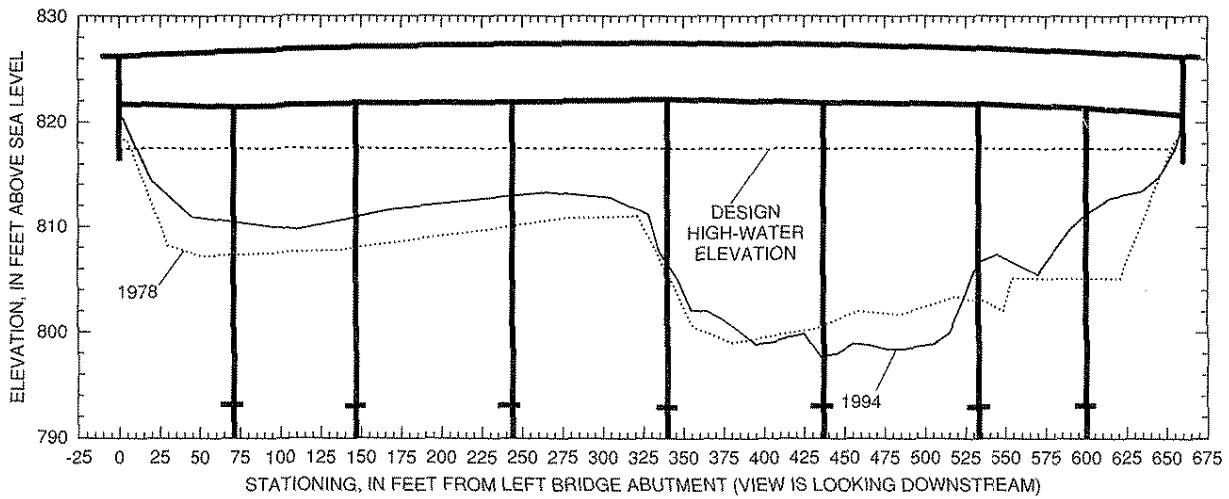
**Figure 13.** Selected bridge-opening cross sections for U.S. Highway 63 bridge crossing the Iowa River at Tama, bridge site number 8.

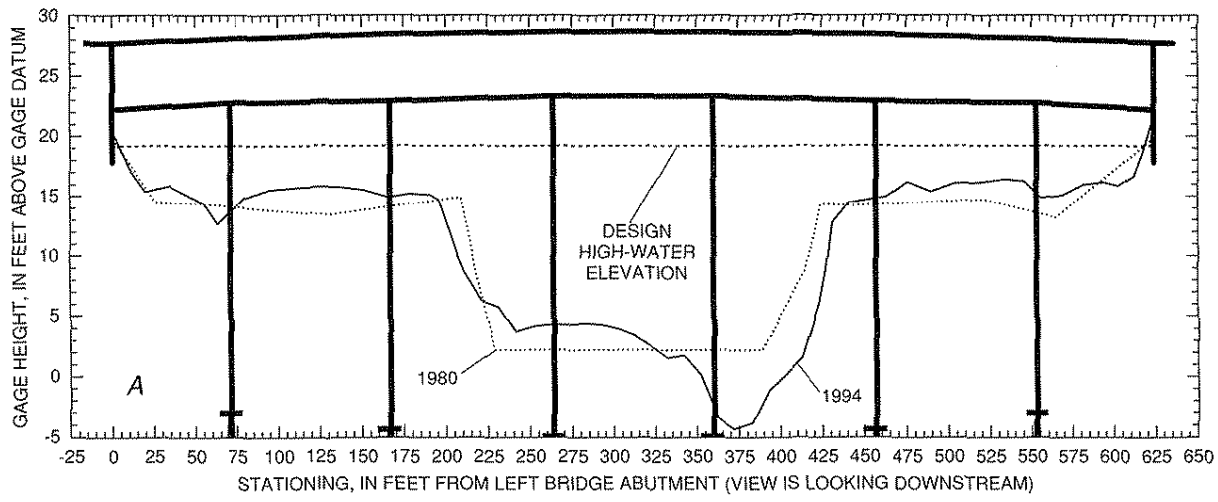
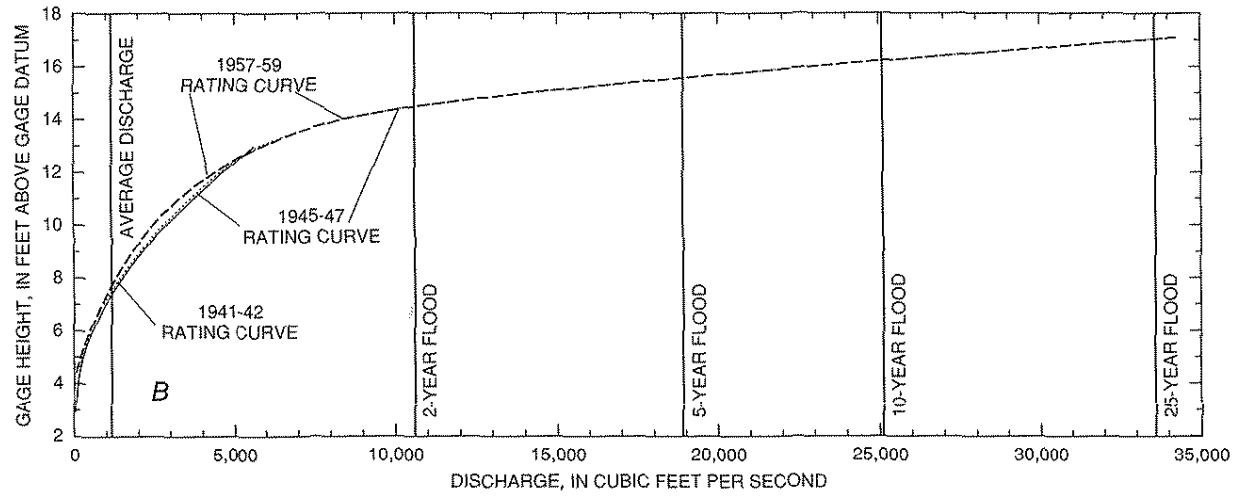
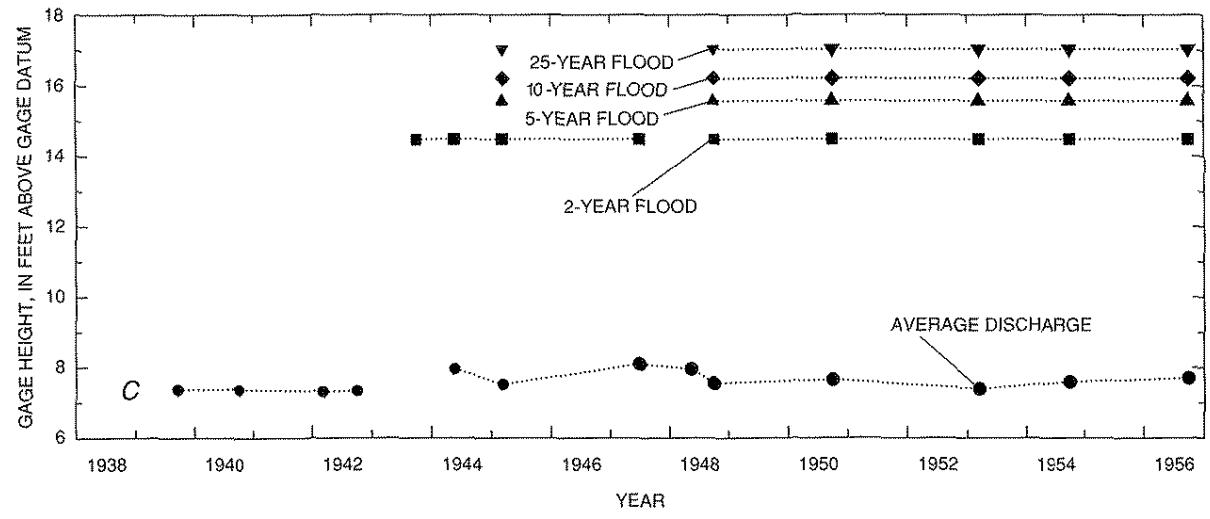
**Figure 14.** Selected (A) bridge-opening cross sections, (B) stage-discharge rating curves, and (C) time series of rating-curve stages for selected discharges for State Highway 21 bridge crossing the Iowa River near Belle Plaine, bridge site number 9 (discontinued streamflow-gaging station number 05452500).

cross-sectional area of 1.2 percent below the design high-water elevation. Figure 14A shows that for the period 1980–94, deposition occurred on the left and right banks of the bridge opening and across the left side of the channel bed, and scour occurred across the right side of the channel bed. The stage-discharge relation of three selected rating curves (fig. 14B) shows a minor trend of increasing gage height for specific low-flow discharges, and a time series of the 14 rating curves developed for the period 1940–59 (fig. 14C) shows no trend in gage heights. The historic stage-discharge rating-curve information indicates that aggradation during the 1940s and 1950s was minimal. The dendrogeomorphic analyses suggest that flood-plain aggradation might have increased after the stream-flow-gaging station was discontinued in 1959.

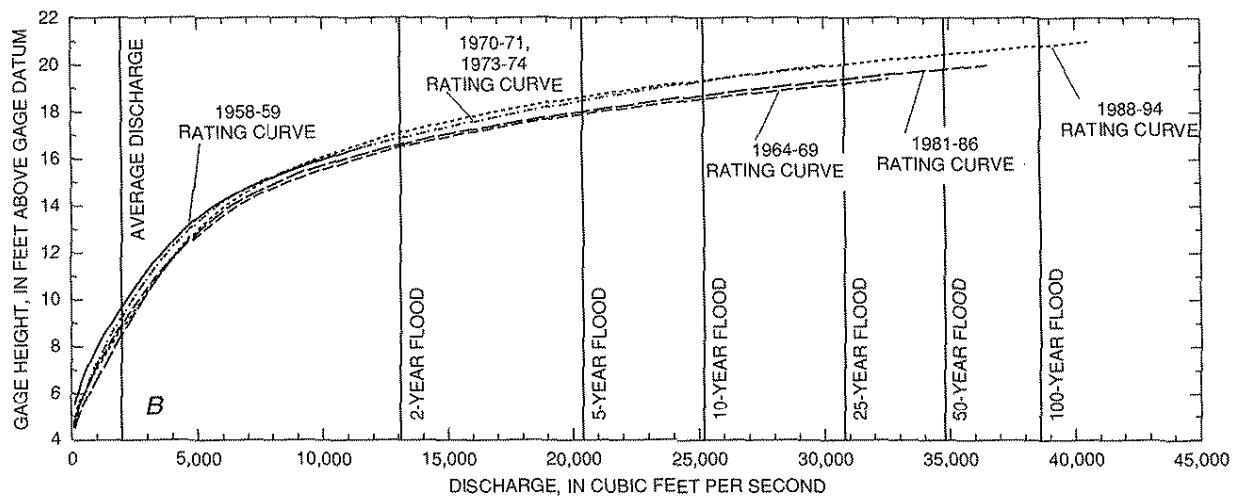
**Figure 15.** Selected (A) bridge-opening cross sections, (B) stage-discharge rating curves, and (C) time series of rating-curve stages for selected discharges for County Road V66 bridge crossing the Iowa River at Marengo, bridge site number 10 (streamflow-gaging station number 05453100).

The stage-discharge relation of five selected rating curves (fig. 15B) shows a general trend of decreasing gage heights for specific low-flow discharges and a general trend of increasing gage heights for specific high-flow discharges. A time series of the 27 rating curves developed for the period of record (fig. 15C) also shows these general trends. It is not known if the effect of Coralville Dam, located approximately 56 river-miles downstream from the County V66 bridge, is contributing to aggradation on the Iowa River at Marengo. Generally, the change in slope of a river by construction of a reservoir will cause deposition not only in the reservoir, but might cause aggradation problems in the channel for a considerable distance upstream as the river adjusts to its new conditions (Upper Mississippi River Comprehensive Basin Study Coordinating Committee, 1970, p. G-10). However, hydraulic analyses would be required to determine the

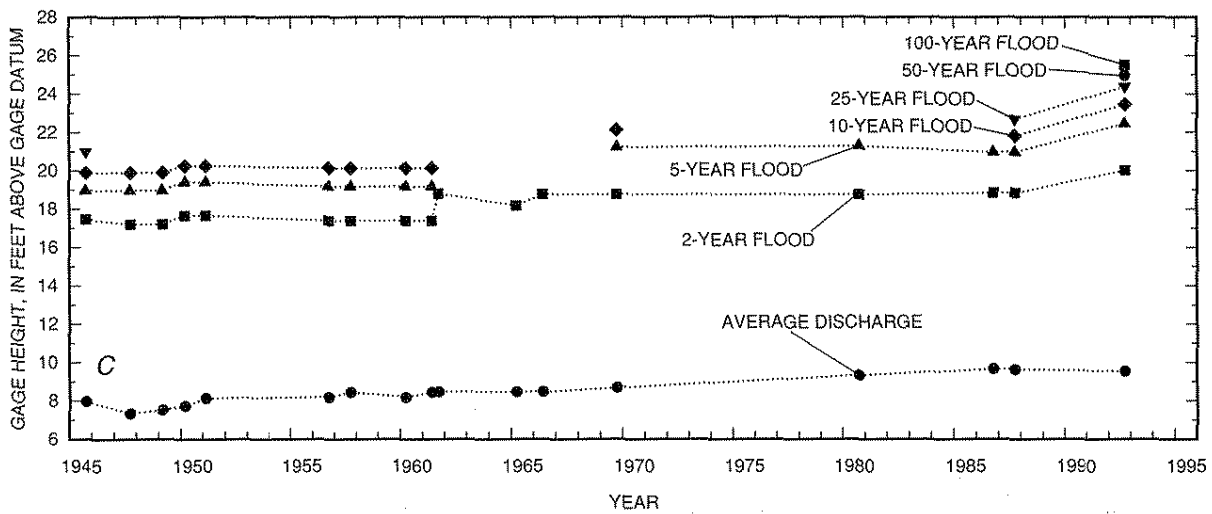
**Figure 16.** Selected (A) bridge-opening cross sections, (B) stage-discharge rating curves, and (C) time series of rating-curve stages for selected discharges for U.S. Highway 63 bridge crossing the South Skunk River near Oskaloosa, bridge site number 11 (streamflow-gaging station number 05471500).

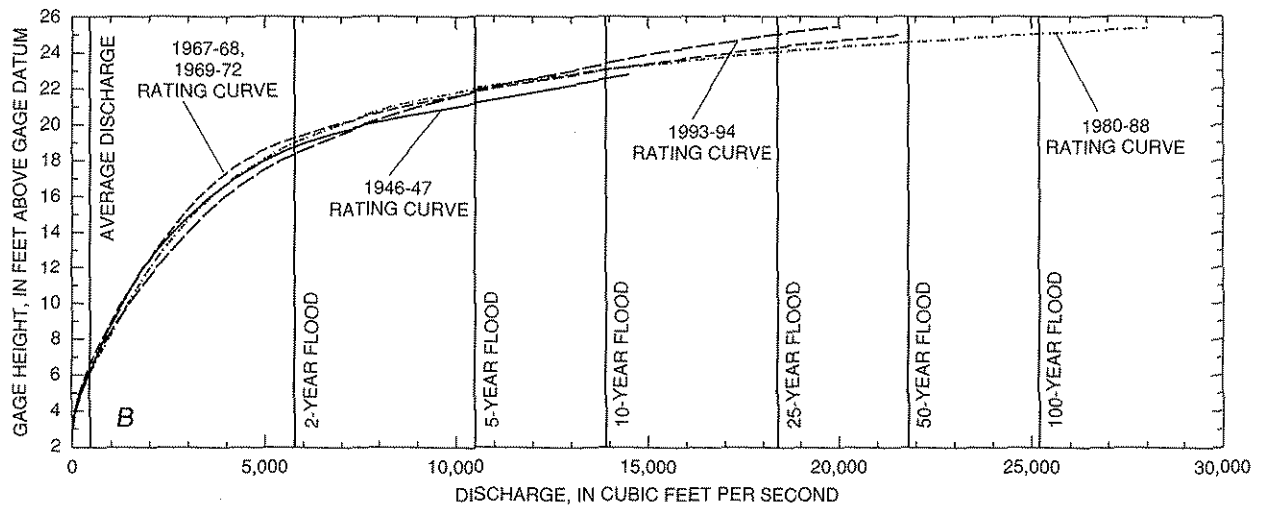
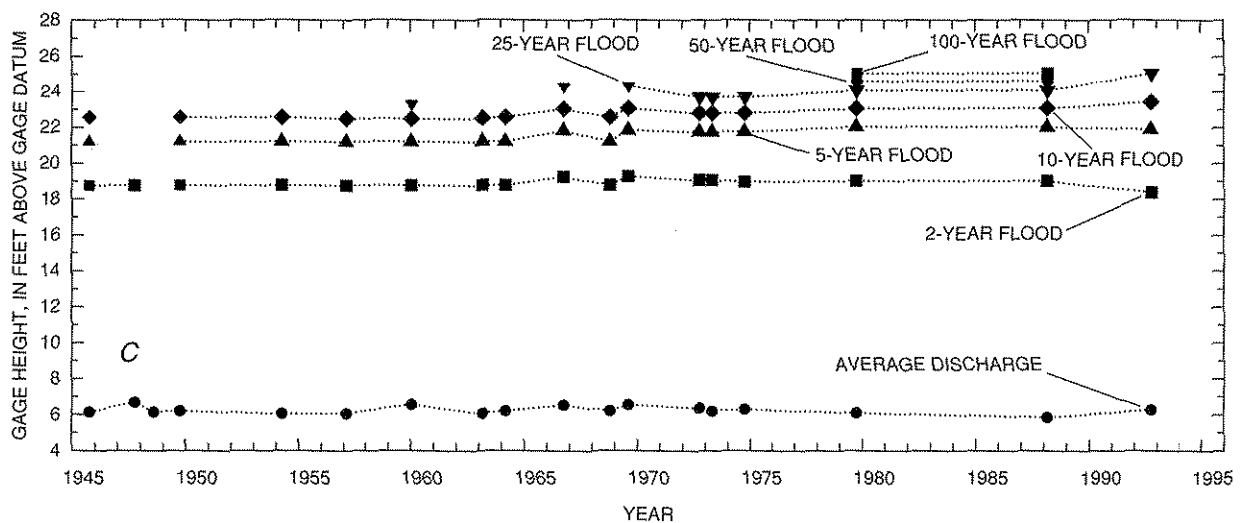
**Figure 17.** Selected (A) bridge-opening cross sections, (B) stage-discharge rating curves, and (C) time series of rating-curve stages for selected discharges for State Highway 149 bridge crossing the North Skunk River near Sigourney, bridge site number 12 (streamflow-gaging station number 05472500).

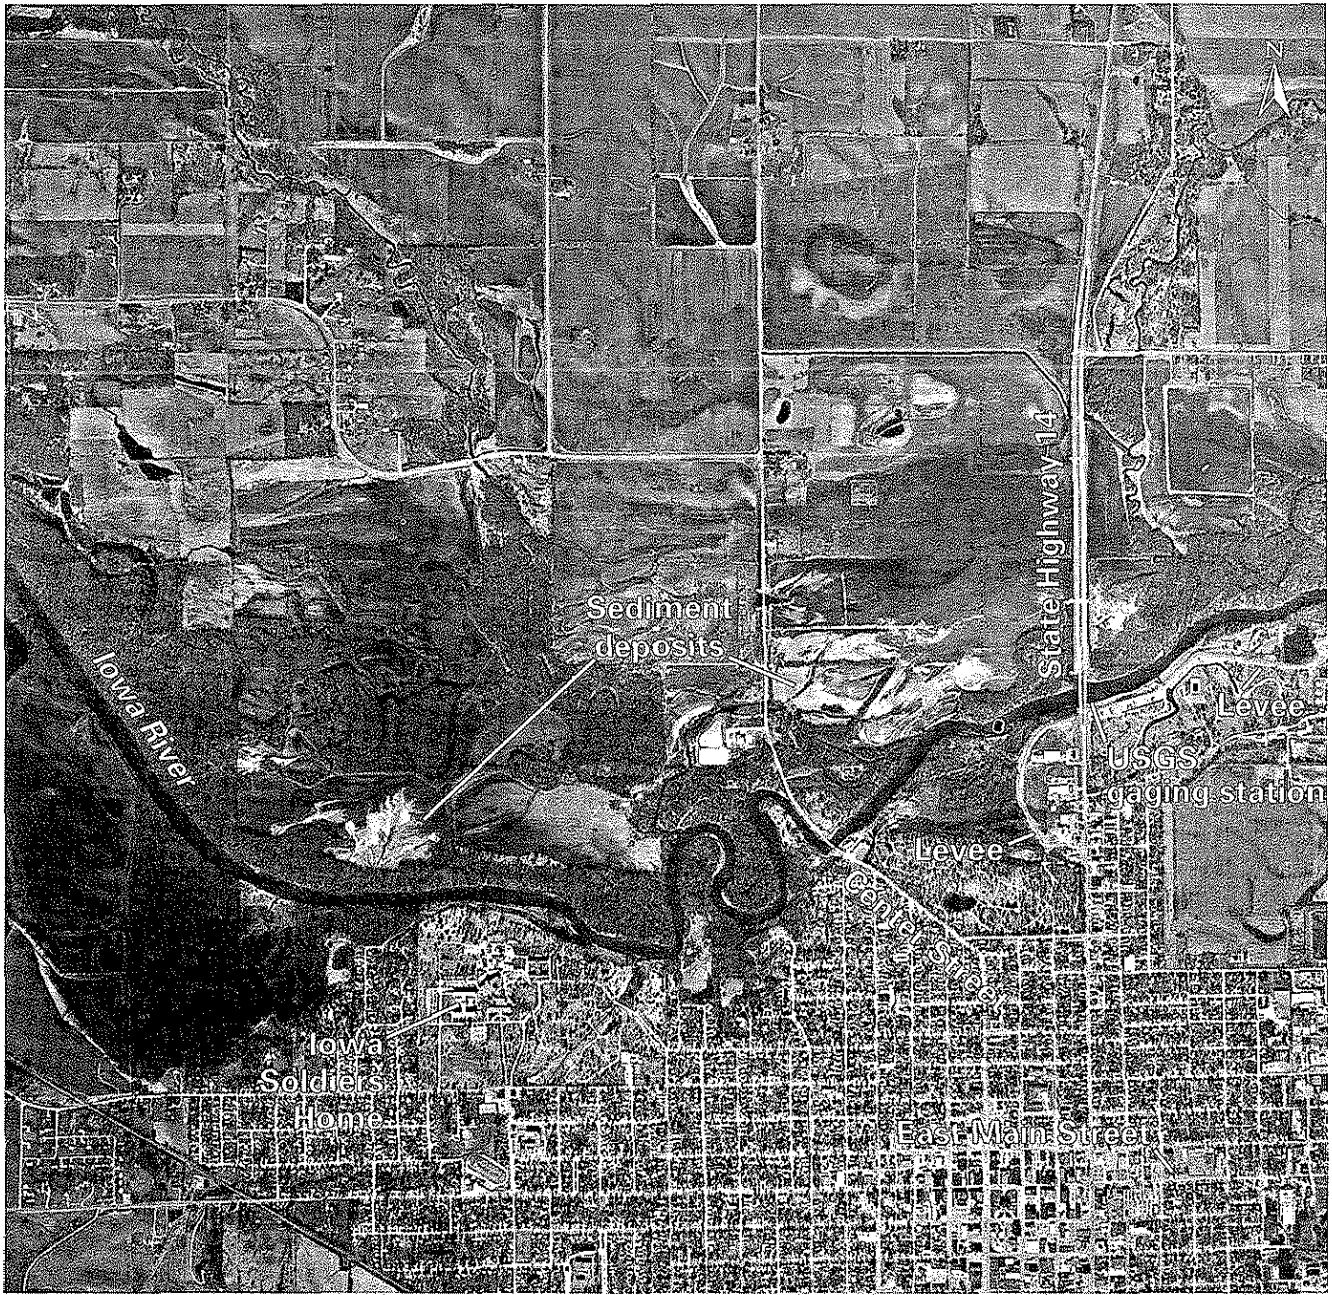
**Figure 18.** Sediment deposits from the 1993 flood along the flood plain of the Iowa River at Marshalltown, Iowa (Photograph on March 24, 1994, by Aerial Services Inc., Cedar Falls, Iowa).

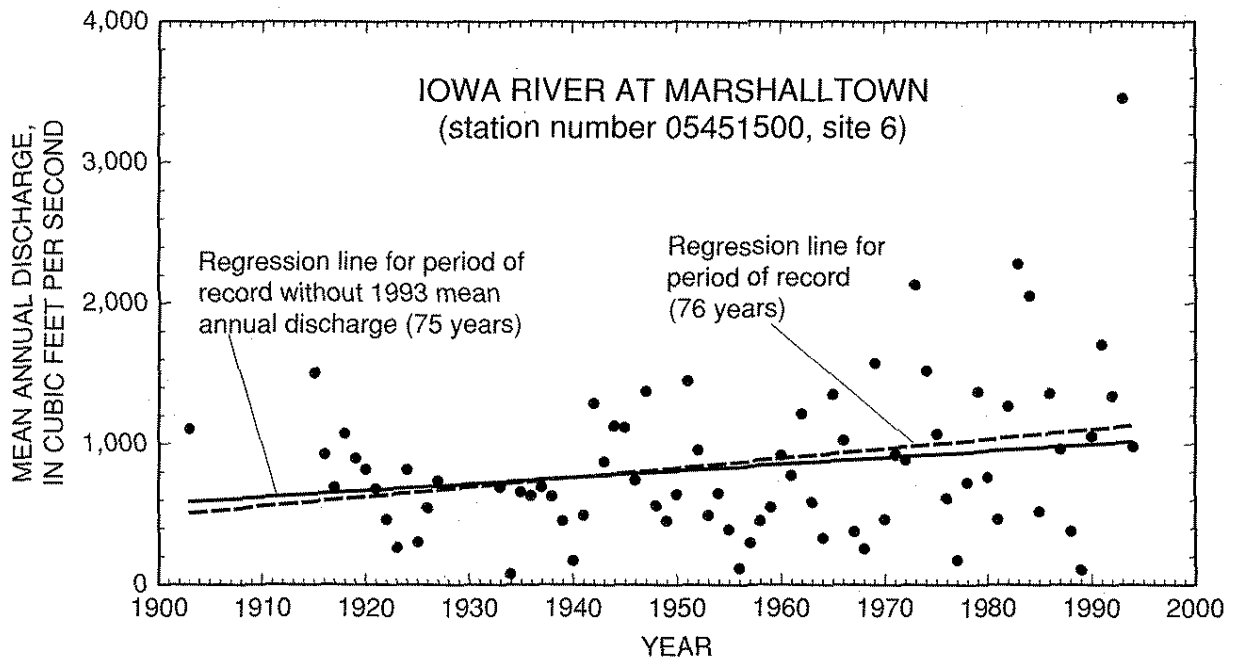
**Figure 19.** Mean annual discharge for the Iowa River at Marshalltown, Iowa, streamflow-gaging station for the period of record through 1994.
