PREVENTING CRACKING AT DIAPHRAGM/PLATE GIRDER CONNECTIONS IN STEEL BRIDGES

Sponsored by the
Iowa Department of Transportation
and the Iowa Highway Research Board
Iowa DOT Project HR-393

JUNE 1998

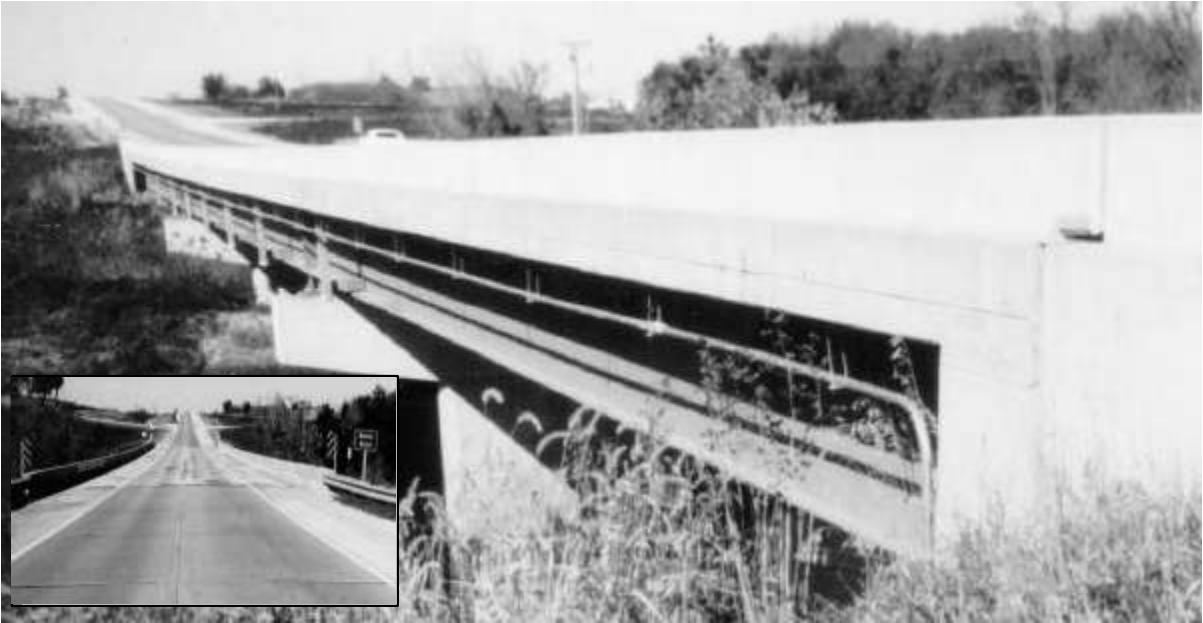
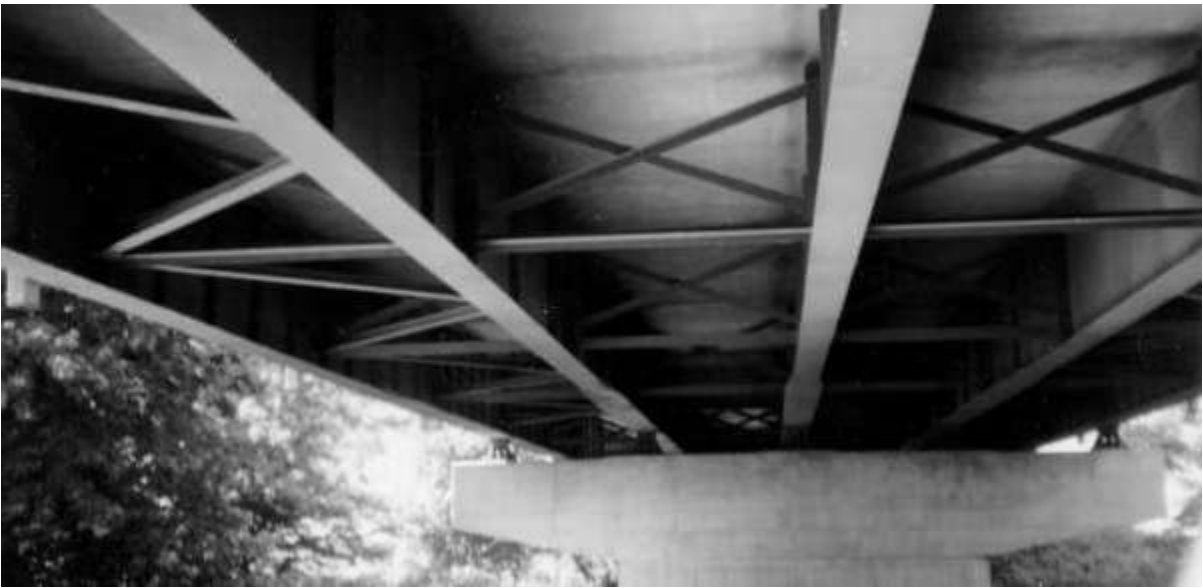
Figure 2. Boone River Bridge on IA-17 (Bridge X1)

(a) Overview and roadway

(b) Diaphragm system

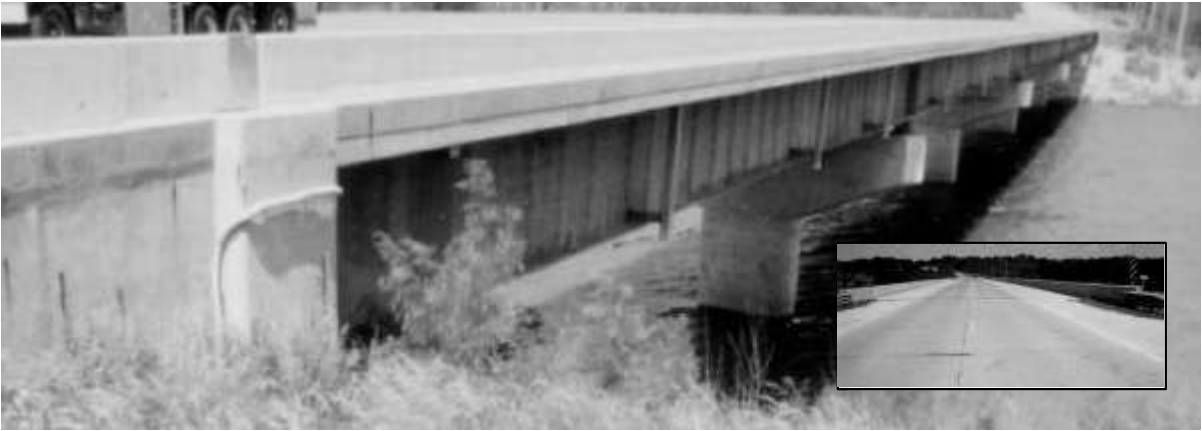
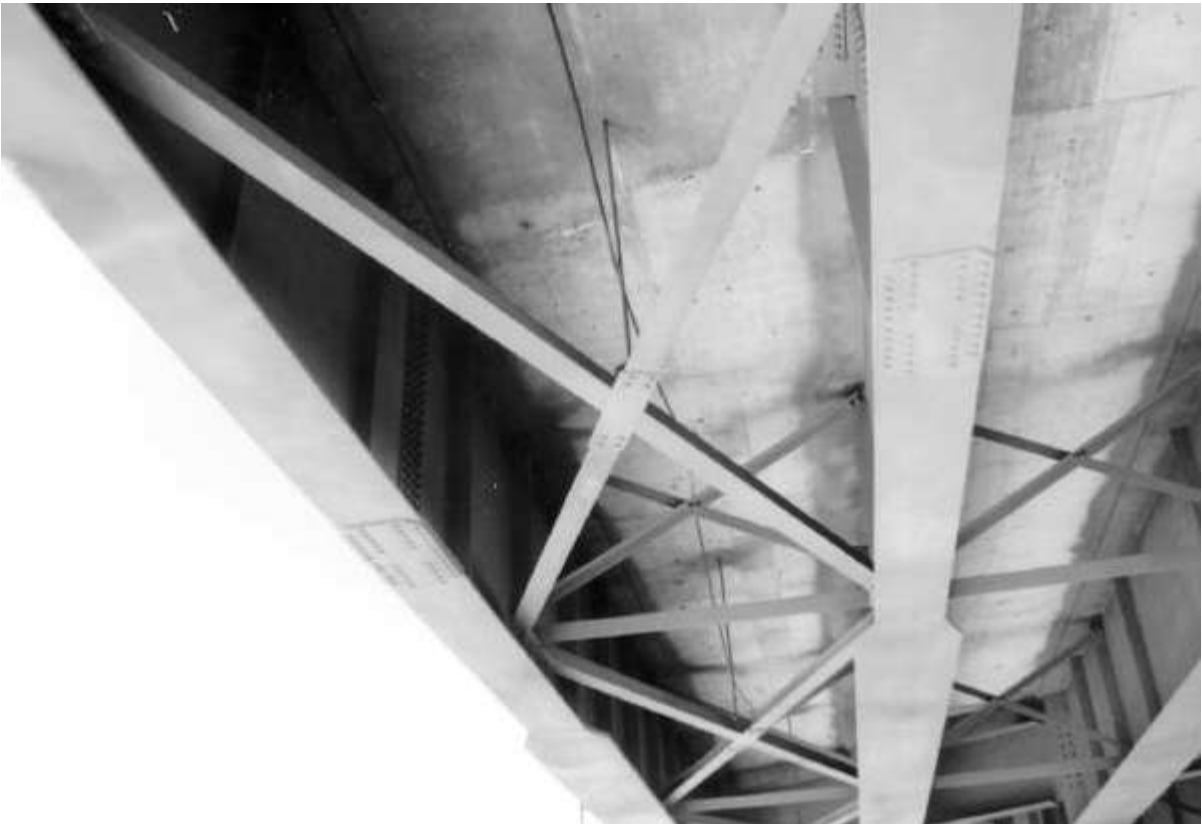
Figure 3. Des Moines River Bridge on IA-210 (Bridge X2)

(a) Overview and diaphragm system

(b) Roadway

The Des Moines River Bridge (Br. No. 0804.9S210) carries Iowa Highway 210 (IA-210) over the Des Moines River west of Madrid in Boone County (Figure 3). The roadway

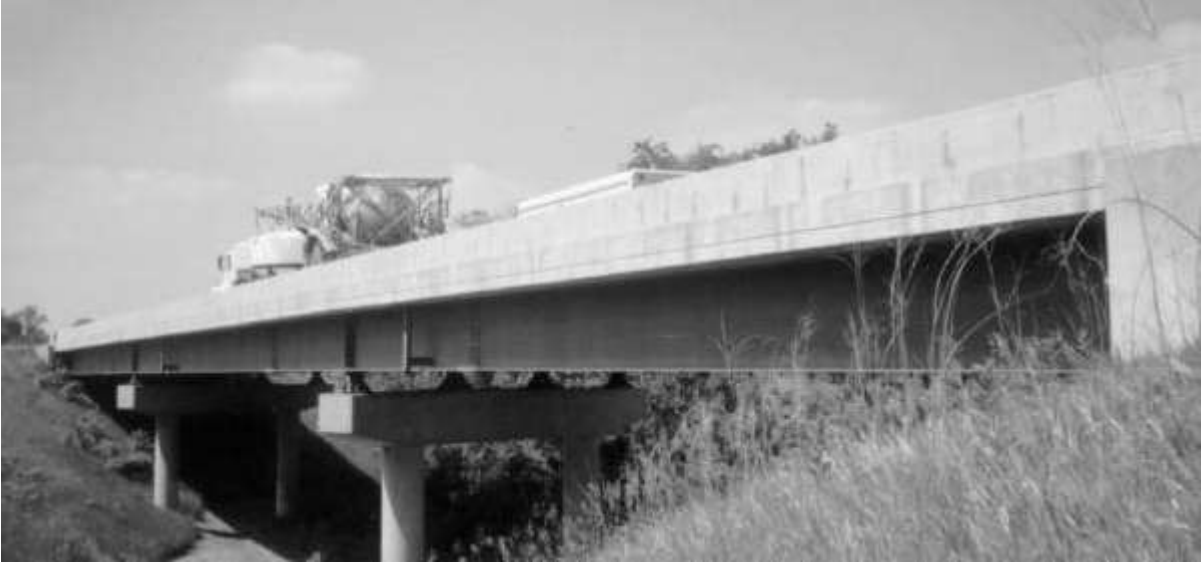
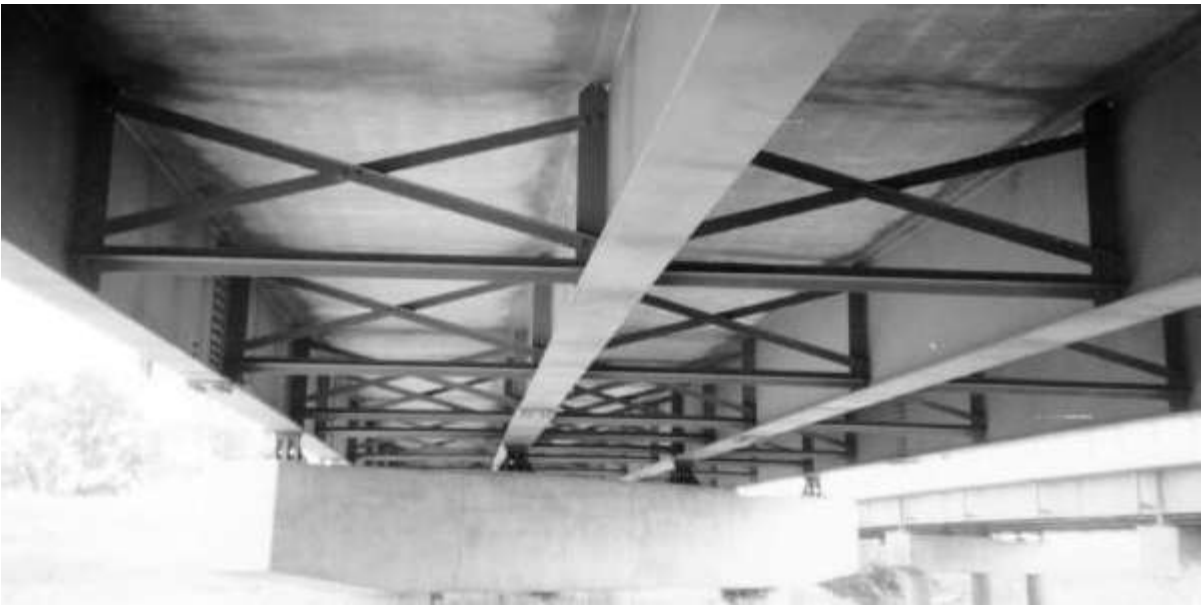
Figure 4. The I-80 Bridge no. 7804.8L080 (Bridge X3)

(a) Overview

(b) Diaphragm system

This bridge (Br. No. 7804.8L080) is located in Pottawattamie County, 3.7 miles (5.9 km) west of the junction of Interstate 80 (I-80) with U.S. 6 Highway. It carries the westbound traffic of I-80 over an abandoned railroad (Figure 4). The bridge was constructed in 1965. The superstructure consists of four continuous steel plate girders topped by a reinforced concrete deck slab. The girders have three spans of 91.5, 117, and 91.5 ft (27.9, 35.7, and 27.9 m), respectively, with a lateral spacing of 9 ft-8 in. (2.9 m) and a total bridge width of 32 ft (9.8 m). The bridge has X-type diaphragms spaced at approximately 22 ft (6.7 m) intervals. The bridge superstructure is skewed 30° , and its supporting two piers and two stub reinforced concrete abutments are supported on piles. Vertical stiffeners are provided at intervals that do not exceed 3 ft-7 in. (1.1 m). Stiffeners are closely fitted to the tension flange with an average web gap height of 1.75 in. (44 mm). Fatigue cracks have been detected in the web gap region at nine locations. As a retrofit, holes were drilled at the crack tips. However, the cracks extended beyond the drilled holes in some locations. Crack extensions were treated by drilling holes at the new crack tip locations. The last fatigue-type inspection of the bridge was in September 1995. The bridge was tested on July 29, 1997. This bridge is referred to as Bridge X3.

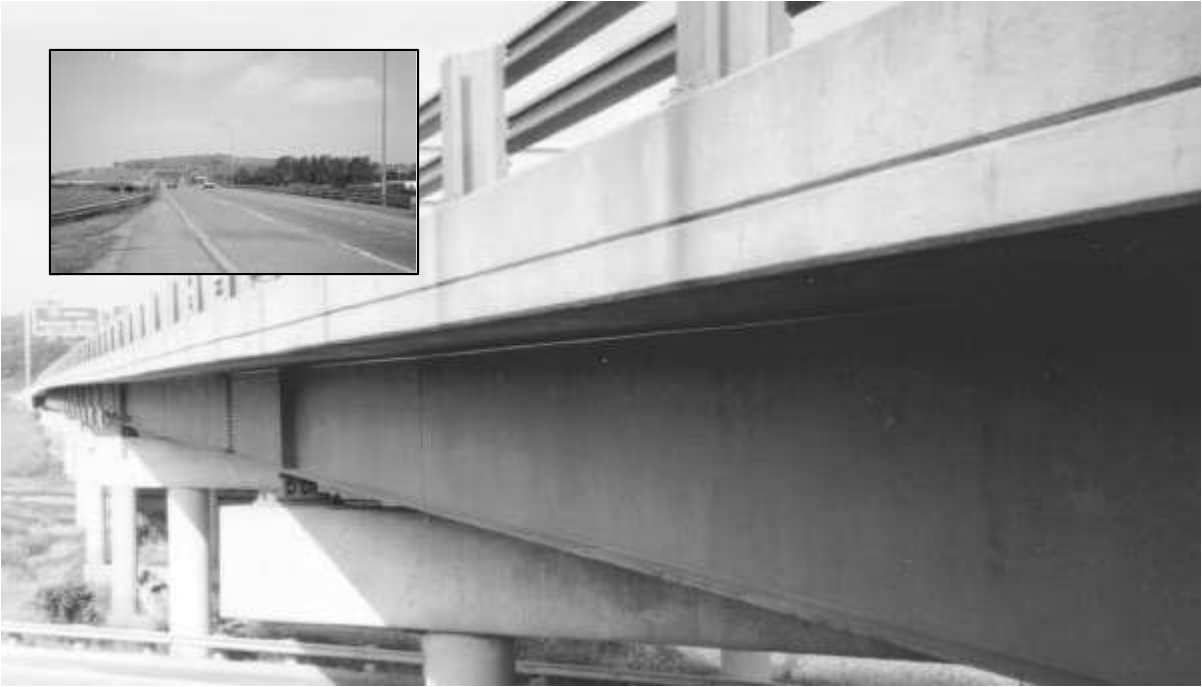
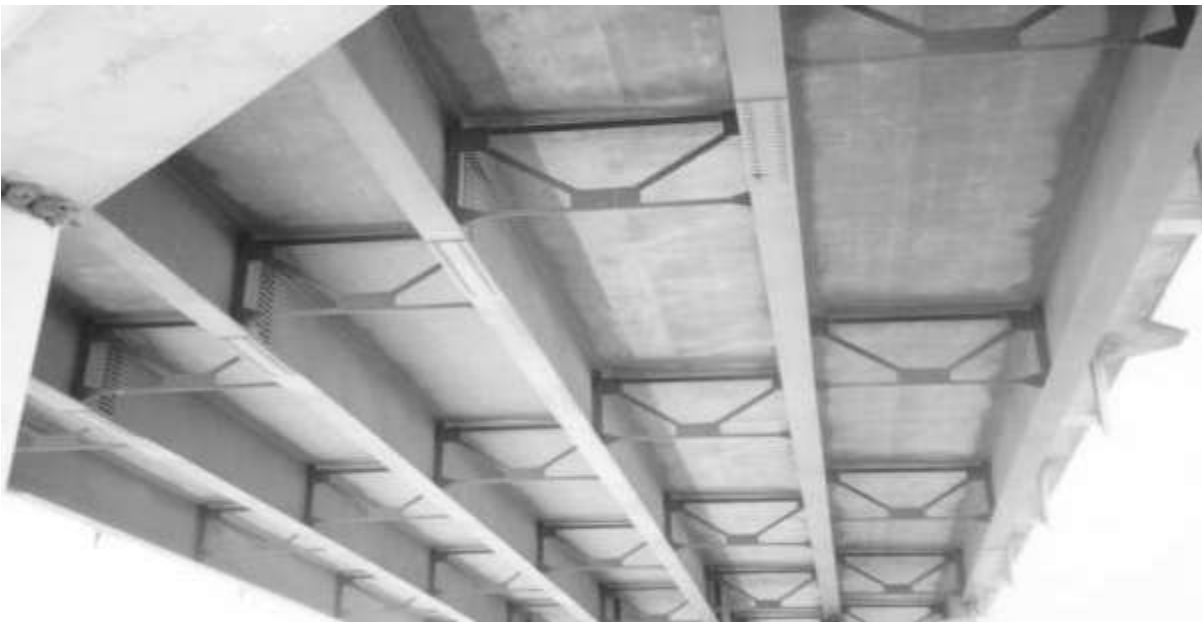
Figure 5. The I-80 Bridge over the Mosquito Creek (Bridge K1)

(a) Overview and roadway

(b) Diaphragm system

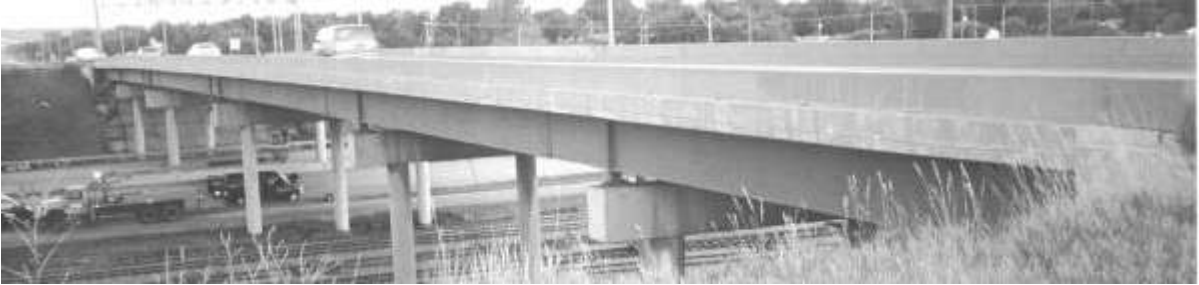
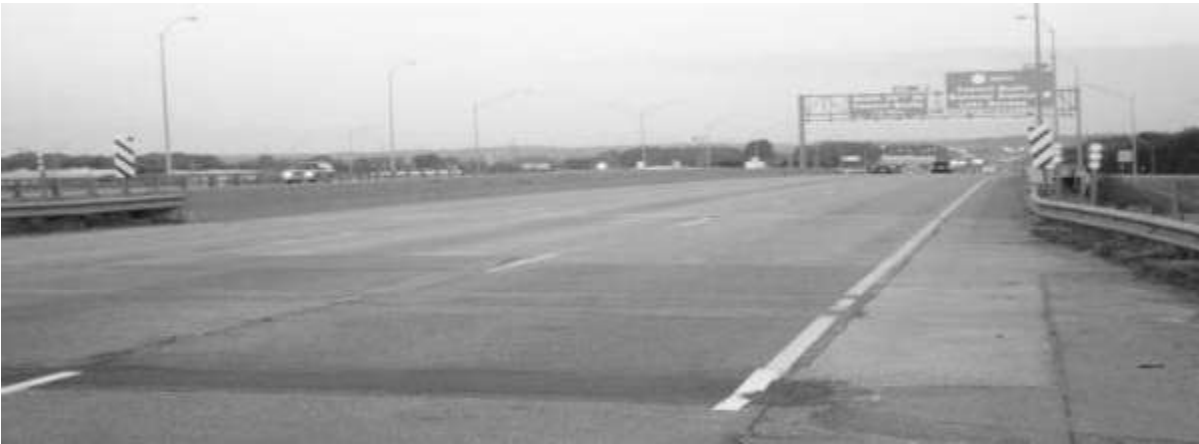
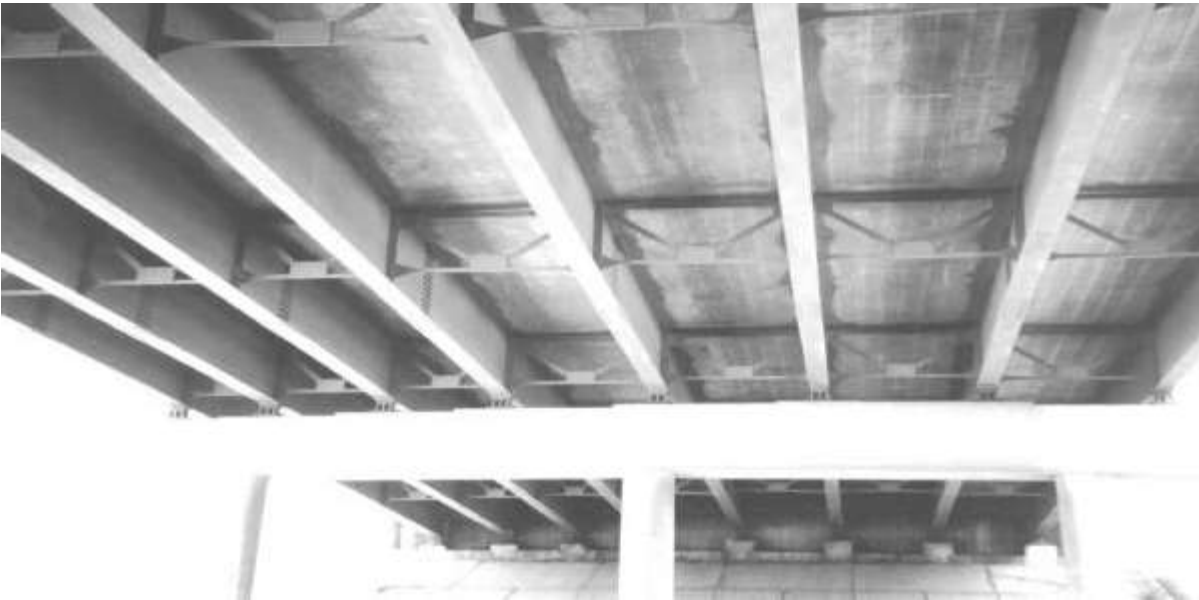
Figure 6. The I-80 Bridge over IA-192 (Bridge K2)

(a) Overview

(b) Roadway

(c) Diaphragm system

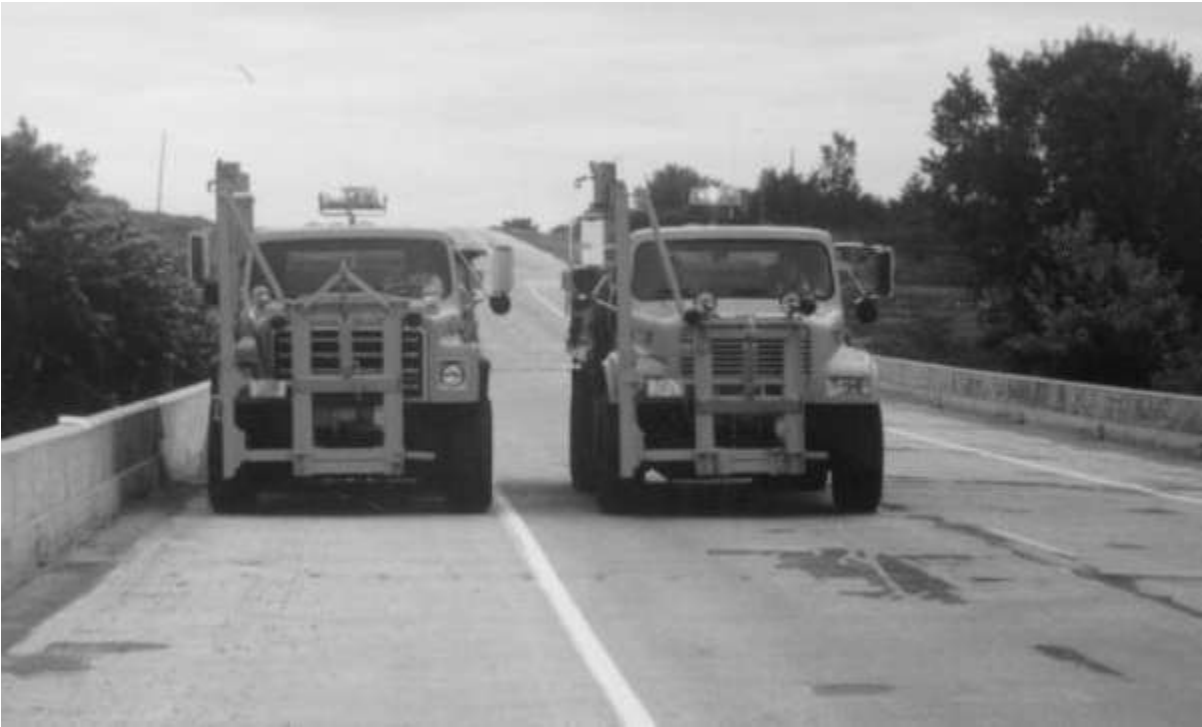
Figure 7. Trucks used for testing Bridge X1

The Iowa DOT provided two loaded rear tandem axle trucks for each bridge (see Figure 7 for trucks used for testing Bridge X1). The majority of the tests (described later) utilized only one truck traveling on the bridge in different lanes and shoulders at speeds varying from 5 mph (8 km/h, crawl speed) to more than 60 mph (96 km/h). For two bridges, however, the two trucks were run side by side in a few tests at the crawl speed. Different trucks were used during tests on different bridges; however, the dimensions and weights were consistently similar. Before testing, each truck was measured and weighed. The gross truck weight ranged from 49 kips (220 kN) to 53 kips (238 kN). Table 1 lists the front axle, rear axle, and gross weights of the test trucks. Although not reported here, additional data were collected during ambient heavy truck traffic.

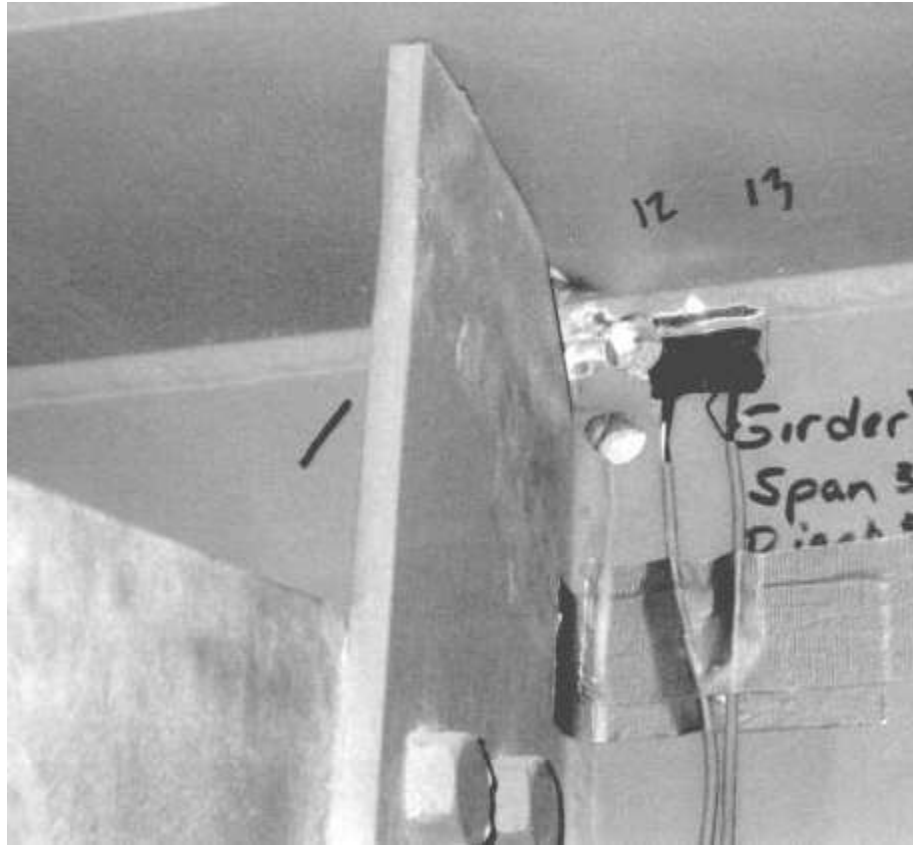
Figure 16. Crack and drilled holes at Location HX3

(a) Overview

(b) Drilled holes and cracks

In addition, for bridges where holes were drilled, sensors were located at the cracked web gap (with diaphragm connection in the negative moment region) with the greatest out-of-plane moments. These are Locations HX3 and HK1 for Bridges X3 and K1, respectively. Figure 16 is a photo for Location HX3 with horizontally oriented cracks and drilled holes. In these locations (HX3 and HK1), the horizontal distribution of the out-of-plane distortion strains and the horizontal out-of-plane displacement were measured. Web gaps of interior girders in the negative moment regions are also susceptible to fatigue cracking. Therefore, four locations were instrumented: IX1, IX3, IK1, and IK2, respectively. At these locations, the out-of-plane distortion was recorded. Further, the strain distribution in the web gap region due to the out-of-plane distortion was measured (using at least three strain gages) in all of them except Location IX1. For Location IX1, two vertically oriented displacement transducers were attached on either side of the web to measure the relative vertical displacement between the flange and the web.

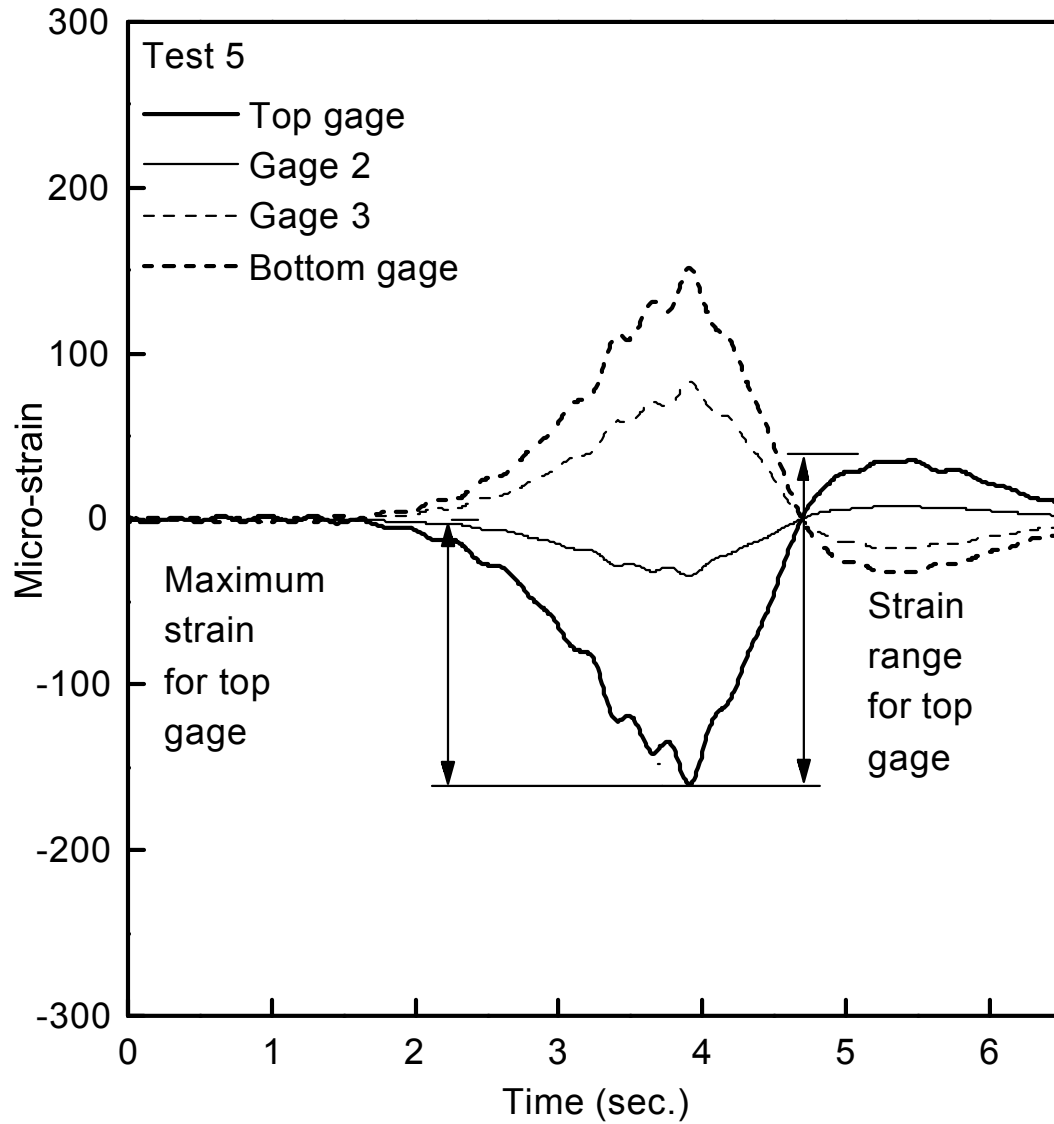
Figure 17. Strain recorded in the web gap region at Location EX1 during Test 5

Figure 17 shows the strain readings of the four gages installed in the web gap at Location EX1 during Test 5. Like all strain plots, it is characterized by a single maximum value followed by a small rebound strain. During Test 5, the maximum recorded strain for Gage 1 was 160 micro-strain (4.64 ksi or 31.97 mPa). This figure illustrates how the strain range is estimated. Strain range is an absolute value with no associated sign. After graphically finding the strain range, the stress range is estimated as described in the previous chapter.

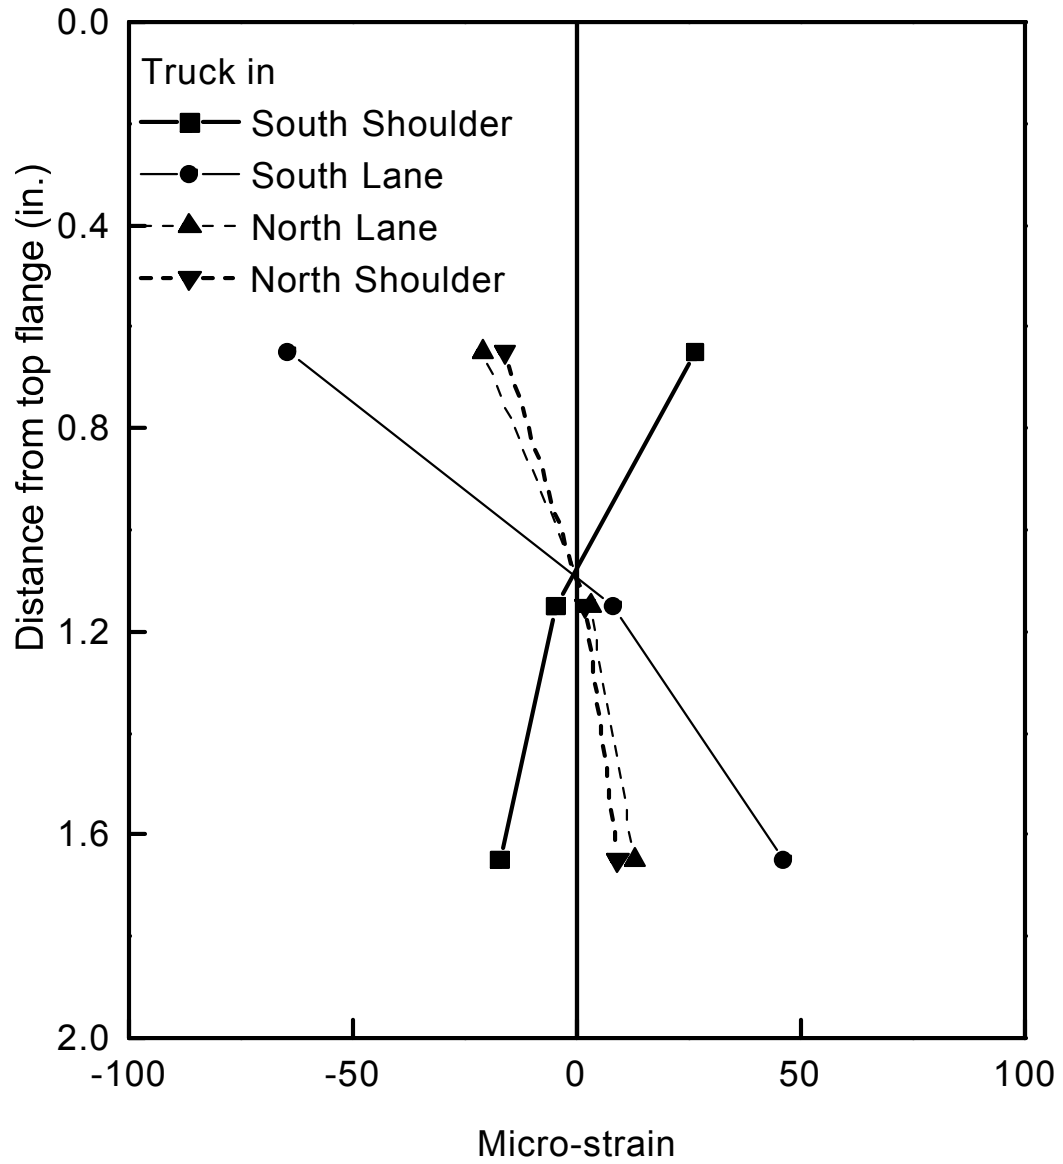
Figure 19. Vertical profile of the maximum strains in the web gap at Location EX2 during Tests 1-4

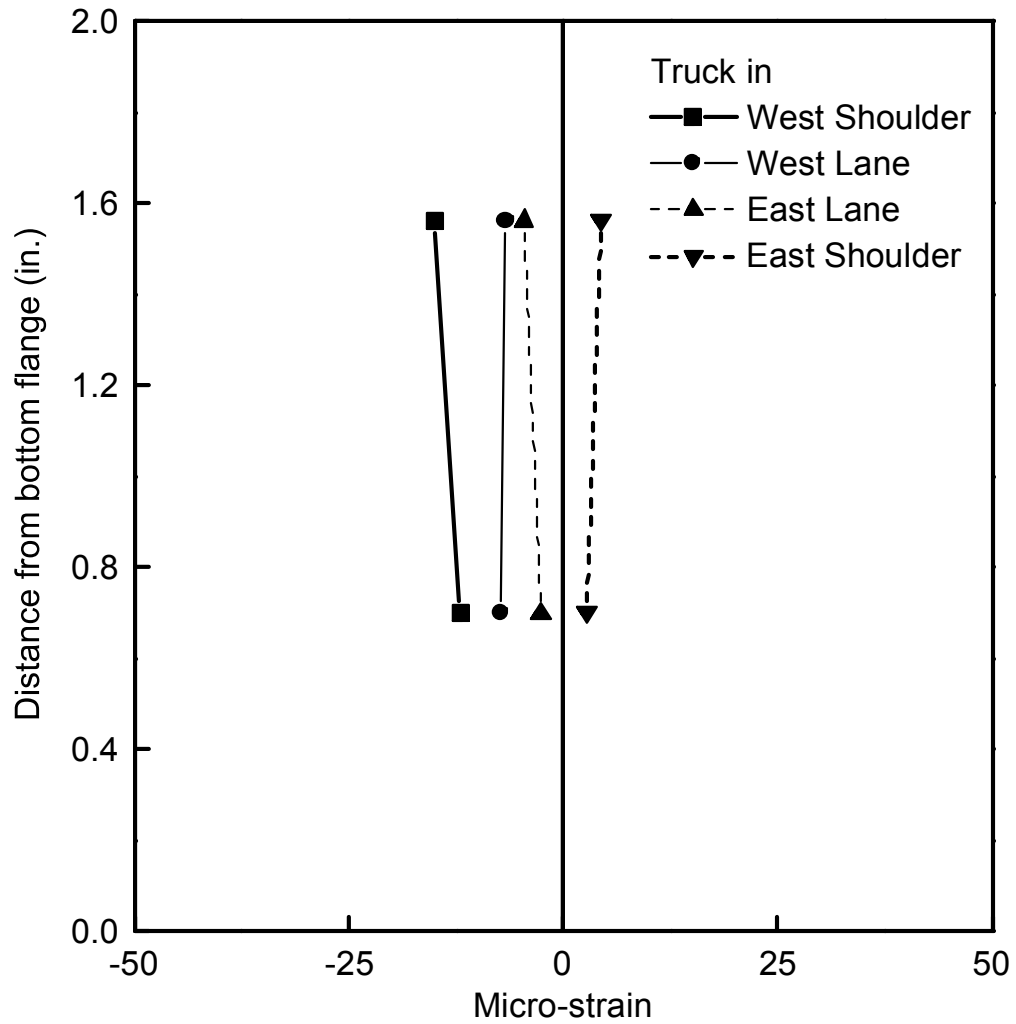
Figure 20. Vertical profile of the maximum strains in the web gap at Location BX1 during Tests 1-4

that the strains and stresses, in addition to being location dependent, are bridge dependent. At Location BX1 near the bottom flange in the positive moment region, the strain distribution in the web gap is shown in Figure 20. The distribution did not exhibit bending behavior. The values of these strains are less than 10% of those at Location EX1 in the negative moment region, explaining why it is more likely that a web gap in the negative moment region would crack.

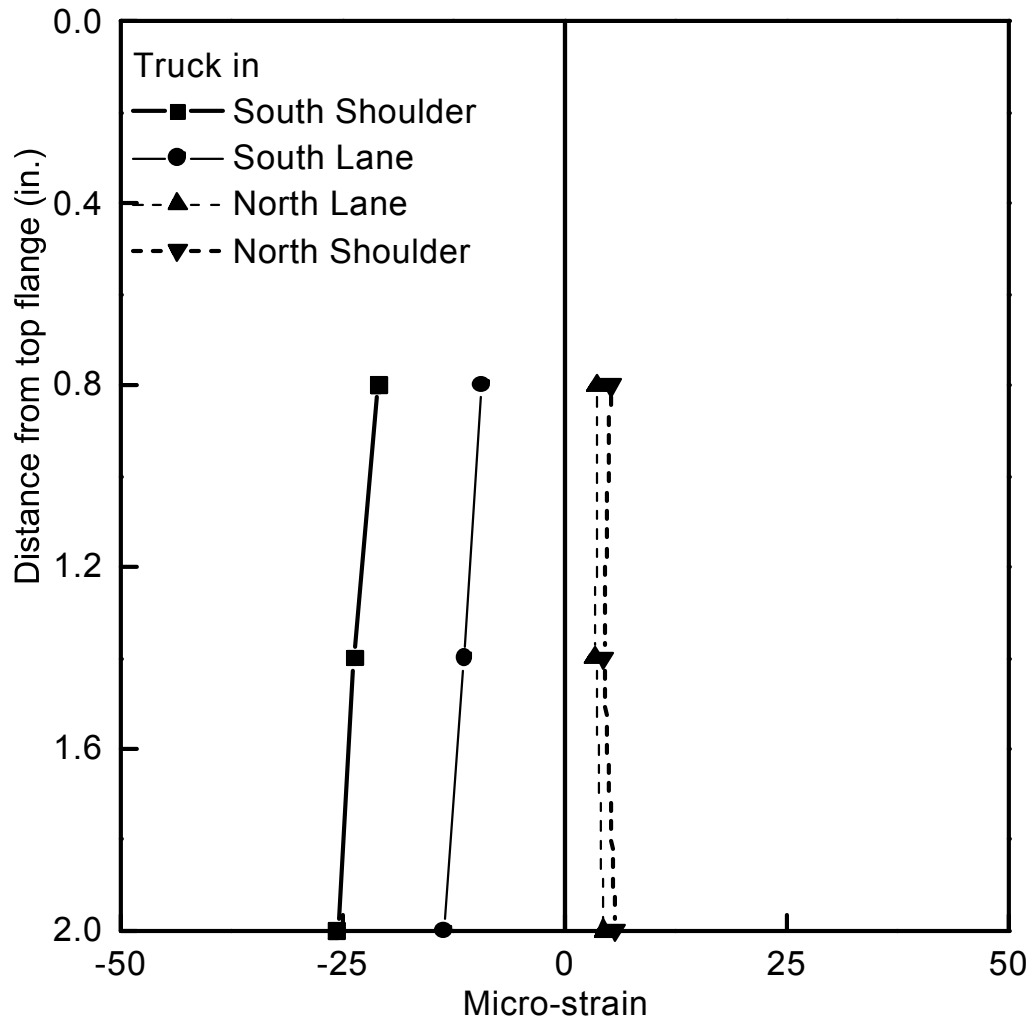
Figure 21. Vertical profile of the maximum strains in the web gap at Location RX2 during Tests 10-13

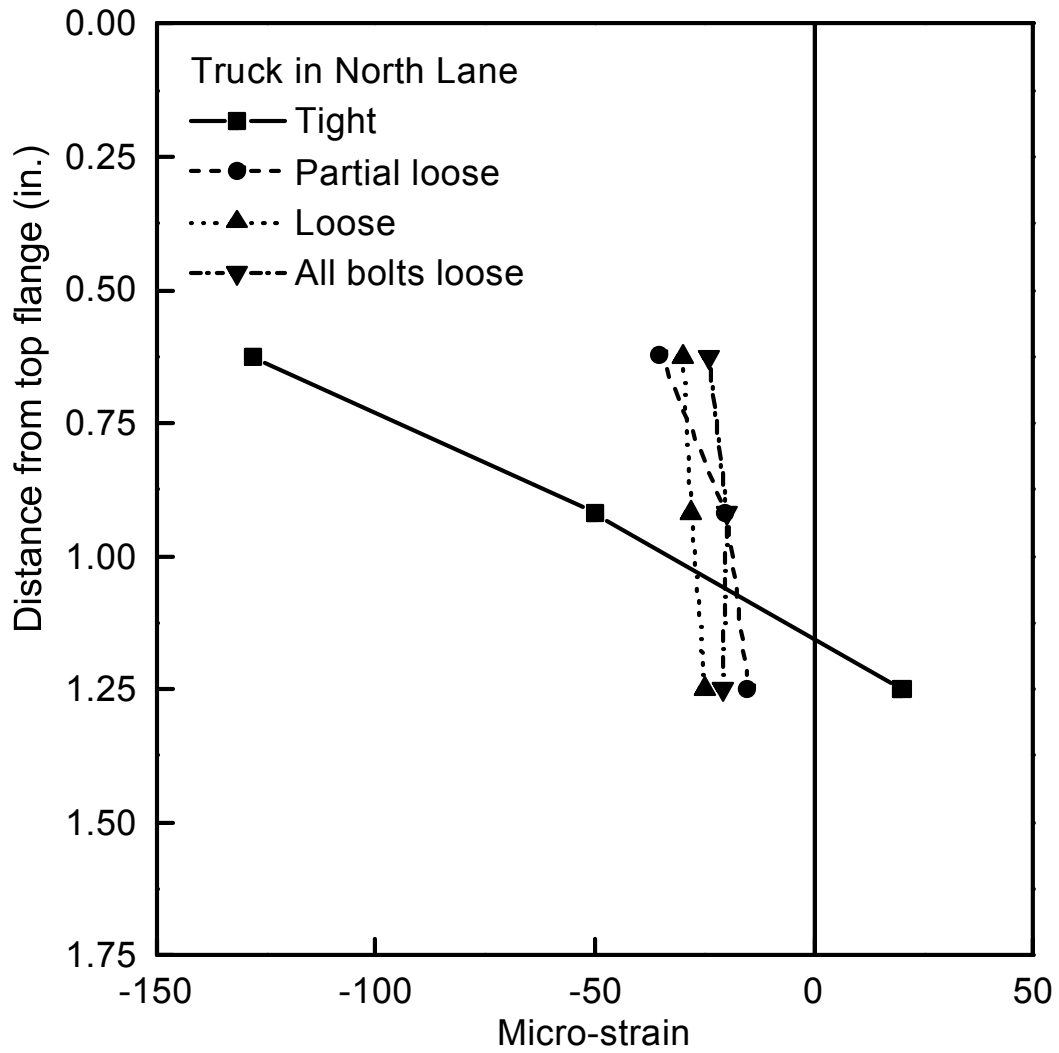
Figure 22. Comparison among maximum strains at Locations EX3 during Test 2 (tight), Test 5 (partial loose), Test 7 (loose) and Test 8 (all bolts loose)

After loosening the bolts, the strains at all locations with diaphragm connections drop significantly. Figure 22 shows a comparison between the vertical profile of the strain in the web gap at Location EX3 during Test 2 (tight), Test 5 (partial loose), Test 7 (loose), and Test 8 (all bolts loose). Obviously, the web gap strains at Location EX3 (and similarly all gaps with diaphragm connections) were reduced upon loosening the bolts. However, the distribution still reflects out-of-plane bending behavior of the web gap. Loosening the exterior diaphragm panel lower bolts only (partial loose) had nearly the same effect as loosening both exterior and interior panel lower bolts (loose) or loosening the exterior and interior panel lower and upper bolts (all bolts loose) on the exterior girders web gap strains. For an interior girder (Location IX3), however, a significant reduction in the web gap strains occurred after loosening the diaphragm bolts of the interior panel (i.e. between partial loose and loose condition). Figure 23 illustrates that for Test 2 (tight), Test 5 (partial loose) and Test 7 (loose) with the truck travelling in the North Lane.

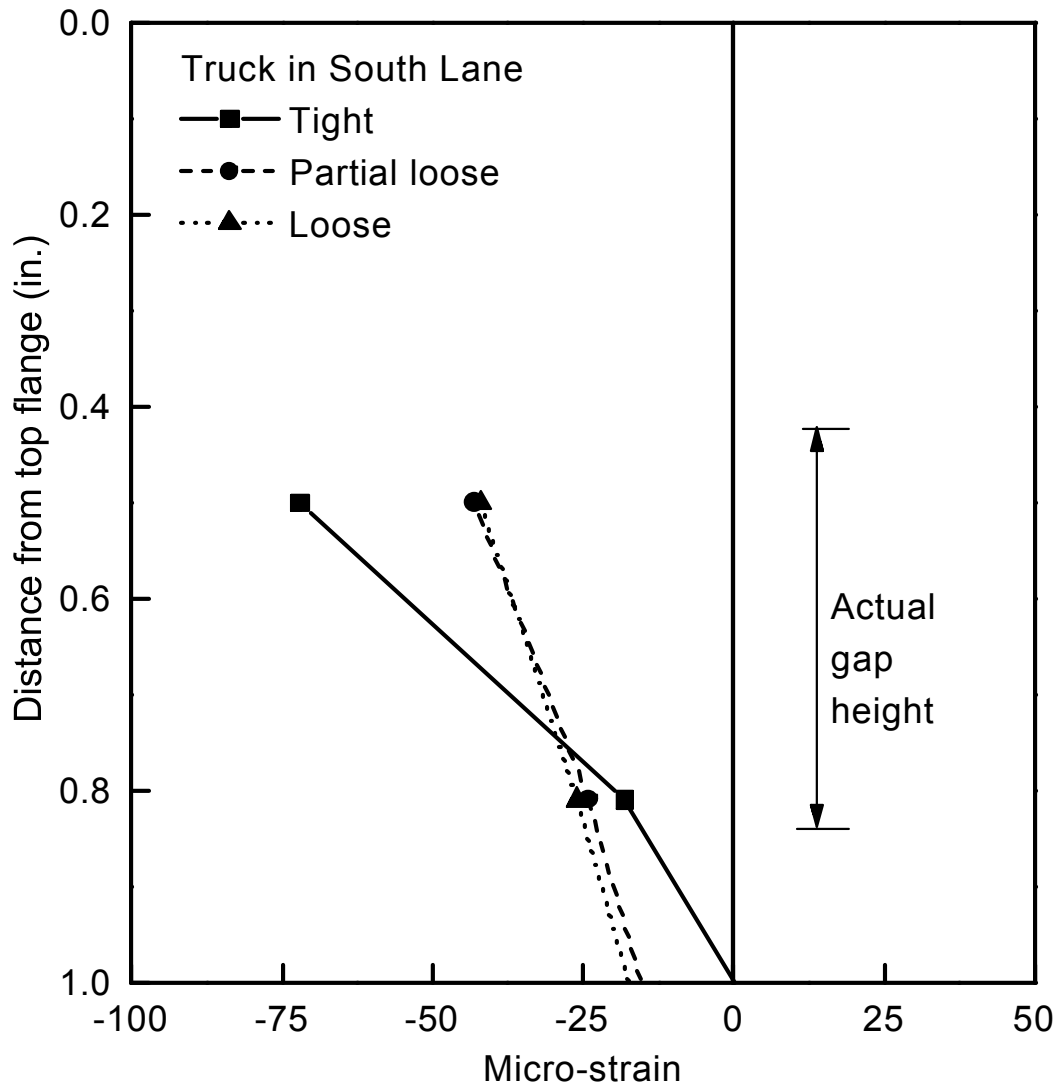
Figure 26. Vertical profile of the maximum strains in the web gap at Location EK2 during Test 1 (tight), Test 4 (partial loose), and Test 7 (loose)

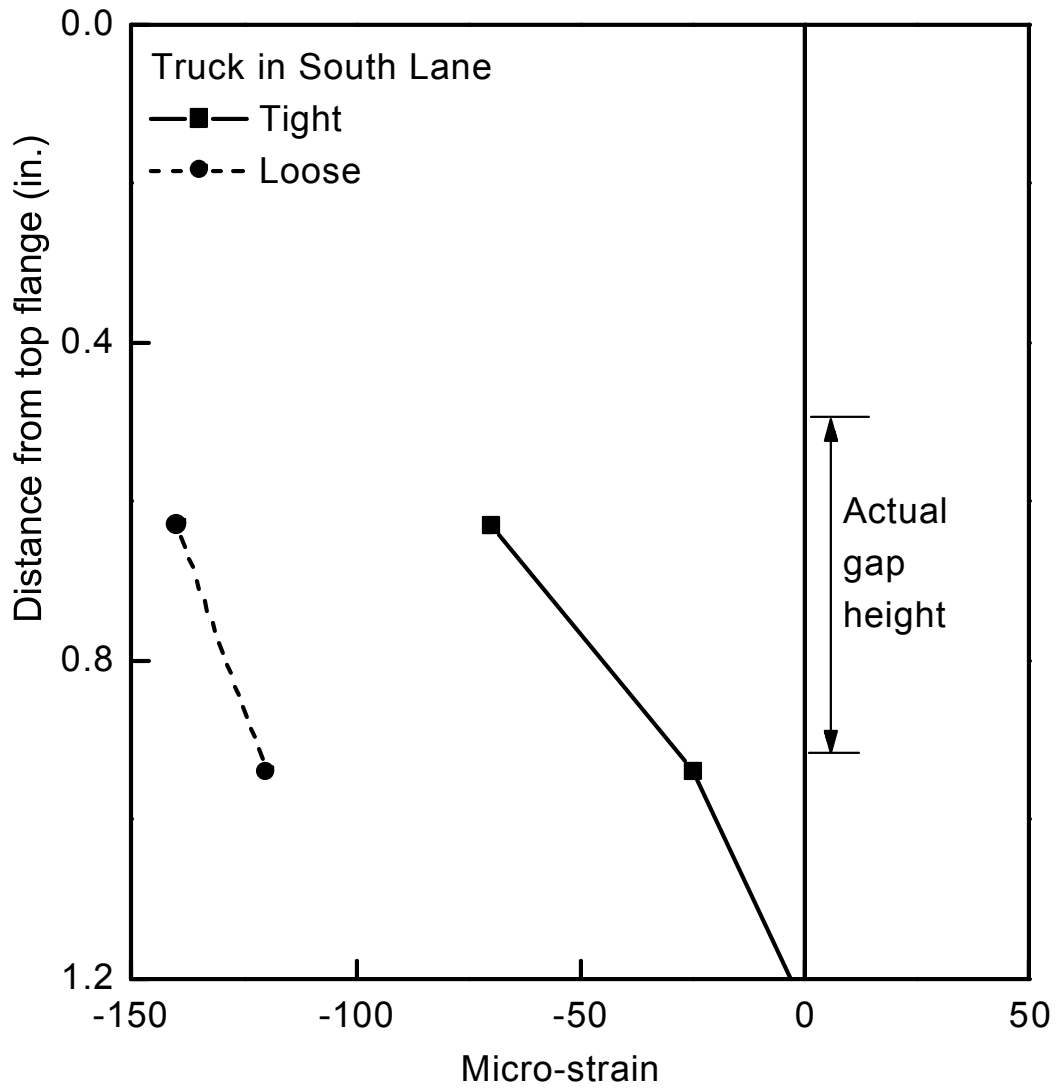
Figure 28. Vertical profile of the maximum strains in the web gap at Location AK1 during Test 1 (tight), and Test 5 (loose)

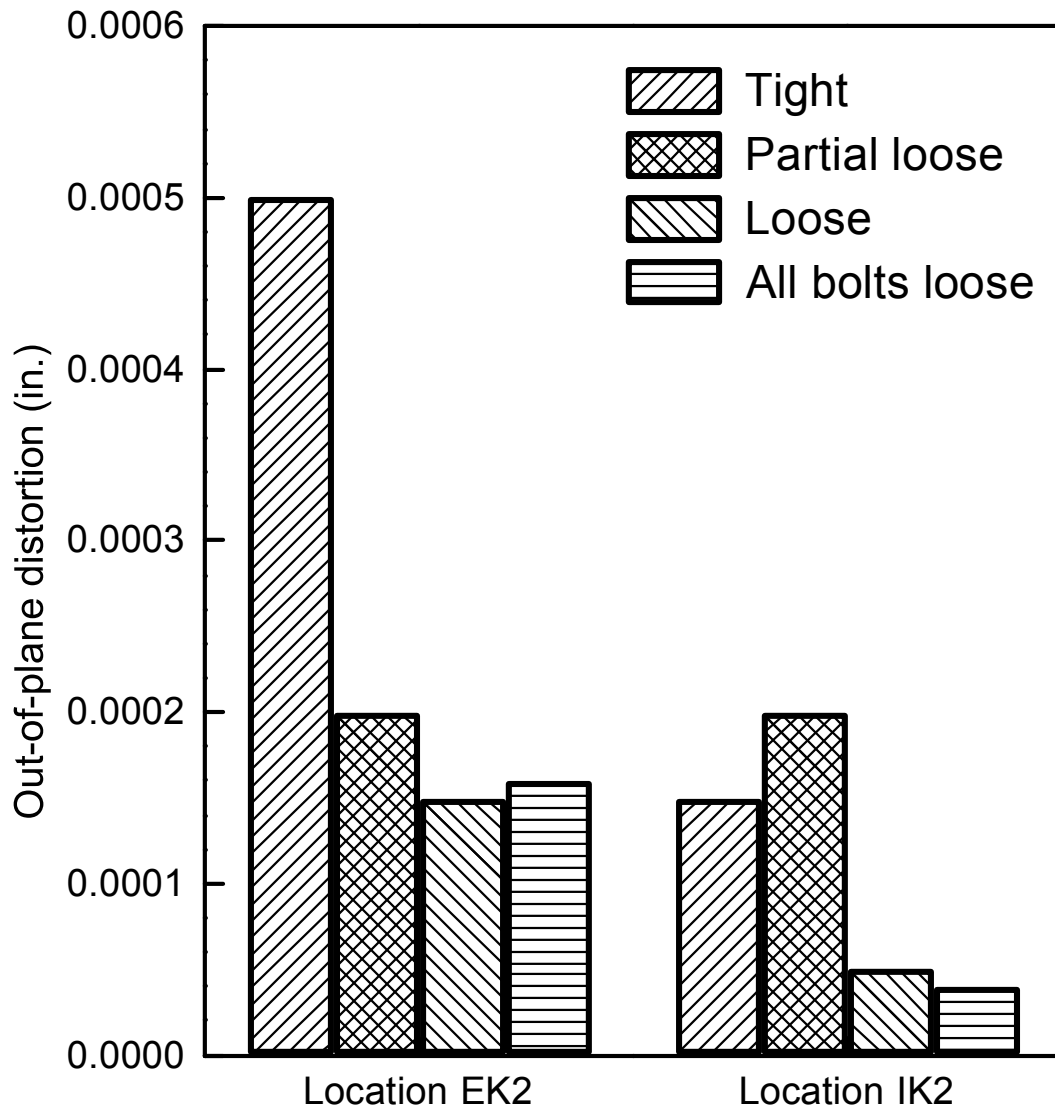
Figure 30. Maximum out-of-plane displacements of Locations EK2 and IK2 during tight, partial loose, loose, and all bolts loose tests

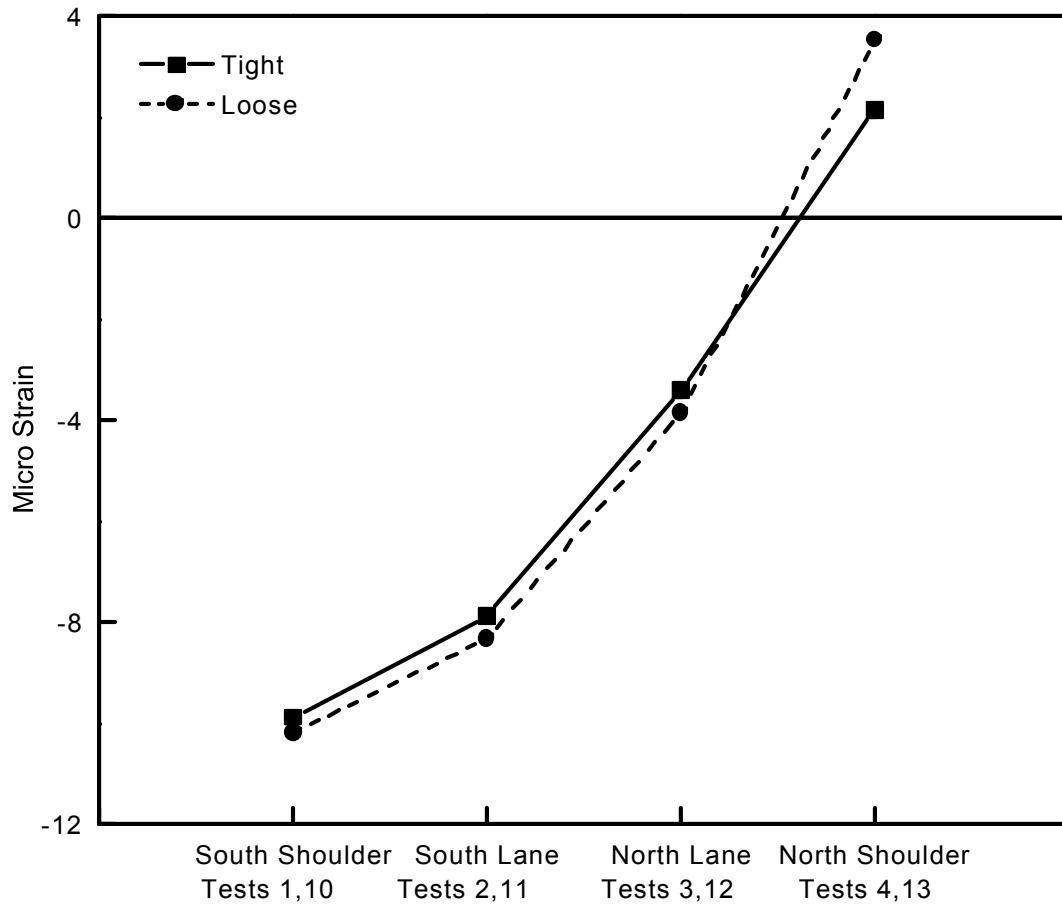
Figure 33. Maximum exterior girder bottom flange strains in Bridge X2 during tight and loose condition tests

The effect of the proposed retrofit method on the lateral live load distribution was investigated in Bridges X2 and K2. Figure 33 shows the maximum exterior girder bottom flange strains during crawl speed tests (Tests 1-4 and Tests 10-13). Apparently, there is a slight change in the strains after applying the proposed method. The investigation showed that loosening the diaphragm diagonal connection bolts had a small effect (within 12% and 15% for Bridge X2 and K2, respectively) on the distribution.
