# THE DETERIORATING ACTION OF SALT AND BRINE ON REINFORCED CONCRETE.\*

**HENRY JERMAIN MAUDE CREIGHTON,**

Department of Chemistry, Swarthmore College.  
Member of the Institute.

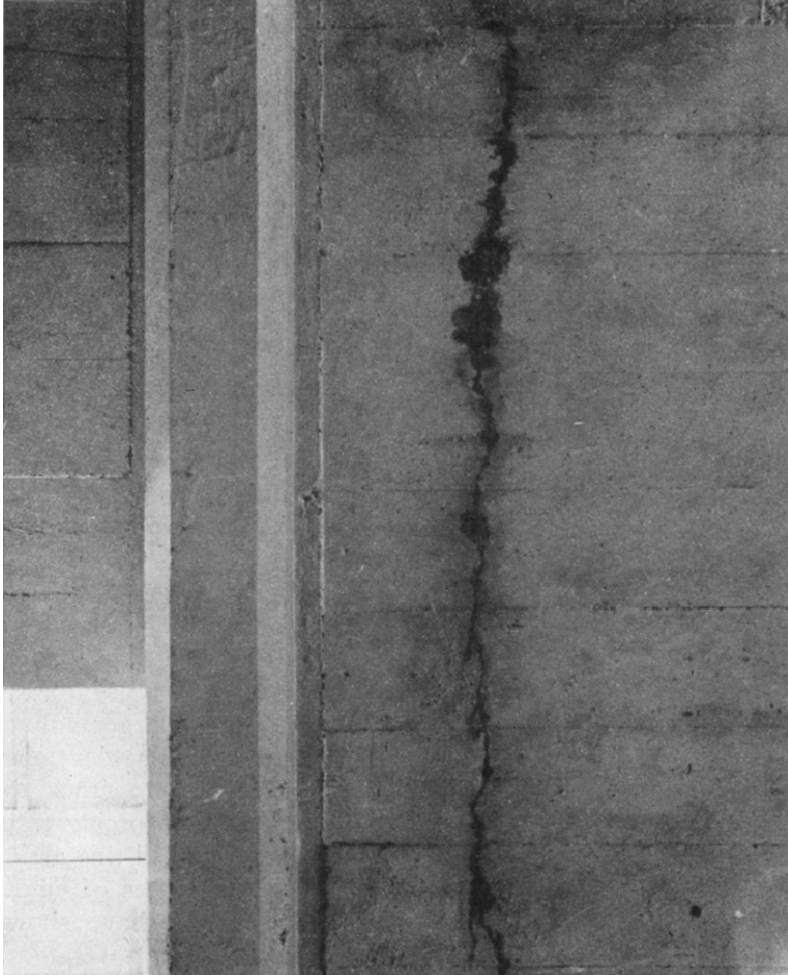
FIG. 1.

In many parts of the country to-day there are reinforced concrete structures housing industries that use large quantities of salt and brine, which are constantly spilled on the floors. In order to ascertain whether the concrete of such buildings has undergone any deterioration, the writer a few years ago examined a large number of them in different cities throughout the country. In practically all the buildings inspected, reinforced concrete floors which came in contact with brine had iron-stained cracks on the under side. Usually these cracks were very narrow, but they indicated, nevertheless, deterioration of the reinforcements, and would continue to grow as the disintegration of the iron progressed. Fig. 1, which is a photograph of the ceiling of a large reinforced concrete building in Detroit, the floors of which are

continually wet with brine, is a typical example of one of these iron-stained cracks in the early stages, and Fig. 2 shows a cracked horizontal beam supporting the floor of a reinforced concrete building in Chicago. In many instances the cracks were found to vary from  $\frac{1}{8}$  to  $\frac{1}{4}$  inch in width, and in some cases deterioration had progressed so far that large pieces of concrete had fallen, or were about to fall, leaving the badly corroded reinforcements

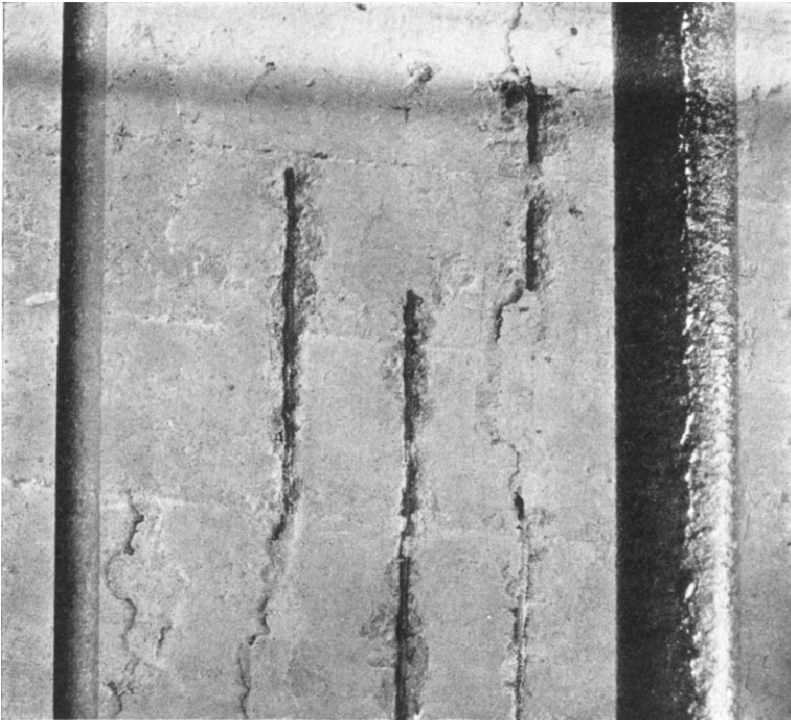
FIG. 3.

exposed, as illustrated by Fig. 3 (photograph taken in Buffalo). An examination of a number of pieces of this fallen concrete showed that in every case a quantity of iron oxide adhered to the concrete where it had come in contact with the reinforcing rods (Fig. 4), and that it was sometimes as thick as  $\frac{1}{8}$  inch. Where the concrete had broken away from the reinforcements, the latter were usually so badly corroded that it was possible to remove thick layers of oxide with the fingers. In a few cases the deterioration had progressed to such an extent that the rein-

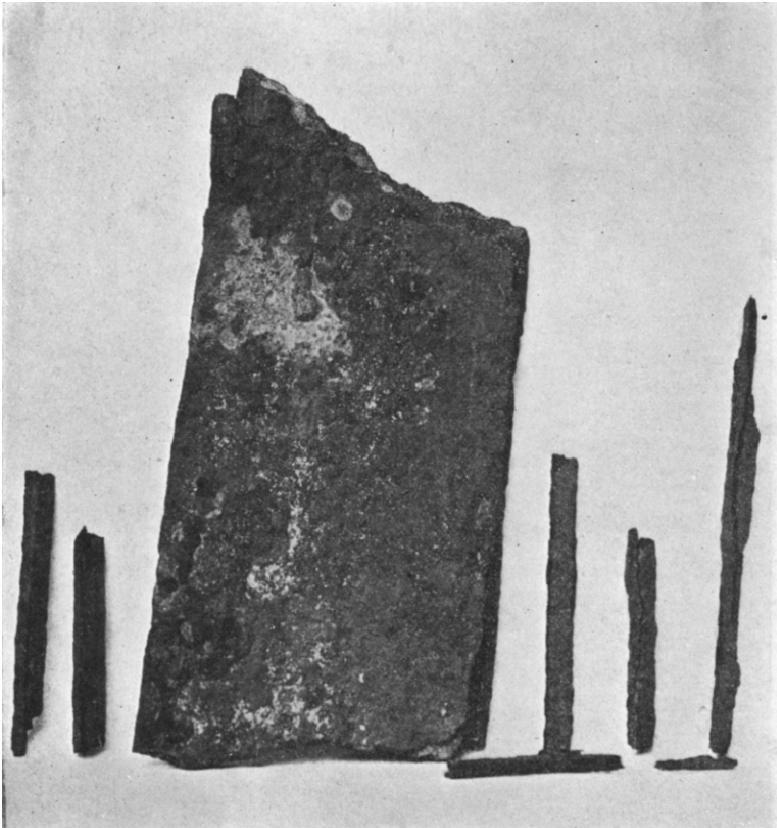
FIG. 5.

forcements had been completely converted into oxide. Fig. 5 shows pieces of iron oxide,  $\frac{1}{8}$  to  $\frac{3}{16}$  inch thick, which were pulled away from corroded reinforcing rods or beams with the fingers.

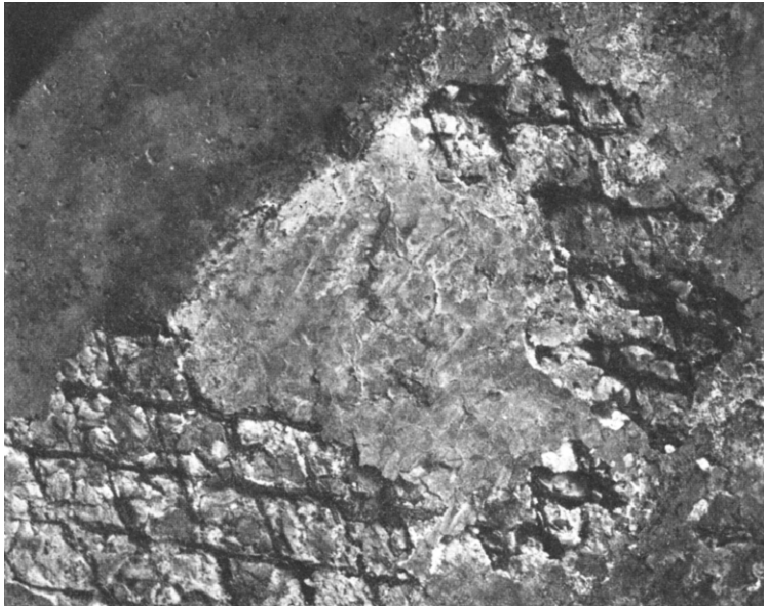
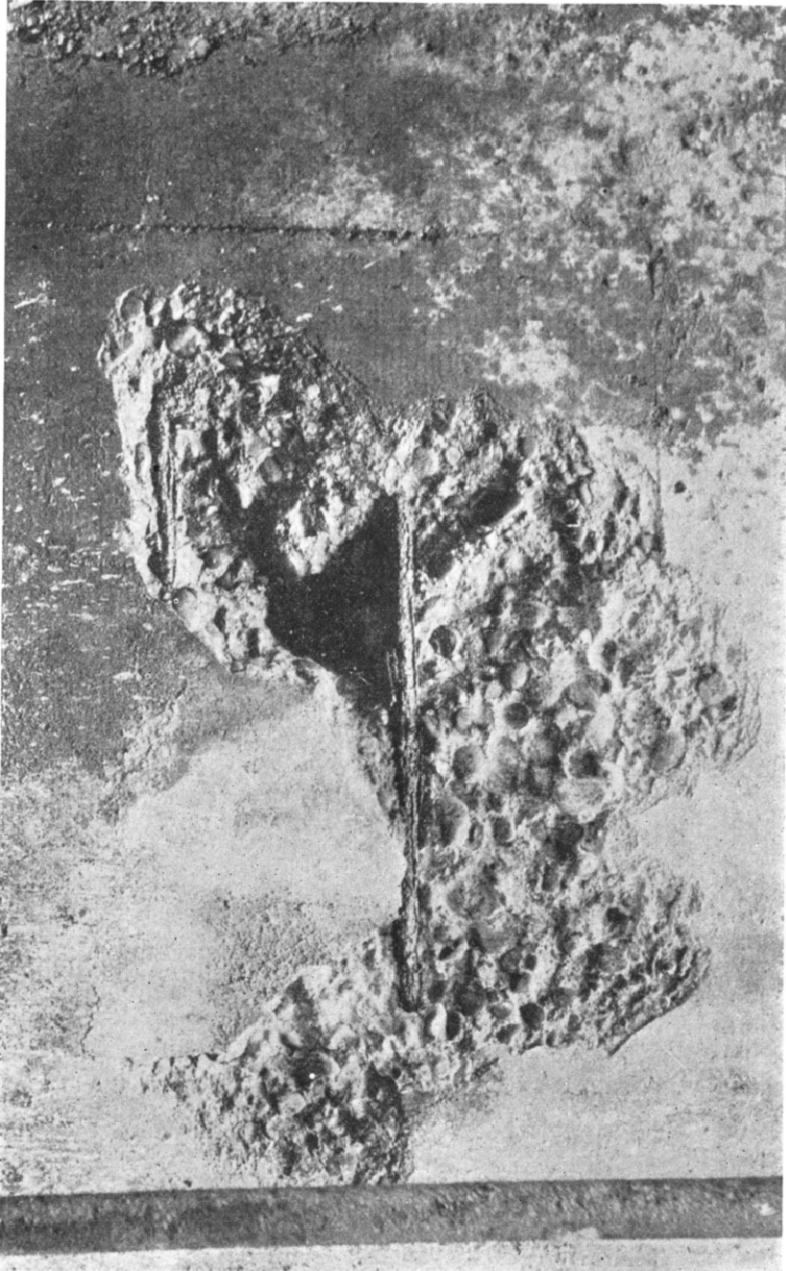
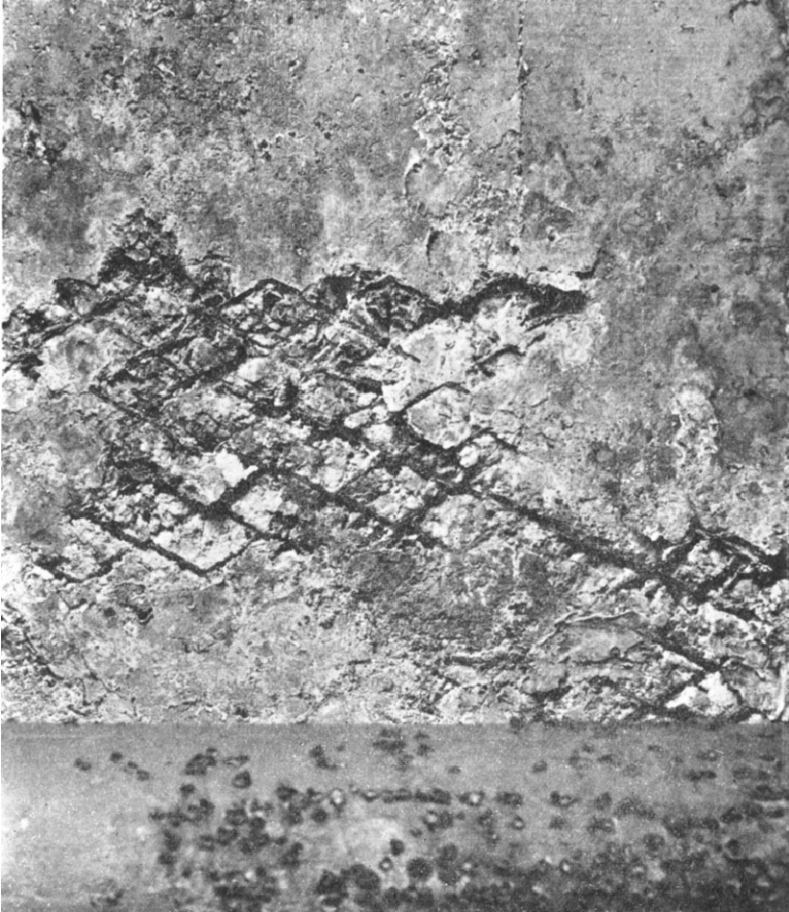
The ceiling of a machine shop of a large reinforced concrete plant in East St. Louis was found to be very badly damaged.

This building, at the time of inspection, was about ten years old. The upper side of the ceiling was continually wet with brine, which constantly leaked through to the under side and wetted it in a number of places. On this ceiling large, brown iron-stains were numerous and in at least twenty places pieces of concrete had fallen, leaving badly corroded, net-iron reinforce-

ments exposed. In one place a piece of concrete twelve feet long and varying from two to eighteen inches in width had broken away. The reinforcements of this ceiling were imbedded at a depth of about  $\frac{3}{4}$  inch from the surface. Photographs of this ceiling are shown in Figs. 6, 7 and 8. Examples similar to these have been observed by the writer in Chicago, Kansas City, Detroit, and Buffalo.

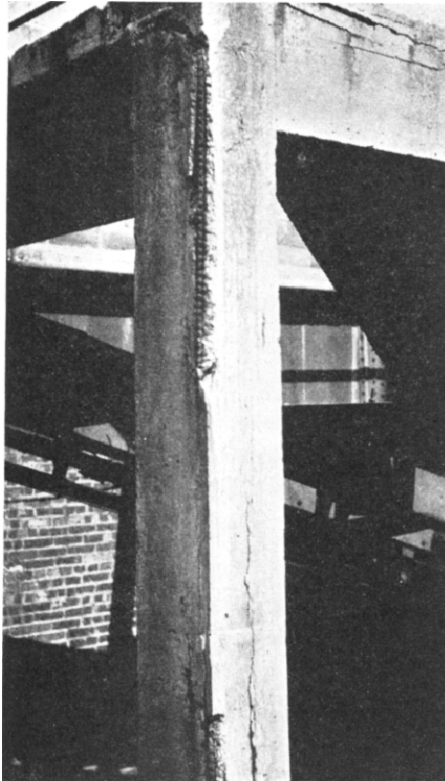
FIG. 9.

At a plant in Kansas City there was found a very interesting cracked reinforced concrete pillar which supported a reinforced concrete platform at the top of an outside staircase. Large quantities of salt were used in the plant, and the platform was often wet with brine. The cracks on the pillar ran parallel to the longitudinal reinforcing rods. In some places the concrete had fallen away from the rods, which were badly corroded, and in others portions of the concrete were easily pulled away. A photograph of this pillar is shown in Fig. 9.

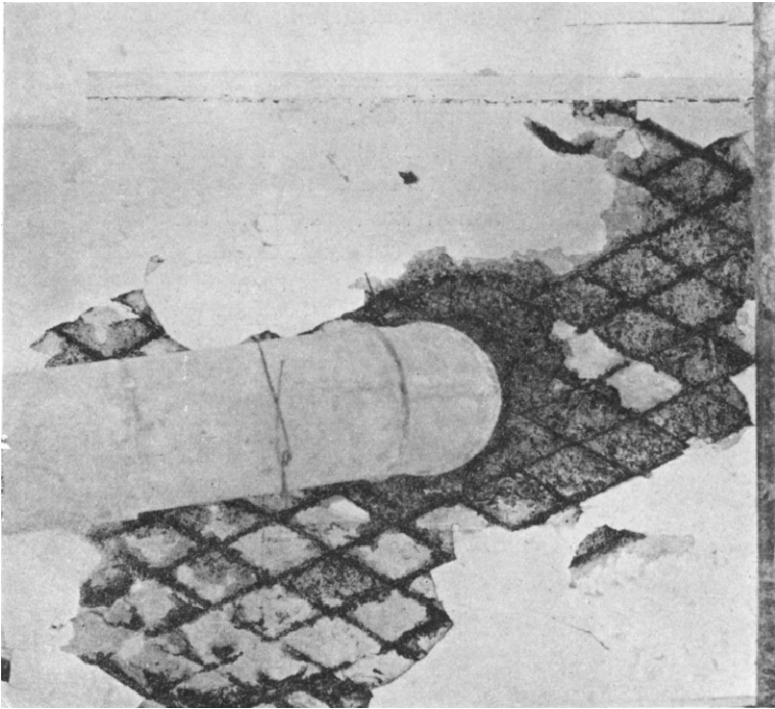
FIG. 10.

Similar cases to the foregoing have been found by the writer in a number of cities in different parts of the country. An excellent example of deterioration of reinforced concrete found in Buffalo is shown in Fig. 10.
