Low, W.A., McNally, A., Davies, B.K., Greenslade, P. (2012), Changes in vegetation over nine years after rehabilitating a linear feature in Australia's arid zone, *Nursing and Health Sciences*, 15(1):31-38

Changes in vegetation over nine years after rehabilitating a linear feature in Australia's arid zone

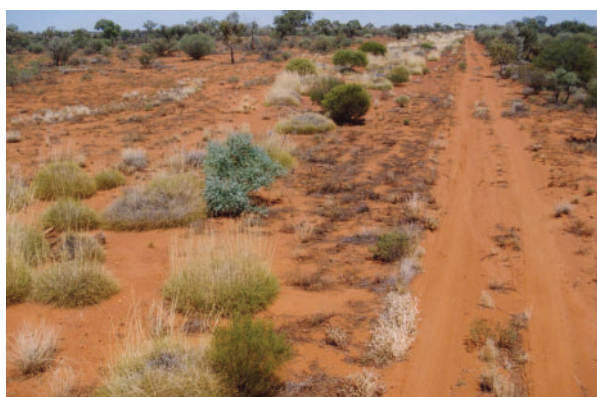
Fig. 2. The creation of a “Triodia road” is clearly delineated as the road passes through an *Acacia aneura* community. The access track at right follows the windrows.

dune crests. *Acacia aneura* (Mulga) and perennial grasses occur on the red earth swales (Fig. 2), and *T. pungens* with occasional *Allocasuarina* sp. (Desert Oak) occurs on the red earthy sand swales (Allan 1984). Minor vegetation assemblages are found on rocky outcrops, in creeks and gorges, and around salt lakes (Allan 1984). All creek crossings sampled were within drainage lines of Land Unit 3b. The botanical names used follow the Australian Plant Names Index (2012).

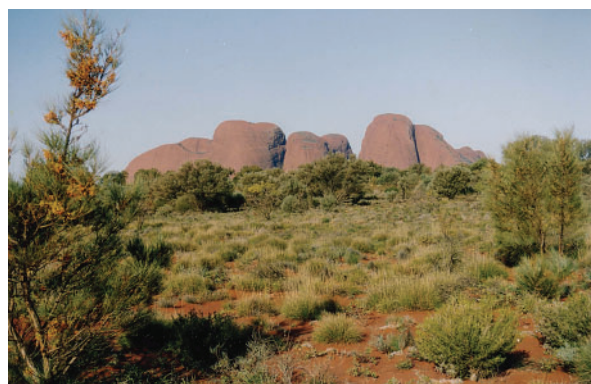
Fig. 4. Natural vegetation surrounding the source material of the road fill. This Fig. shows a soft spinifex community dominated by *Triodia pungens*, with *Grevillea juncifolia* in the foreground and *Allocasuarina decaysneana* and *Aluta maisonneuvii* to the left.

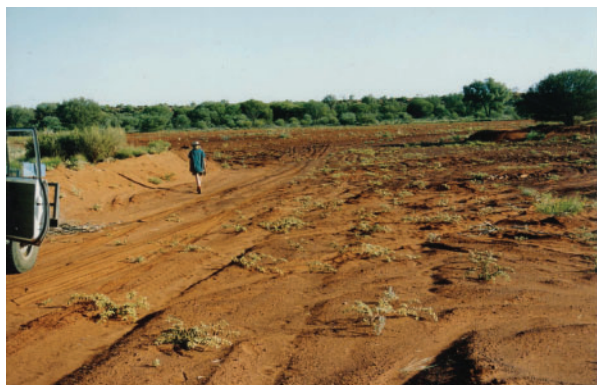
Fig. 3. The sand quarry where the fill for the rehabilitation of the road was sourced. Notice the depth of the soil removed (over 1 metre). Some road areas may have been filled with soil from this depth, hence the poor growth results for some areas.

Rehabilitation of the road involved first ripping, mainly longitudinally along the road surface, but if slope was excessive, a sinuating pattern of rips were made (Fig. 3). The depressions were filled with imported sand from the Simpson Land System, (Land Unit 5d1, Allan 1984; Fig. 4). Ripping has been shown to be beneficial in restoring infiltration capacity (Luce 1997). Finally the windrows were scalped of top soil from the edge of the road and the material graded over the road into the centre so that the surface was re-contoured to relate to the surrounding environment. A single trial site (site 23), was established in September 1992 along a 200–300 m stretch of road with brush to provide cover.

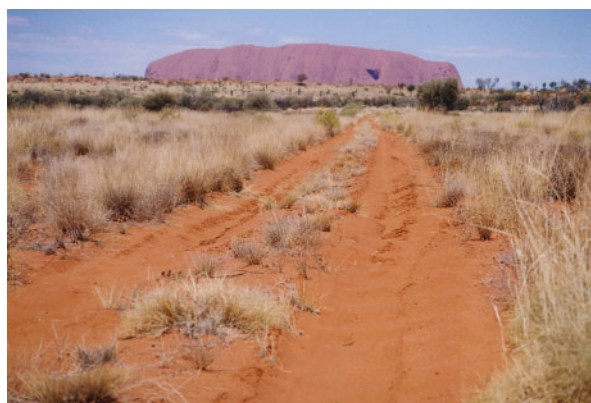
Fig. 5. Site 6A and B in 1992 (Simpson Land System). Initial revegetation in this sandy land unit where road fill is similar to adjacent soils is progressing well.

On long slopes, diversion banks were cut diagonally across the rehabilitated road every 200–300 m to force water into adjacent land units where the slope was 3% or more. These diversion banks were constructed over the whole 35 km of the road and their position was determined by slope. No maintenance has been carried out on the road since then and traffic has been minimal and restricted to the occasional maintenance and indigenous vehicle (Fig. 5).

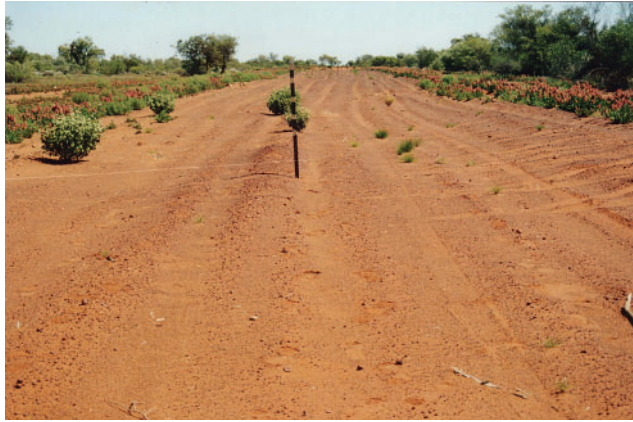
Fig. 6. Site 12A and B (Gillen Land System) 10 months after rehabilitation in 1992. The road remains bare, whilst *Acetosa vesicaria* dominates the verge. Note the relatively poor growth due to being overlain with sub soil.

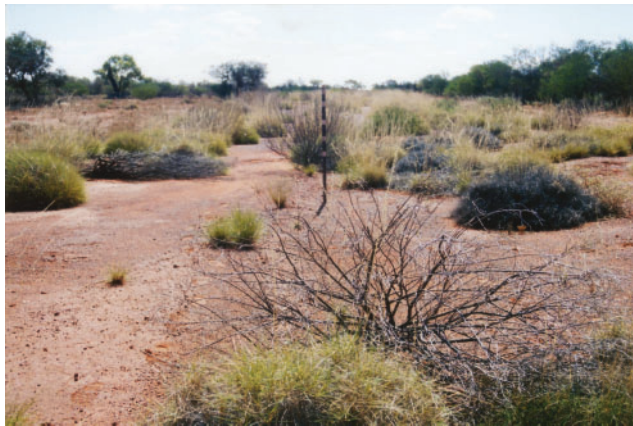
Fig. 7. The same site (Site 12A and B) in 1999, 8 years after rehabilitation. Note the dominance of the dune field species *Triodia pungens* and *Eragrostis eriopoda*. Also note the relatively poor herbaceous cover at this site due to the use of subsoil fill material.

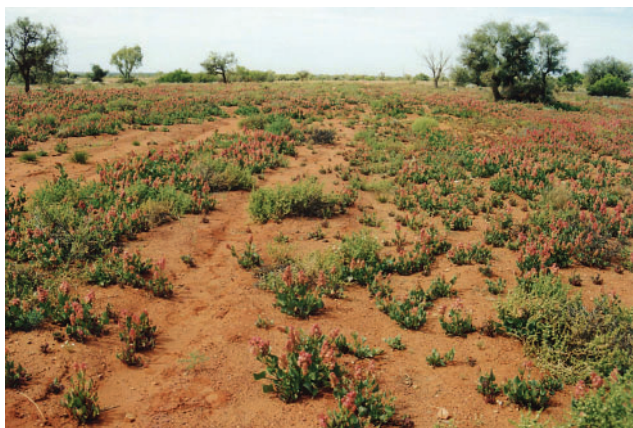
Fig. 8. Site 10 in 1992, 10 months after rehabilitation (Gillen Land System). The road has revegetated more quickly than Site 12 due to being overlain with topsoil fill. The weed species *Acetosa vesicaria* has colonised the road surface.

Within the Gillen Land System, the trajectories of each sub-site 10A, 10B (Figs 8, 9) and 11B were similar, although *Sclerolaena cornishiana* (Cartwheel Burr) dominated the road and windrows, and *Eremophea spinosa* the reference sites in later years (Fig. 28). In the same land system, the road site (sub-site 12A) has clustered closely in the *T. pungens* species space continually, although *T. pungens* comprised less than 10% of windrows. The reference sites (sub-site 13A) and the windrows (sub-site 12B) were similar in that they were variable over time but with *Sclerolaena convexula* (Tall Copper Burr) dominant in 1999 (Fig. 29).

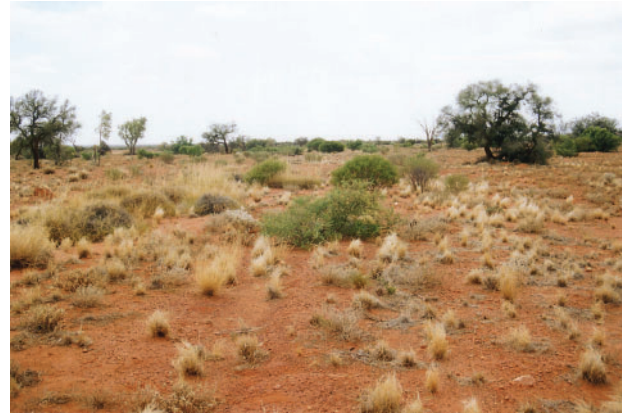
Fig. 9. The same site (Site 10) in 1999. This figure illustrates the dramatic change in species composition and dominance since 1992. The ground cover is becoming similar to adjacent areas. *Acetosa vesicaria* is absent. The site is dominated by dune field species including: *Triodia pungens*, *Aristida* spp. and *Aluta maisonneuvii*. Once again the growth at this site can be attributed to being overlain with topsoil, not subsoil like Site 12.

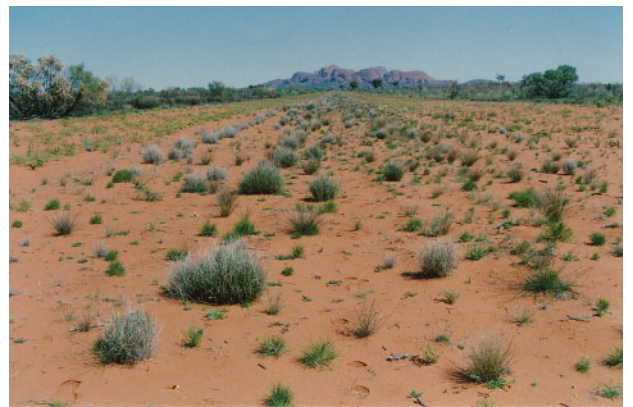
Fig. 10. Site 6A and B in 1992 (Simpson Land System). Initial revegetation in this sandy land unit where road fill is similar to adjacent soils is progressing well.

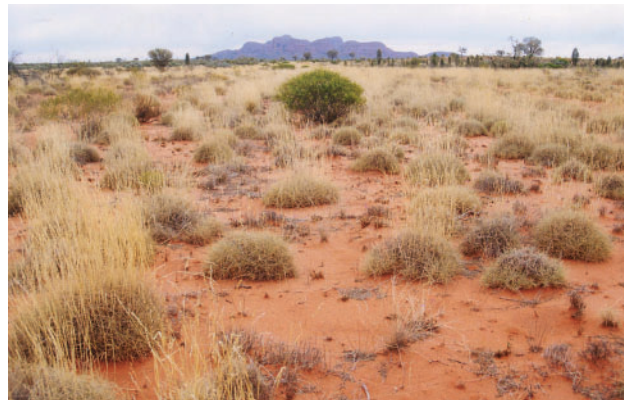
Fig. 11. The same site (10) in 1999, 8 years later. The site has revegetated well and now looks similar to the adjacent vegetation. The successful revegetation of this site with appropriate species is typical of the rehabilitated sites of the Simpson Land System.

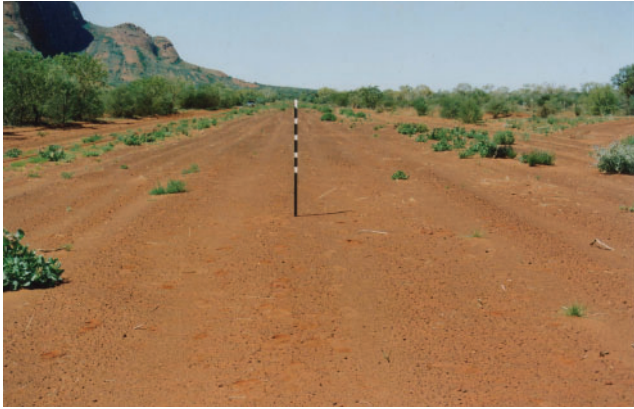
Fig. 12. Site 14C and D (Karee Land System) 1992, 10 months after the rehabilitation. Lack of growth due to land fill being sub-soil and local windrow material was insufficient to cover land fill. The windrow has been colonised by pioneer species such as *Salsola kali* and the introduced Ruby Dock.

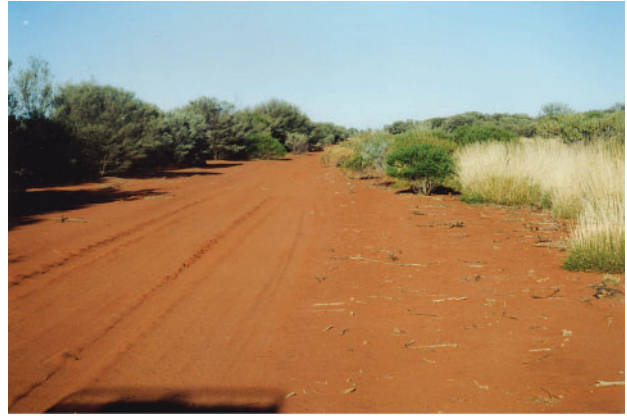
Fig. 14. A mulga swale south of Site 3, 1999, in Simpson Land System. Scalped material from the windrow to recover local top soil to cover the sand plain land fill was insufficient and the windrow area to the left was left unproductive. In contrast to this, the road area to the right has regenerated well.

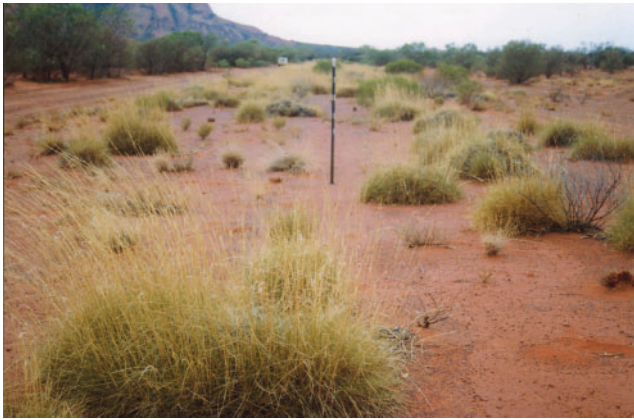
Fig. 13. Site 14C and D eight years after rehabilitation is dominated by dune field species *Triodia pungens* and *Acacia ligulata*. *Alyogyne pinoniana* has germinated and died within the eight-year period. The windrows are comparatively bare, possibly due to scalping during rehabilitation, *Acacia aneura* delineates the surrounds and *Triodia pungens* the road.

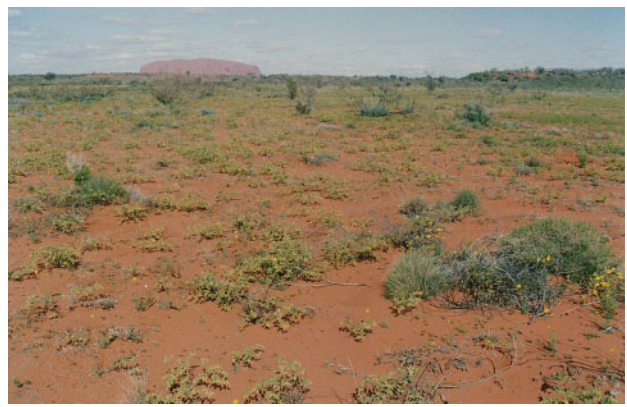
Fig. 15. Site 5, a control burnt site 10 months after burn in 1992. *Rulingia loxophylla* has abundantly resprouted from rootstock. *Rulingia* also resprouted profusely at many of the scalped windrow sites.

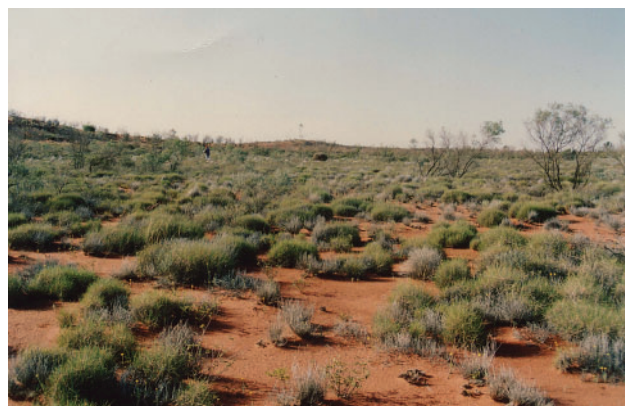
Fig. 16. Site 4, the adjacent unburnt control site, 1992 (Simpson Land System). This site hasn't been burnt for quite a while as evident from the presence of mature spinifex clumps. *Triodia pungens* and *Eragrostis eriopoda* are well established.

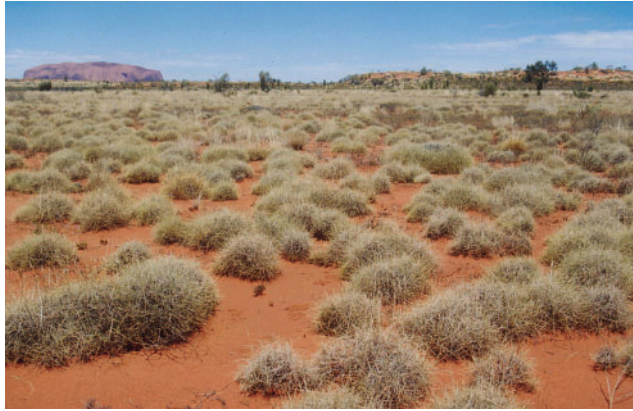
Fig. 17. Site 5, burnt control eight years later (refer Fig. 15). *Rulingia loxophylla* has been replaced by *Triodia pungens*. This site is now floristically similar to the adjacent unburnt control site (Site 4).

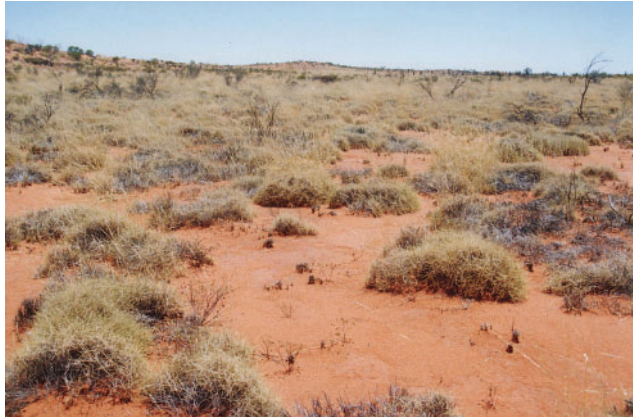
Fig. 18. Unburnt control site (Site 4) in 1999. Although more established, the vegetation of this site is similar to that of the adjacent burnt control site (refer Fig. 17 above). The site is dominated by *Triodia pungens* with *Acacia aneura* shrubs in the background. *Grevillea juncifolia* has matured and died.

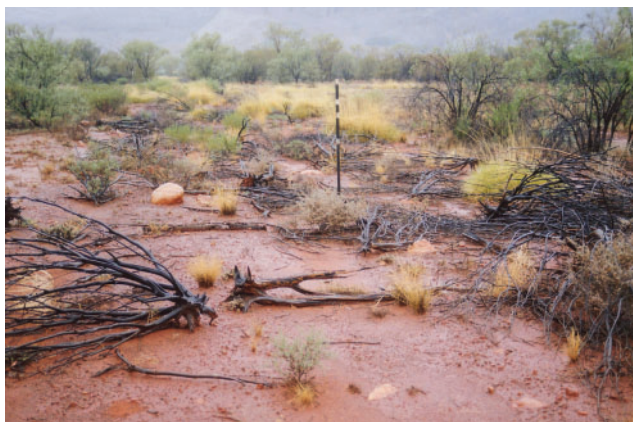
Fig. 19. Site 23A Brush covered site in 1999. This site has remained covered throughout the monitoring period. It has regenerated well.

In the brush cover study, the uncovered site 23B, although slower to revegetate, had a greater species richness by almost two-thirds than the brush-covered site (23A) by 1999 but, without replication, this result is not indicative of an effect. *Triodia pungens* and *Eragrostis eriopoda* persisted on both sites (Figs 19, 20).

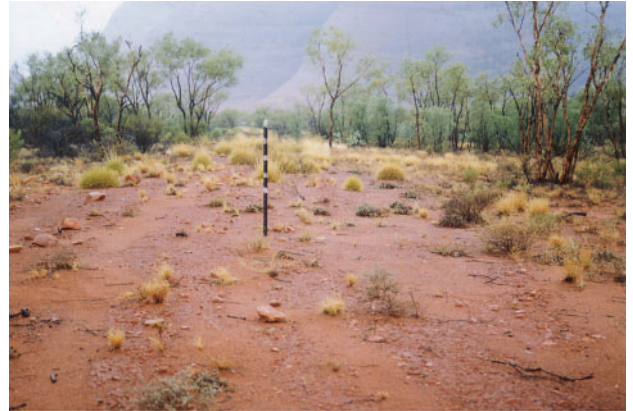
Fig. 20. Site 23B Brush cover trial site, uncovered site, 1999. Although slower to start, after 8 years of rehabilitation the uncovered site has a similar level of vegetative cover to the covered site (see Fig. 19) and supports a greater species diversity.

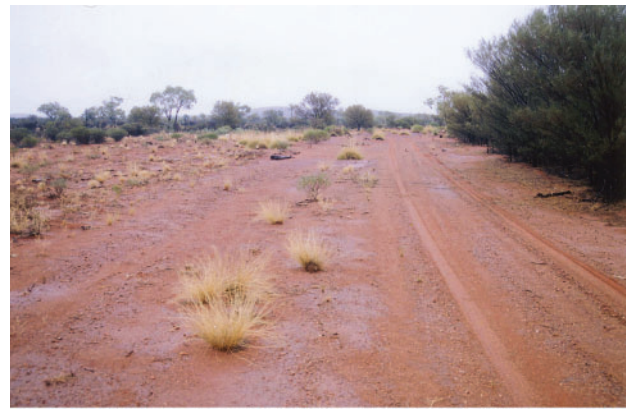
Fig. 21. A mulga swale in the the Old Kata Tjuta Road in Karee LS 8 years after rehabilitation. The reconstructed surface has held its form quite well. However, revegetation is much slower to respond here due to the sand used as landfill originating from deep within the soil profile.

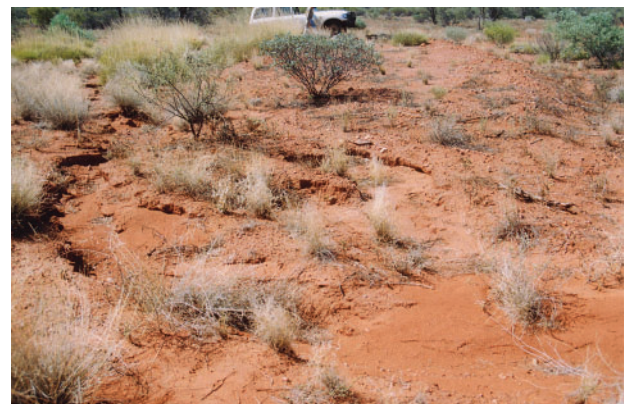
Fig. 22. Runoff from in front of pond bank on the road south of Kata Tjuta near Site 12 has lead to rilling on the lower end of the pond bank. However, the runoff has been effectively dispersed as sheet flow over the natural plain downstream.

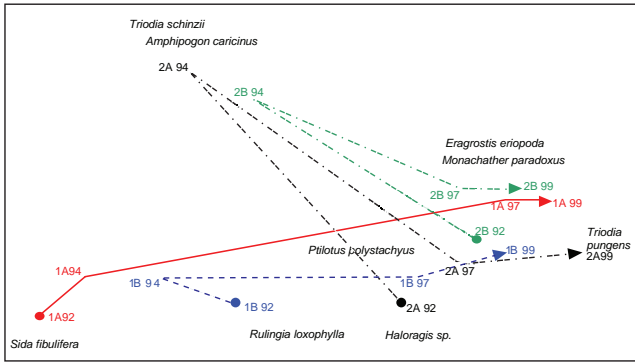
Fig. 23. Ordination of herbage composition for Simpson land system, sites 1 and 2 (1992–1999). Sub-site locations are represented by continuous line for road (1A); dashed line for windrow (1B); dashed and dotted line for natural vegetation (reference sites) (2B (part burnt)); and dotted line for burnt natural vegetation (2A). The number represents the year sampled.

In the Simpson Land System, trends for sites 1 as well as 2, although variable, cluster with *T. pungens* by 1999 with burnt sites (sub-sites 2A, 2B) showing the closest affiliation with this species. By 1997, *T. pungens* and *Eragrostis eriopoda* (Woollybutt Grass) were becoming uniform across all sub-sites (Fig. 23). In the same system, on all sub-sites of sites 3, 4, 5, (Figs 14–18, 24) dominant species have changed with *Triodia basedowii* (Hard Spinifex) becoming more dominant though time, although the road sub-site changed from a *Sida fibulifera* (Silver Sida) dominance, in 1992, to *E. eriopoda*, with a *T. pungens* influence in 1999. The dominant species of windrows sub-site 3B were *Sida cardiophylla* and *Rulingia loxophylla* although in 1999 the site was heading towards *E. eriopoda* dominance. The burnt sub-site (sub-site 5A) was similar to the windrows (Fig. 24). On sites 6 and 7, *R. loxophylla* has remained dominant on the windrows throughout monitoring but *T. pungens* replaced *T. basedowii* on the reference site and road (Fig. 25).

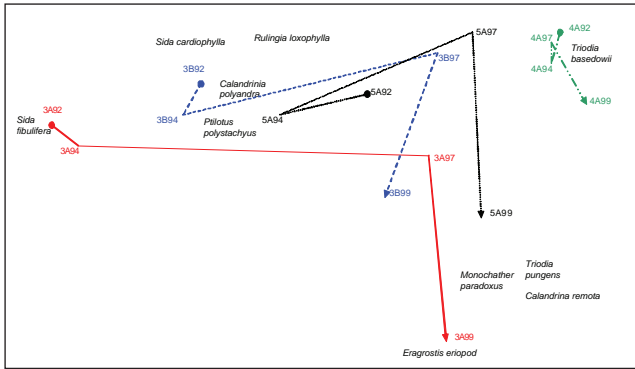
Fig. 24. Ordination of herbage composition for Simpson land system, sites 3, 4 and 5 (1992–99). Sub-site locations are represented by continuous line for road (3A); dashed line for windrow (3B); dashed and dotted line for natural vegetation (4A); and dotted line for burnt natural vegetation (5A). The number represents the year sampled.

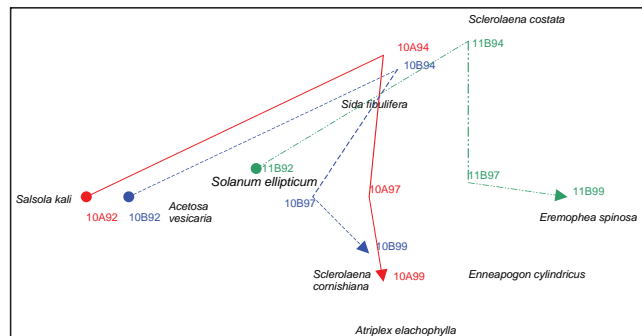
Fig. 28. Ordination of herbage composition for Gillen land system, sites 10 and 11 (1992–99). Sub-site locations are represented by continuous line for road (10A); dashed line for windrow (10B); and dashed and dotted line for natural vegetation (11B). The number represents the year sampled.

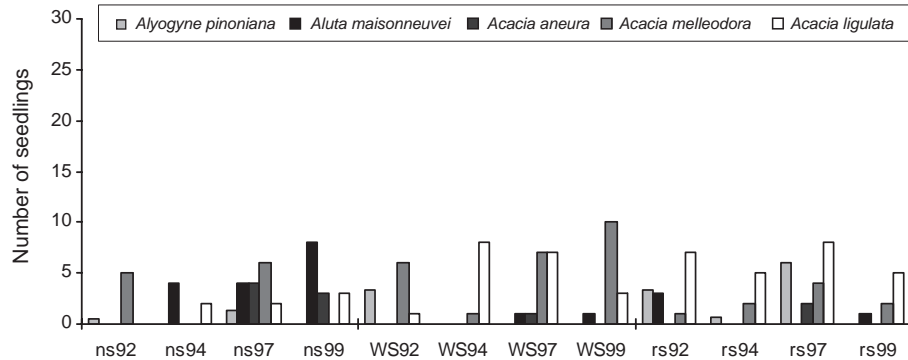
Fig. 30. Tree and shrub seedlings of selected species recorded in the Simpson land system (1992–1999). Sub-sites are represented by the prefixes: ns, natural; ws, windrow; and rs, road. The number represents the year sampled.

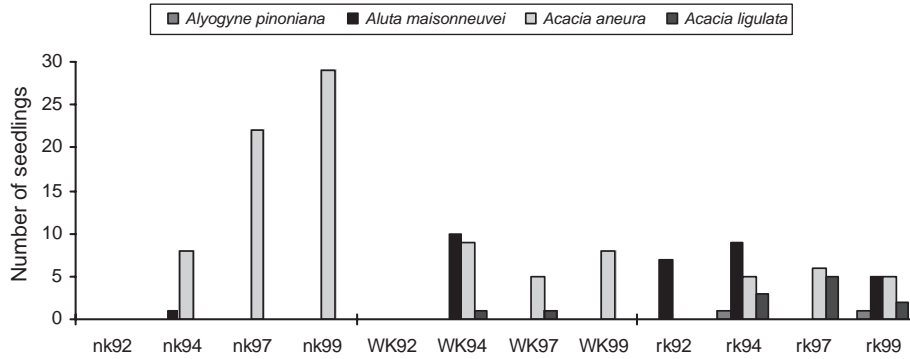
Fig. 32. Tree and shrub seedlings of selected species recorded in the Karee land system (1992–1999). Sub-sites are represented by the prefixes: nk, natural; wk, windrow; and rk, road. The number represents the year sampled.

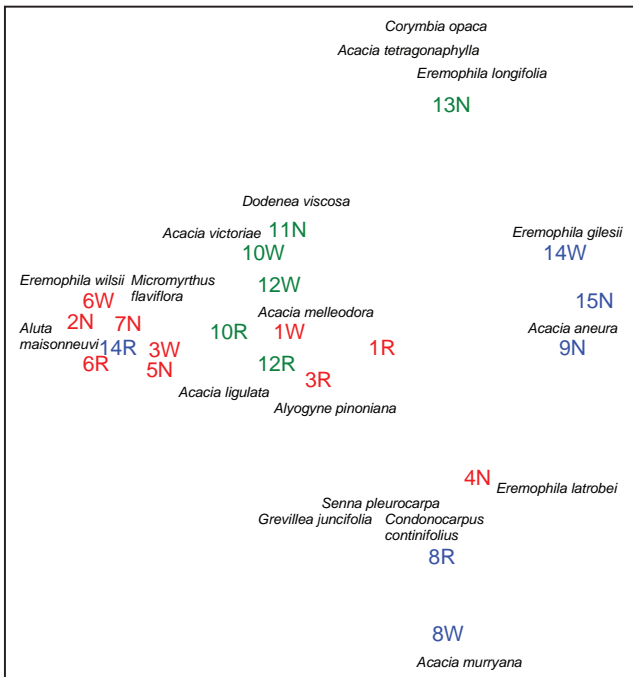
Fig. 33. Ordination of juvenile tree and shrub densities for 1999 for the all sub-sites. Sub-sites are numbered as in Table 1, with R for road, W for windrow and N for undisturbed vegetation.

have clustered within the dune field species (Fig. 34). The dominant juvenile species present in these rehabilitated areas were *A. melleodora* and *A. pinoniana*. Both road and windrows at site 8 (Karee) are located in a transitional species space in the ordination plot because of dominance by *Acacia murrayana* (Colony Wattle), common in dunefields and other sandy soils (Latz 1995). Only windrows at site 14 (Karee) carried juvenile species representative of the local system (Fig. 33).

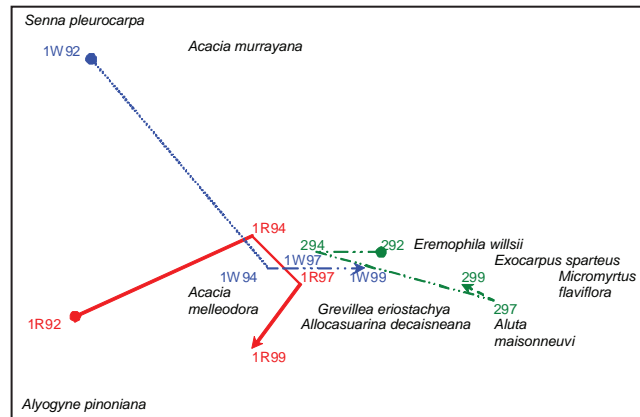
Fig. 34. Ordination of juvenile tree and shrub densities for Simpson land system, sites 1 and 2, (1992–1999). Sub-site locations are represented by continuous line for road (1R); dotted line for windrow (1W); and dashed and dotted line for natural vegetation (2). The number represents the year sampled.

This pattern is clearer in the trajectories of juveniles for all sites and for all years in the Simpson System (Figs 34, 35). On sites 1 and 2 the trajectory for the road (site 1R) is away from *A. pinoniana* dominance in 1992 because of the increased density of juvenile *A. melleodora* in 1994 and 1997, and returns to *A. pinoniana* dominance in 1999 as Fig. 34. Although the windrows were dominated by *Senna pleurocarpa* (Fire Bush) in 1992, by 1999 the dominant species of juvenile plants was more
