A CHARACTERIZATION OF LANDSLIDE OCCURRENCE IN THE KIGEZI HIGHLANDS OF SOUTH WESTERN UGANDA

Thesis Submitted to the Faculty of Science at Nelson Mandela University
In Fulfilment of the Requirements for the Degree of
PHILOSOPHIAE DOCTOR

December 2018

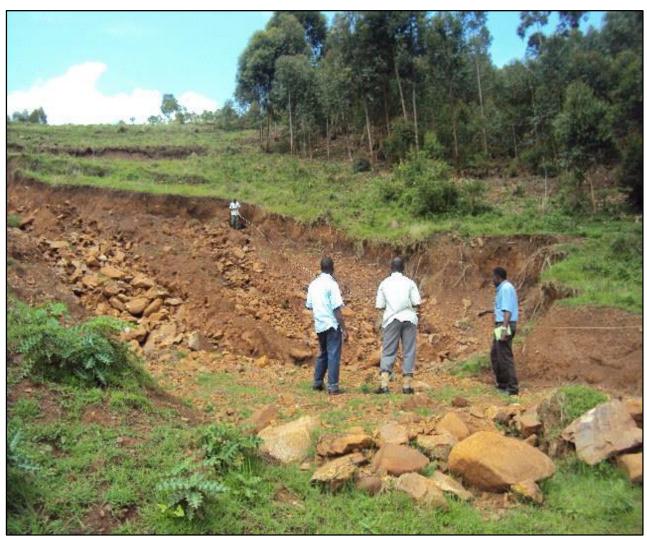
Fig. 3.1: Field investigations to map and measure landslide scars and their distribution.

Landslides were surveyed by focusing on relief features such as concave and convex forms, slope gradient variations, shape of slope meso-forms, fractures, and other non-anthropogenic linear elements. Field surveys and measurements of landslide sites was done in relation to slope position and other topographic parameters (Fig. 3.1). The dimensions of landslide scars were established by carrying out measurements of their average width, depth and overall length from head to toe using tape measures. Landslide morphological analysis was carried out from the valley bottoms

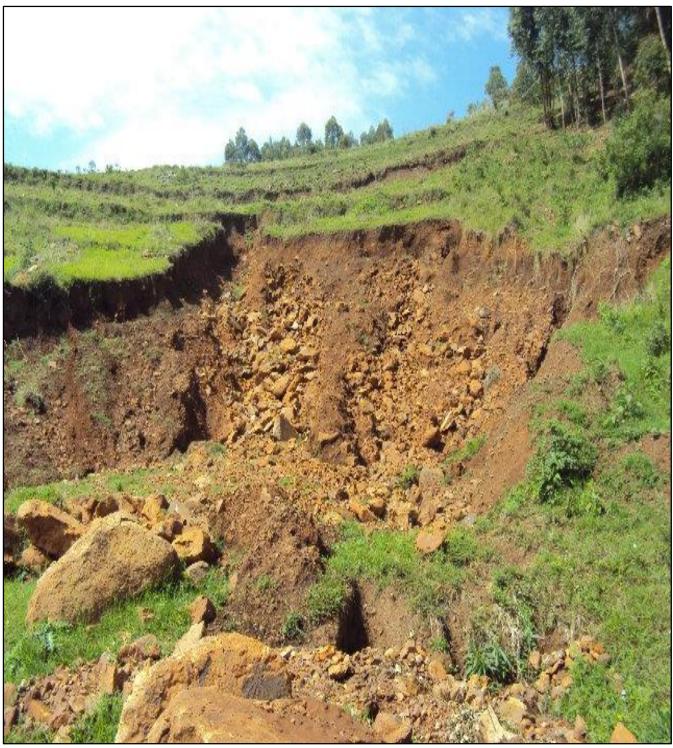
Fig.3.3: Landslide occurrence in Kigezi highlands.

About 51% of landslide scars have a number of tongues which converged together following topographic hollows. Convergence of the landslide arms occurred in zones where two or more topographic hollows from upslope joined into one wider hollow.

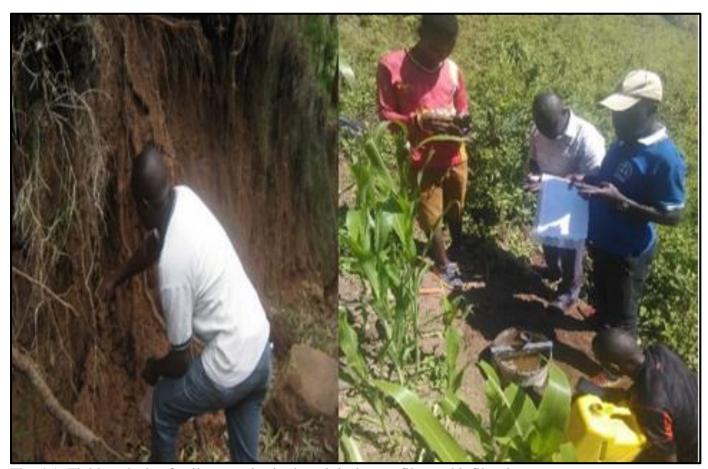
approximately the same level in order to promote vertical water movement and prevent lateral flow. A ruler was firmly placed vertically into the inner ring and water was poured continuously in both the inner and outer rings (Fig. 4.1). The time taken to reach steady state water infiltration rate at all sites varied between 1 and 2 hours. The drop-in water level or volume in the inner ring was used to calculate an infiltration rate.

Fig. 4.1: Field analysis of soil properties in the mini-pits, profiles and infiltration tests.

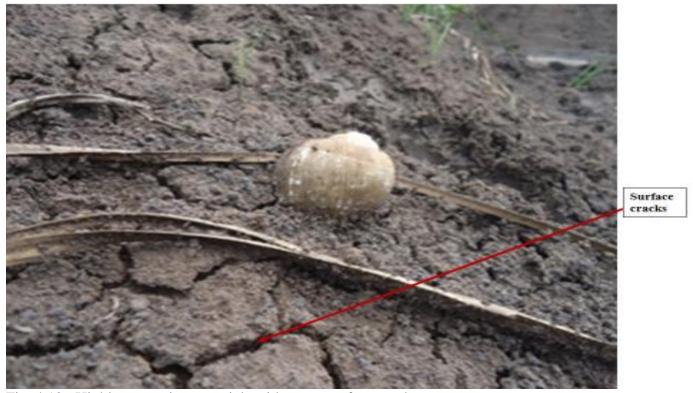
Fig. 4.12: Highly expansive materials with many surface cracks.

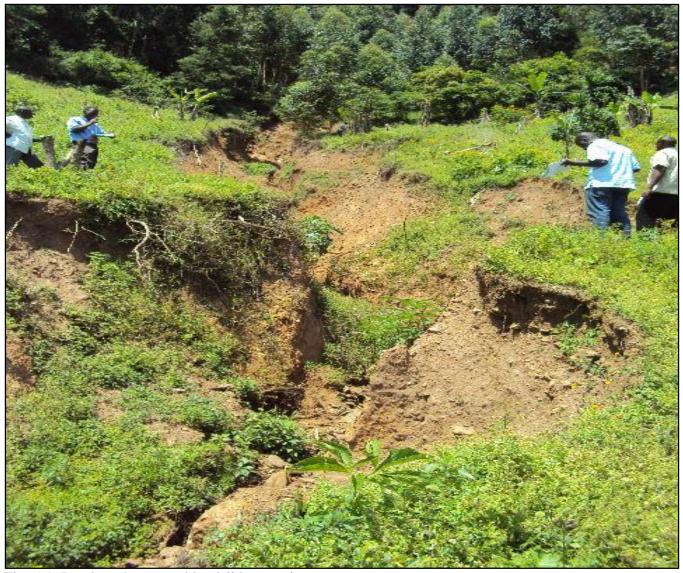
Fig. 5.1: Land-use/cover and landslide mapping

Two methods were used to identify the spatial-temporal landslide distribution in the study area. These were aerial photograph interpretation, field surveying and mapping. Aerial photograph interpretation (API) was used to identify the past landslide scars which occurred before 2005. These landslide scars are no longer visible on the landscape due to the high rates of vegetation regeneration. The landslide scars are easily concealed by soil materials mobilized from the hilltops and spur slopes into topographic hollows where landslide occurrence is dominant. The soils accumulating within the landslide scars encourages rapid vegetation regeneration, owing to the high rainfall amounts in the study area. It is only aerial photographs taken during the period when the scars were still visible, that can be used to identify and analyse such landslides. The advantages of using API in landslide investigations include rapid definition of landslide boundaries, identification of large landslides, and an appreciation of slope conditions (Rembold et al., 2000). Black and white aerial photographs for three different periods including 1985, 1995, and 2005 (Table 5.1) were used to assess the location of historical landslide scars in the study area. Following Zone (2007), a mirror stereoscope with dimensions 718 x 260 x 310 mm with an optical path of 50mm which allows the viewer to magnify on areas of interest was used to analyse the aerial photographs and identify the historical landslide scars within the study area. The landslide scar details from the aerial photographs were scanned, digitized and their locations were analysed using ArcGIS software. The scanned/ digitized landslide scar locations from the aerial photographs were incorporated with the rest of the field mapped landslide scars to generate landslide distribution maps for the study area in a GIS environment.

Field surveying was undertaken to identify and map visible landslide scars in the catchment as presented in Chapter 3 on topographic parameters. Field investigations were undertaken between June 2014 and August 2016 to identify visible landslide scars in the catchment (Fig. 5.1). The landslide scars were mapped using handheld GPS recievers. Coordinates for the mapped landslide scars were imported into ArcGIS 10.1 software to produce a landslide distribution map for the study area. Through spatial analysis in a GIS environment, the landslide and land use/cover maps were overlain to derive the requisite relationships.
